CONCRETE AND WOOD TIE PERFORMANCE THROUGH 425 MGT

TRANSPORTATION TEST CENTER
PUEBLO, COLORADO 81001

1. Report No. FRA/TTC-81/06		2. Government Accession No.		3. Recipient's Catalog No. PR82 200379	
4. Title and Subtitle Concrete and Wood Tie Performance, 425 MGT				5. Report Date October, 1981

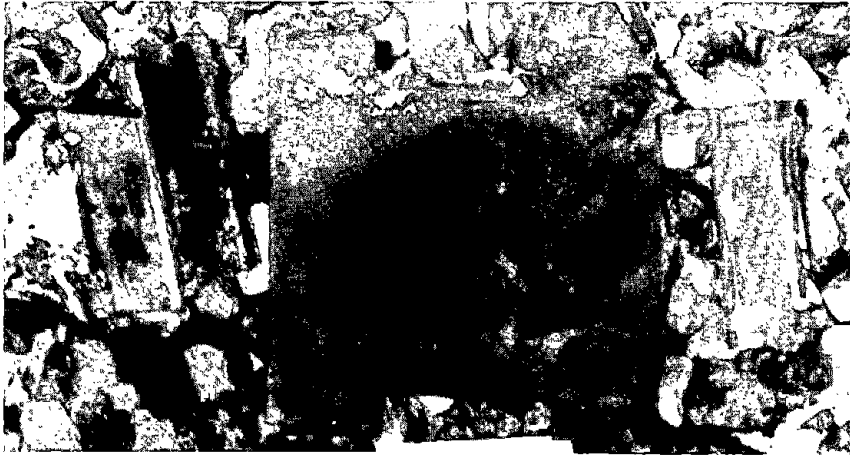
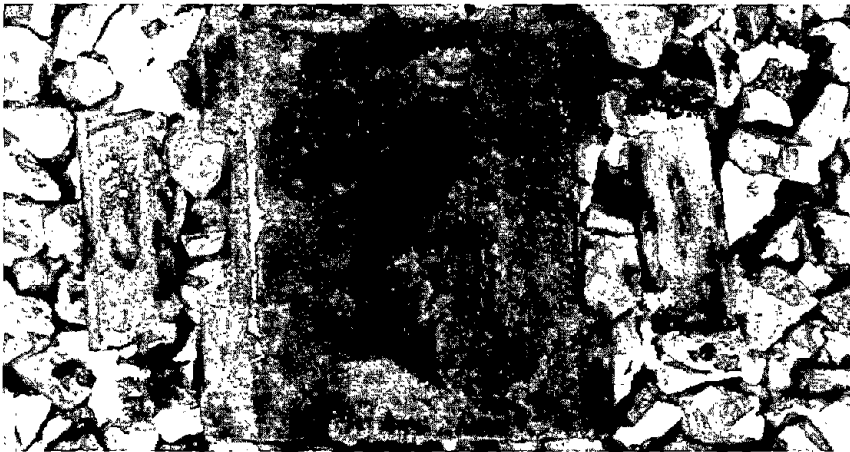
FIGURE 5-8. TYPICAL CONDITION OF PADS FROM 3° CURVE
OF SECTION 17, 235 MGT.

Type P-2
Soft corded
rubber pad

Type P-8
hard poly-
ethylene pad

Type P-7
Soft, grooved
rubber pads

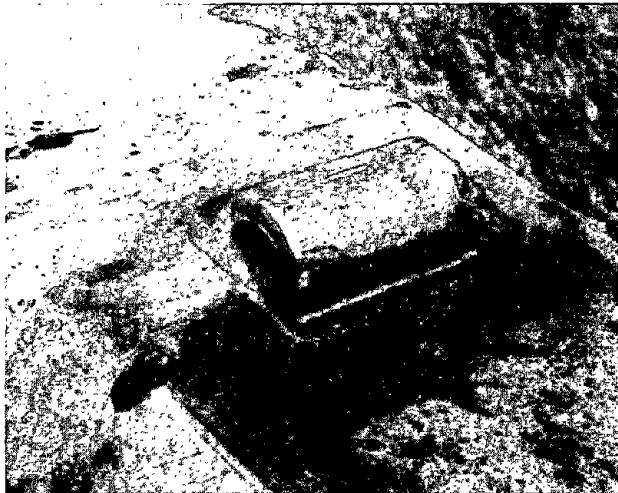
FIGURE 5-10 FASTENER SHOULDER WEAR.

frequently exceeded 1/8" and ranged up to 3/16". Wear up to 1/8" also was found in subsection H₁. This type of wear will result in gage widening and could eventually result in loss of ties, unless weld repair of the shoulders is undertaken.

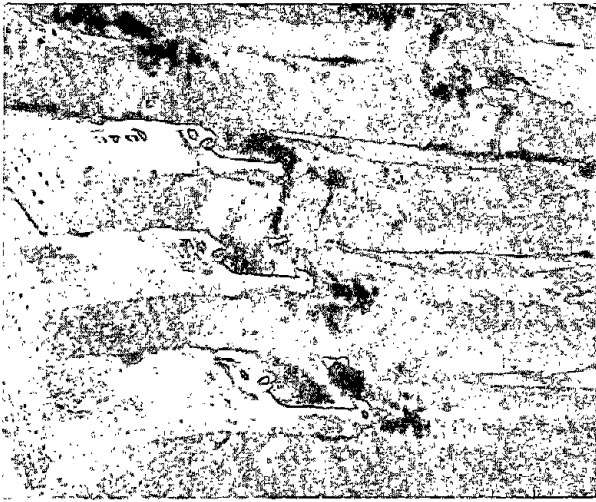
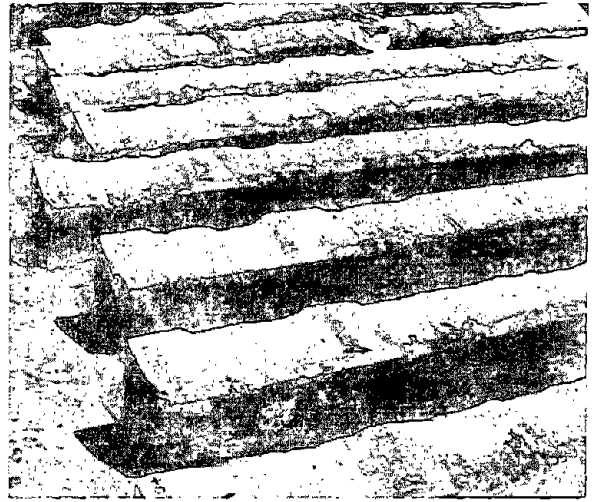
FIGURE 5-11 GENERAL CONDITION OF TIES REMOVED FROM SECTION 17.

Type T-2 Ties

Type T-1 Ties

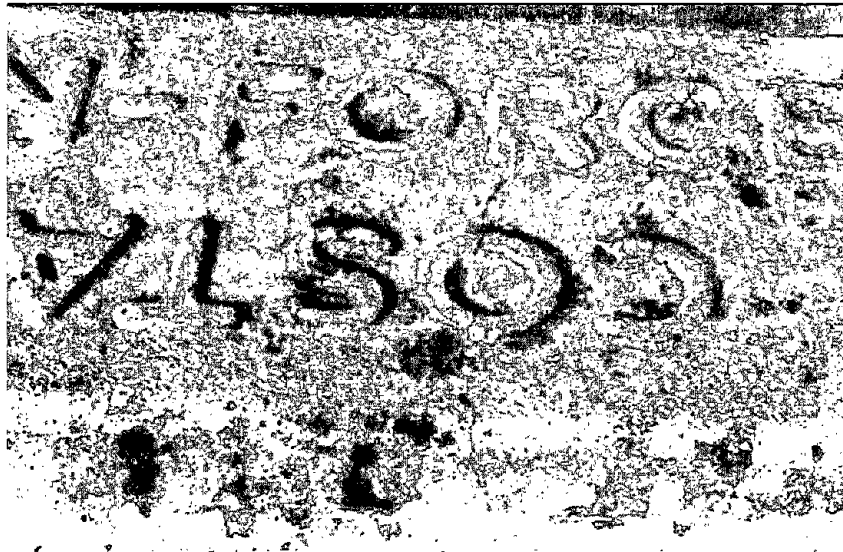
FIGURE 5-12 TOP SURFACE CRACK PATTERN ON TYPE T-1 TIES.

- Top surface cracks as shown in Figure 5-12 could be seen on many of the Type T-1 ties from a small region of the curve. These cracks were discovered very early in the operations program and were originally inspected at 100 MGT. It was noted that they had grown very little in the following 325 MGT. The original inspection identified 35 ties with cracks of this type, 32 of which were located in a zone of 141 ties in subsection 17A, which contained hard polyethylene pads. The top center cracks were

noticed very early in the FAST operations program, and observers have reported that they grew very little after first appearing. Therefore, the cracks could have been caused by an initially poor ballast support condition.

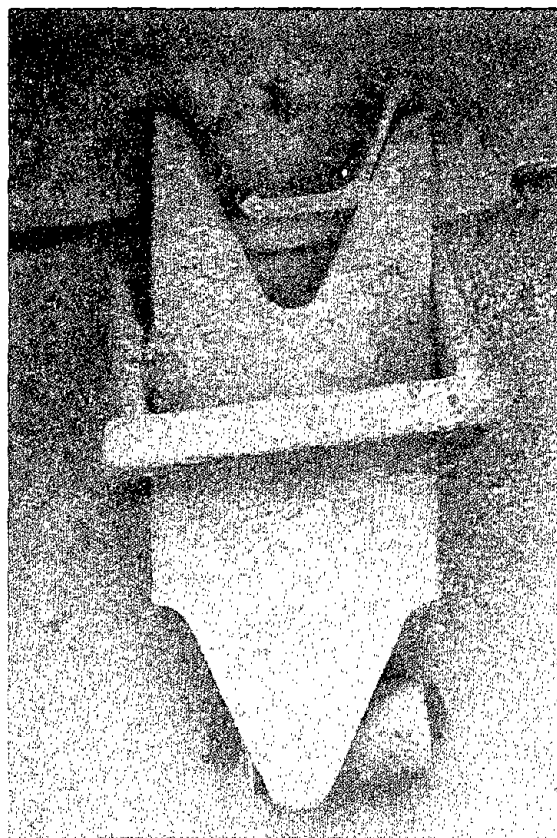
(c) Insulator Broken,
Clip Displaced

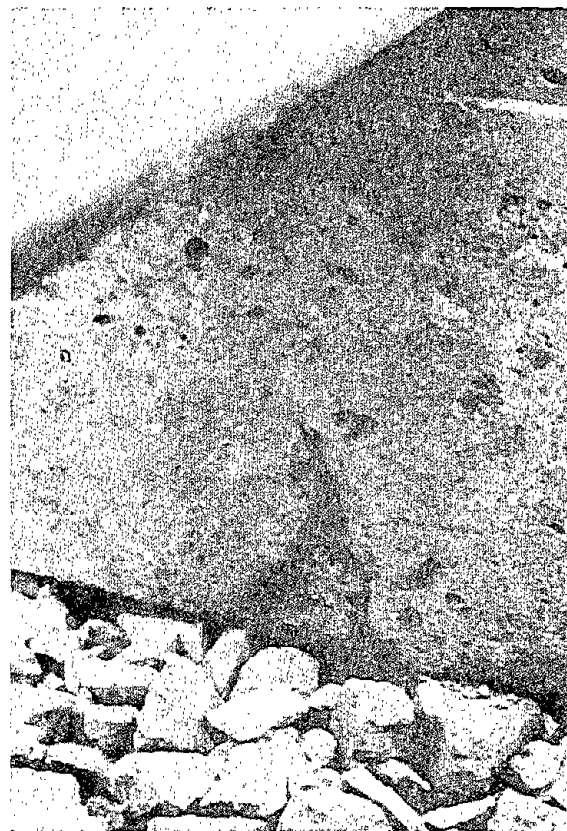
(d) Rail Seat
Bending Crack
