**Federal Railroad
Administration**

Performance of Degraded Roller Bearings

6. AUTHOR(S) Kevin Kesler and Chris Tinto		Revised: 12/28/90	
7. PERFORMING ORGANIZATION NAME(S) AND ADDRESS(ES) ENSCO, Inc. Applied Technology and Engineering Division 5400 Port Royal Road Springfield, VA 22151		8. PERFORMING ORGANIZATION REPORT NUMBER DOT-FR-89-08

9. SPONSORING/MONITORING AGENCY NAME(S) AND ADDRESS(ES) Federal Railroad Administration Department of Transportation 400 Seventh St., S.W. Washington, DC 20590		10. SPONSORING/MONITORING AGENCY REPORT NUMBER FRA/ORD-90/12

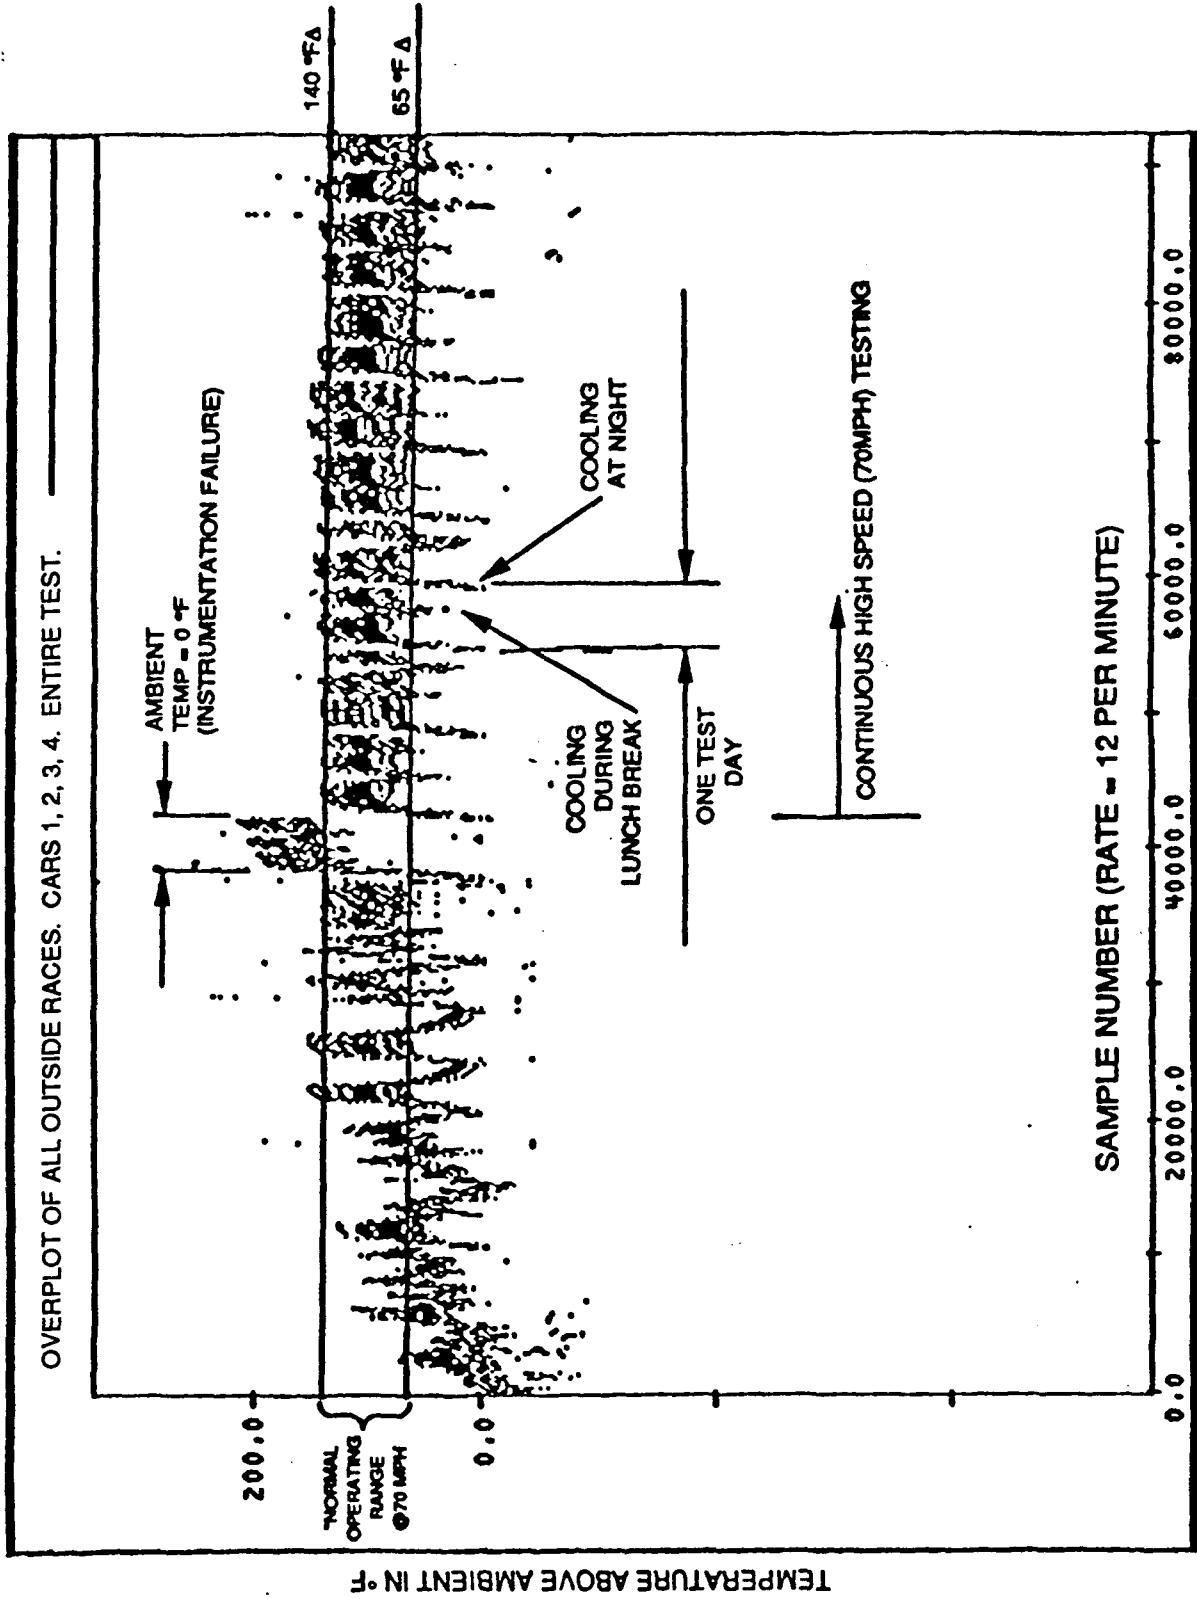
FIGURE 4-1

The operating temperatures for each of the bearings for the entire 5,000-mile test are plotted together in Figure 4-1. The cyclic pattern evident in the data is typical of heating and cooling of the bearing at the beginning and end of the test day. The range of operating temperatures for the entire test for all "normally" operating bearings (normal meaning no thermal runaway) ranged between 65°F and 140°F (18° C and 60° C) above ambient at 70 mph with a full 100-ton load.

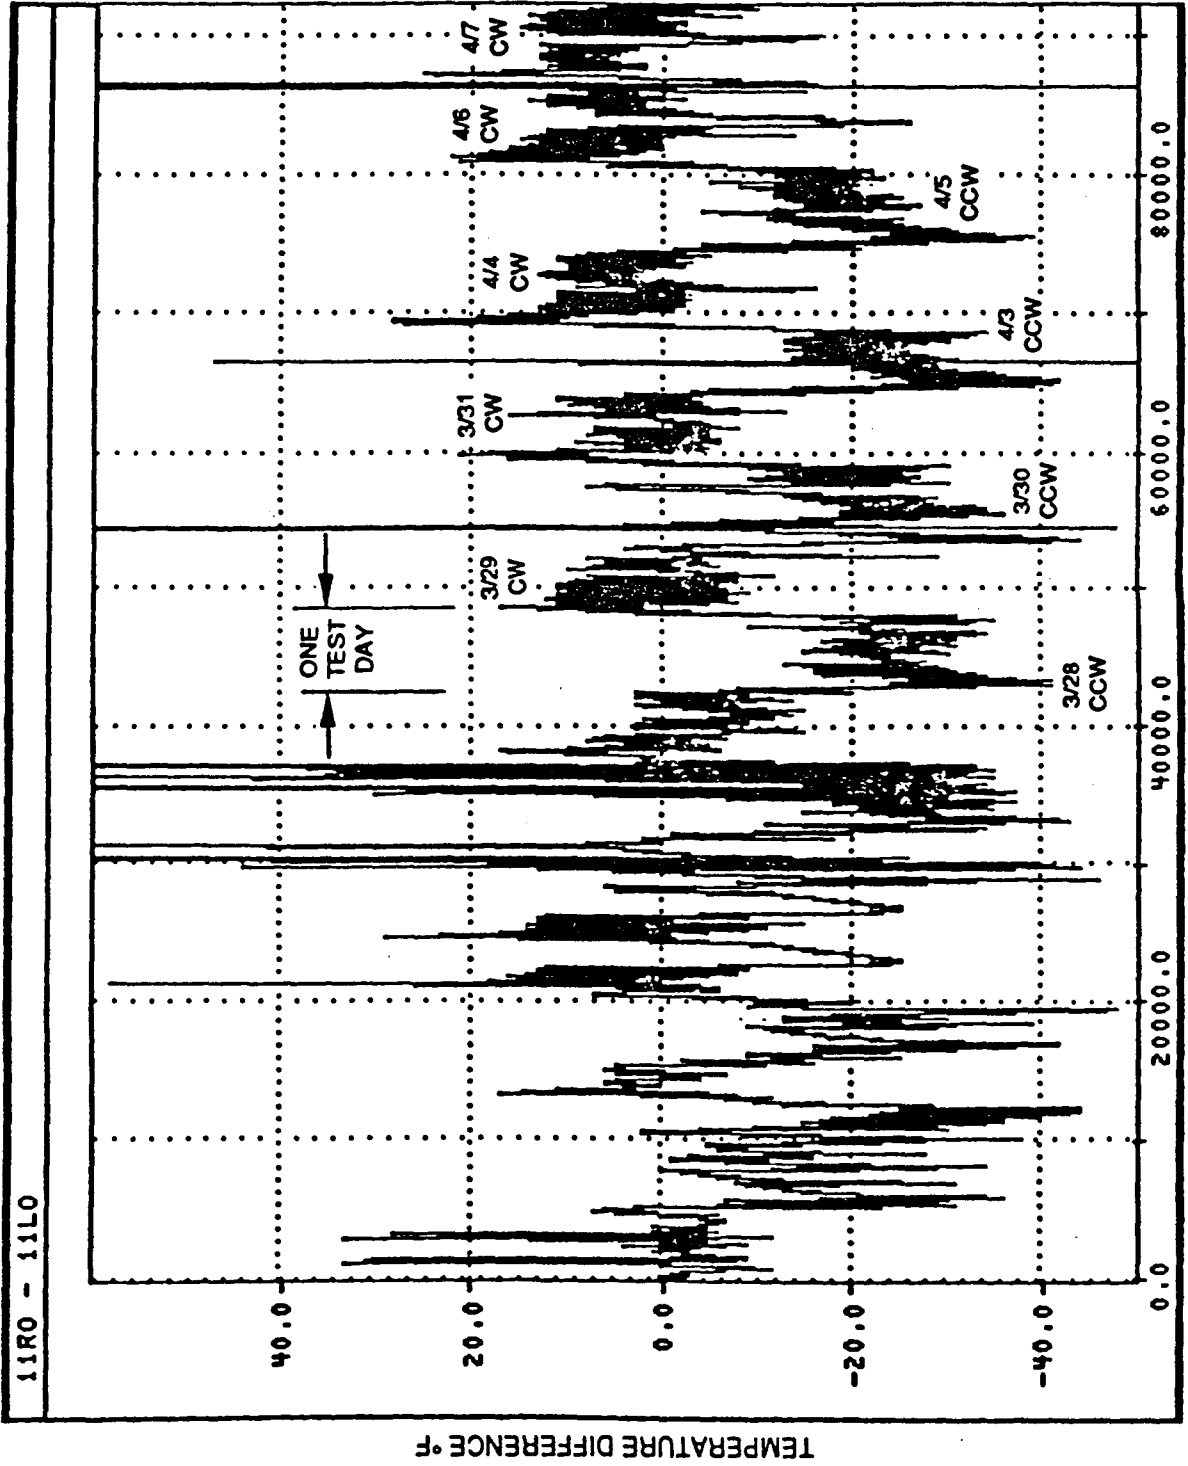
FIGURE 4-2

Plots of the difference in temperature between right and left side outboard races are shown in Figures 4-2 and Figure 4-3 for car 1, axles 1 and 2, respectively. The daily cyclic pattern evident in these plots is caused by the difference between temperatures for the bearing on the outside of the RTT loop (high rail) and the bearing on the inside of the RTT loop (low rail).

The mean of the cyclic pattern is indicative of the nominal difference between the left-side and right-side bearings under normal conditions.

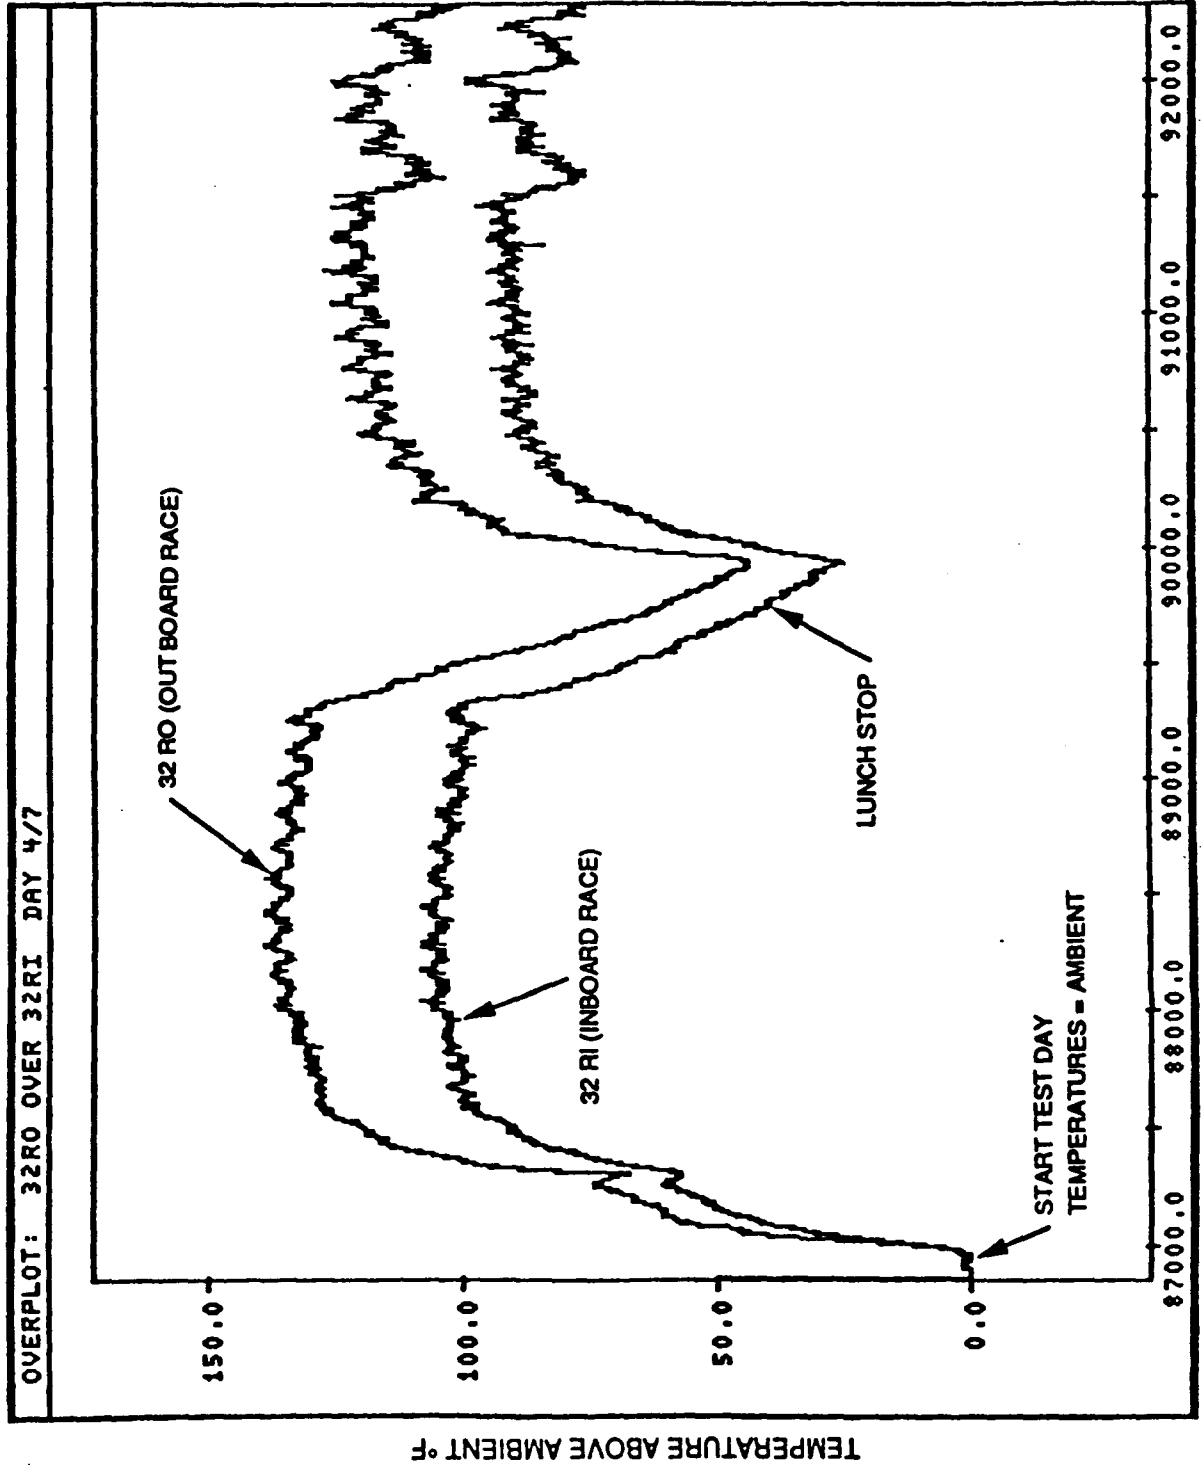
FIGURE 4-4

The results show that the outboard race of this bearing ran about 30° F warmer than the inboard race at 70 mph. This result was observed on other bearings, though not on all, indicating that significant thermal gradients can exist across one bearing.

Figure 4-4 shows the temperatures above ambient for the inboard and outboard races on bearing 32R (car 3, axle 2, right side) for testing on 4/7/89.

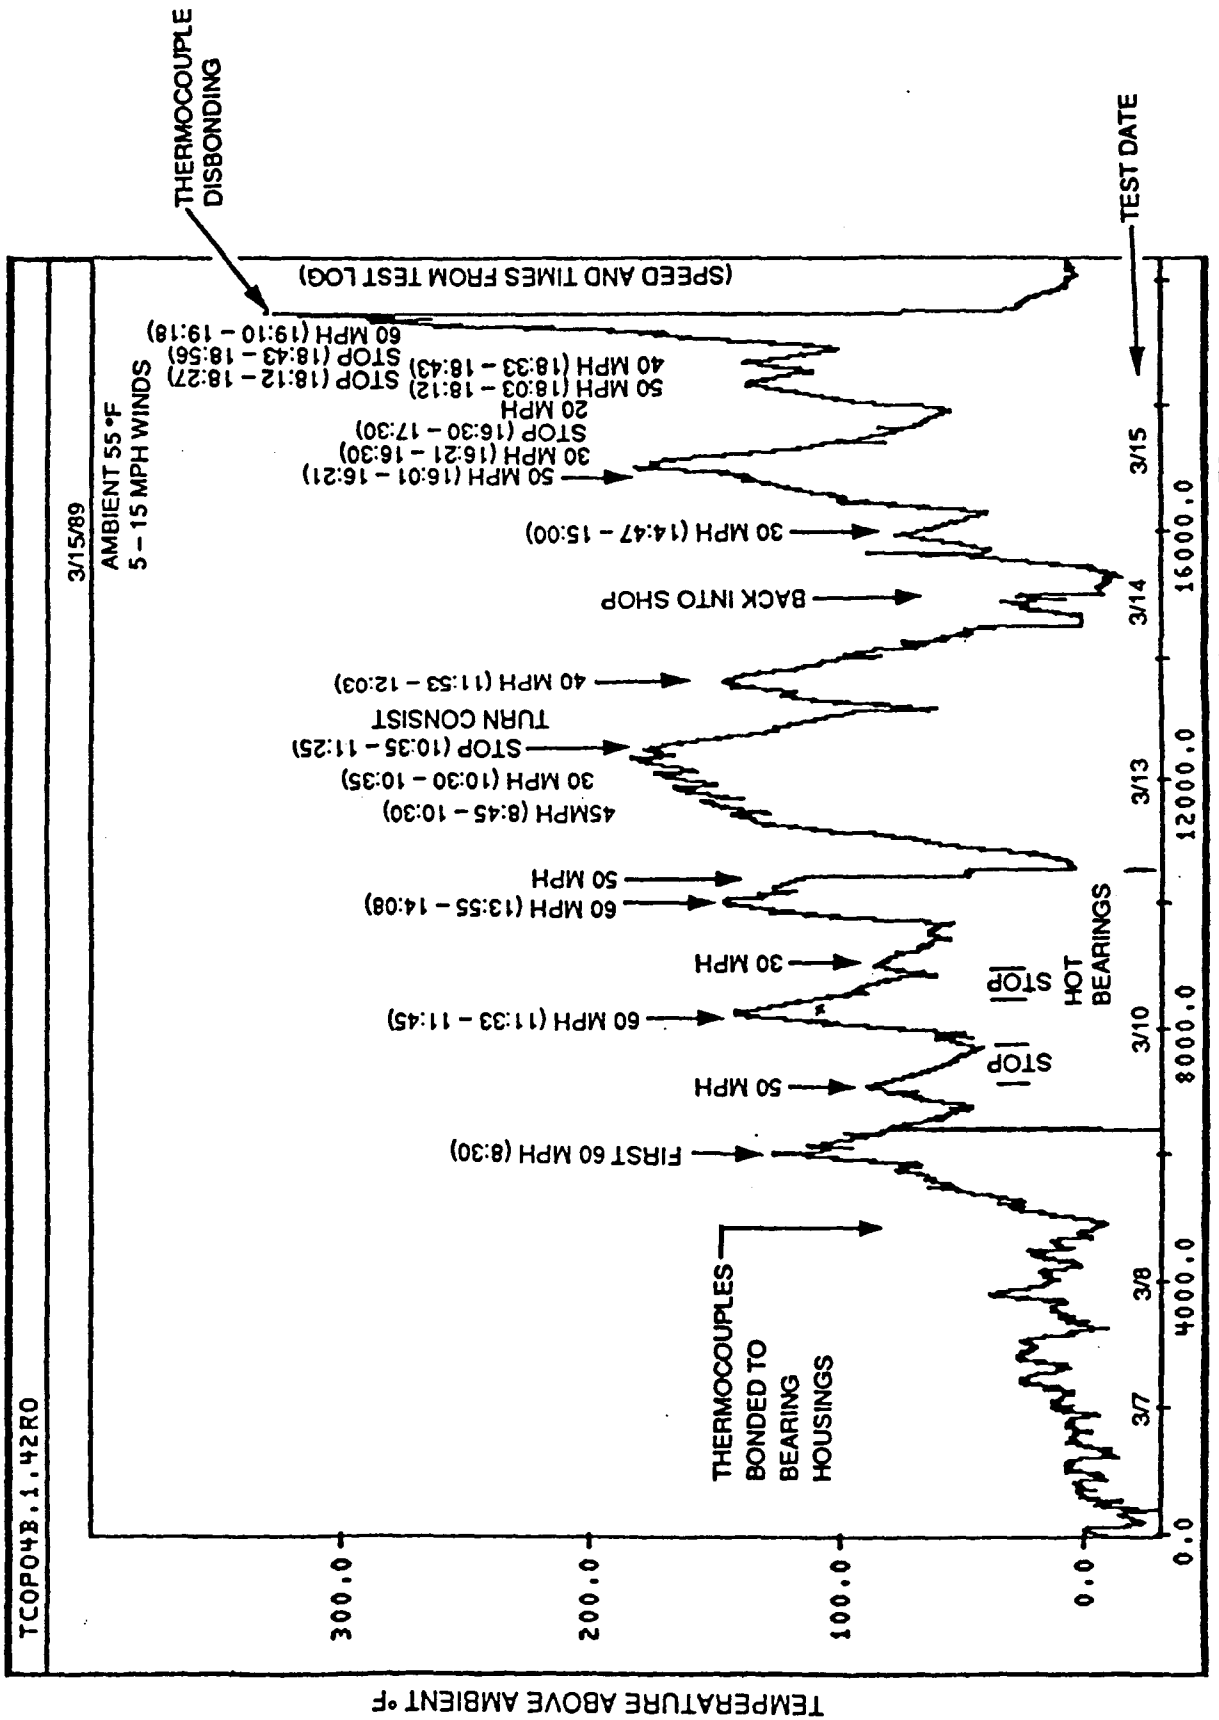
FIGURE 4-10

On March 13th the bearing 42R heated rapidly to around 130° F above ambient at 45 mph operations and continued to heat up when slowed to 30 mph. During this general warming trend, brief periods of warming during curve negotiation and cooling during tangent running were observed.

The maximum heating rate observed prior to removing the bearing from service was 12.8° F per minute. The maximum cooling rate was 7.2° F per minute.

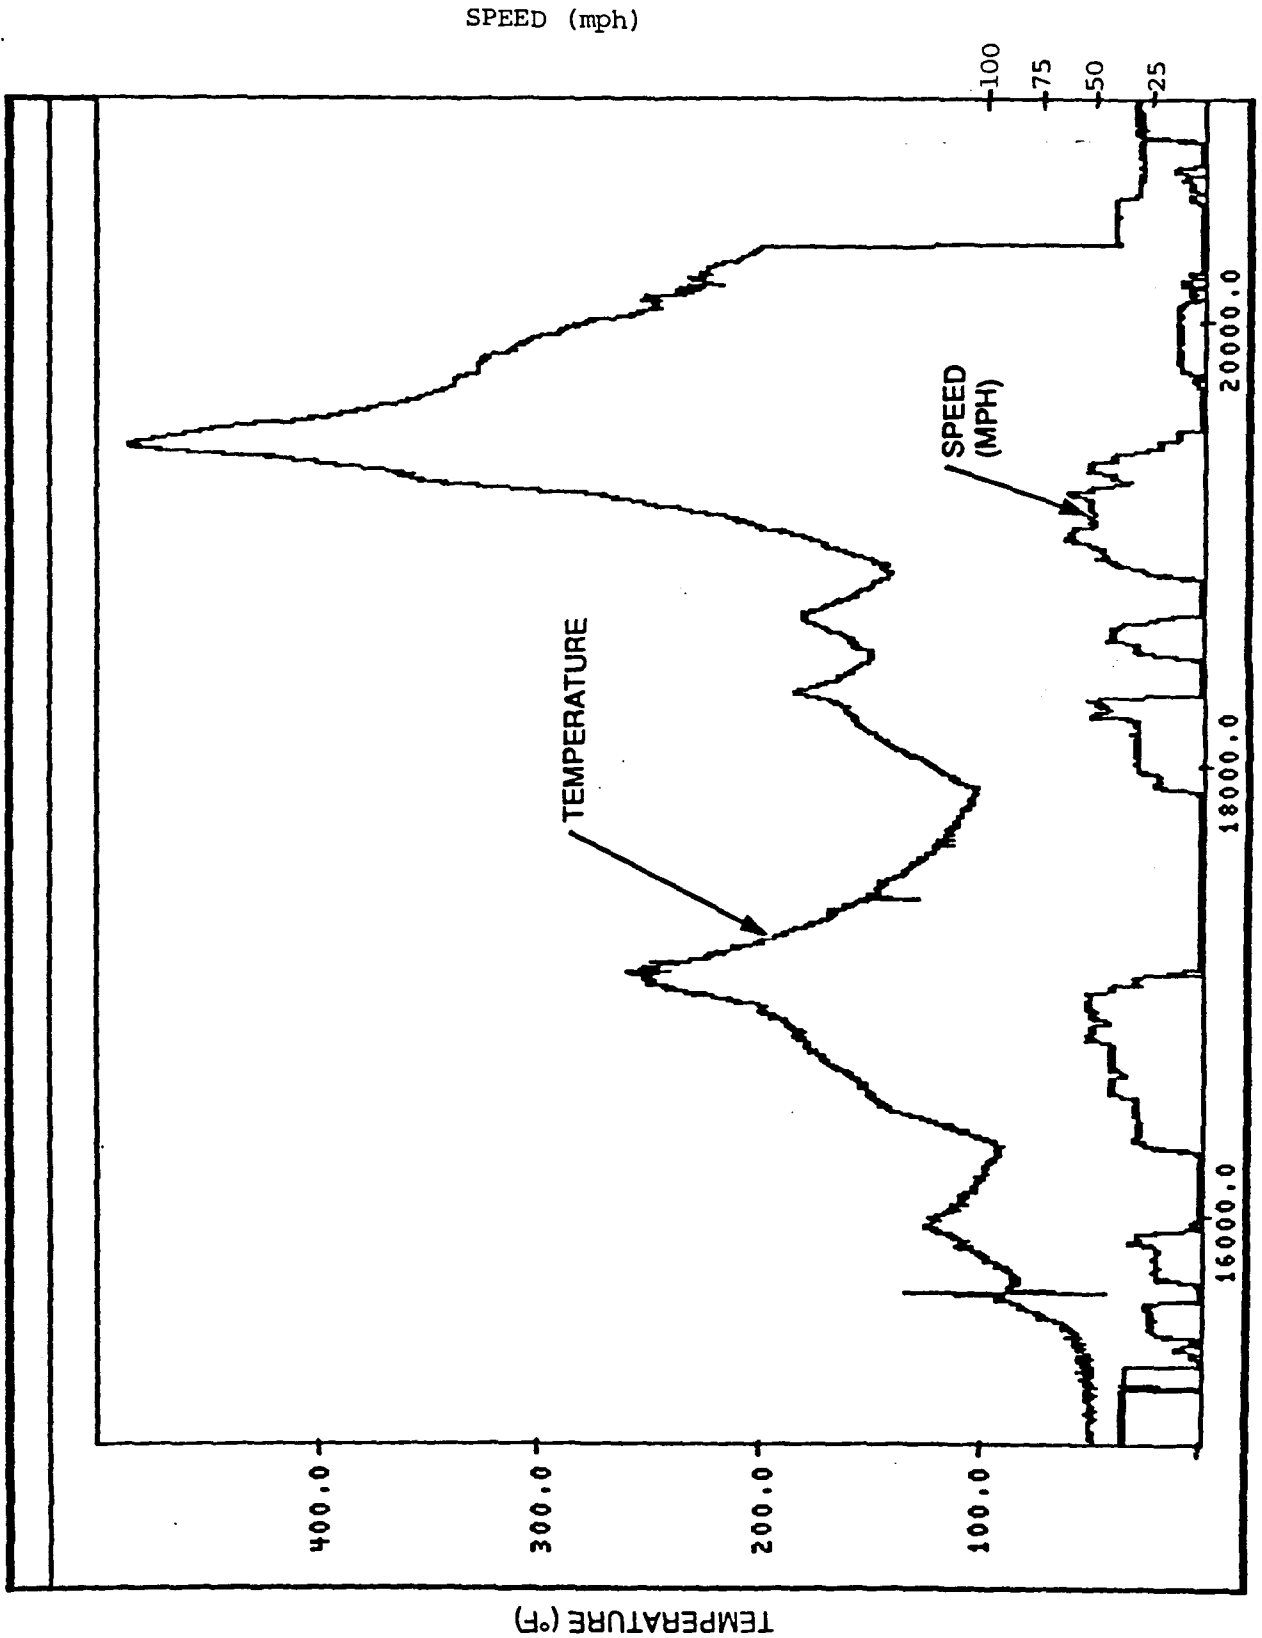
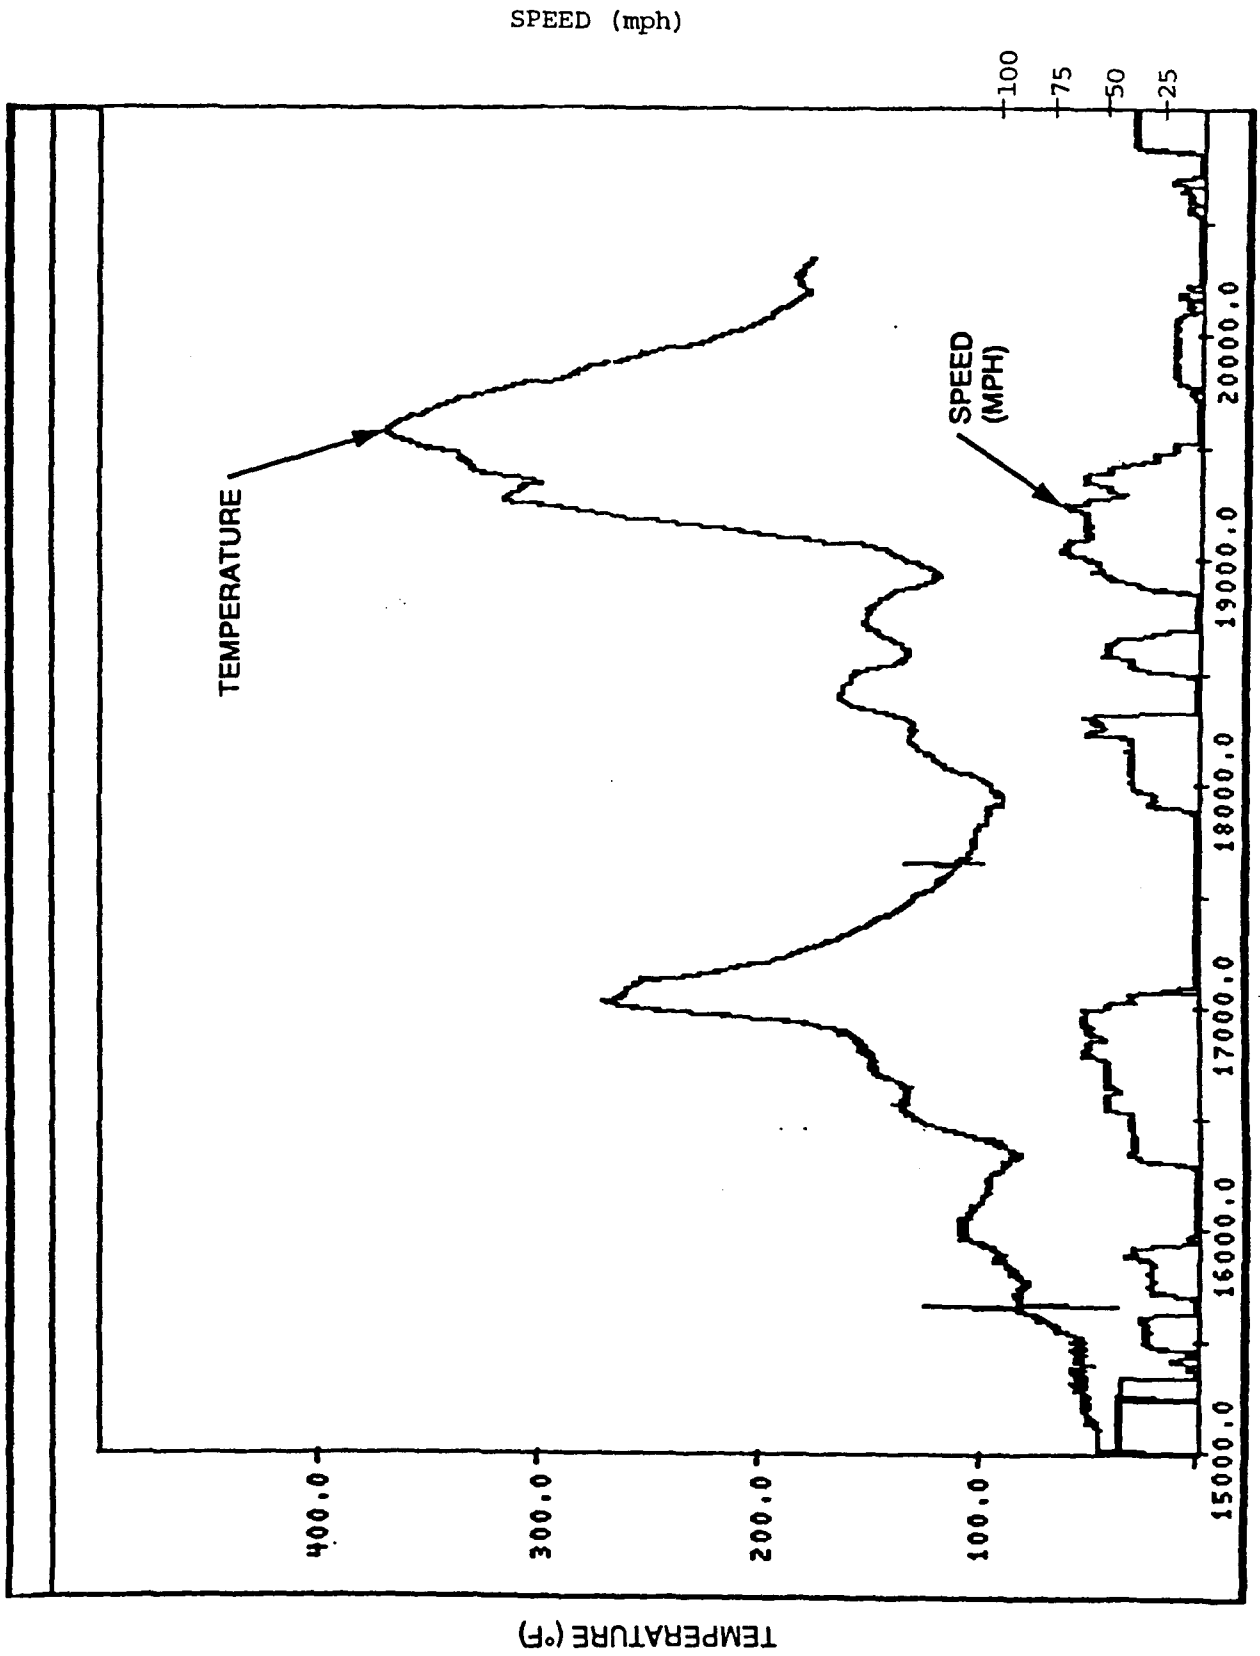
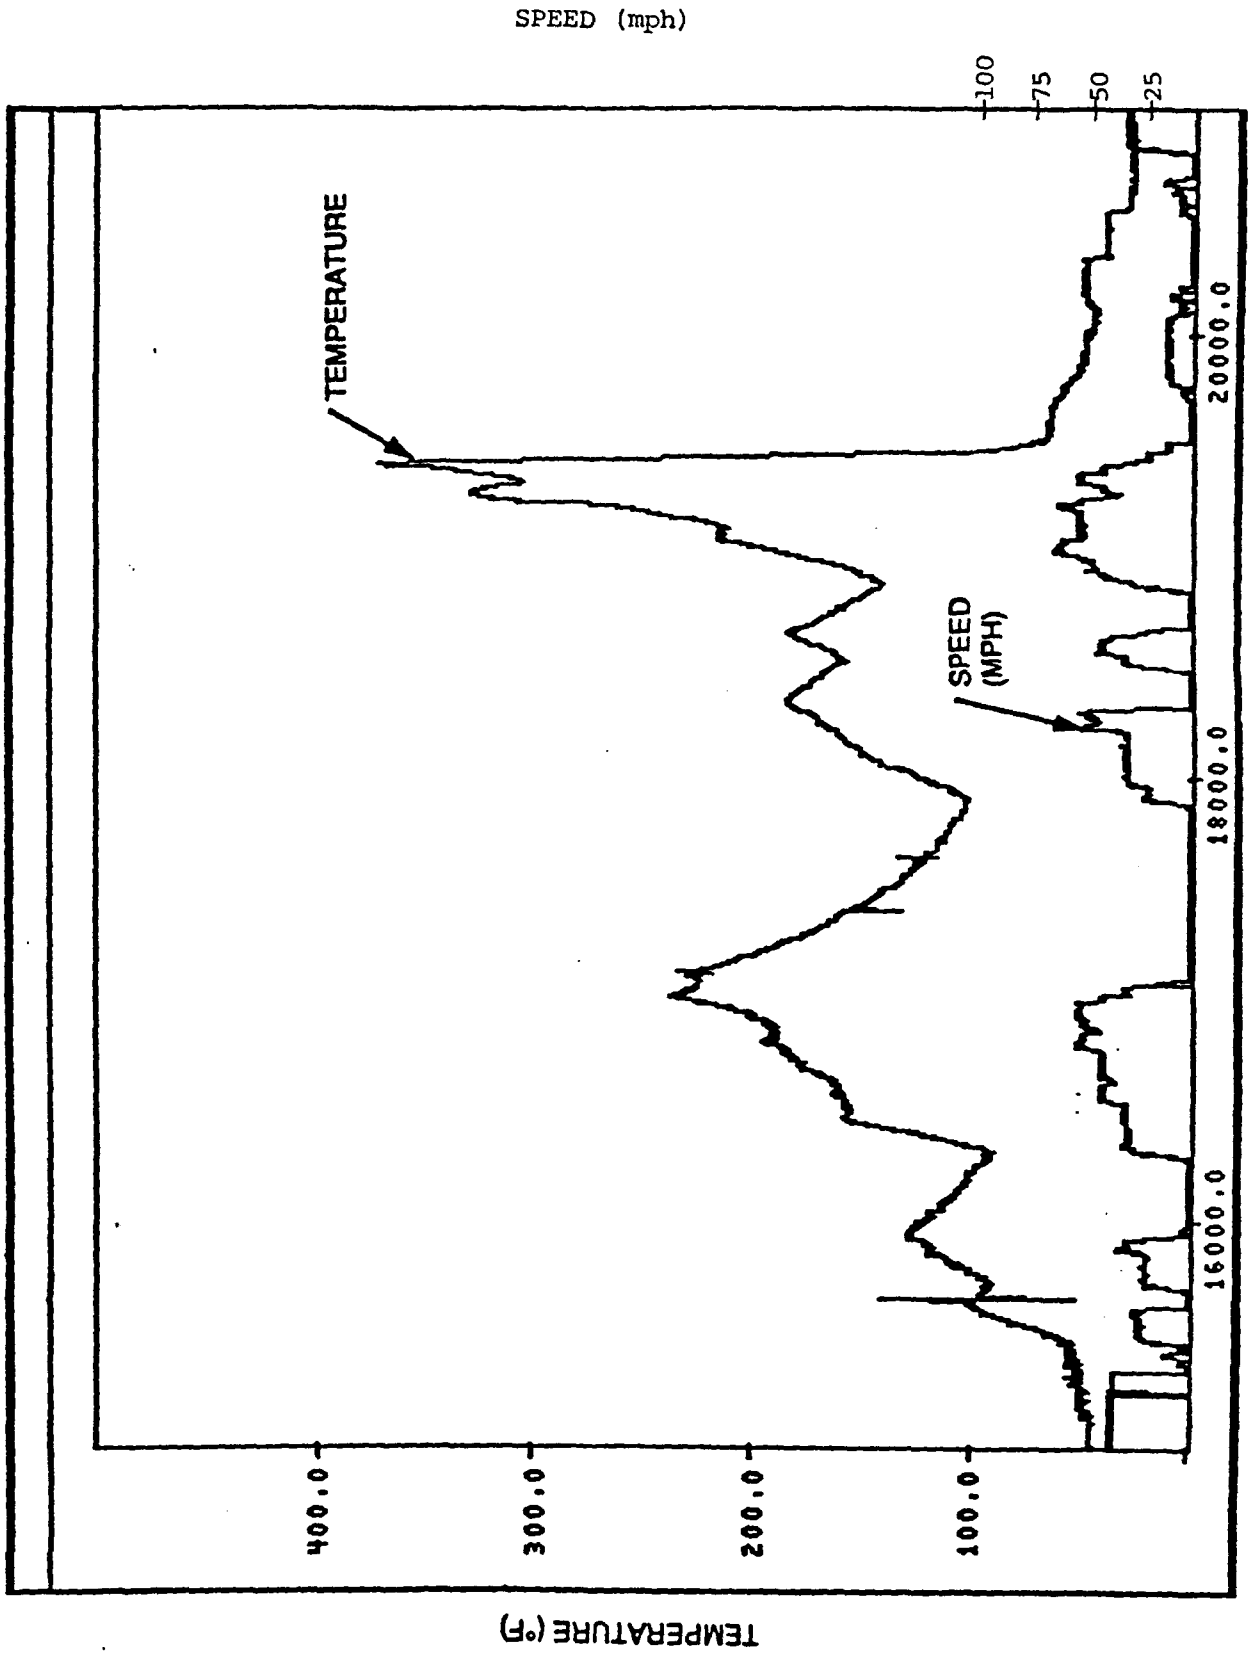
Maximum bearing overheating and cooling rates observed during the test occurred on March 15th. During testing at 50 mph and later at 60 mph on that day, two overheating events occurred for bearing 42R. The top of cup, inboard race and outboard race temperatures for bearing 42R on that day are shown in Figures 4-12, 4-13 and 4-14. The heating and cooling rates associated with each of these events are derived in Figures 4-15 through 4-20.

<u>Peak Temp.</u>	<u>Max. Heating Rate/min</u>	<u>Max. Cooling Rate/min.</u>
Top of Cup	258° F	6.7	5.1
Outboard race	234° F	5.2	3.7
Inboard race	270° F	12.8	6.4
