**Federal Railroad
Administration**

Performance of Degraded Roller Bearings

6. AUTHOR(S) Kevin Kesler and Chris Tinto		Revised: 12/28/90	
7. PERFORMING ORGANIZATION NAME(S) AND ADDRESS(ES) ENSCO, Inc. Applied Technology and Engineering Division 5400 Port Royal Road Springfield, VA 22151		8. PERFORMING ORGANIZATION REPORT NUMBER DOT-FR-89-08

9. SPONSORING/MONITORING AGENCY NAME(S) AND ADDRESS(ES) Federal Railroad Administration Department of Transportation 400 Seventh St., S.W. Washington, DC 20590		10. SPONSORING/MONITORING AGENCY REPORT NUMBER FRA/ORD-90/12

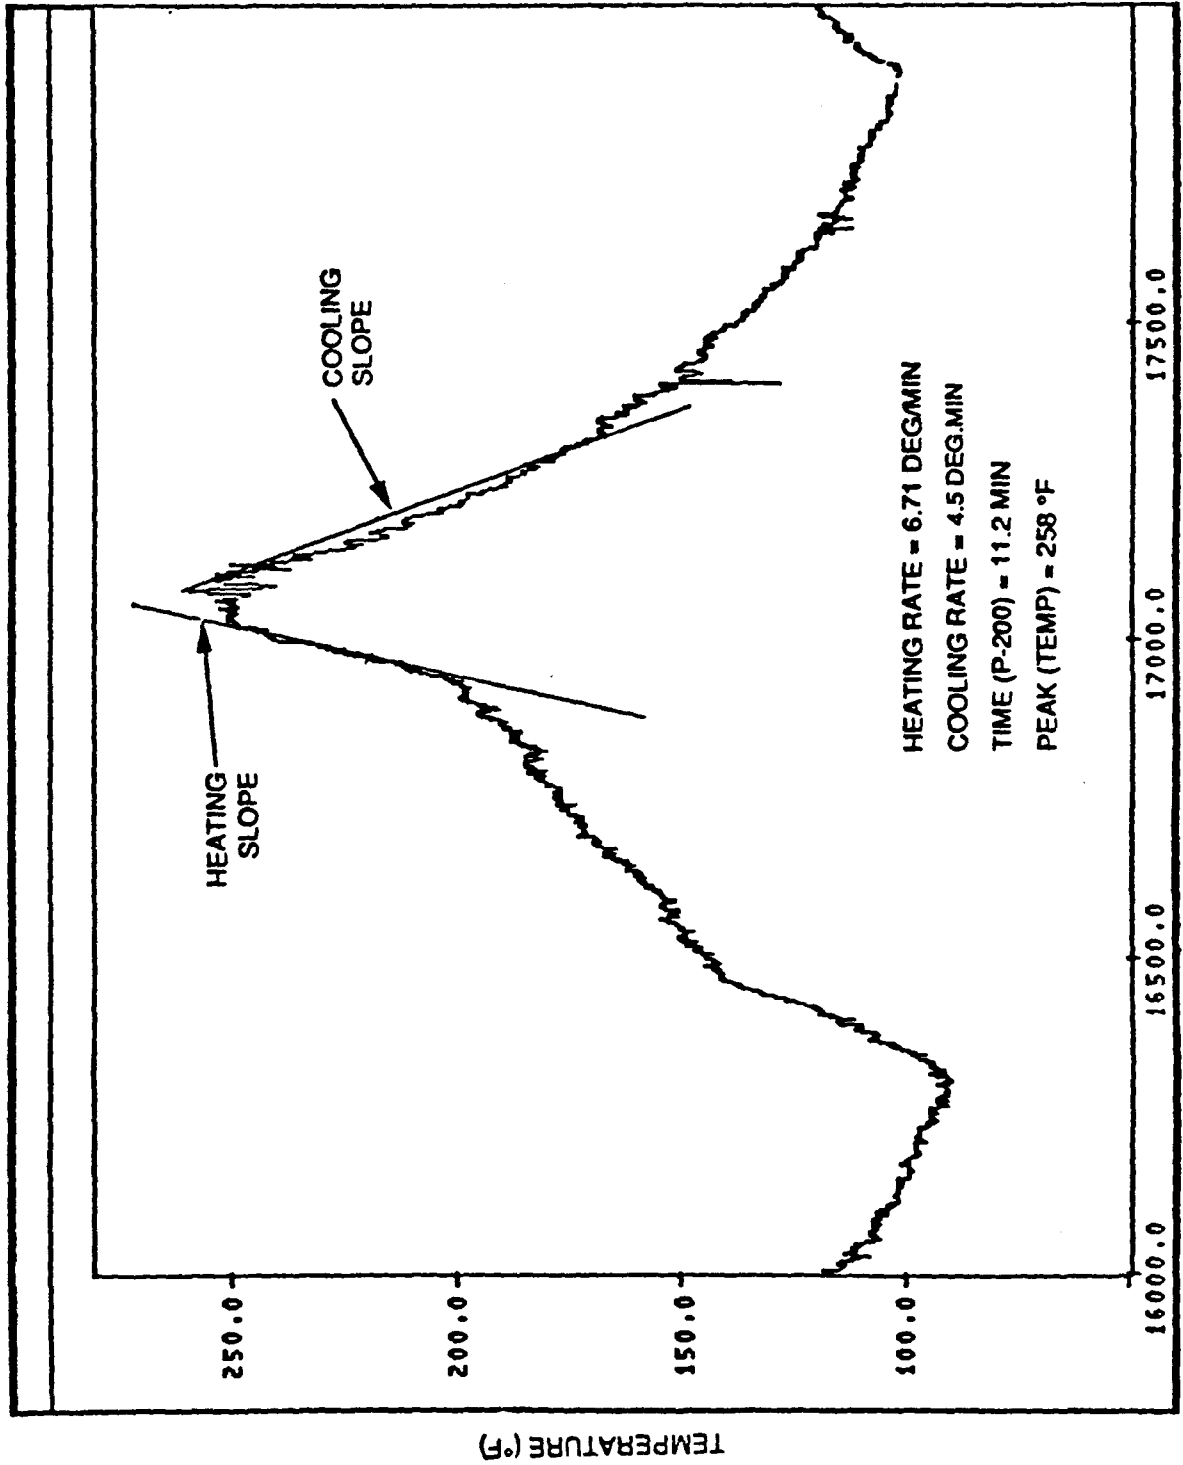
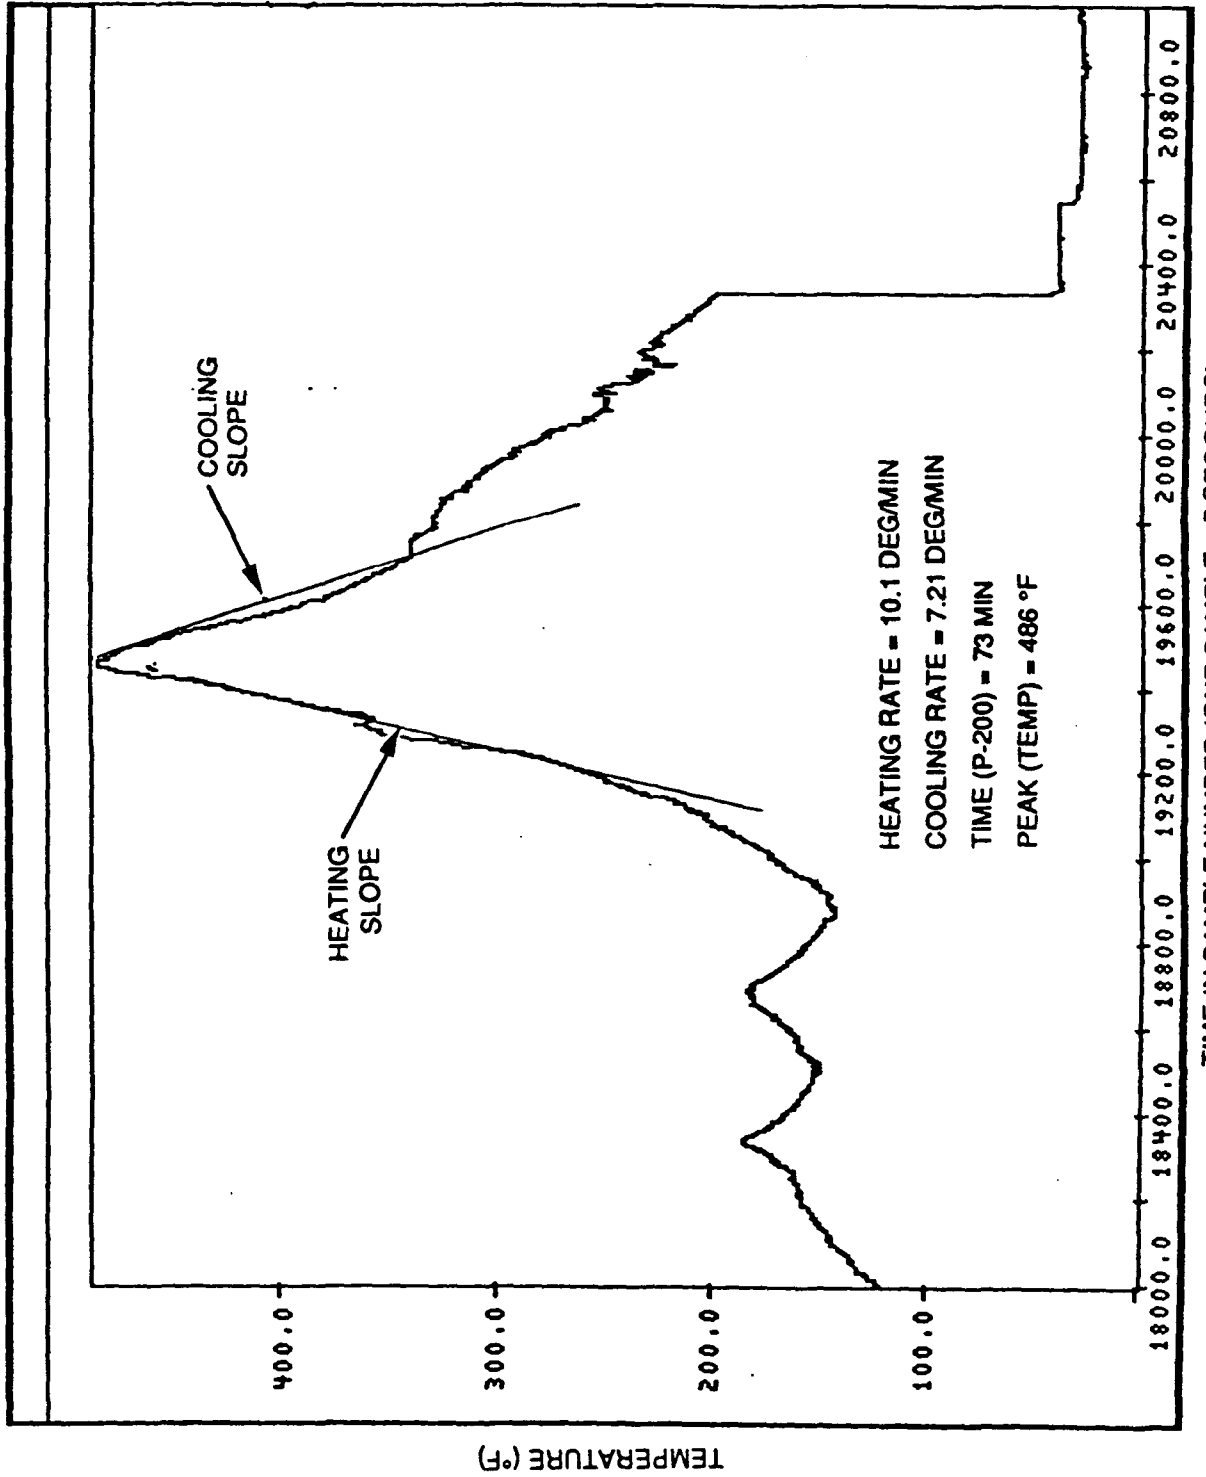
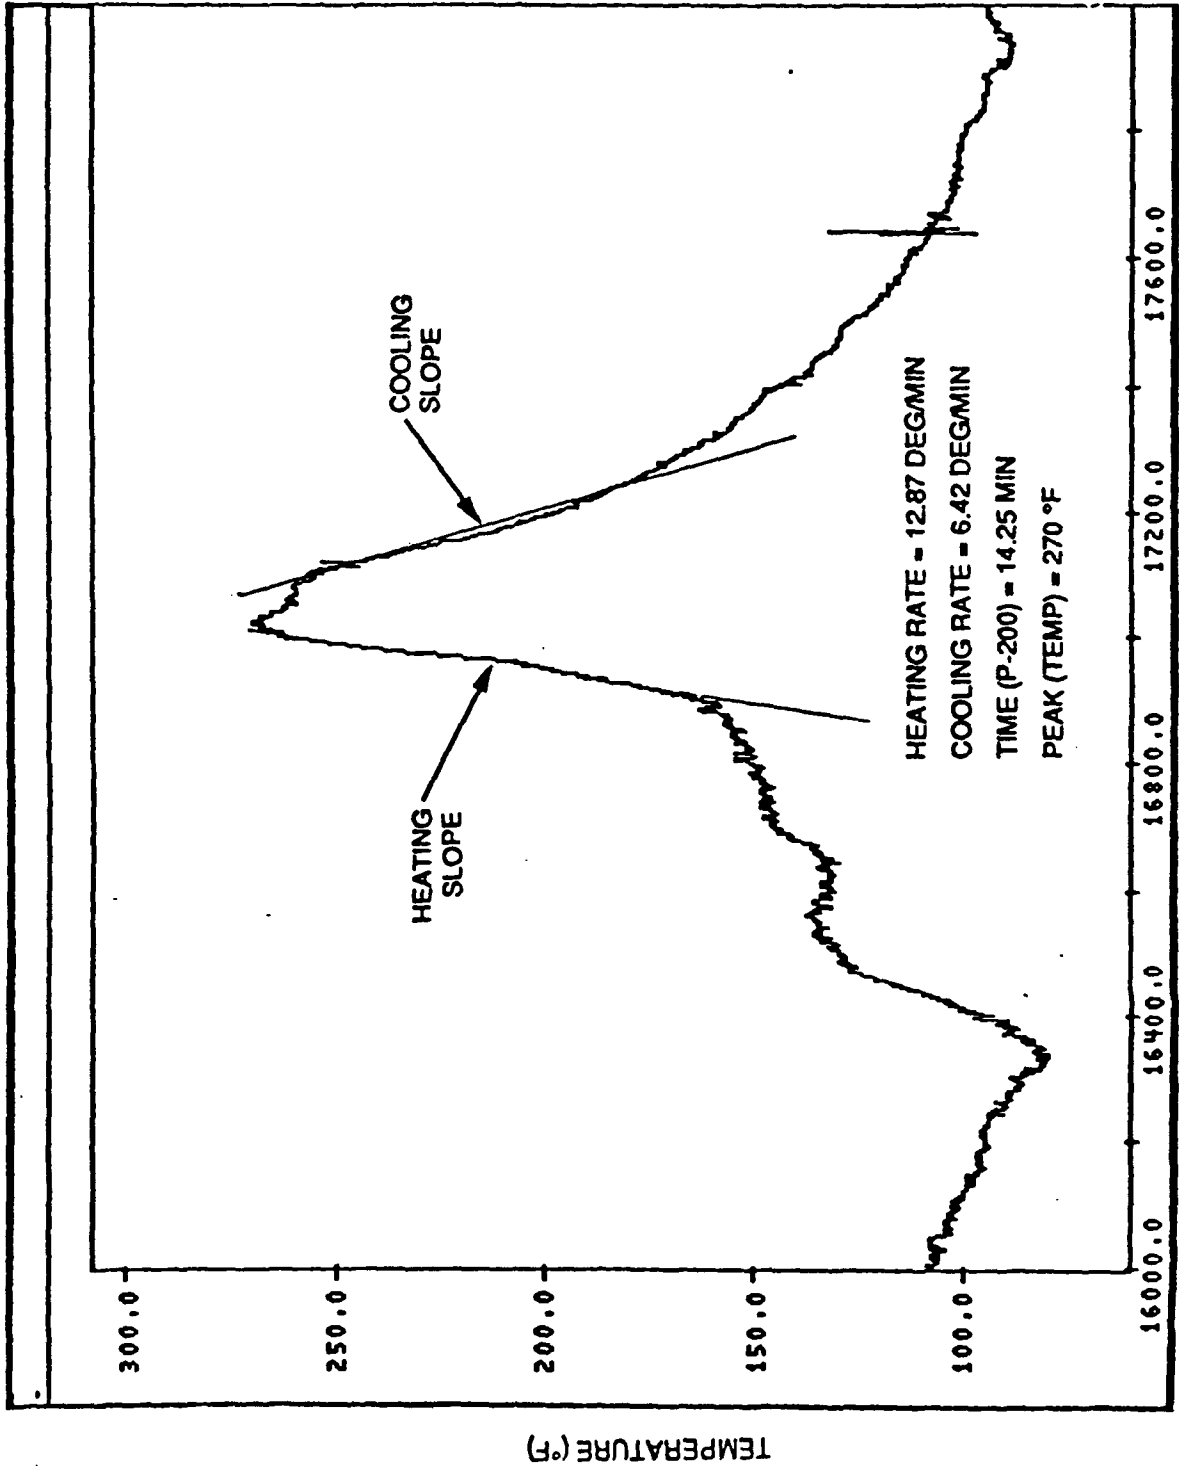
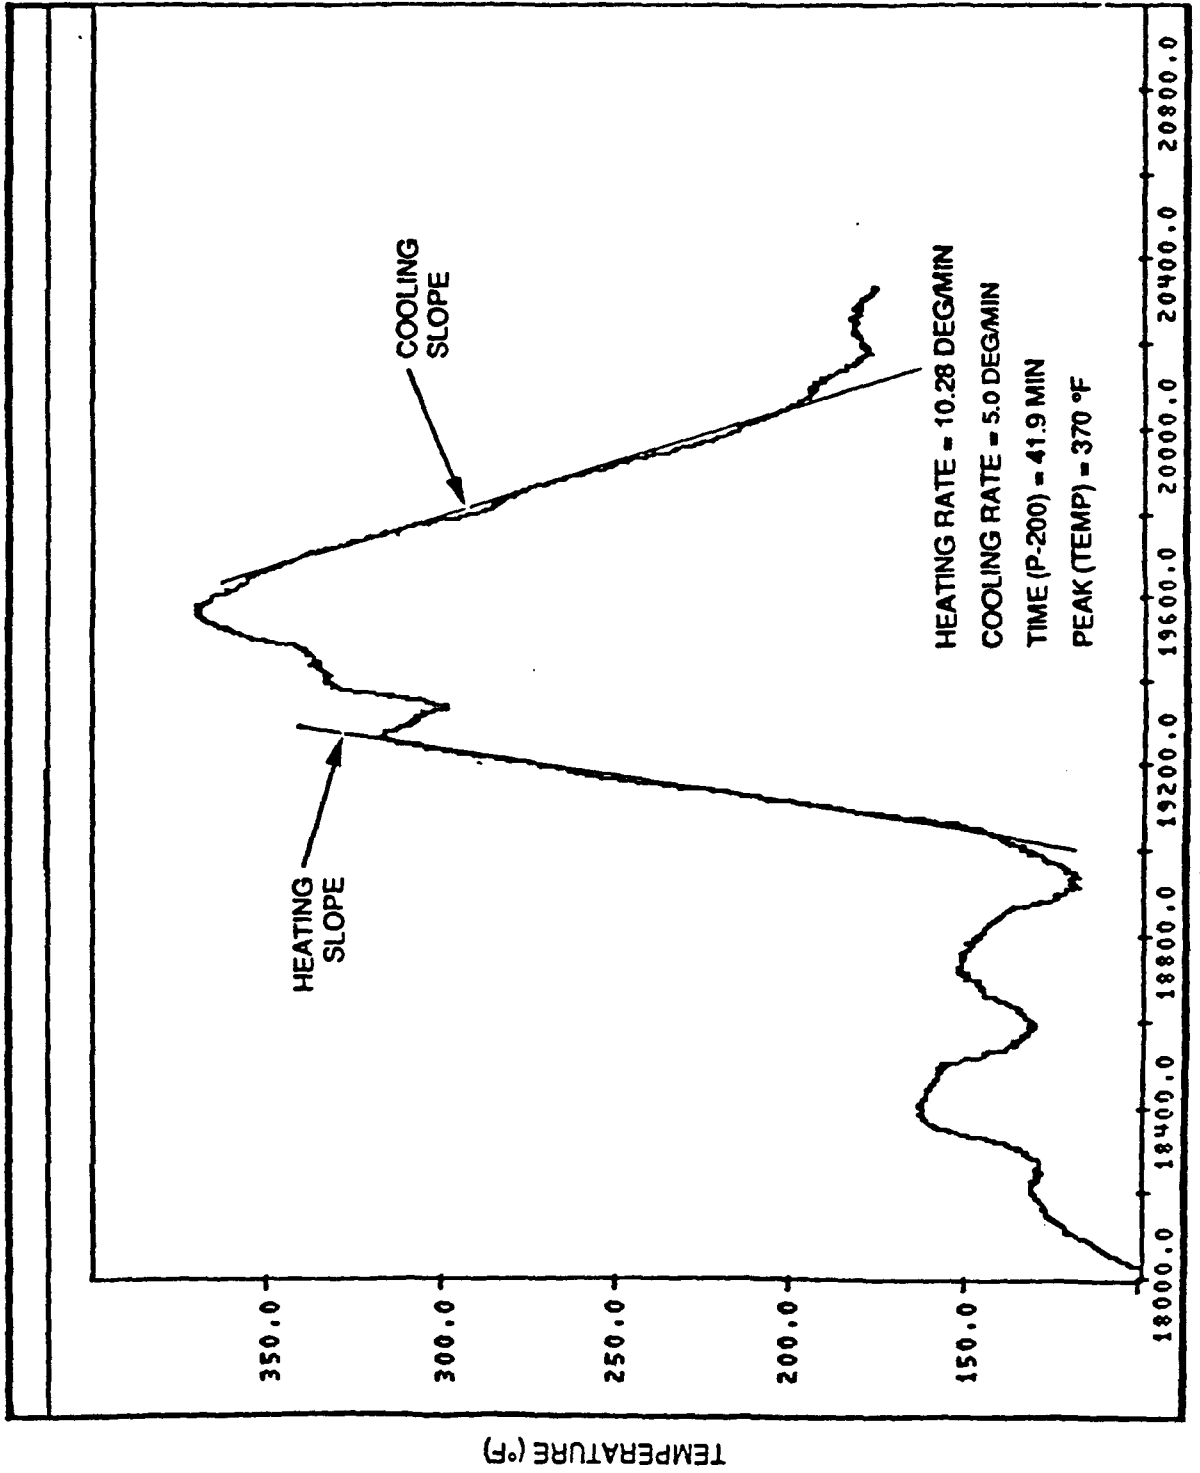
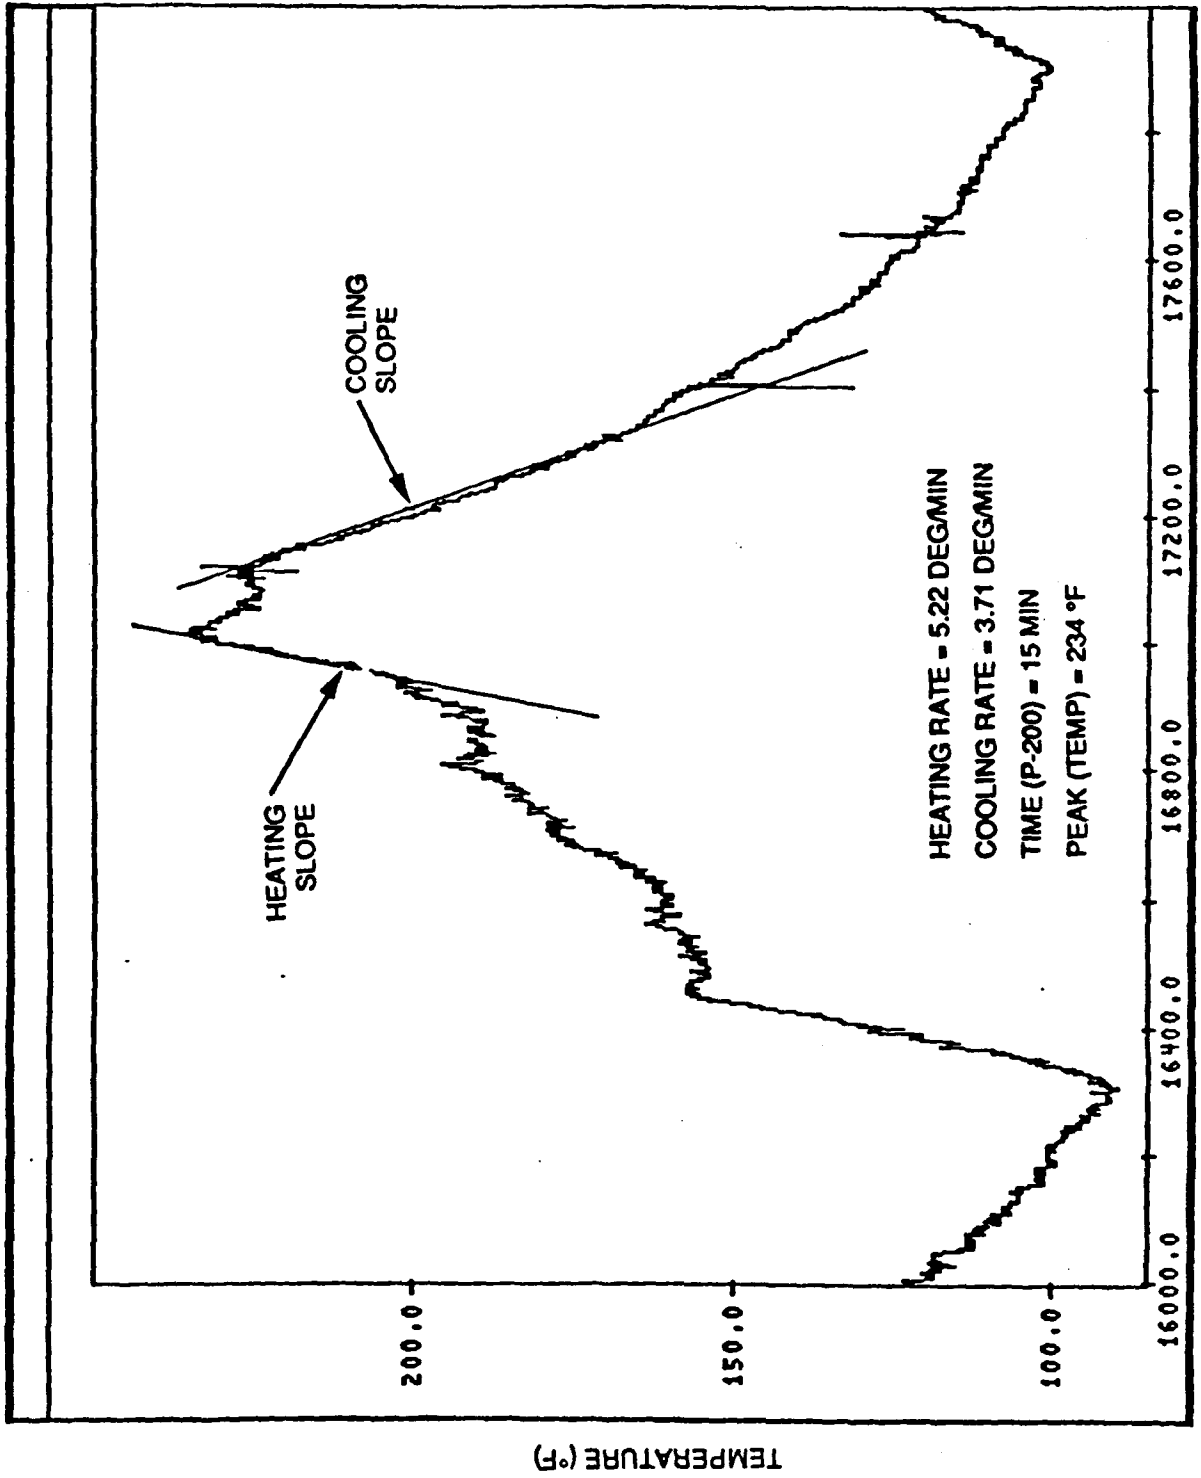
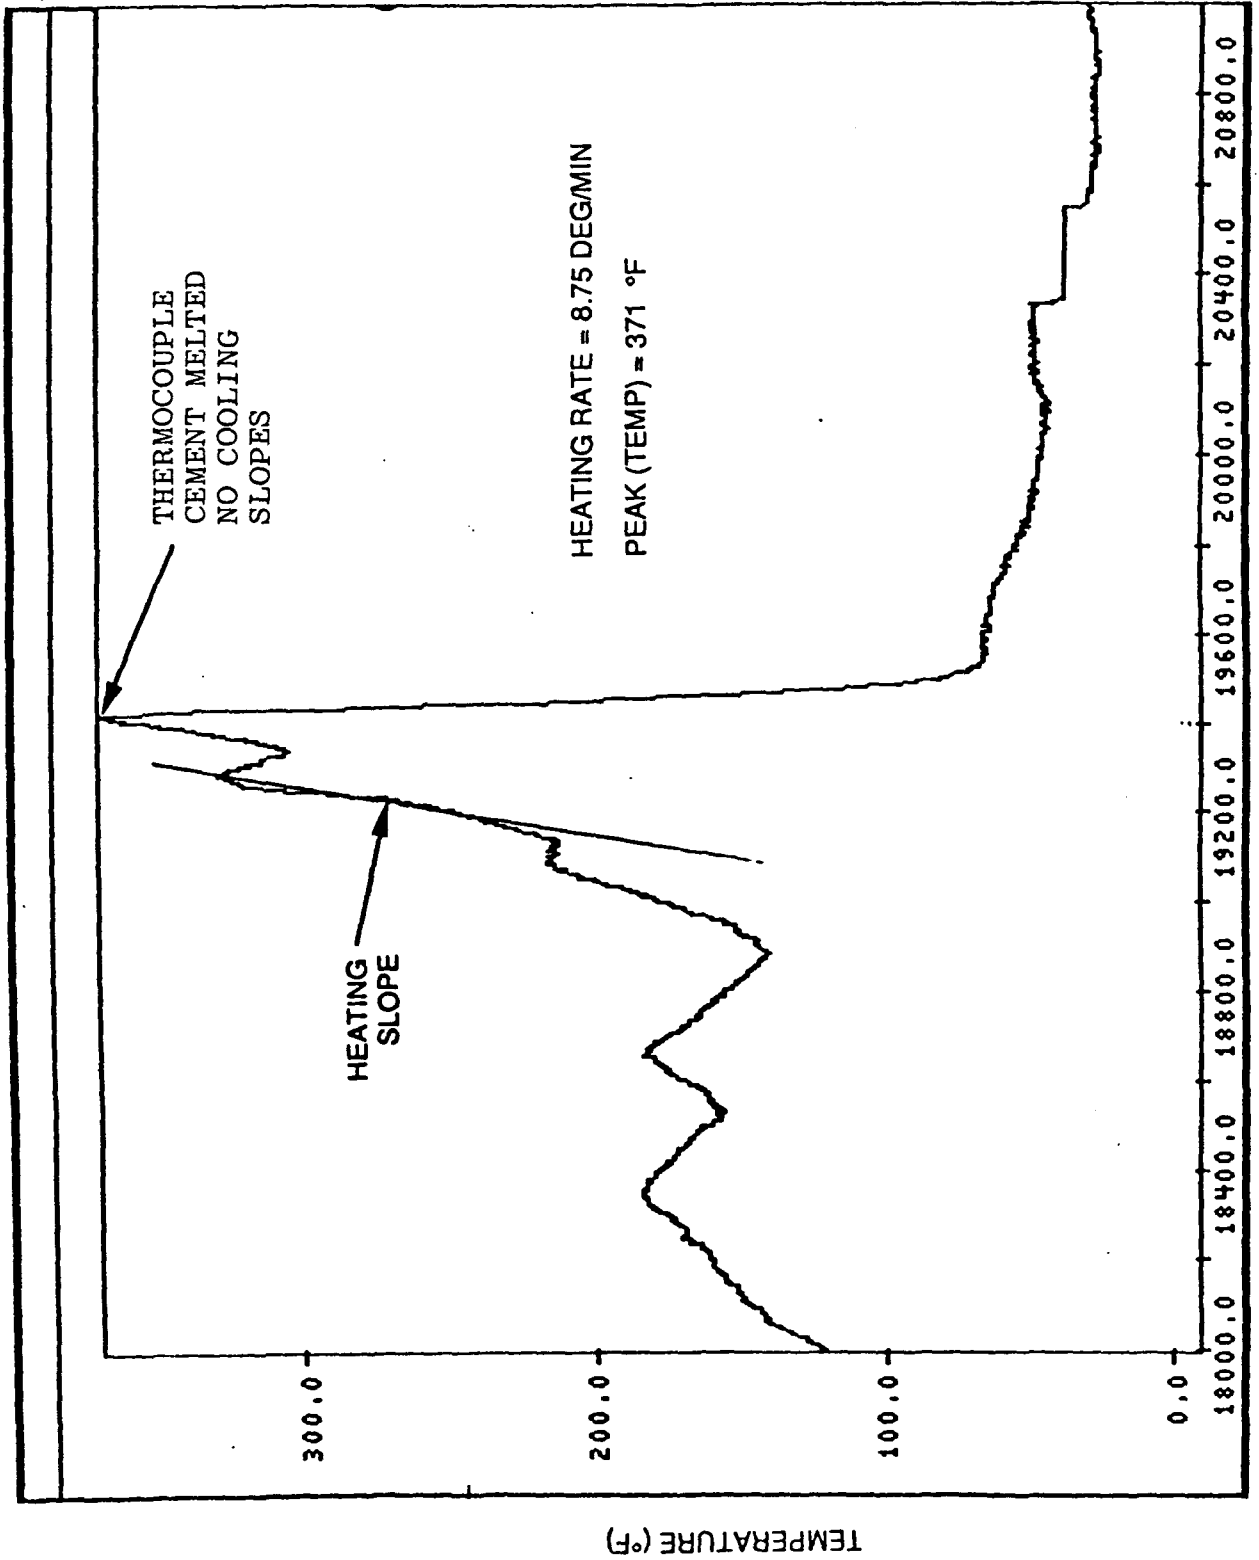
Maximum bearing overheating and cooling rates observed during the test occurred on March 15th. During testing at 50 mph and later at 60 mph on that day, two overheating events occurred for bearing 42R. The top of cup, inboard race and outboard race temperatures for bearing 42R on that day are shown in Figures 4-12, 4-13 and 4-14. The heating and cooling rates associated with each of these events are derived in Figures 4-15 through 4-20.

<u>Peak Temp.</u>	<u>Max. Heating Rate/min</u>	<u>Max. Cooling Rate/min.</u>
Top of Cup	258° F	6.7	5.1
Outboard race	234° F	5.2	3.7
Inboard race	270° F	12.8	6.4

For the particular bearing failure which occurred during this test, wayside detectors would have to have been spaced 8 miles apart to have detected this bearing overheating and prevent temperatures from exceeding the 340° F grease flash point. The wayside detector spacing recommended in a 1977 report prepared for the FRA by Shaker Research Corporation was 30 miles. That recommendation was based on an analysis of derailment statistics.
