U.S. Department of
Transportation

Federal Railroad
Administration

Accident Report of Chicago Metra Commuter Train Derailment on September 17, 2005

1. AGENCY USE ONLY (Leave blank)		2. REPORT DATE October 2015		3. REPORT TYPE AND DATES COVERED Final Report	
4. TITLE AND SUBTITLE Accident Report of Chicago Metra Derailment on September 17, 2005				5. FUNDING NUMBERS RR28A3/MLH94

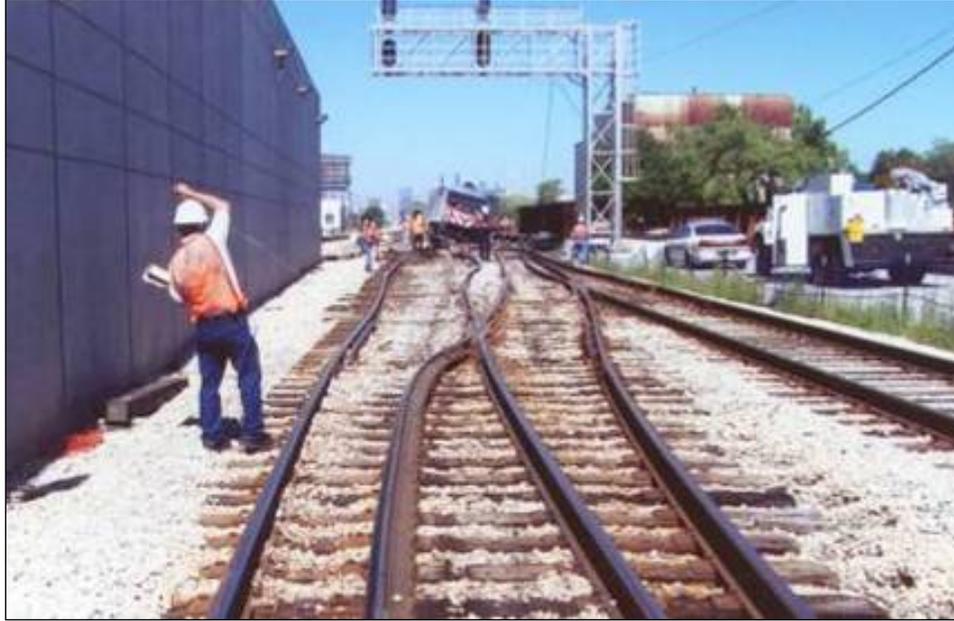
Figure 5. Switch Where the Derailment Initiated

The leading cab car 8570 derailed at the switch and continued to follow the track on the right side of the rails. The trailing cars followed, plowing through the ties, rail, and ballast. The cab passed cleanly between the bridge girders on the 47th Street bridge, which was about two car lengths beyond the point of derailment. The cars likely experienced sawtooth buckling after the derailment occurred. The photo in Figure 5 shows the switch where the derailment occurred. The view is from the south, looking north down the track in the direction the train was heading.

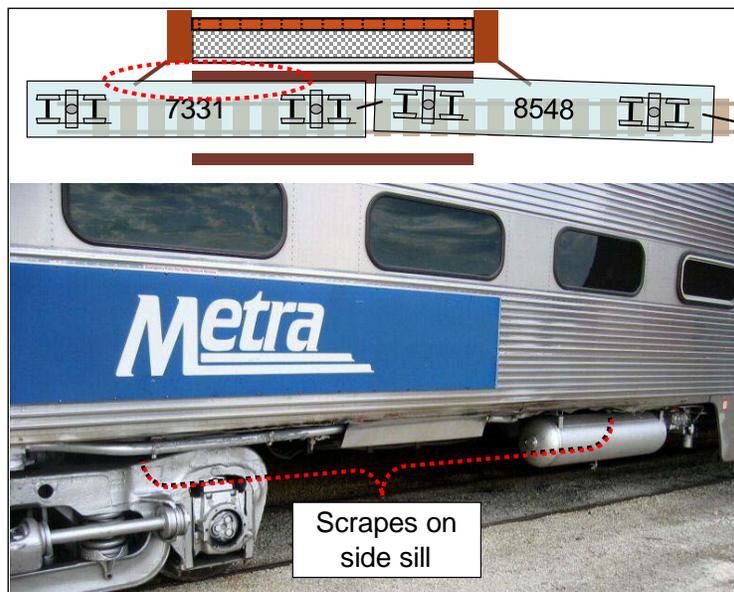
Figure 6. Evidence of Contact Between Car 7331 and the Bridge Structure

The first coach car (7331) followed the cab over the bridge, but it passed closer to the bridge girder, incurring minor scraping on the rear right side of the car body just below the side sill (Figure 6). The scraping was likely caused by the top of the bridge girder, which is about two feet above the top of the rail. The bottom of the side sill is usually about three feet above the top of the rail, but since the car was off the rail and plowing through ties and ballast, contact was able to occur.

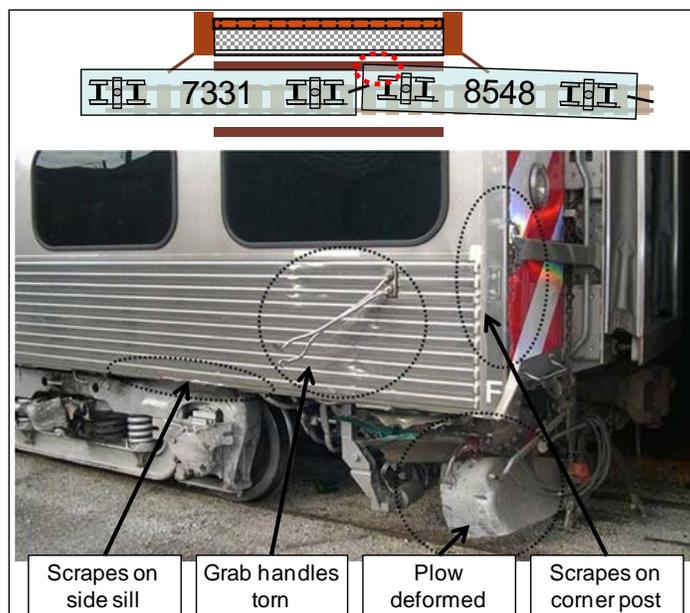
Figure 7. Minor Damage to the Front Right Corner of Car 8548 after Contact with the Bridge

The second coach car (8548), which was originally a cab car but was utilized as a passenger car after the new cab cars were put in service, passed over the bridge even closer to the bridge girder. There was contact between the bridge girder and the front, right corner of the car, which caused bending of the right corner of the plow and damage to the electrical boxes. There was also some damage to the frame of the leading truck and scraping on the side sill (Figure 7).

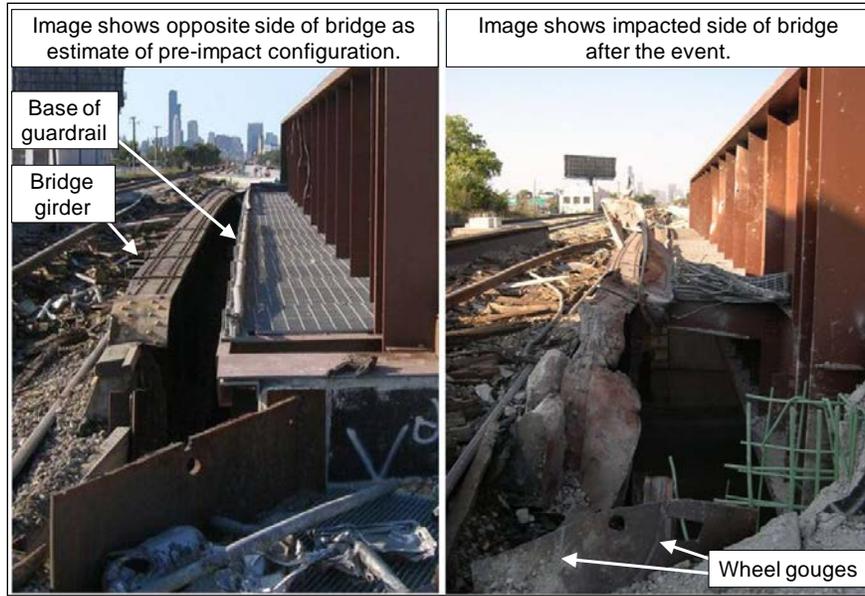
Figure 8. Damage to the Bridge Structure

The photos in Figure 8 show the bridge structure before (approximate) and after impact. The most significant damage to the train occurred when the third coach car (7488) encountered the bridge. It appeared that the right wheels of the leading truck were in line with the bridge girder, as indicated by wheel gouges in the steel ballast retention plate (Figure 8, right photo). The leading truck of car 7488 impacted and rode up and over the girder, forcing the truck into the bottom of the car. The impact caused significant vertical deformation of the floor but did not significantly lift the car body. The interior floor on the right side of the car, forward of the bolster, deformed 16” to 20” vertically, causing the right side wall of the car to bulge outward (Figure 9, left photo). Both wheel sets separated from the lead truck and the truck bolster was severely fractured (Figure 9, right photo). The right front corner of the car body impacted a tubular steel hand rail, which dented the right corner post and penetrated the occupant compartment. The corner post and end beam were displaced about 8 inches longitudinally (Figure 10). All cars remained coupled up to this point (as shown in Phase 3 of Figure 9).

There was significant damage to the bridge that was impacted by cars 7488 and 7351 (see Figure 8). The ballast retaining plate, which shows the point of contact of at least one set of wheels, was significantly deformed. A large amount of concrete was obliterated down to exposed, bent rebar, and several lateral supports were deformed and detached from the structure. This damage created a hole in the bridge, through which debris fell to the road below. The damage pattern on the bridge (Figures 20 and 21) can be used to estimate the gross motions of the rail vehicles involved in the derailment.

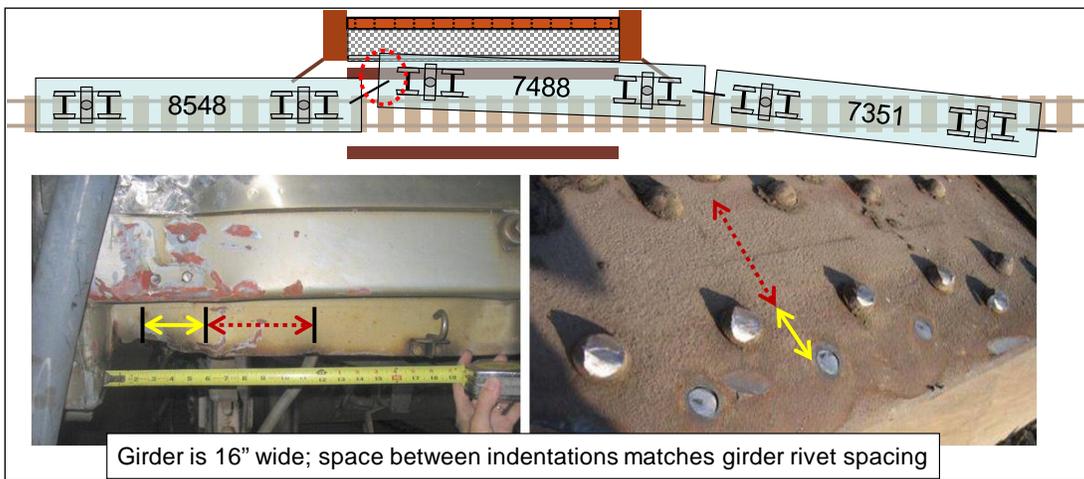
Figure 11. Front of Car 7488

The car continued to slide along the girder, shearing off rivets on top of the girder. The right front buffer wing inboard of the corner post (Figure 11) shows indents that match the spacing of the bolts on the top of the girder. The rear truck of car 7488 impacted the corner of the bridge girder, causing the front wheel set to detach from the truck and the truck to detach from the car.

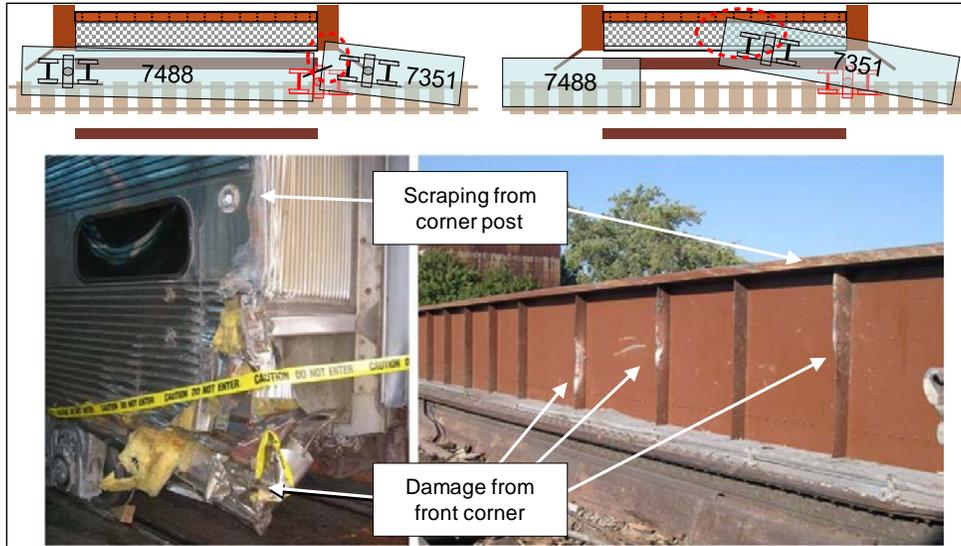
The lead truck of the fourth coach car (7351) impacted the detached truck from car 7488 at the bridge entrance and climbed up and over the truck and bridge girder. This vertical motion caused cars 7488 and 7351 to decouple. The lead truck of car 7351 scraped along the top of the girder for the length of the bridge. The right corner post and end beam scraped along the side gussets of the retaining wall. The corner post scraped along the top of the wall, as evidenced by paint transfer. The impact with the wall gussets caused the junction of the corner post end beam attachment to displace downward about 8 inches (Figure 12). The rear truck of car 7351 derailed, remained on the ground, impacted the detached rear truck from car 7488, and continued to drag it along the track. The front of the car fell off the girder and down on the track near the end of the bridge.

Figure 12. Front of Car 7351, Showing Damage from Impact with Bridge Girder (left) and Damage to the Gussets of the Retaining Wall (right)

The fifth car in the consist, 7351, showed damage to both trucks as well as to the right front corner of the car. The bottom of the right corner post displaced downward by roughly 8 inches, and the side of the corner post showed signs of scraping the retaining wall of the bridge (see Figure 12). There was no intrusion into the occupied space of this car.

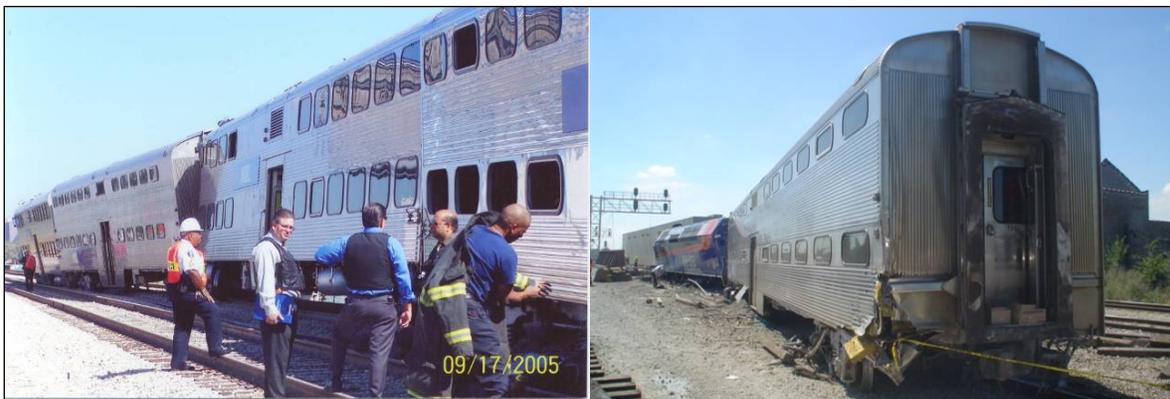
Figure 13. Final Resting Positions of Cars 8570, 7331, 8548, and 7488 (left) and Car 7351 and Locomotive 409 (right)

The photos in Figure 13 and the diagram in Figure 14 depict the final resting positions of the cars. The left photograph in Figure 13 shows cars 8570, 7331, 8548, and 7488 (from left to right, looking north). The right photograph shows car 7351 and the locomotive 409 looking back to the south. All the cars remained upright, with a small amount of yaw resulting from sawtooth buckling and roll resulting from the derailment and subsequent plowing into ballast. The leading cab (8570) traveled approximately 780 feet from the point of derailment. As described above, the third and fourth coach cars (7488 and 7351) decoupled and were separated by 50 feet when the cars came to rest.

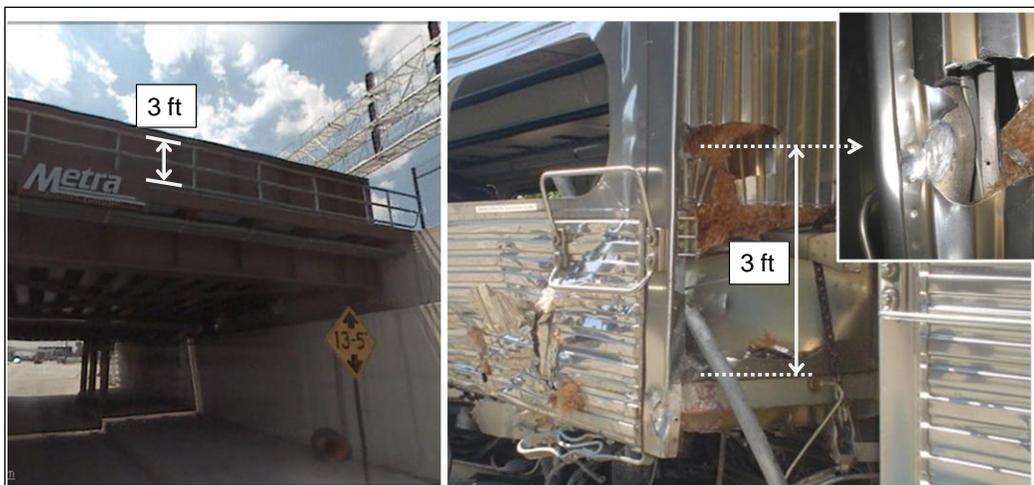
The first three cars passed over the bridge with scraping between the car bodies and the bridge girders on either side. The cab car (8570) was the least affected, showing only minor scraping on the trucks and the equipment suspended below the car body as a result of plowing into the ballast subsequent to derailment. On the right side of the first coach car (7331), there was a scrape at the bottom corner of the body that spanned from just aft of the entry doors to the rear truck. This scrape punctured the outer shell of the car in several places, but did not penetrate into the occupied volume. The front right corner of the second coach car (8548) showed the most damage of the first three cars. The right corner of the plow, the grab handles on the side of the car, several components suspended beneath the car, and the rear step ladder were deformed from impact with the bridge structure (Figure 15).

Figure 15. Images of the Opposite Side of the 47th Street Bridge (left), Damage to the Front Right Corner of Car 7488 (right), and the Impact Point of the Top Edge of the Railing to the Corner Post (inset right)

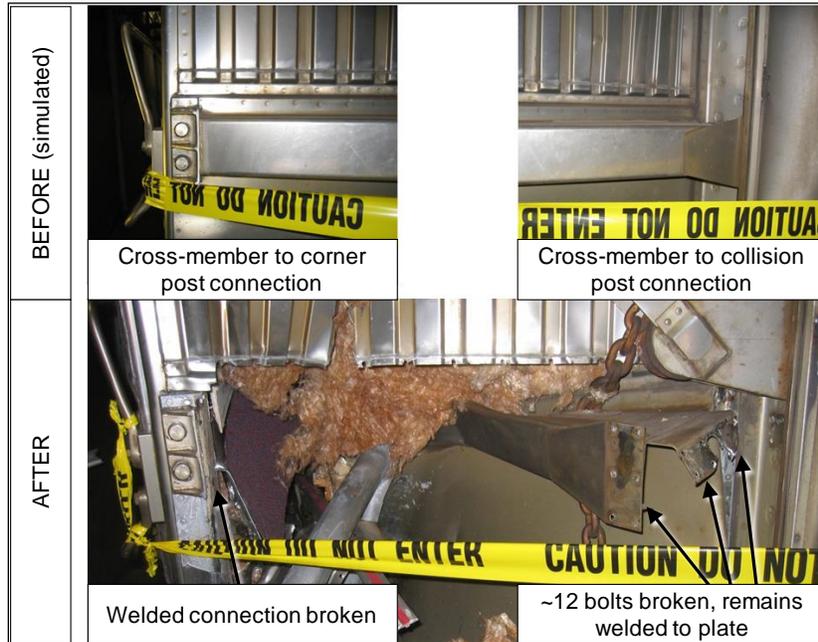
Figure 16. Damage to the Right End Frame of Car 7488: Simulated End Frame Before the Impact (top) and Actual End Frame After the Impact (bottom)

The fourth car in the passenger consist (7488) impacted the right bridge girder, causing significant deformation of the right front corner of the car body. The initial point of impact appears to have been with the railing that was attached to the west side of the bridge (see similar railing in Figure 15 and diagram of the bridge in Figure 20). The leading edge of the railing, which measured 3 feet from the bottom rail to the top rail, impacted the corner post (Figure 15, inset right). The railing then impacted the lateral beam connecting the corner post to the collision post, which detached completely at the corner post connection and partially at the collision post connection (Figure 16). The railing penetrated the occupied volume; however, the magnitude of penetration is not known, because the railing was partially removed during the initial response to

the derailment. (The top photos in Figure 16 simulate the end frame of car 7488 before the crash by mirroring photographs of the left side of the car.)

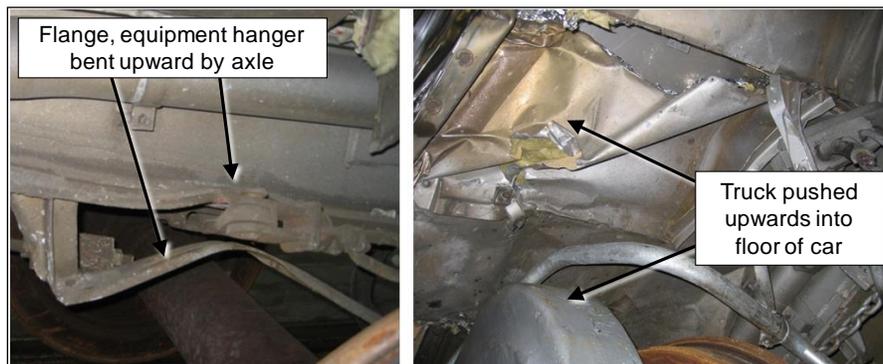
As the front truck of car 7488 impacted the bridge girder, both axles separated from the truck bolster; but the fractured bolster remained attached to the car body. The rear truck separated from the car body entirely. One of the axles showed signs of a direct impact and was bent to roughly a 5-degree angle; however, it is unclear whether this axle was detached from the front or the rear truck. This axle came to rest beneath the doors of the car (see Figure 7). The impact to the truck (Figure 17), in turn, deformed the front right side of the car, as evidenced by both an outward bulge of the car body (Figure 18), and an upward deformation of the floor of the car (Figure 19).

Figure 17. Impact of the Axle of the Front Truck of Car 7488 with the Floor of the Occupant Volume

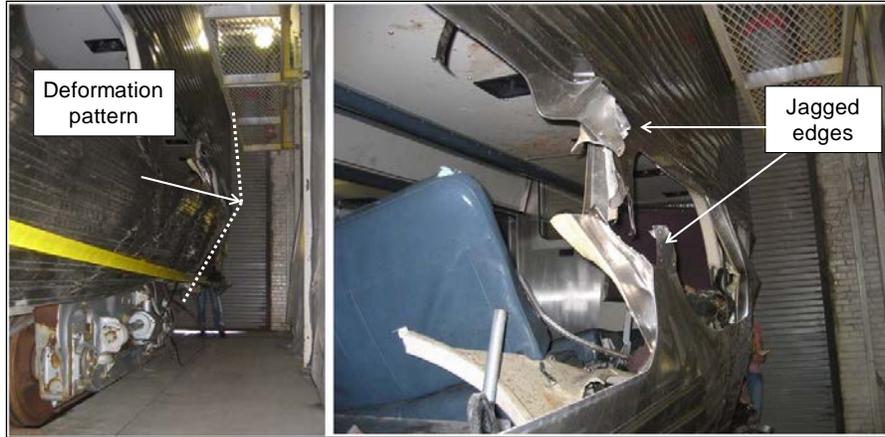
Figure 18. Outward Deformation of the Right Side of Car 7488, Tearing the Sheet Metal and Exposing Jagged Edges

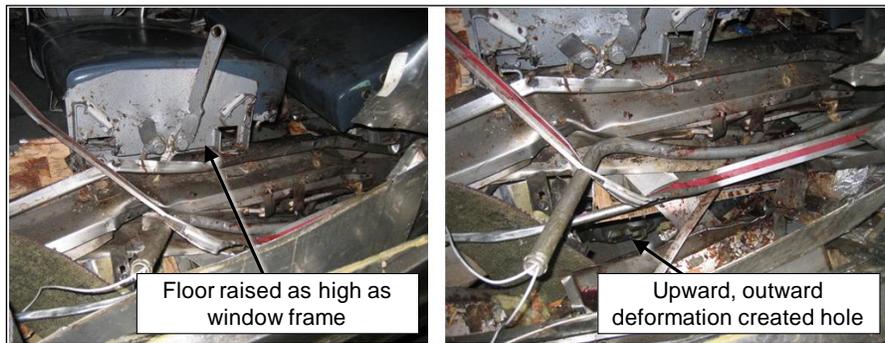
Figure 19. Upward Deformation of the Interior Floor, Resulting in a Breach of the Occupant Volume

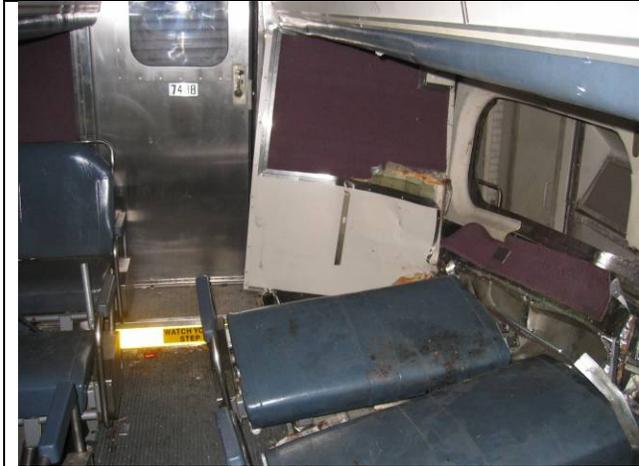
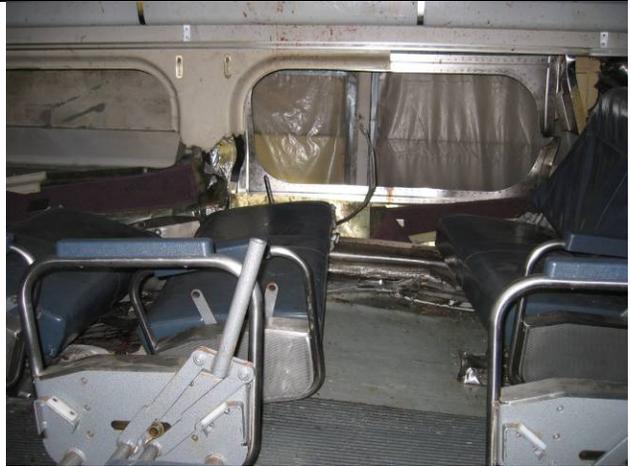
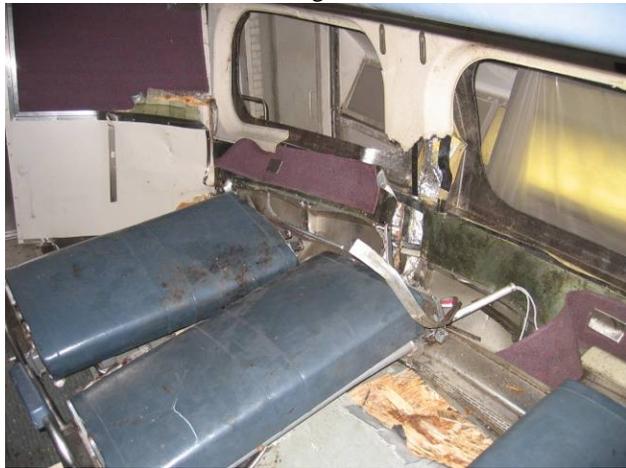
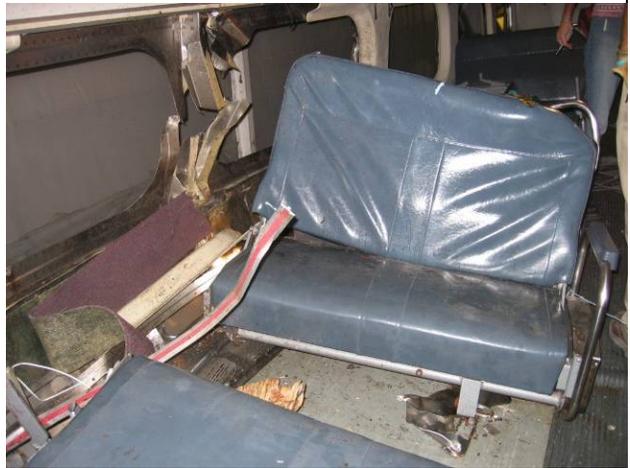
Figure 22. Interior View of the Front Right Corner of Car 7488

In contrast to the first three cars, there was severe damage to the interior of the fourth car in the consist (car 7488, also referred to as the third coach car). The integrity of the occupant compartment was compromised in the first three to four rows of seats on the right-hand side of the car, lower level. The floor of the car body was deformed vertically by 1 to 2 feet between the third and fourth rows of seats when the front truck impacted the bridge girder. The side wall was deformed inward by roughly 1 foot at the base and outward by roughly 1 foot at the bottom edge of the window frame. The occupant compartment was penetrated by fractured metal from the car body siding and the railing from the bridge. At least one fatality resulted from the loss of survivable space (Figure 22). There were also significant vertical and longitudinal car body accelerations that caused secondary impact injuries, as indicated by the residual blood and body matter on the seats, floor, and ceiling. The passengers throughout the car were thrown from seats into the aisle or ceiling, or over seatbacks. Many passengers needed assistance exiting the car; some exited through windows.

Most of the seat backs in the front half of the car were detached from the seat bases. Some of the seat backs may have been removed by rescue personnel, but several seat backs likely detached during the accident, which exposed the steel mounting posts— a severe secondary impact hazard (Figure 23). The seat design relies on gravity to keep the seatbacks on the mounting posts. The separation of the seat backs from the seat bases indicates a significant vertical component of the car body acceleration. Also due to significant vertical forces, five or six seat pedestals in the front of the car were crushed or deformed, and a railing fragment traversed several rows into the occupant volume at the front of car (Figure 24).
