***Federal Railroad Administration
Office of Railroad Safety
Accident and Analysis Branch***

***Accident Investigation Report
HQ-2015-1009***

***CSX Transportation (CSX)
Mount Carbon, WV
February 16, 2015***

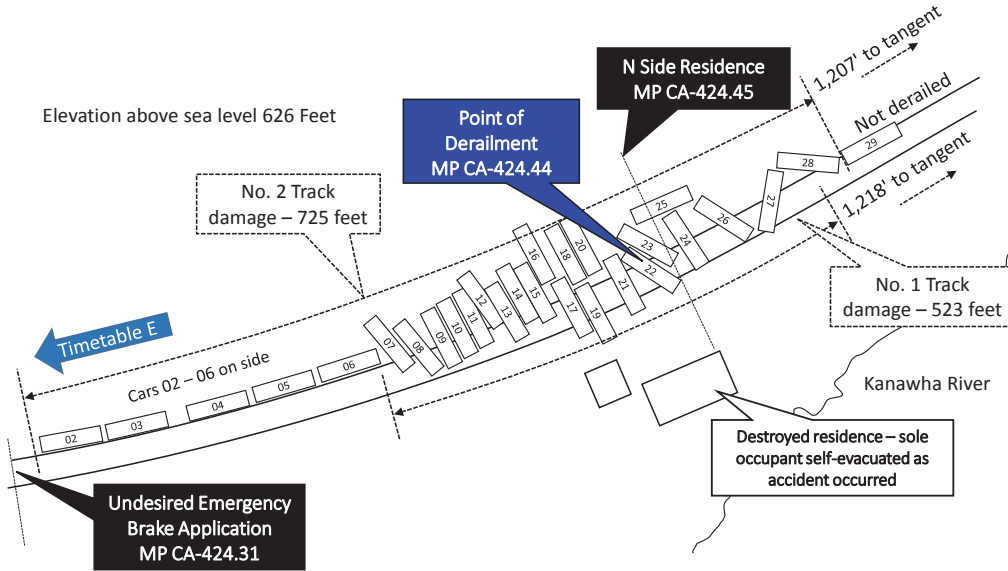
sketch

CSX Mt. Carbon, WV Crude Oil Train K08014 Derailment February 16, 2015
