REPORT NO. UMTA-IN-06-0009-83-3

COLD WEATHER TRANSIT TECHNOLOGY PROGRAM

VOLUME 3 - INVESTIGATION OF THE HIGH INCIDENCE OF RAIL PULL APARTS ON CONTINUOUS WELDED RAIL

May 1983

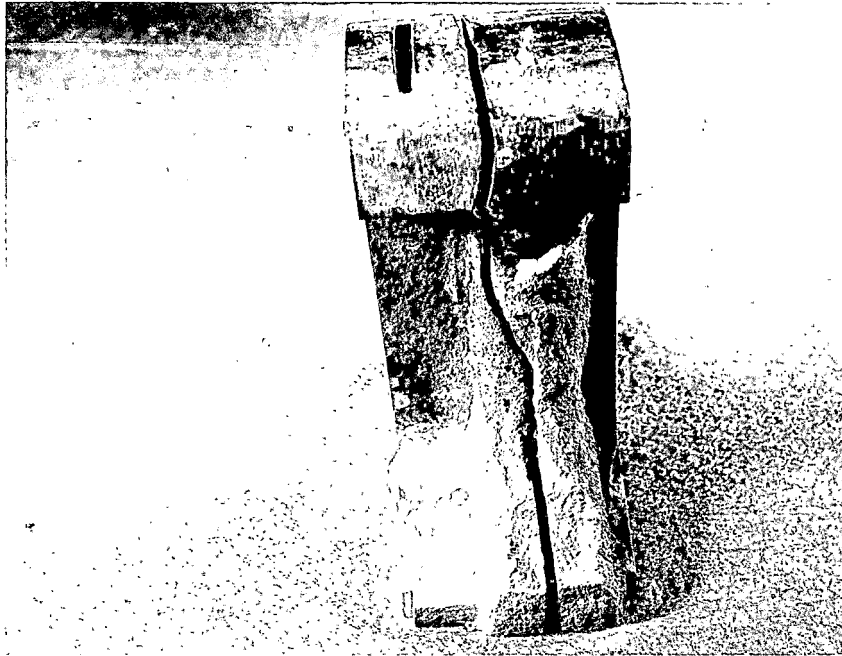
Figure 3.3-1 Side View of the crack in failure specimen #1.

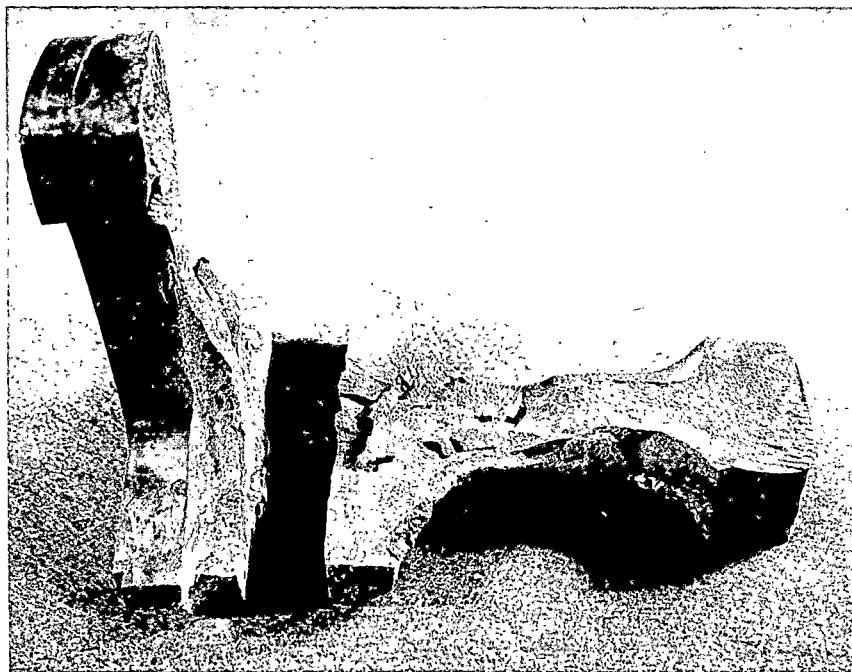
Figure 3.3-2 Failure specimen #1 opened to show the fracture surface.

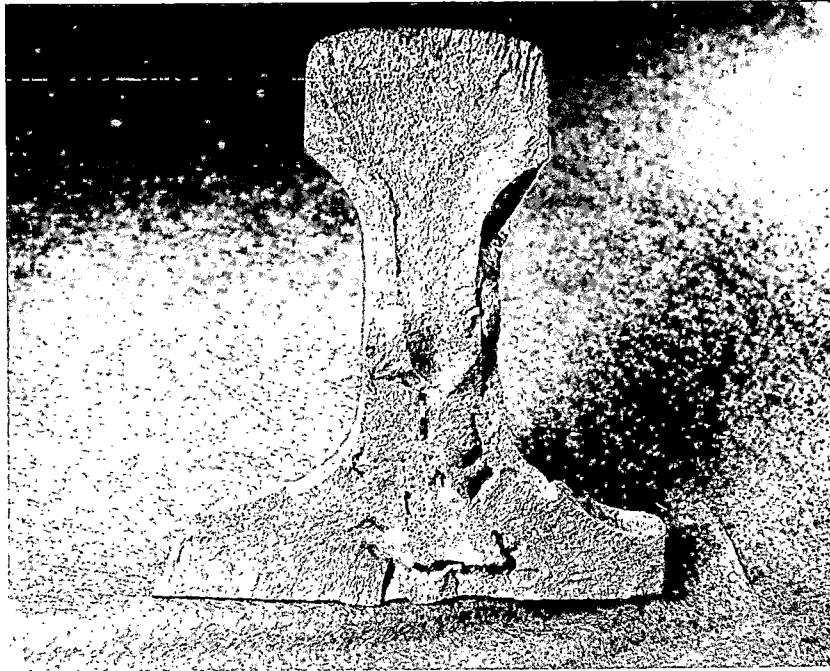
Figure 3.3-3 Fracture surface of #1 showing lack of fusion in the bottom half of the weld.

sponge porosity and a flat oxidized surface showing little or no tensile fracture. Figures 3.3-4 and 3.3-5 are sections taken from the top and bottom, respectively. The lack of fusion in the bottom (Figure 3.3-5) is evidenced by the lack of melting of the rail ends in contrast to Figure 3.3-4, which indicates good fusion in the head of the rail. The variation of fusion from top to bottom shows that the top half of the rail was preheated more than the bottom half.

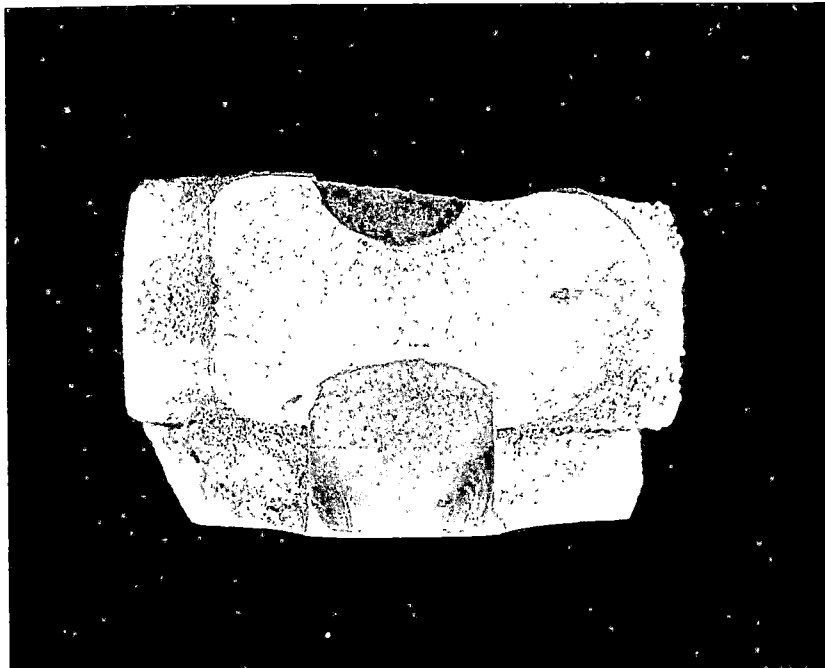
Figure 3.3-4 Section taken from the top of #1, showing fusion in the top half.

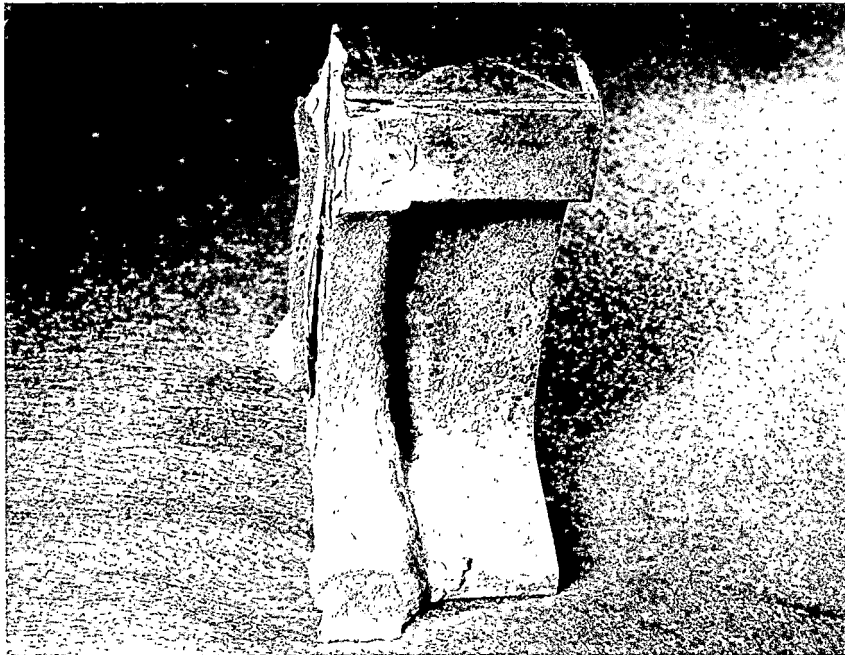
Figure 3.3-6 Side view of specimen #3 showing crack along the weld interface.

Specimen #3 (Figures 3.3-6 through 3.3-9) is an example of a weld in which no fusion was achieved. The crack runs straight up the side of the weld along the interface between the weld metal and the rail (Figure 3.3-6). The lack of fusion is evidenced in Figure 3.3-7 by the flat, oxidized (dark colored) appearance of the fracture. Figure 3.3-8 shows that one corner of the rail had begun to melt, otherwise no fusion had occurred. The photomicrograph in Figure 3.3-9 shows complete lack of fusion along the interface between the weld metal and the rail.

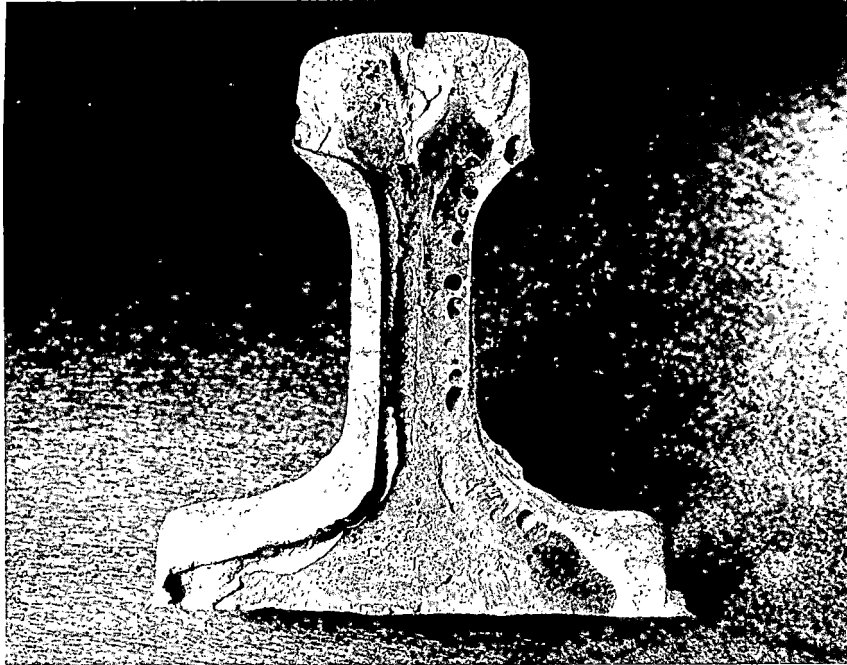
Figure 3.3-7 Fracture surface of #3 showing lack of fusion (dark area) throughout the weld zone.

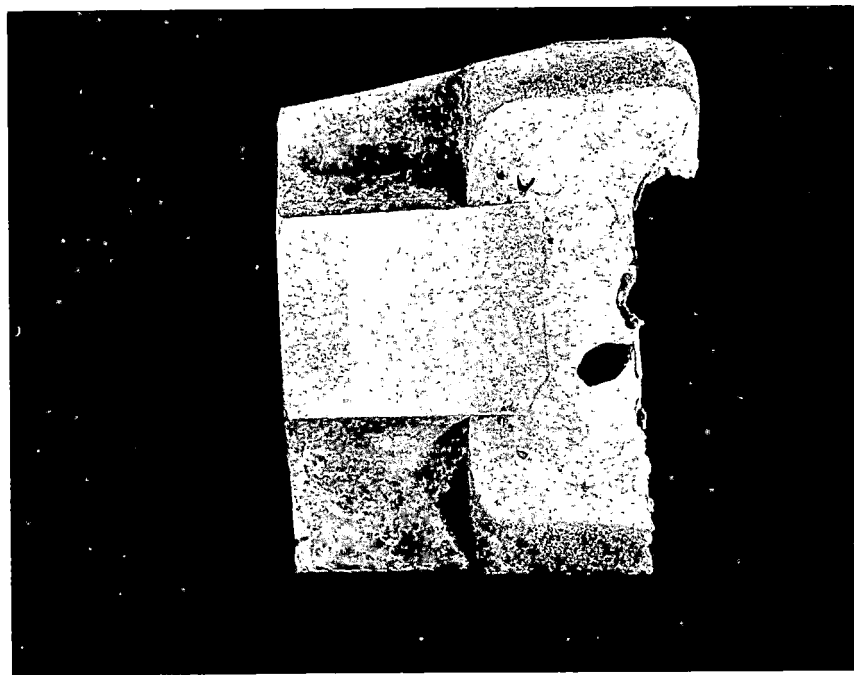
Figure 3.3-8 Section of #3 showing almost no melting of the rail.

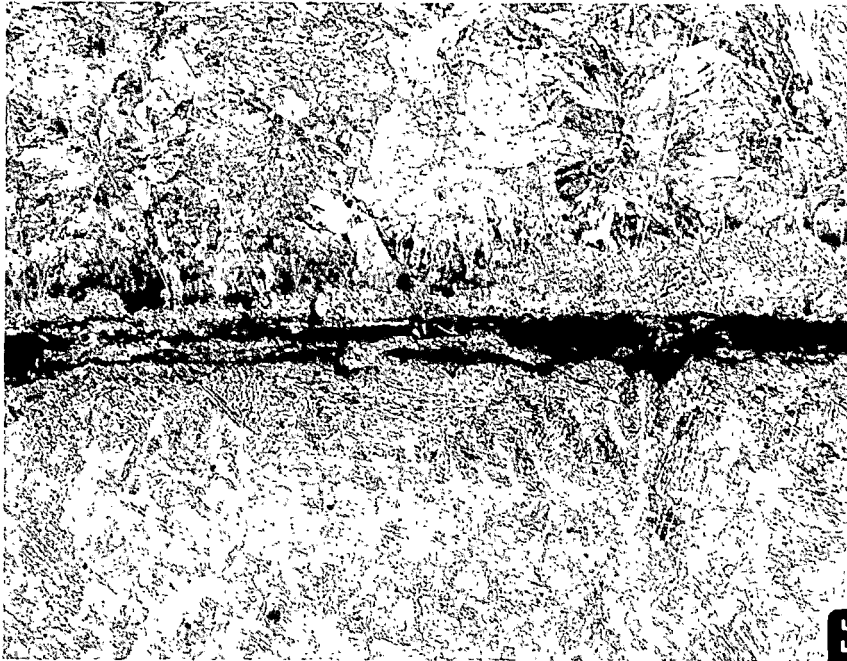
Figure 3.3-9 Photomicrograph showing lack of fusion along the weld interface of #3. Nital Etch. (100x)

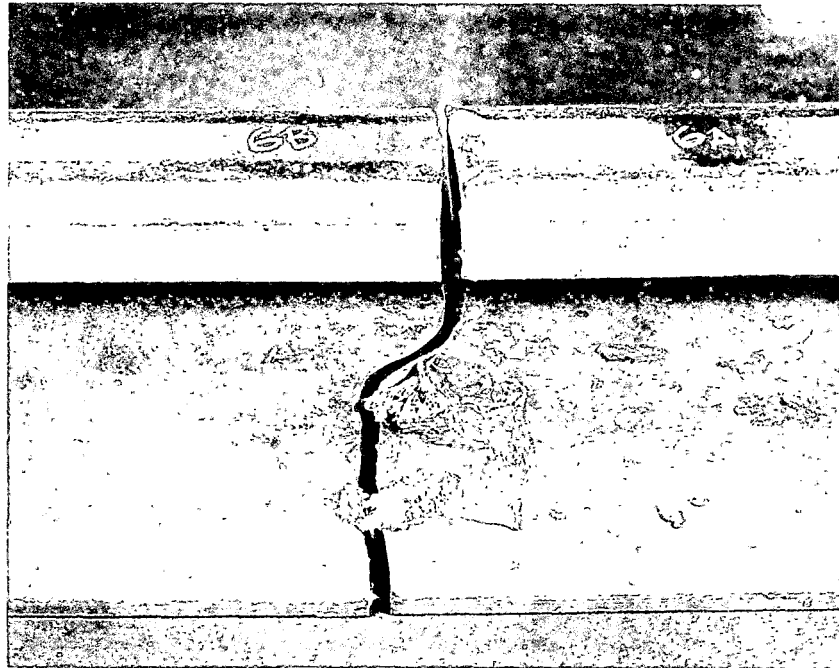
An example of a bus bond failure is shown in Figures 3.3-10 through 3.3-13. In this type of failure, cracking developed from the point where the copper bus wire was welded to the rail (Figure 3.3-10). Figure 3.3-11 is a section through the bond site showing the copper penetrating into the rail. Figure 3.3-12 is a photomicrograph at 100X showing a hard layer of untempered martensite which formed at the interface of the copper bus and the rail. This layer, shown in more detail in Figure 3.3-13, was made up of martensite with a hardness as high as RC 57. Intergranular cracking and copper penetration are evident in the photograph.

Figure 3.3-10 Failure specimen #6 showing typical bus bond type failure.

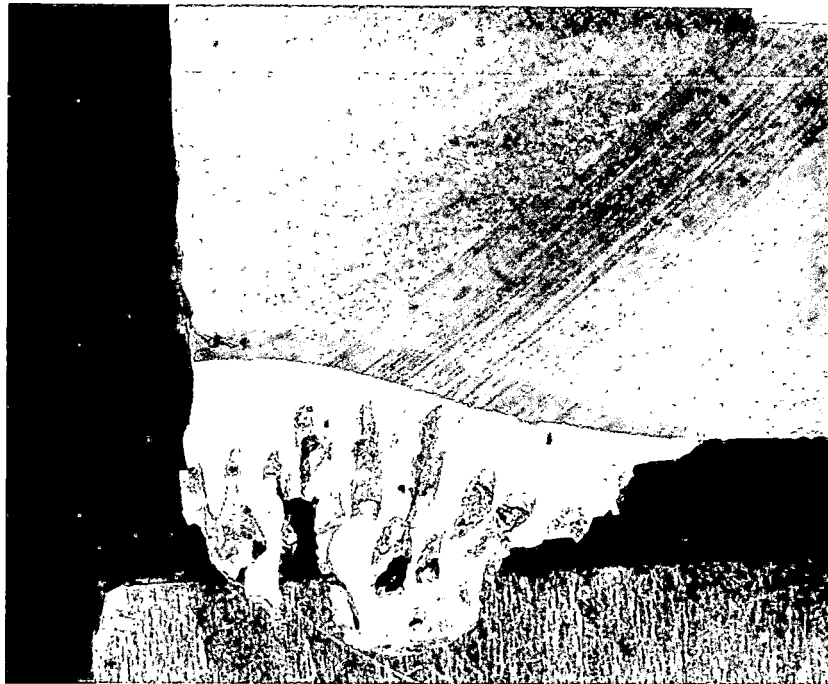
Figure 3.3-11 Cross section of a bus bond showing penetration of the copper into the rail. (10x)

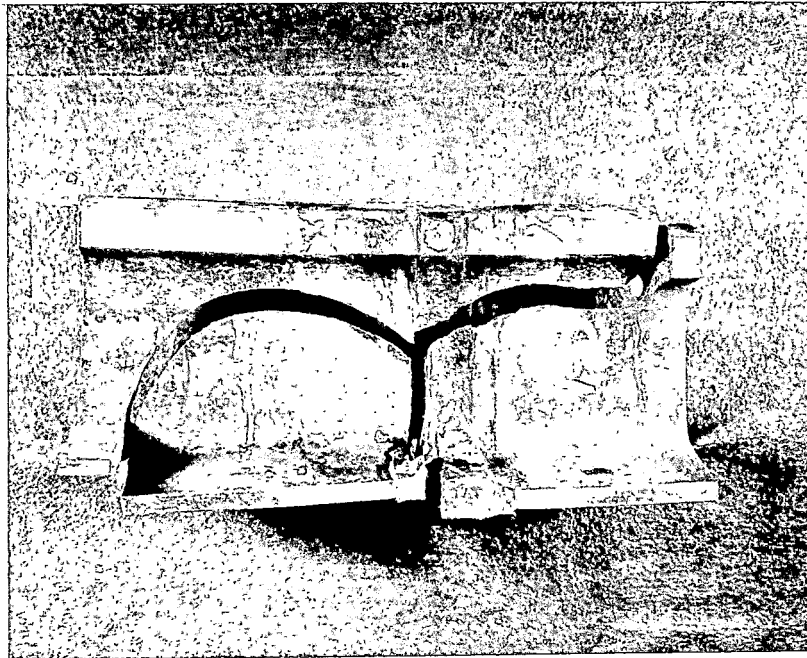
Figure 4.3.1-1 Calorite weld specimen #C-1 after bend test.

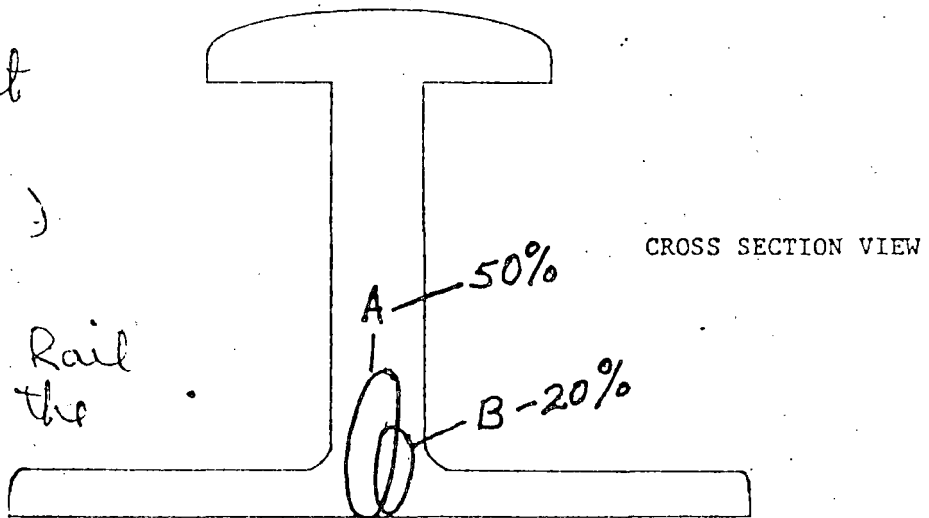
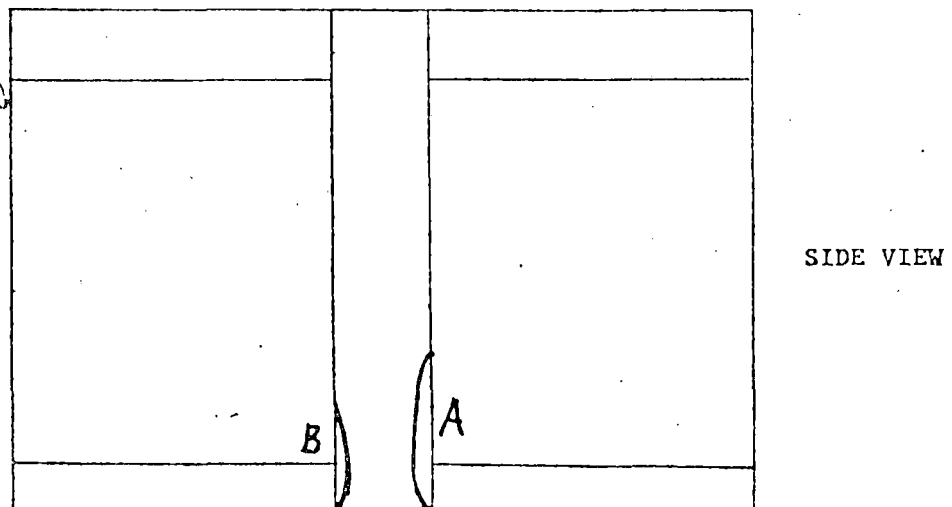
Figure 4.3.1-5 Ultrasonic inspection report on specimen #T-1

NDI INDICATIONS
ORIGINATED FROM
AREAS OF SPONGE LIKE
POROSITY - A CONCENTRATION
OF VOIDS WAS
NOTED AT THE FUSION
LINE - this could
have given a
crack like
appearance -

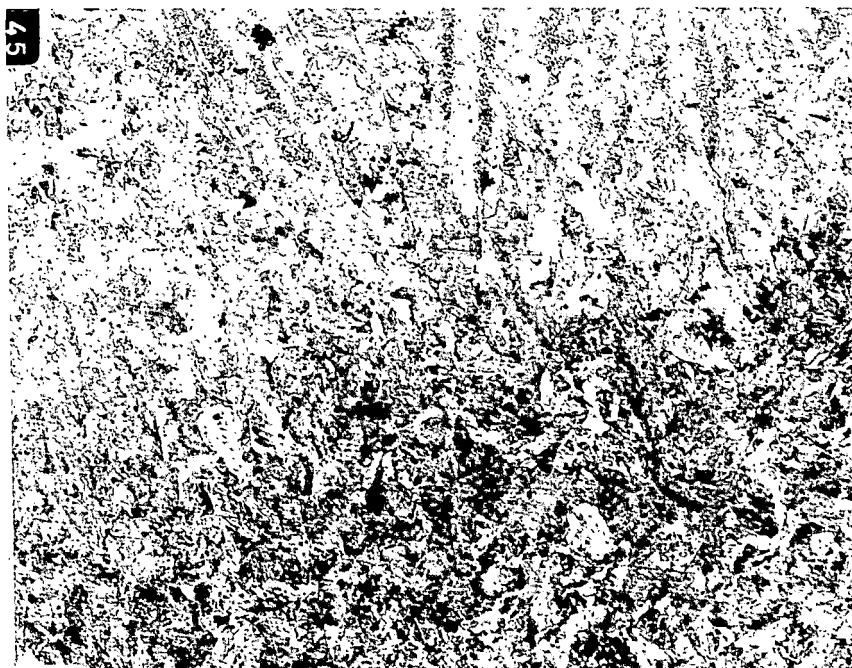
Figure 4.3.2-6 Weld interface - complete fusion - specimen #C-4 (1900°F preheat). Nital Etch. (100x)

Figures 4.3.2-6 through 4.3.2-9 illustrate microscopic conditions observed in the weld joints. A normal completely fused joint is illustrated by #C-4 (Figure 4.3.2-6) welded at 1900⁰F preheat. Lack of fusion is illustrated by #C-3 (Figure 4.3.2-7) welded at 900⁰F preheat. Specimen #C-12 (Figure 4.3.2-8) shows a case in which complete fusion was achieved at 1500⁰F preheat, but a large inclusion was retained in the weld. Specimen #C-11 (Figure 4.3.2-9) is an example of cracking which developed in a weld which was too hard (RC 52-53).

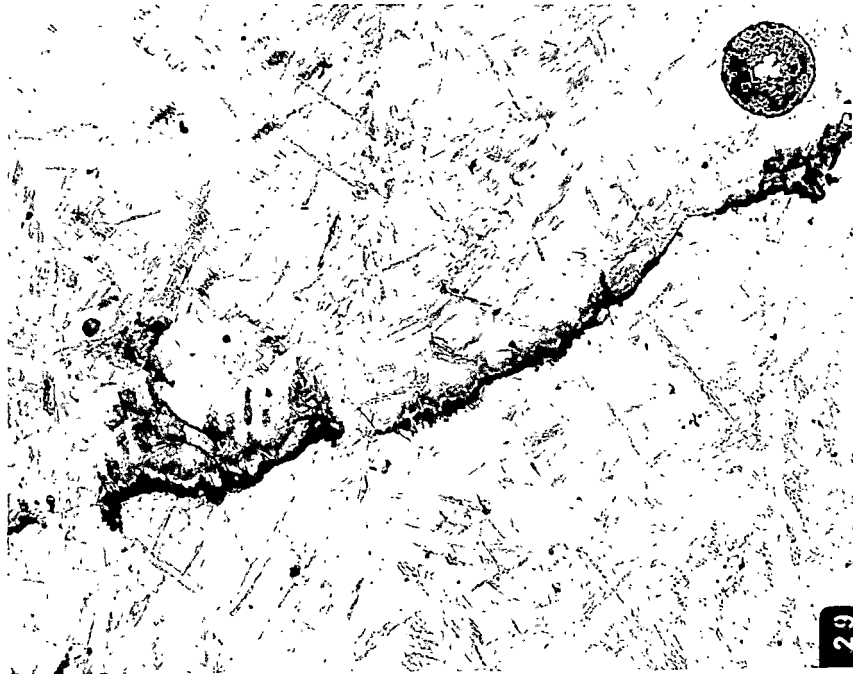
Figure 4.3.2-9 Cracking resulting from excessive weld hardening (RC 52-53) in specimen #C-11 (1100°F) preheat). Nital Etch. (100x)

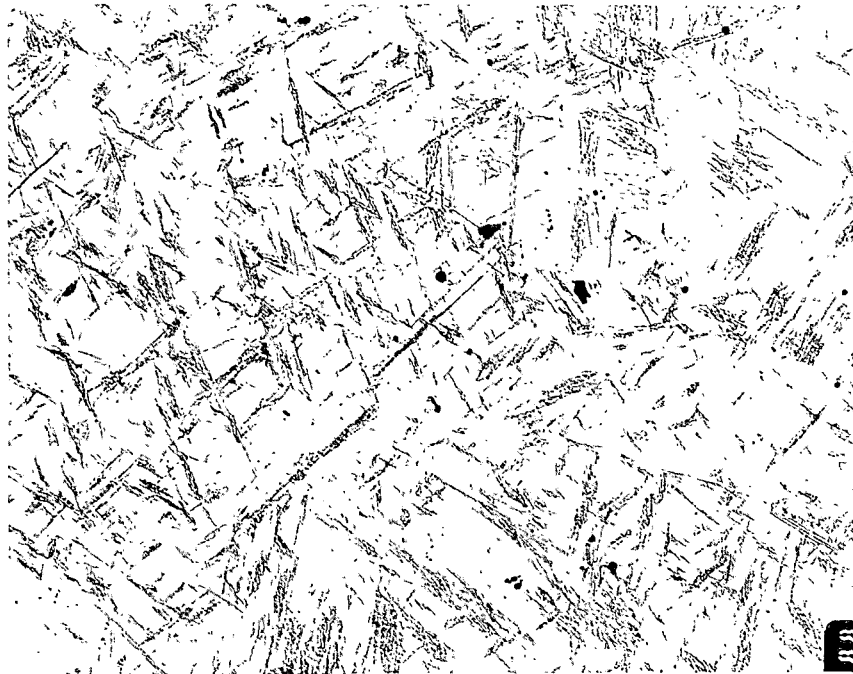
Figure 4.3.2-10 Photomicrograph - specimen #C-1 showing hard (RC 51) weld containing martensite and upper bainite. Nital Etch. (100x)

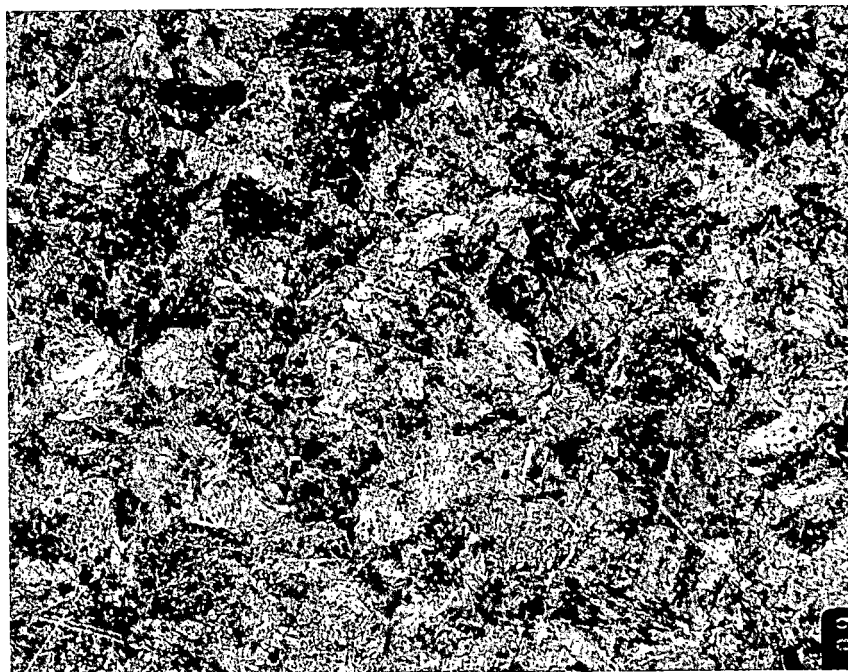
Figure 4.3.2-14 Photomicrograph from specimen #T-3 showing soft (RC 28) weld containing fine pearlite. Nital Etch. (100x)

US Thermit welds (RC 28) was substantially lower than the Calorite welds. This was due to the lack of alloying elements in the US Thermit weld metal, which results in a completely pearlitic microstructure, Figure 4.3.2-14. Hardness in the US Thermit welds was approximately the same as that of control cooled rail. Therefore, in the chrome rail, the weld was softer (RC 28) than the rail (RC 32-35).

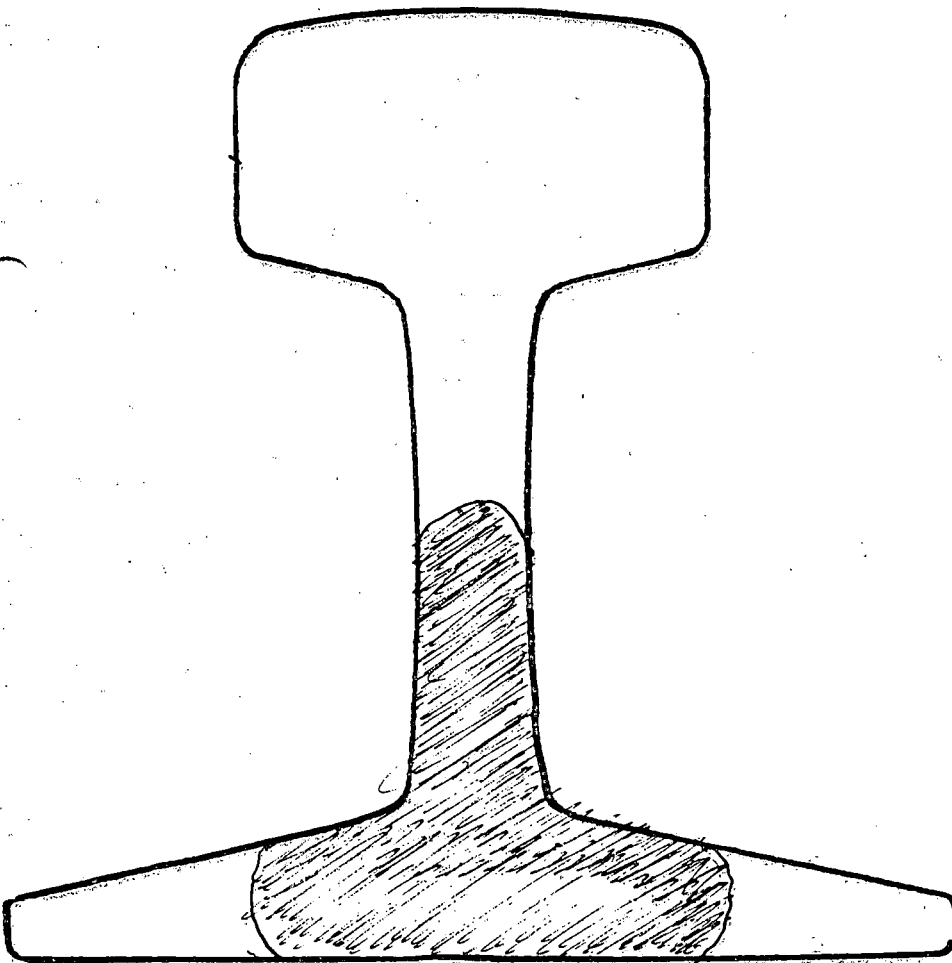
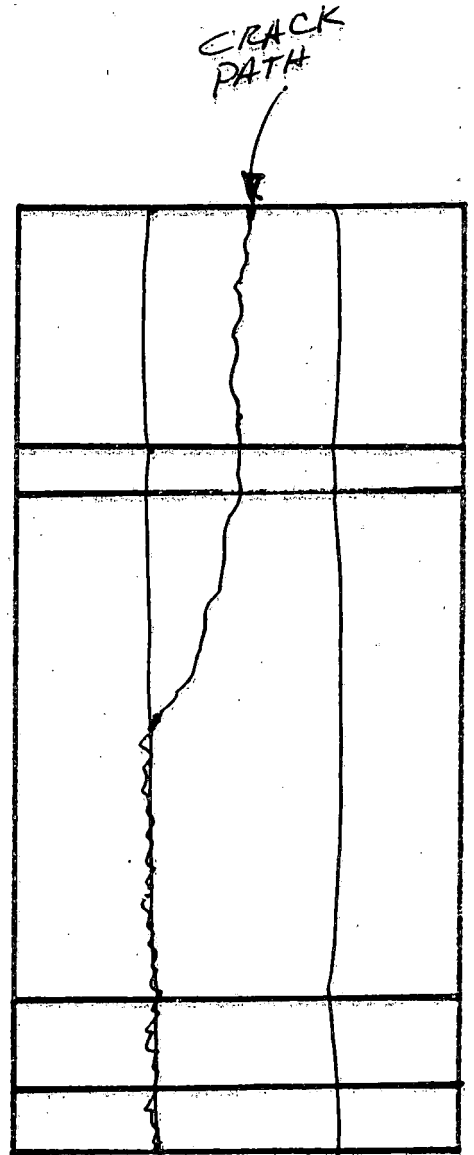
SPECIMEN NO. #1 A,B
RAIL TYPE 115#

FAILURE LOCATION WELD
TYPE OF WELD CALORITZ GAP USED _____
% UNFUSED METAL 30%
PROBABLE CAUSE OF FAILURE LACK OF FUSION AT BOTTOM OF WEB.
COMMENTS: _____

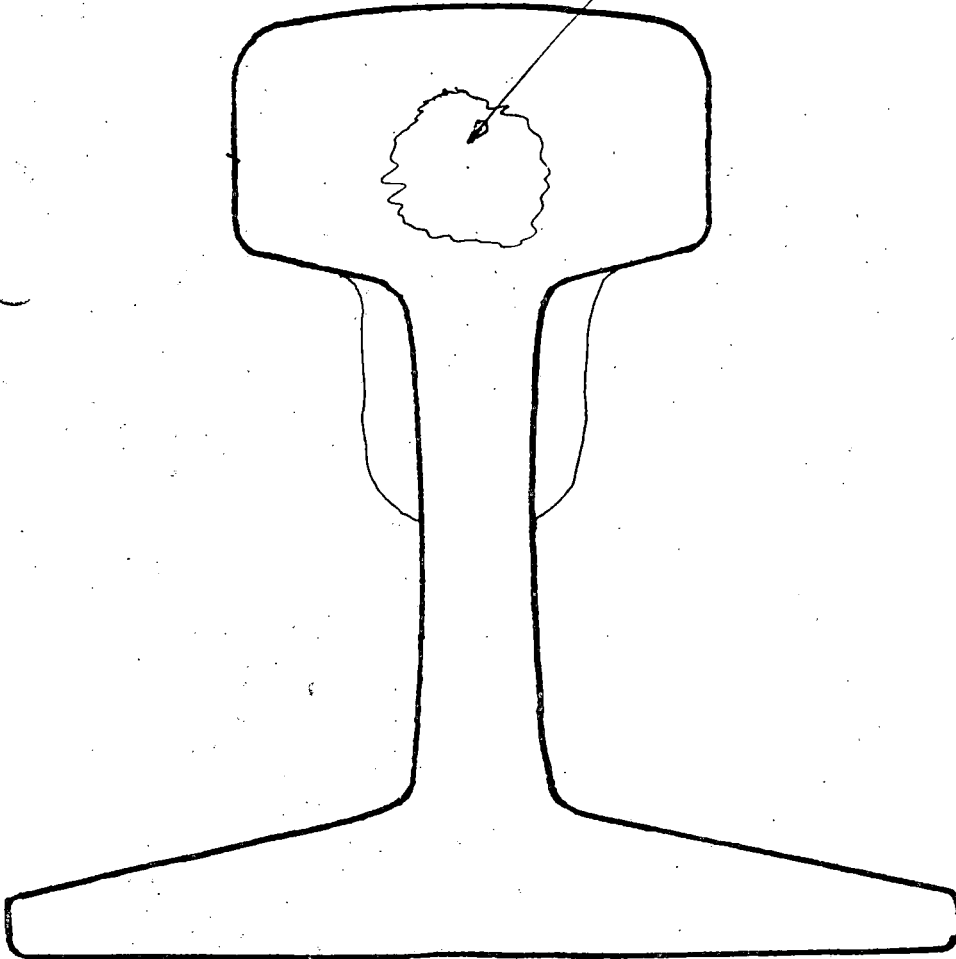
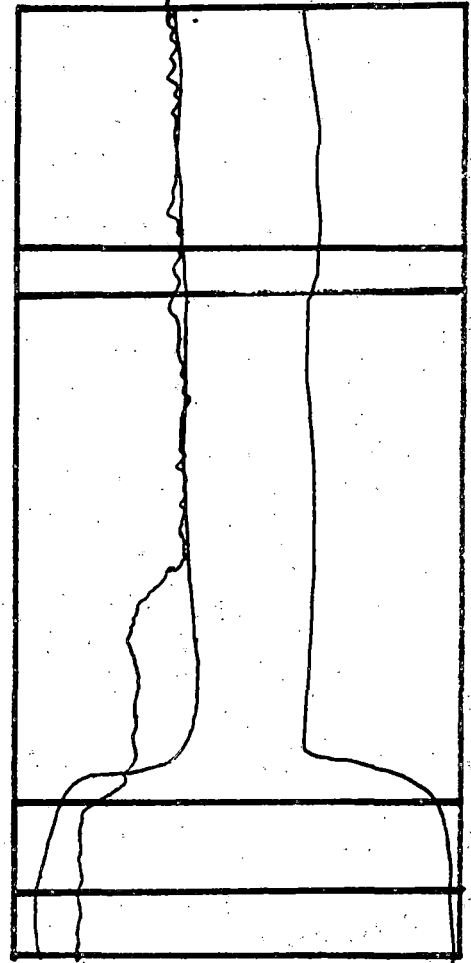
POSSIBLE
SLAG INCLUSION

FAILURE LOCATION WELD (HAZ)
TYPE OF WELD UNKNOWN GAP USED _____
% UNFUSED METAL 10%
PROBABLE CAUSE OF FAILURE SLAG INCLUSION / BRITTLE HEAT AFFECTED ZONE,
COMMENTS: _____

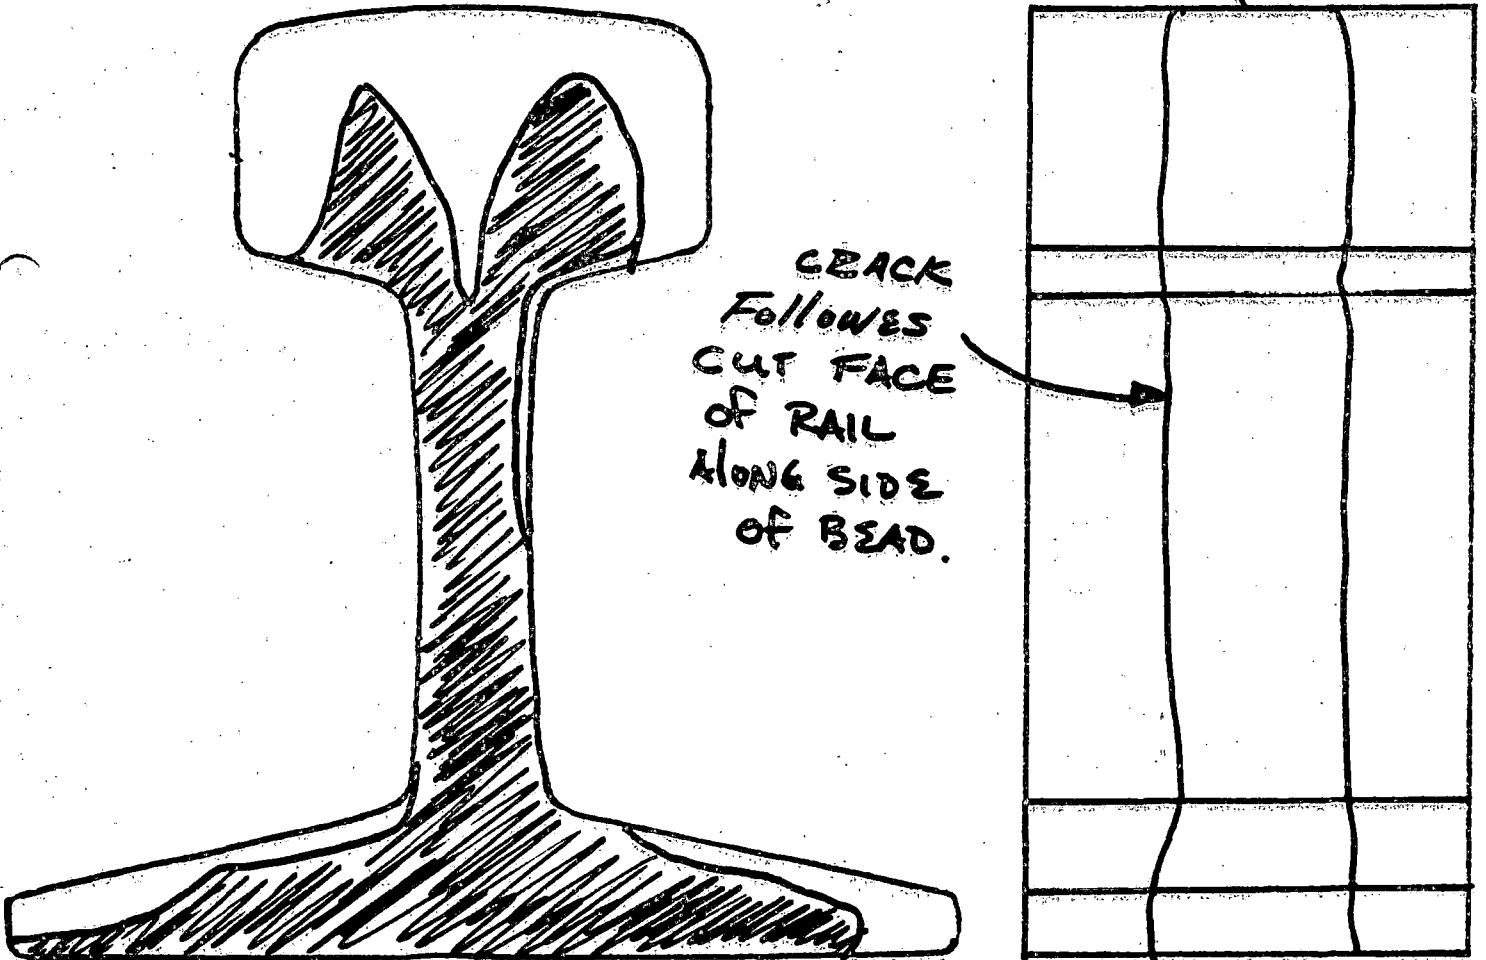
SPECIMEN NO. 3A
RAIL TYPE 115# A1B

FAILURE LOCATION WELD
TYPE OF WELD CALORITE GAP USED ~ .45"
% UNFUSED METAL 80-90%
PROBABLE CAUSE OF FAILURE LACK OF FUSION DUE TO INADEQUATE PRE HEAT.
COMMENTS:

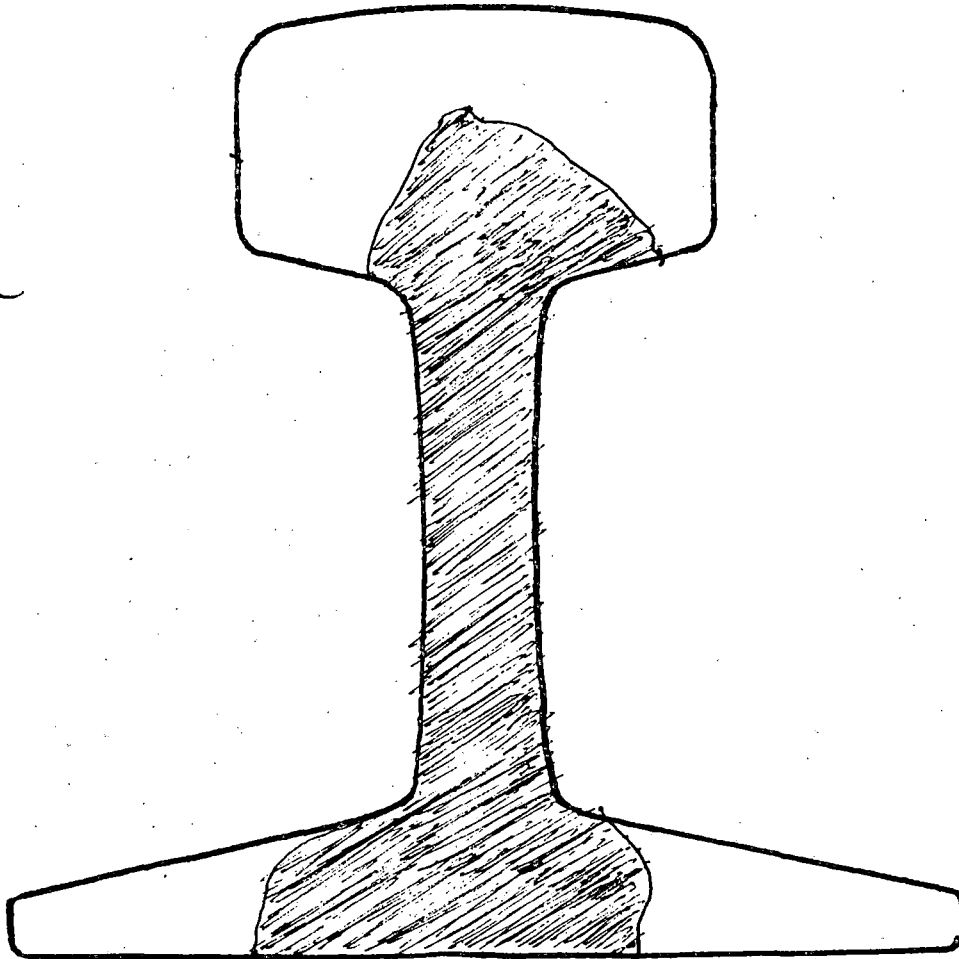
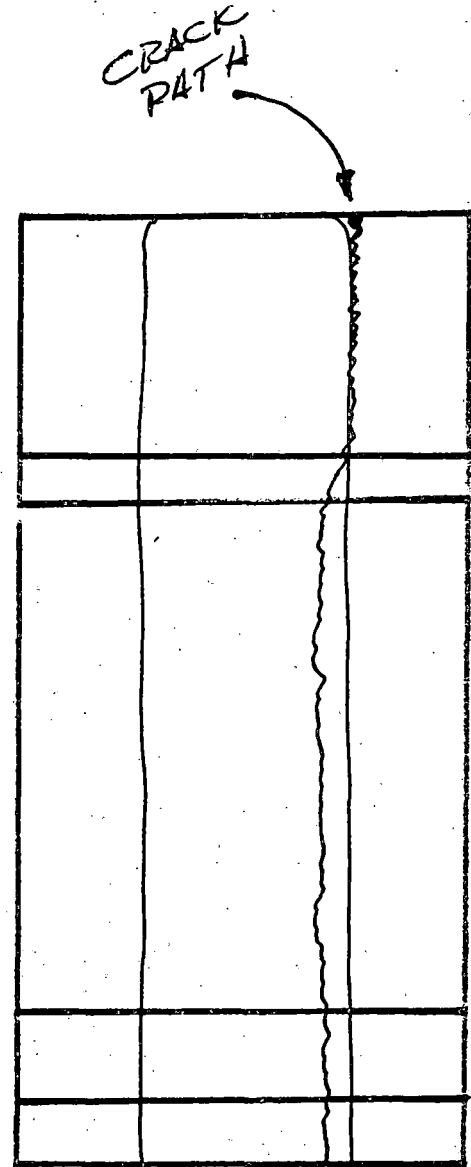
SPECIMEN NO. #4 A,B
RAIL TYPE 115#

FAILURE LOCATION WELD
TYPE OF WELD CALORITE GAP USED _____
% UNFUSED METAL 75-80%
PROBABLE CAUSE OF FAILURE LACK OF FUSION
COMMENTS: TOP OF RAIL INDICATES POSSIBLE BRITTLE HAZ.

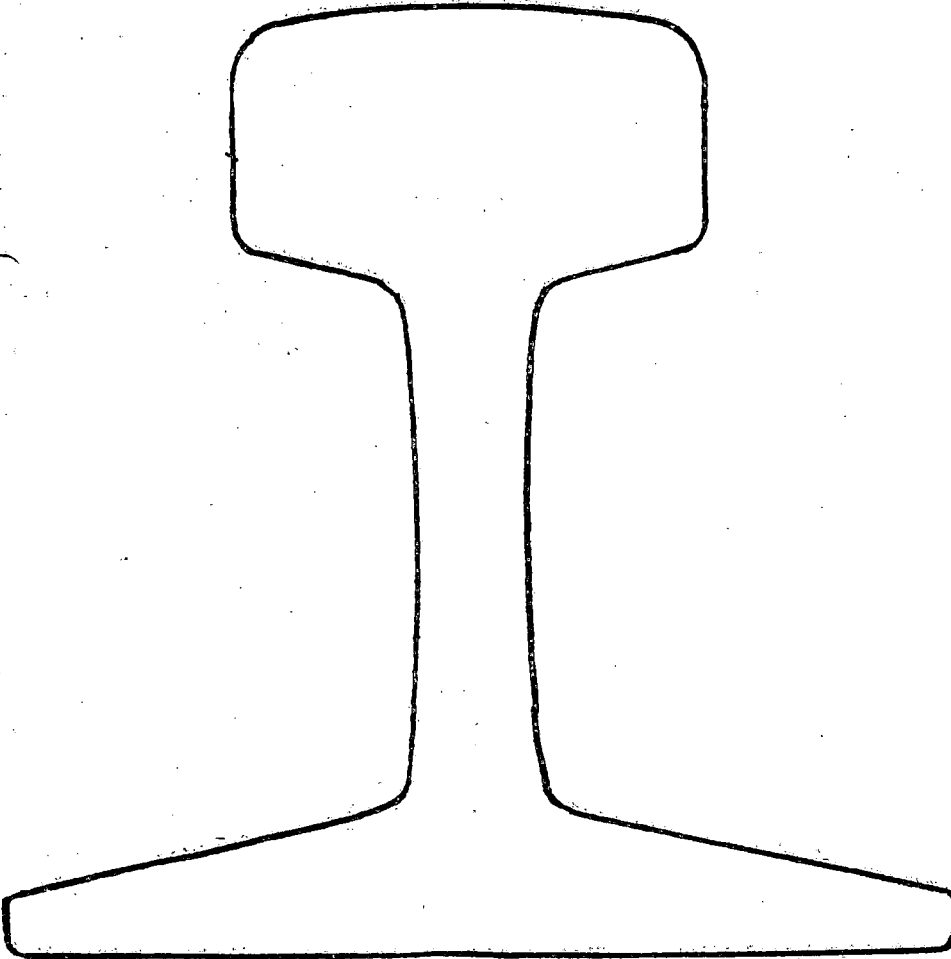
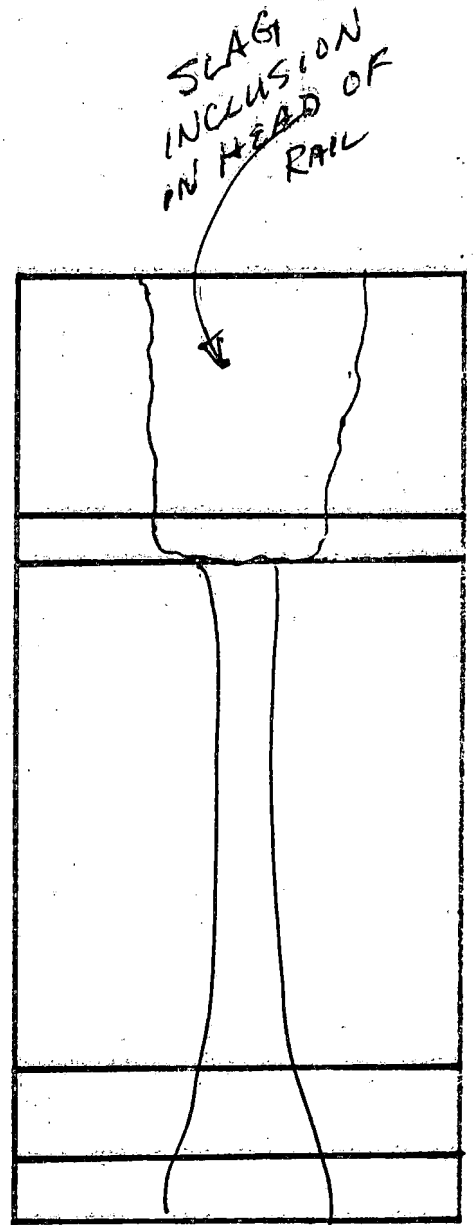
SPECIMEN NO. #5 A, B
RAIL TYPE 115#

FAILURE LOCATION WELD
TYPE OF WELD US THERMIT GAP USED _____
% UNFUSED METAL 30%
PROBABLE CAUSE OF FAILURE WELD METAL RUN OUT
COMMENTS: POSSIBLE IMPROPER SEALING OF MOLD AT BOTTOM,

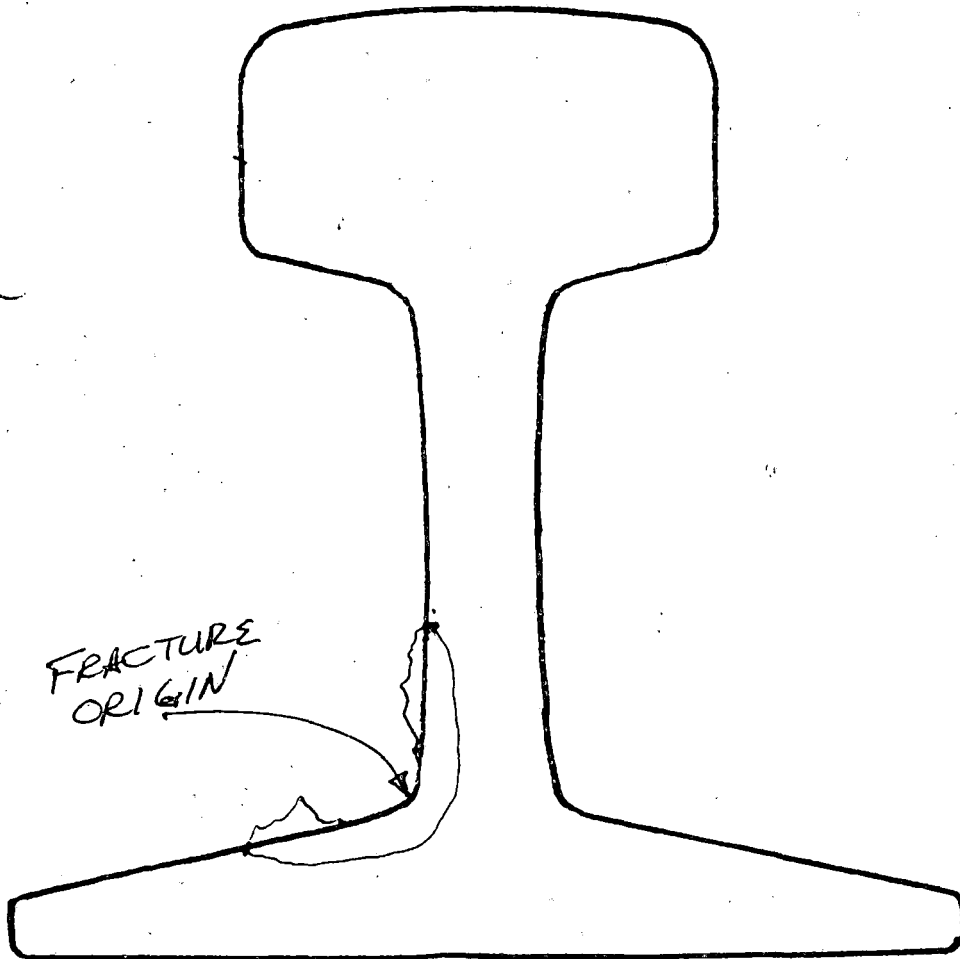
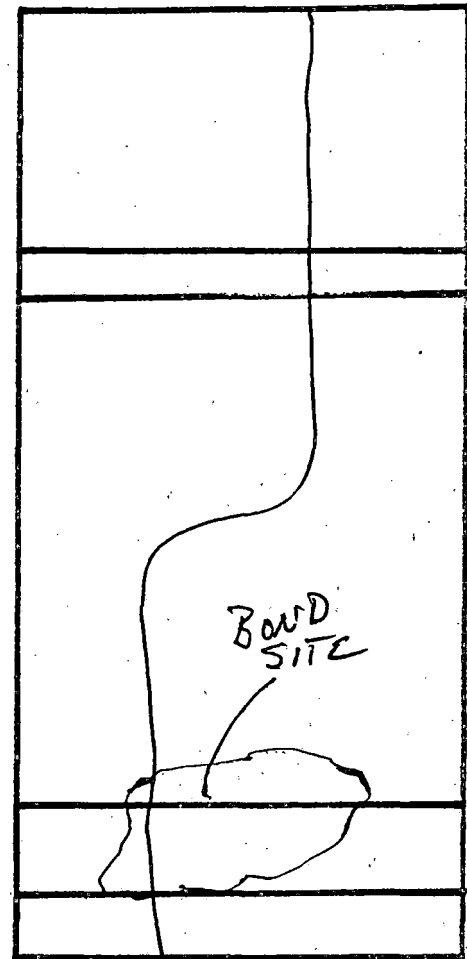
SPECIMEN NO. #6 A, B
RAIL TYPE 115#

FAILURE LOCATION Bus BAR BOND
TYPE OF WELD _____ GAP USED _____
% UNFUSED METAL _____
PROBABLE CAUSE OF FAILURE OVERHEATING OF BOND
COMMENTS: _____

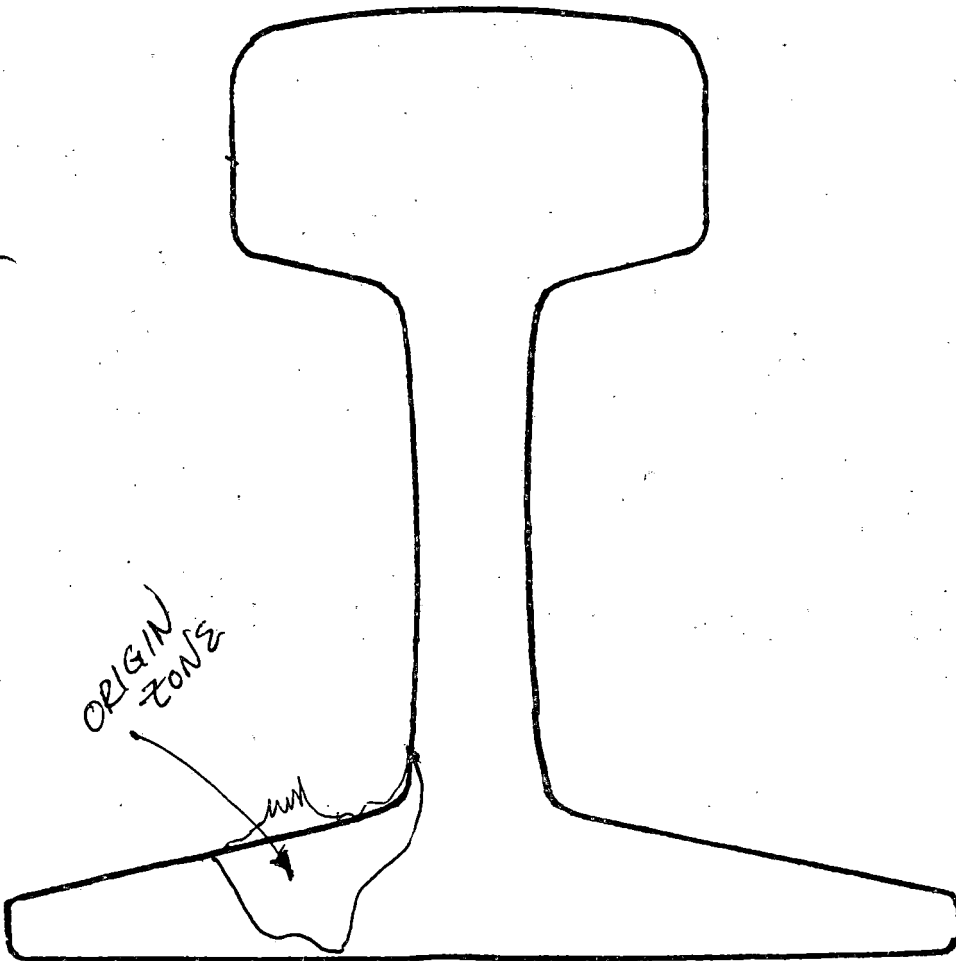
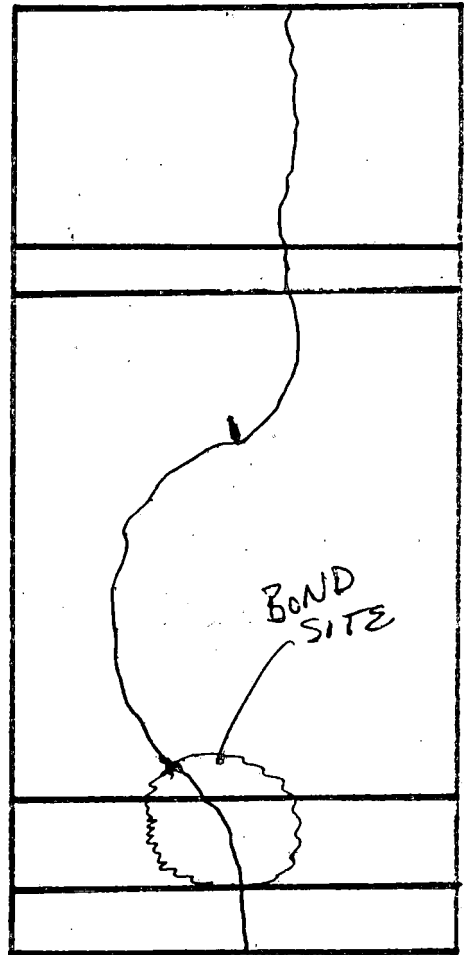
SPECIMEN NO. # 7
RAIL TYPE A, B

FAILURE LOCATION Bus Bar Bond
TYPE OF WELD _____ GAP USED _____
% UNFUSED METAL _____
PROBABLE CAUSE OF FAILURE OVER HEATING OF BOND -
COMMENTS: _____

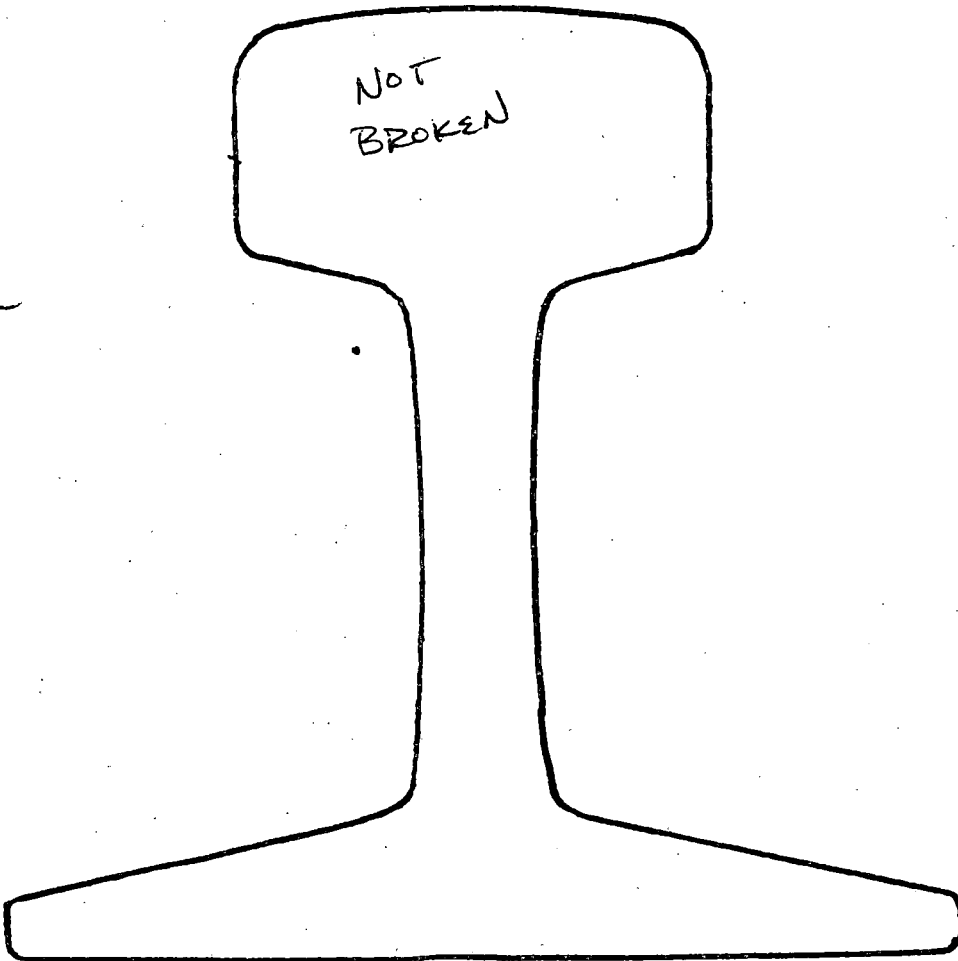
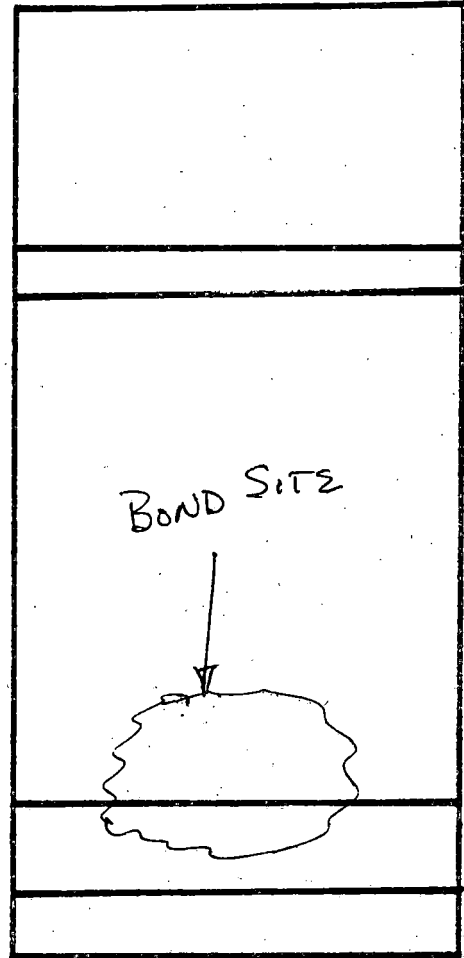
SPECIMEN NO. #8 A,B
RAIL TYPE 115#

FAILURE LOCATION Bus Bar Bond
TYPE OF WELD _____ GAP USED _____
% UNFUSED METAL _____
PROBABLE CAUSE OF FAILURE _____
COMMENTS: POOR BOND OF BUS BAR TO RAIL / RAIL DID NOT
BREAK - BUS PULLED OFF.
