REPORT NO. UMTA-IN-06-0009-83-3

COLD WEATHER TRANSIT TECHNOLOGY PROGRAM

VOLUME 3 - INVESTIGATION OF THE HIGH INCIDENCE OF RAIL PULL APARTS ON CONTINUOUS WELDED RAIL

May 1983

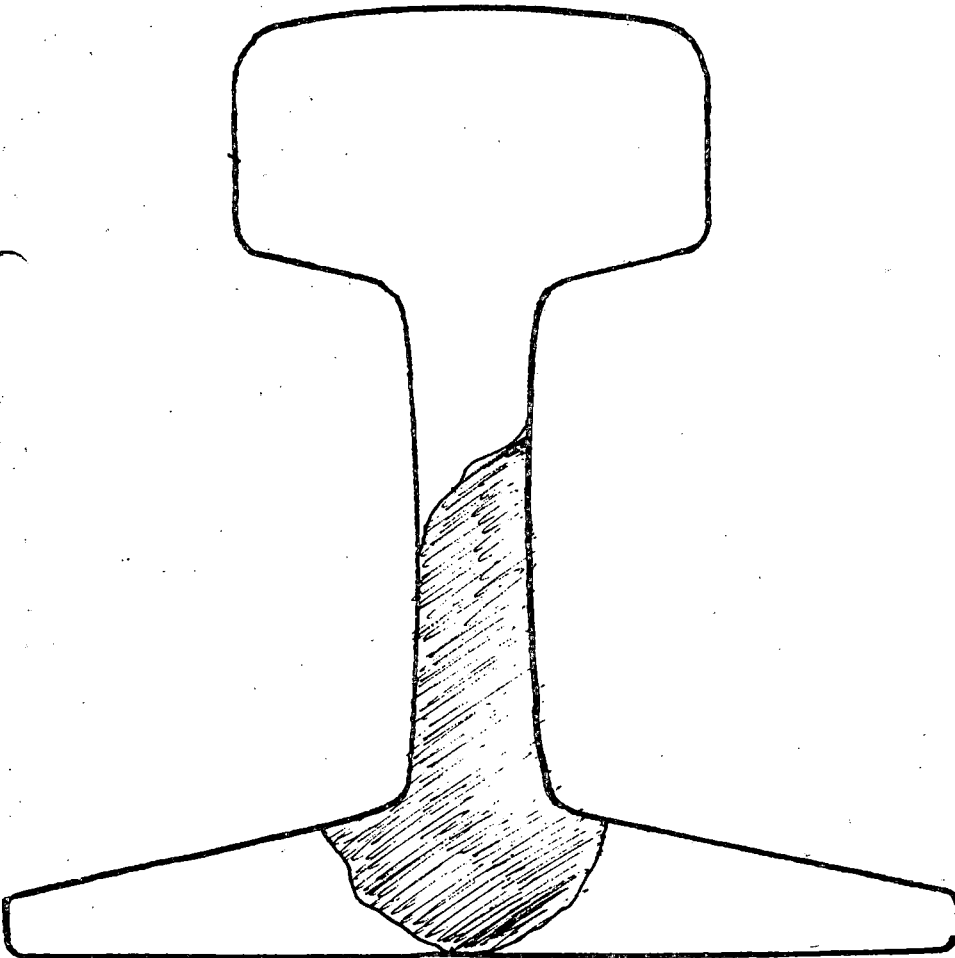
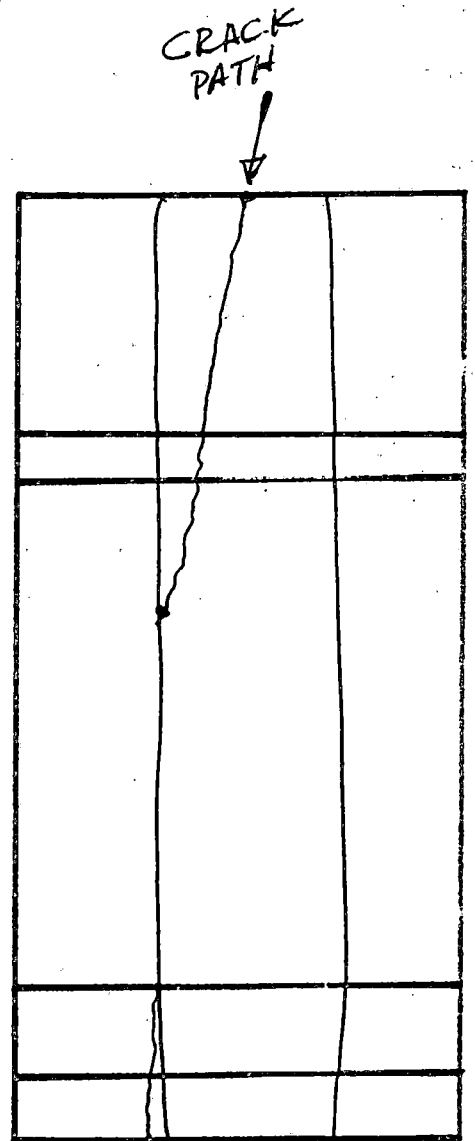
#9
115#

FAILURE LOCATION WELD
TYPE OF WELD CALORITZ GAP USED _____
% UNFUSED METAL 30%
PROBABLE CAUSE OF FAILURE LACK OF FUSION IN WEB
COMMENTS: _____

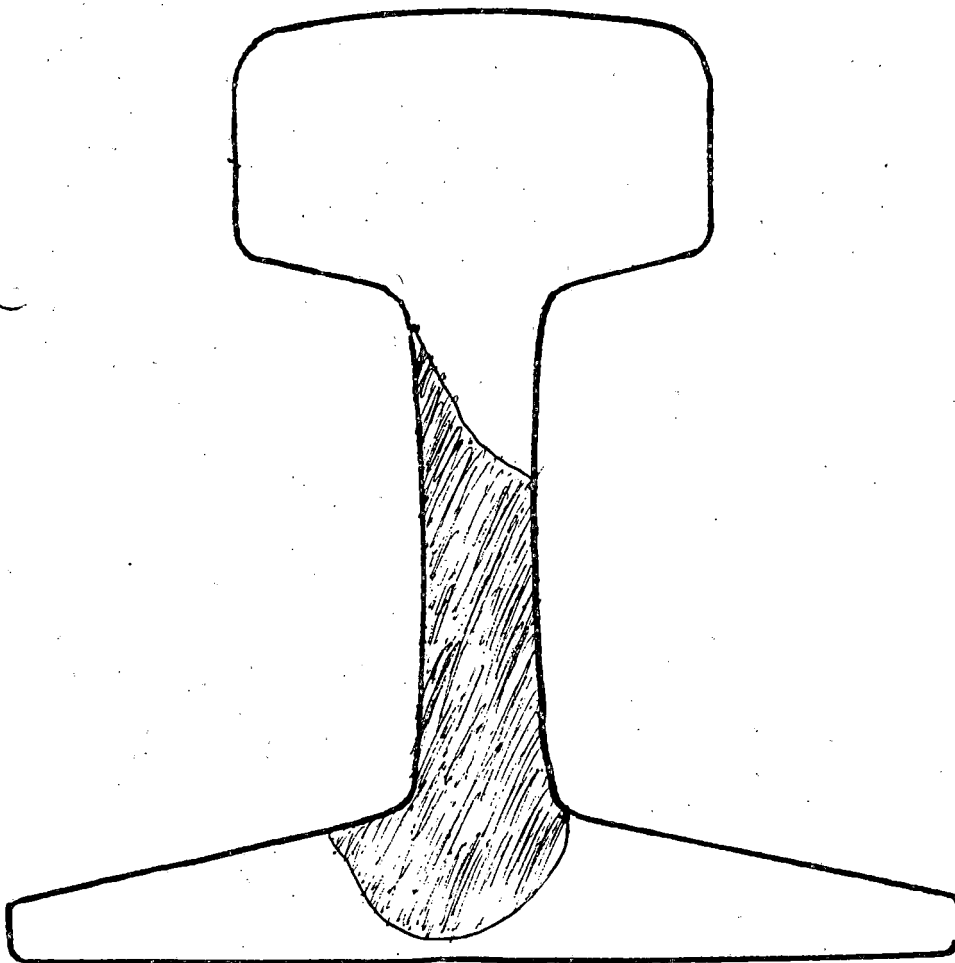
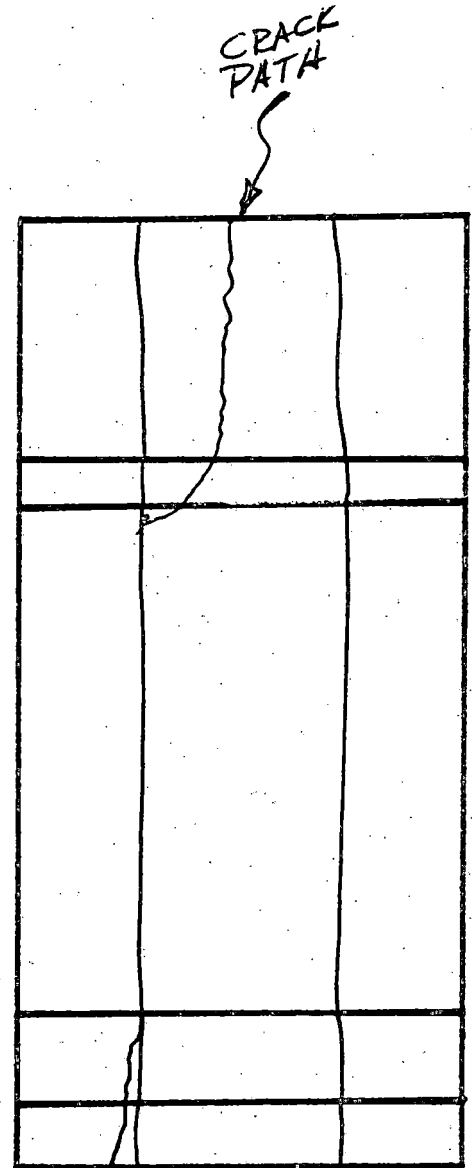
SPECIMEN NO. # 10
RAIL TYPE 115#

FAILURE LOCATION WELD
TYPE OF WELD CALORITE GAP USED _____
% UNFUSED METAL 40%
PROBABLE CAUSE OF FAILURE LACK OF FUSION IN CENTRAL WEB,
COMMENTS: POSSIBLE TORCH MISALIGNMENT DURING PRE HEAT.

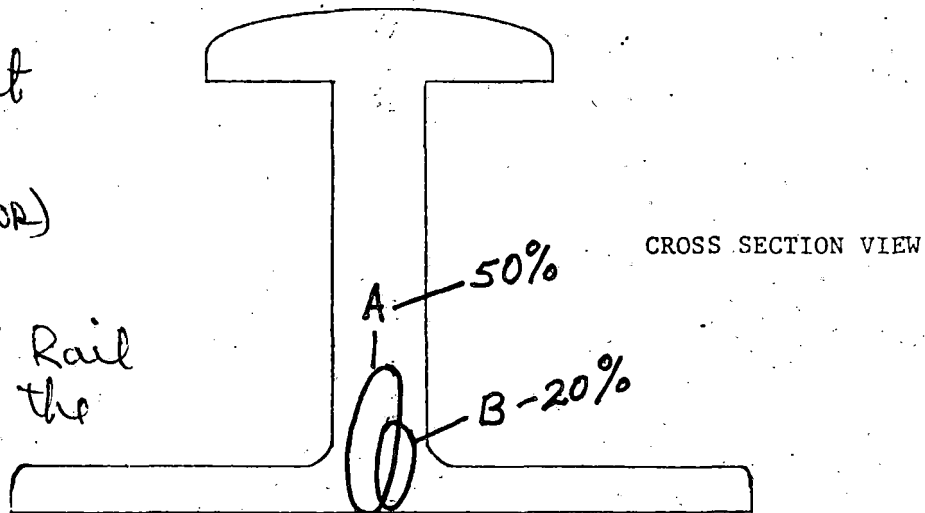
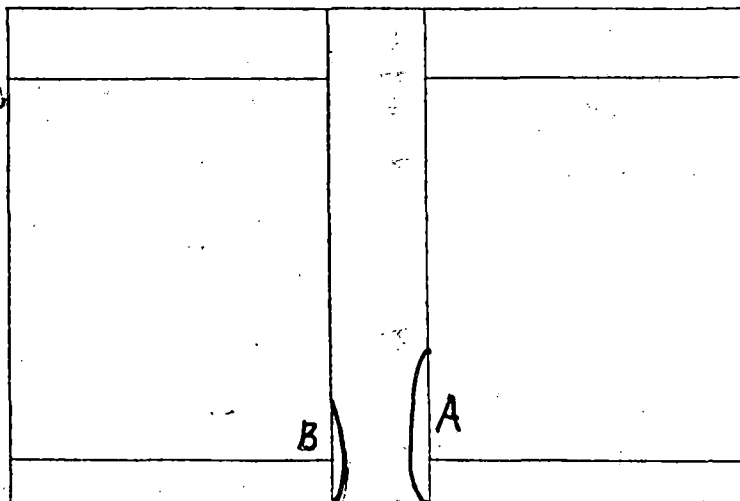
NDI INDICATIONS
 ORIGINATED FROM
 AREAS OF SPONGE LIKE
 POROSITY - A CONCENTRATION
 OF VOIDS WAS
 NOTED AT THE FUSION
 LINE - THIS COULD
 HAVE GIVEN A
 CRACK LIKE
 APPEARANCE -

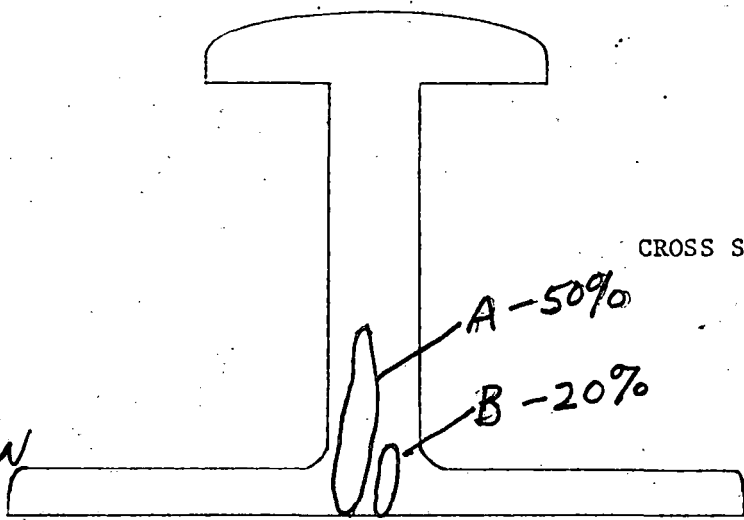
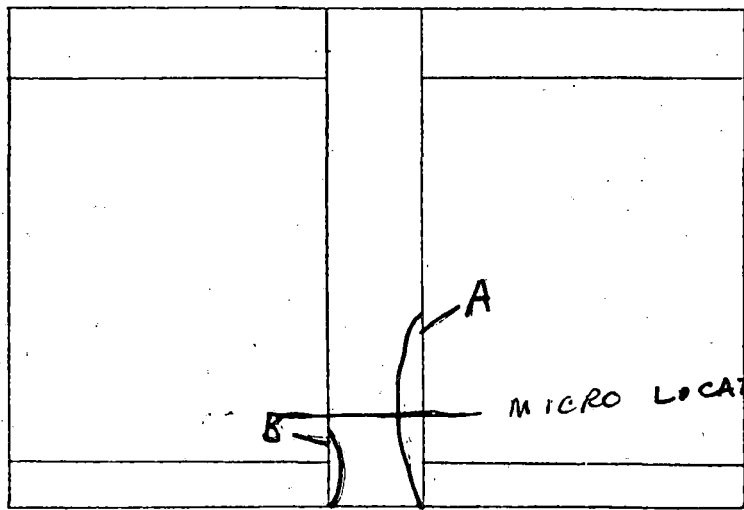
NOTHING FOUND
ON MICRO SECTION

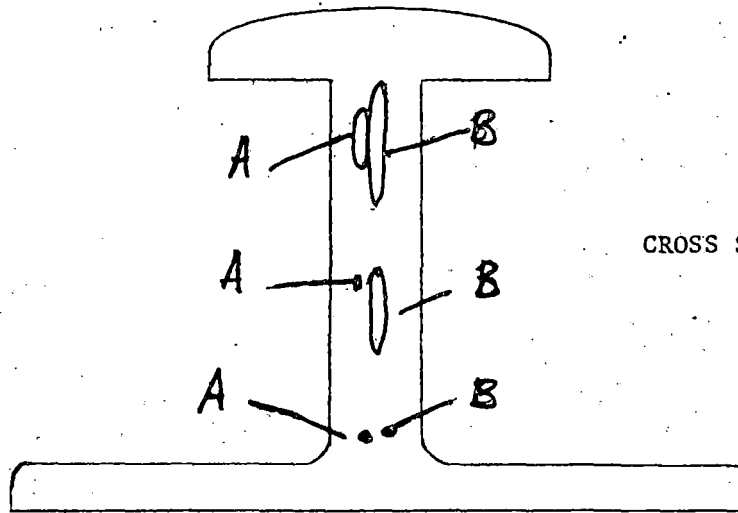
MICRO SECTION
FAILED TO
SHOW DEFECT

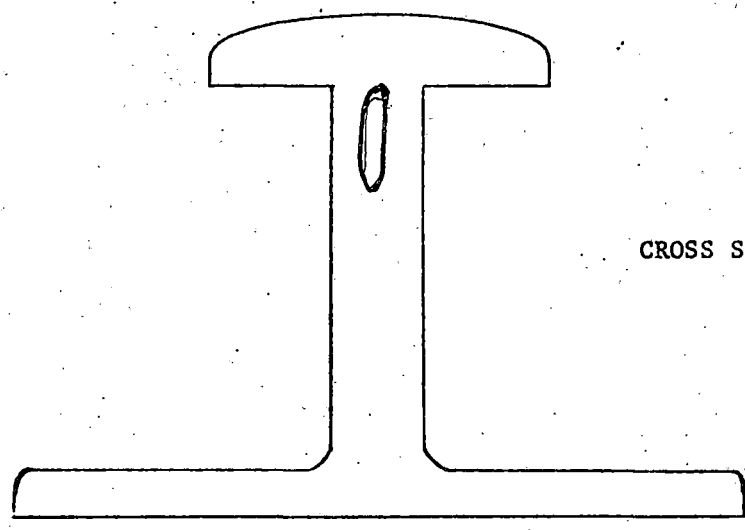
MICRO SHOWED
CRACK THRU
CENTER OF
WELD
