# Tank Car Damage Assessment Procedure Study

William P. Wright

DOT/FRA/ORD-84/04

May 1984  
Final Report

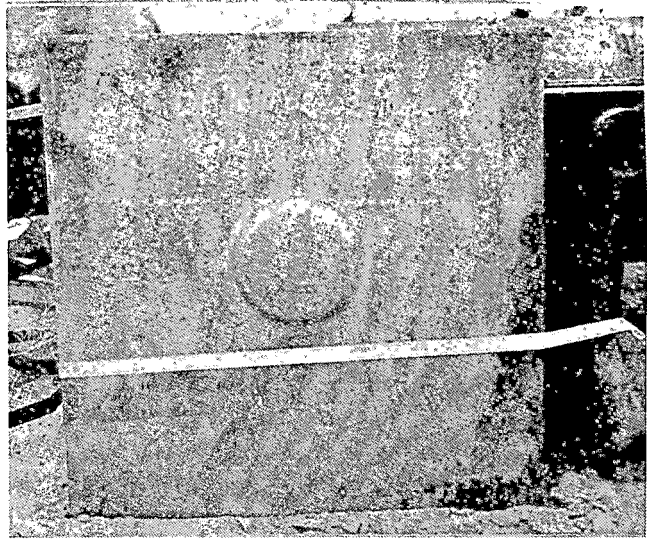
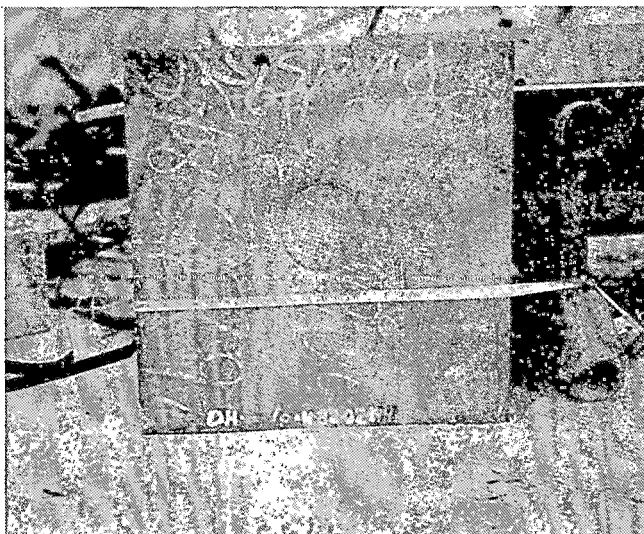
Figure 6: Bottom Side of Plate From Test No. 1

Nine tests were conducted using the flat tup with a diameter of 13.97 cm {5.5 inches}. The symbol designation for this tup is  $T_{LF}$ . A summary of the die diameters and hammer heights for these tests is presented in Table 1. The three die diameters used were 15.24 cm {6.0 inches}, 20.96 cm {8.25 inches}, and 27.94 cm {11.0 inches}. For this tup and the 15.24-cm die, the primary failure mechanism is shear with the tup penetrating the plate in a punching type action. Figure 4 presents a view of the plate following Test Number 2 {DH-16-11-82-03-136} where there was a complete punch through. The hammer height {HH} was 82.55 cm {32.5 inches}. By reducing the HH by 1.27 cm {0.5 inches}, the tup failed to punch through as shown in Figure 5

The DM measurements for Test Number 1 are presented in Figure 7. The diameter of the bottom of the dent, measured from the plot, is less than the diameter of the tup, an apparent contradiction. However, when the tup fails to perforate the plate, the hammer rebounds and at the same time the plate contracts due to elasticity.

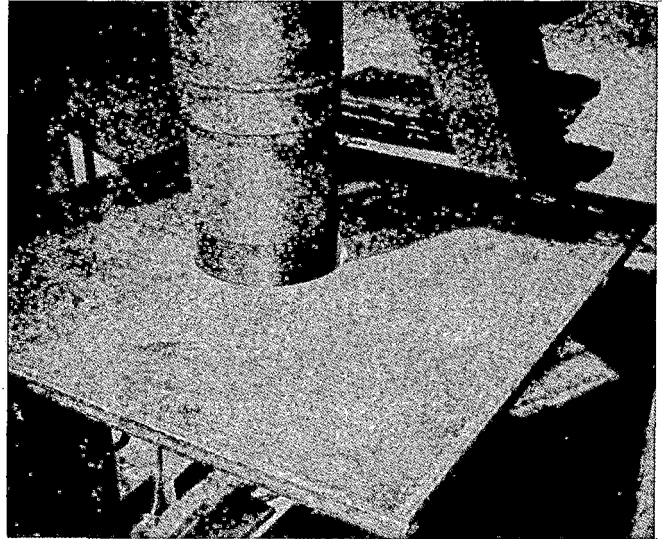
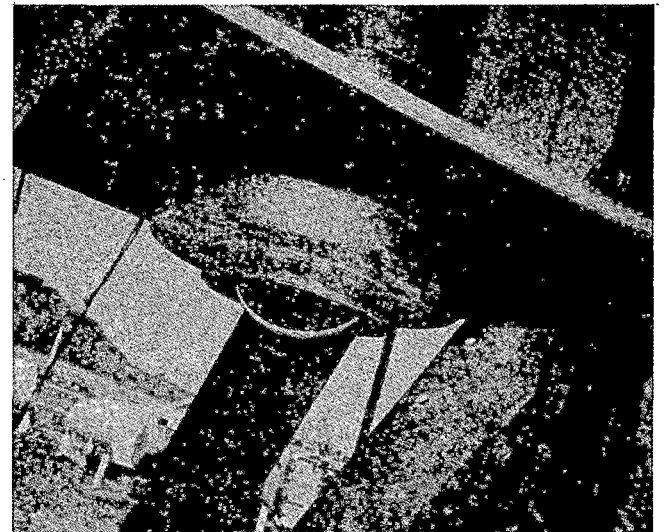
Figure 9: Impact Side of Plate From Test No. 15

Even though the tup had a hemispherical shape, a shear plug was formed in Test Number 15. Photographs of the result are presented in Figures 9 and 10. In that test, the die diameter was 15.24 cm {6.0 inches} and the HH value was 178 cm {70 inches}. The perforation was not a clean punch through so the plug and tup jammed in the die.

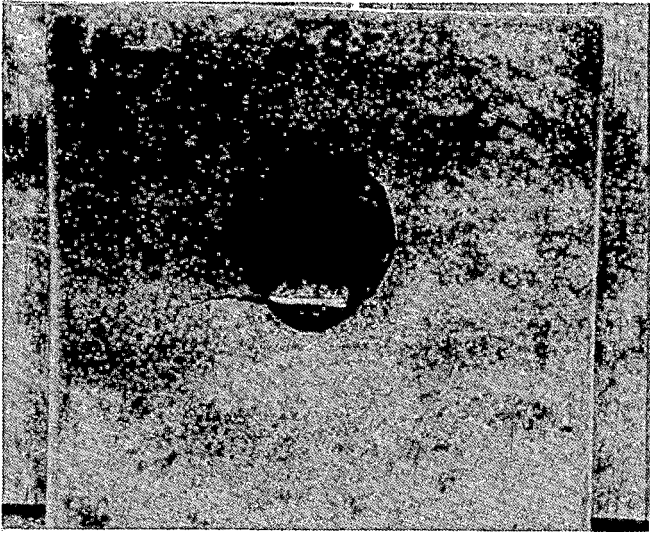
Figure 11: Impact Side of Plate From Test No. 25

A representative sample of a perforation is presented in Figures 11 and 12. The test in question is Test Number 25 where the die diameter was 27.94 cm {11.0 inches} and the HH was 178 cm {70 inches}. The large crack appeared to have started on one side of the bulge and then propagated circumferentially. The damage mechanism appears to have been a severe thinning of the steel around the sides of the bulge with the thinned metal eventually separating by ductile fracture.

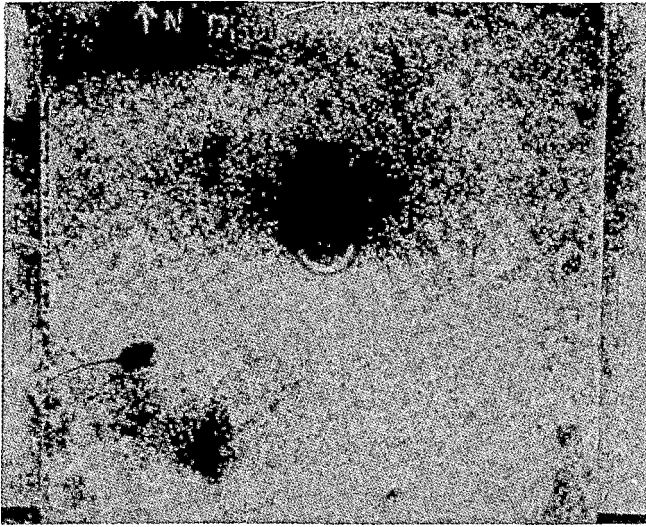
Figure 15: Impact Side of Plate From Test No. 40

Figures 15 and 16 presents photographs of the impact side and the bottom side of a sample plate where the  $T_{MH}$  tip was used. The response of the plate was similar to that obtained for the larger hemispherical tip. Figure 17 presents a sample of the DM measurements for this group of tests, which is also similar to the previously discussed group. The dent depth as functions of drop hammer energy/die area ratio are presented in Figure 18. The trends are similar to the those of the previous group of tests, but the dent depths are greater.

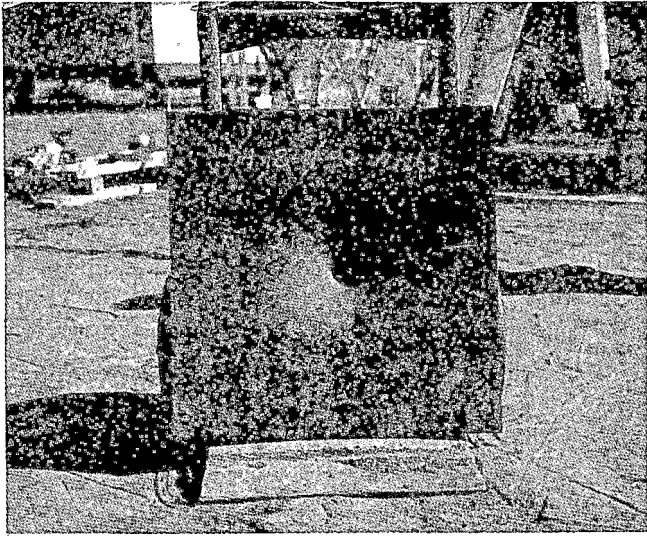
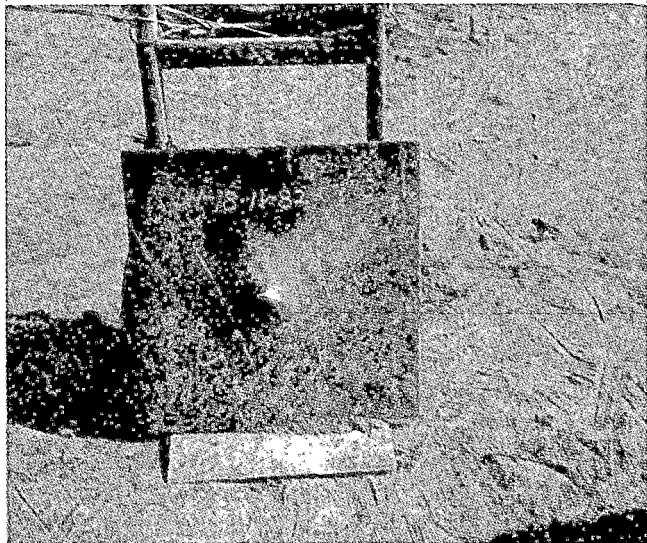
Figure 19: Impact Side of Plate From Test No. 69

The remaining tests were performed using the  $T_{SH}$  tup. Table 4 presents a summary of the tests conducted. Photographs of the impact side and the bottom side of a plate from a sample test are presented in Figures 19 and 20 respectively. Figure 21 presents a sample of the DM measurements which shows that the plates experienced a great deal of bending due to the relatively large amount of material between the edge of the die and the tup.

In practically all of the  $T_{SH}$  tup tests visible cracks were observed on the bottom side of the plates on or near the apex of the bulges. The seriousness of these types of cracks with respect to a tank car rupture cannot be estimated with current knowledge. However, this data indicates that for a bend of radius 2.54 cm {1.0 inch} and a dent depth of 3.81 cm {1.5 in-

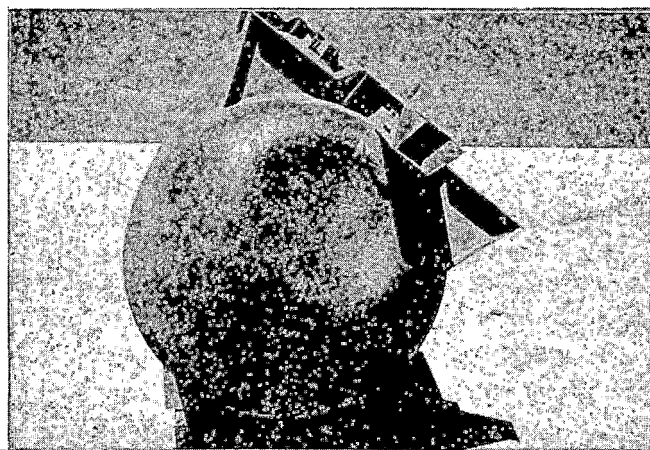
Figure 25: A Damaged End of the 1/5 Scale Tank Car Model

ends of the model and the bulged section of the three plates were inspected by the magnetic particle (direct contact, coil, and electric magnet contour probe) and ultrasonic methods. The 10 MHz transducer was used to inspect the thin 1/5 scale tank (approximately 3 mm thick) and the 2.25 MHz transducer for the thicker sample plates (approximately 15 mm thick) for better resolution.

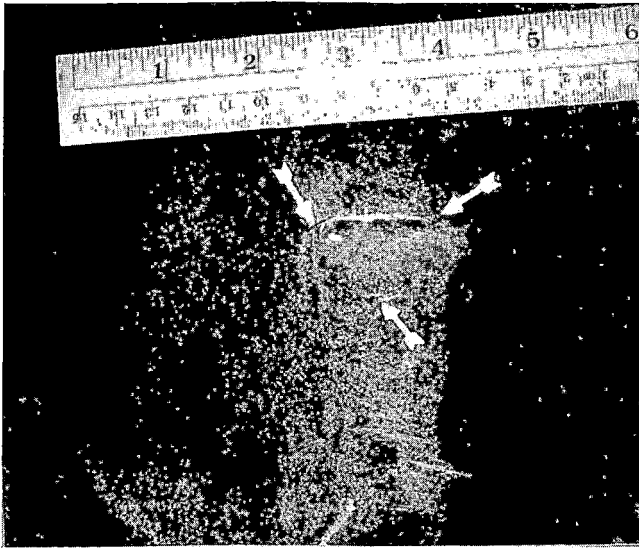
Figure 26: Magnetic Particle Crack Patterns on Plate Number DH-18-11-82-06-160

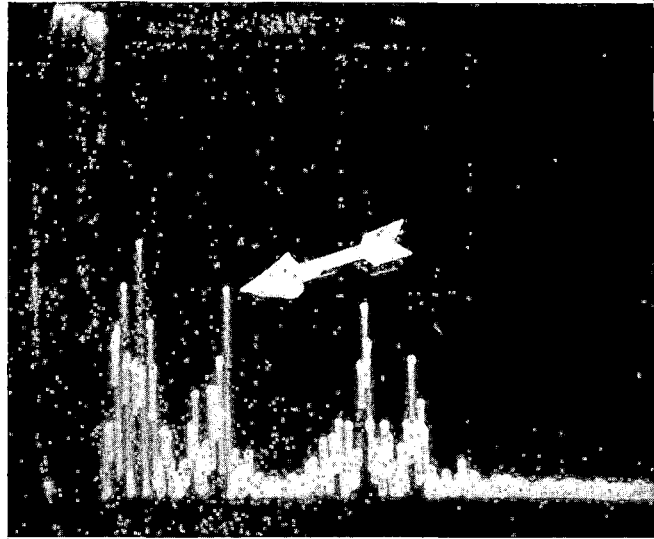
Figure 28: Ultrasonic Inspection Indication of 1.1 cm Crack Pattern

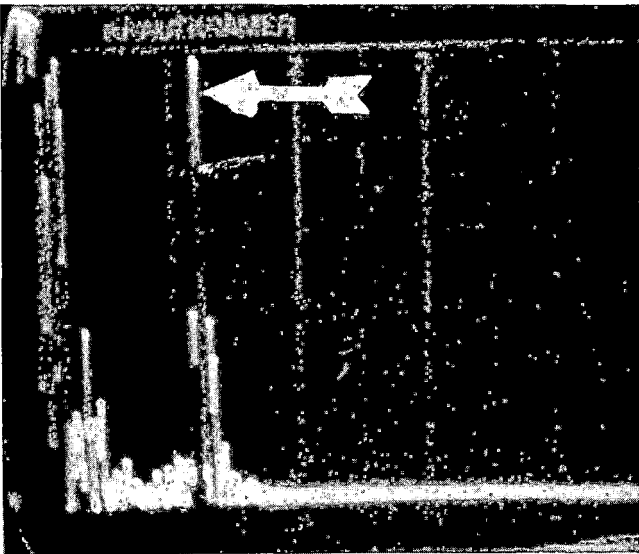
Figure 27: Ultrasonic Inspection Indication of 4 cm Crack Pattern

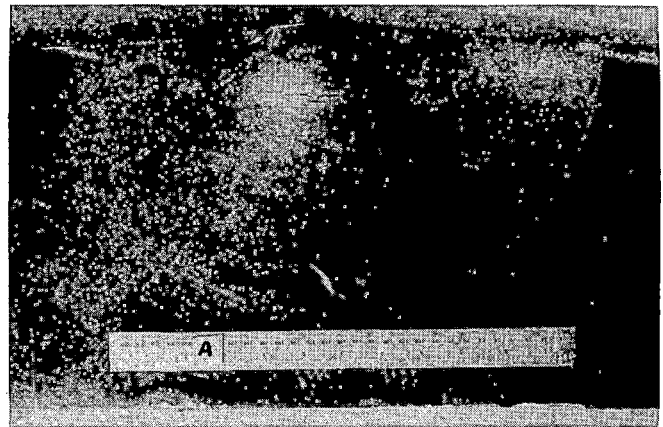
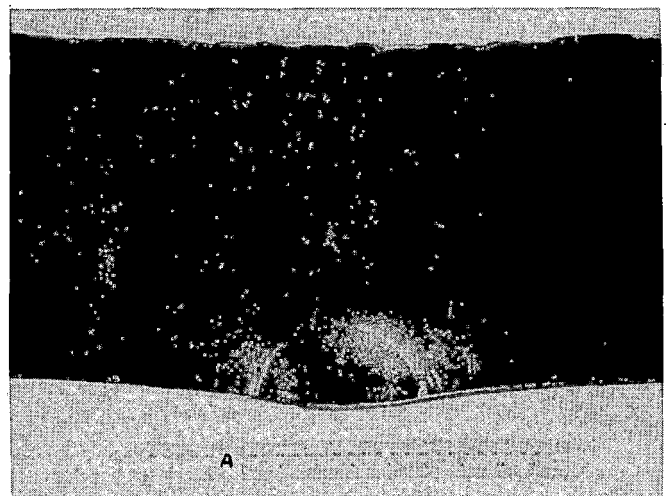
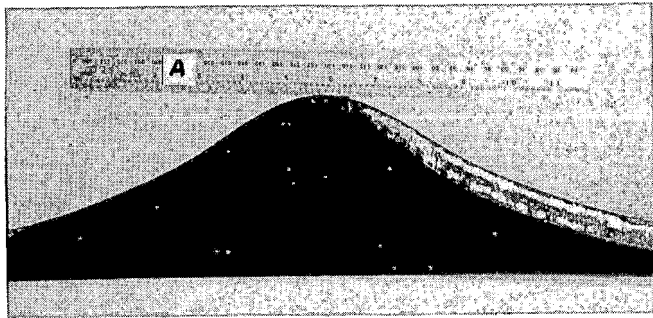
Figure 29 a: Convex {Bottom} Side of Flat Plate Specimen

The NDE techniques used included visual inspection, liquid penetrant inspection, and various ultrasonic techniques. Figure 29 presents three views of one of the impacted plate specimens showing the general shape of the dent. Liquid penetrant inspections were done on both the convex and the concave sides of the ten plate specimens to determine the degree of surface cracking. A map was made for each specimen showing both size and location of all surface cracks and tears. A sample of such a map is presented in Figure 30. The sample shows no signs of cracking on the concave sides of the dent except for the tears when the thickness was completely penetrated. It was observed that the surface cracks run in the rolling direction of the steel which may be indicative that the manufacturing process influences the residual strength level.

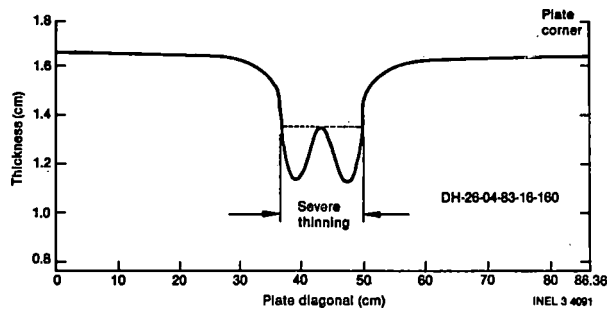
thinning. Section thinning as much as 32% was observed. Figure 33 presents an example of typical areas of severe thinning which consist of two lobes on the thickness plot the plate specimen. Figure 34 presents a case where the thinning level was not severe. Those areas of greatest thinning constitute the points where the residual strength are in question.

Figure 33: Thickness Plot Showing Severe Thinning

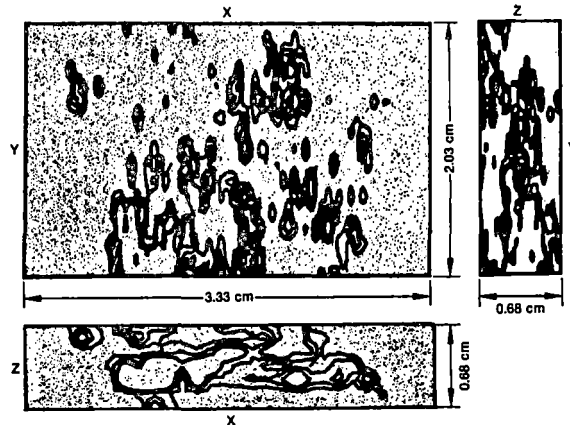
entirely absent in areas of little or no deformation, thus indicating that the targets in question are associated with deformation. If further work confirms current interpretation of the extended and point-like targets as representing severe and moderate damage preceding failure, respectively, and if the same or similar phenomena are found in other tank car materials, ultrasonic measurements made in situ on damaged tank cars will be a powerful tool for assessing tank car status in the field.

Figure 40: Flaw Contour Plots Generated by an Ultrasonic Imaging System
