**Federal Railroad
Administration**

Task Force Report Rail Failure Evaluation

May 1984

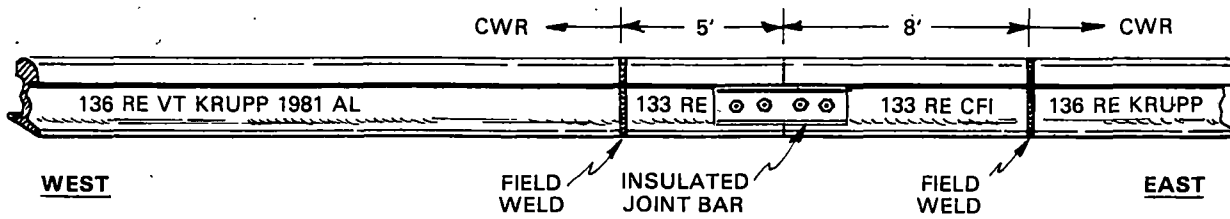
1a. RAIL AS ORIGINALLY INSTALLED OCTOBER 20, 1983

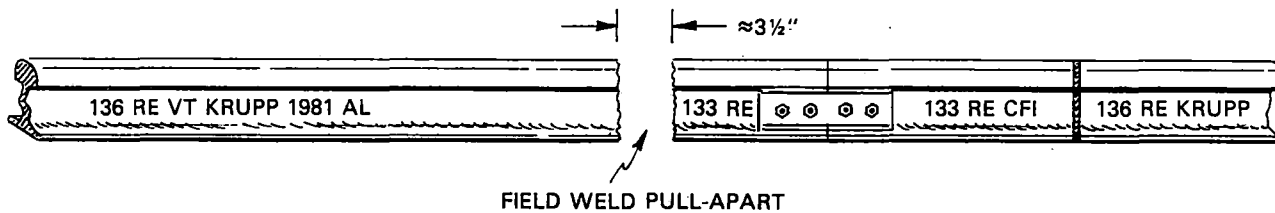
1b. RAIL PULL-PART AS DISCOVERED NOVEMBER 12, 1983 (6:49am)

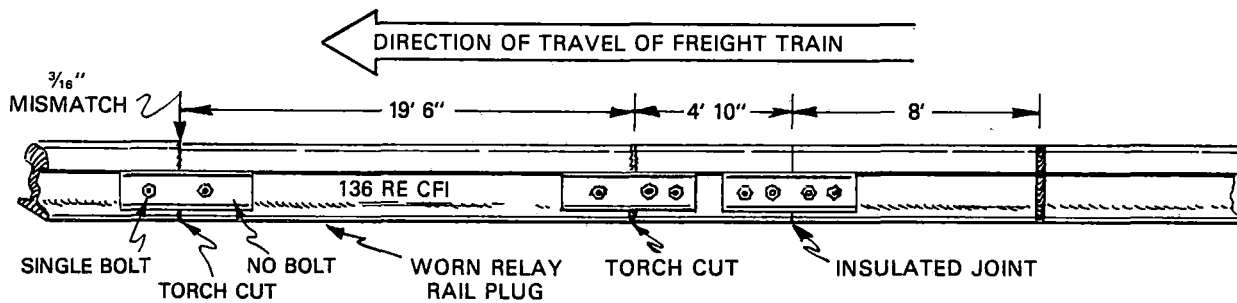
Temporary repairs involving the removal by torch of the original chrome-vanadium alloy rail and the insertion of a temporary carbon steel plug rail with joint bars, had almost been completed, (see Figure 1c) when a west bound freight passed over the repaired section of rail at an estimated 52 mph. Following the passage of the freight train, additional temporary repairs were completed (Figure 1d), and the passenger train entered this section of the track at nearly maximum authorized speed (approximately 73 mph).

1c. STATE OF TEMPORARY REPAIRS AT TIME OF FREIGHT TRAIN PASSAGE (9:15am)

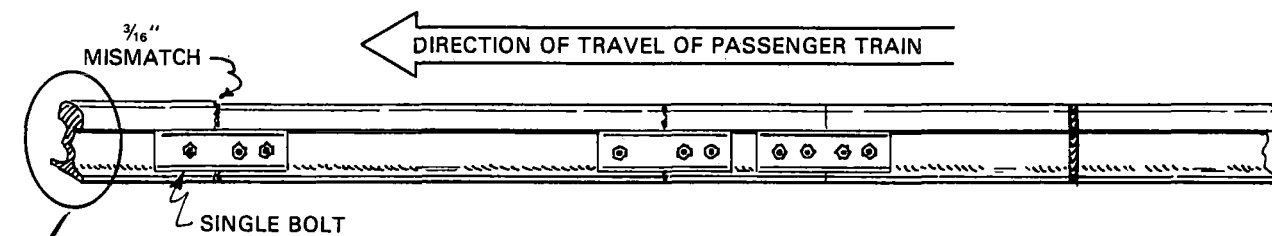
1d. STATE OF TEMPORARY REPAIRS AT TIME OF AMTRAK PASSAGE (10:10am)

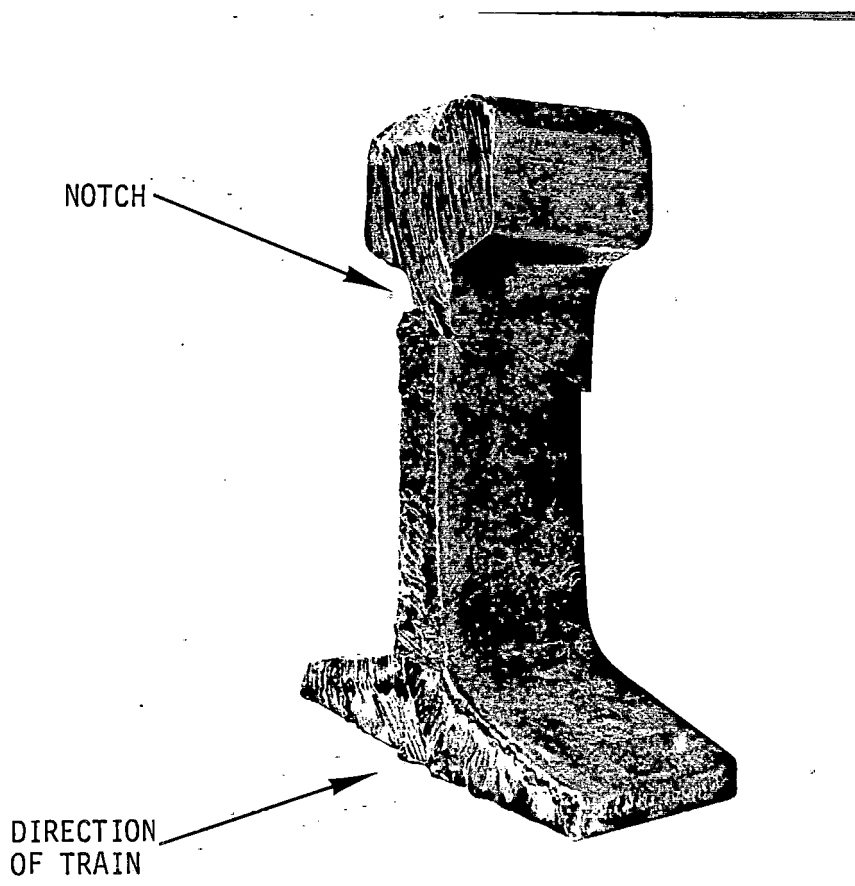
FIGURE 5. PHOTO OF RAIL END

between the notch root and the beginning of the rapid fracture surface (see Figure B-1). It is, therefore, probable that the torch cutting operation left a defect in the rail end, and that this initial defect probably provided the origin for the sudden rail failure. The initial defect was in the form of a sharp-tipped crack of the order of 0.1 inch long and inclined approximately 45 degrees downward into the rail web.

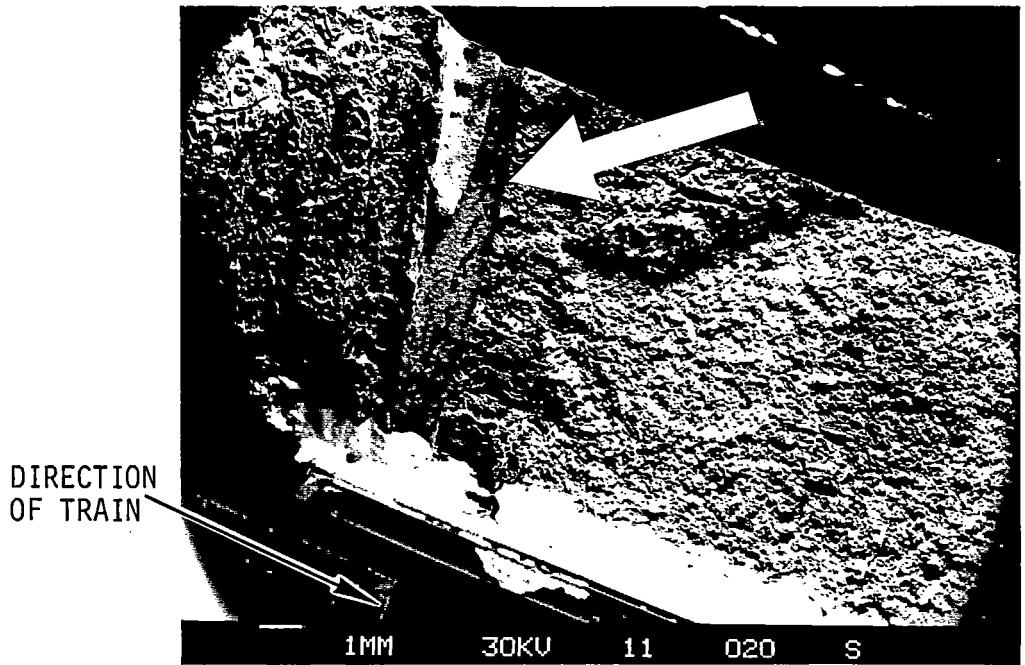
FIGURE B-1. SEM PHOTO OF FRACTURE SURFACE AT ORIGIN

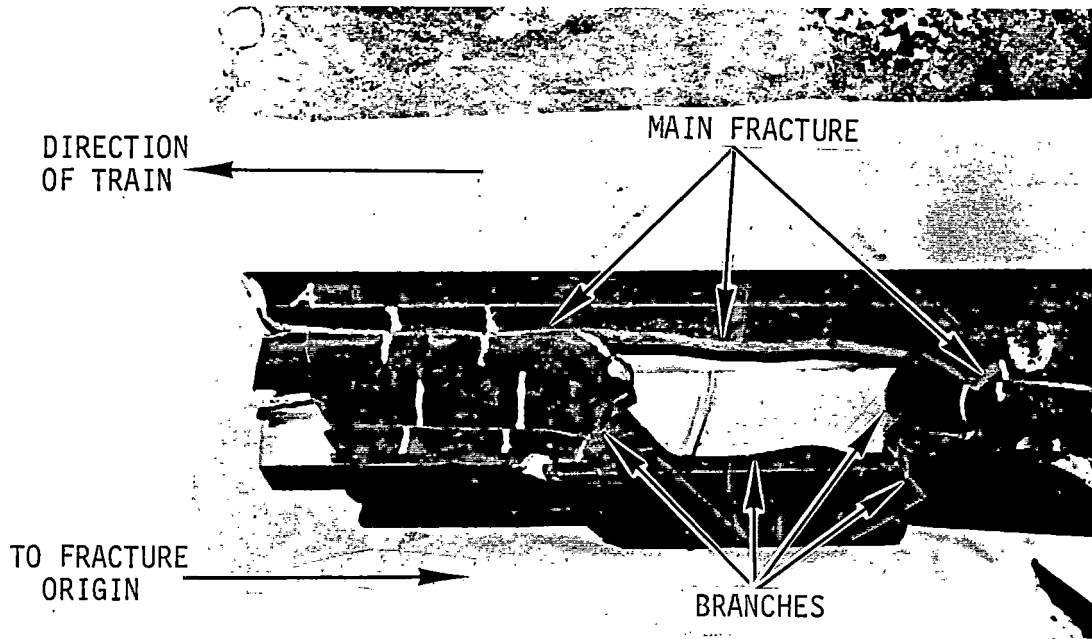
FIGURE B-3. EXAMPLE OF CRACK BRANCHING

13. Crack branching similar to Item (10), with one case of branching including breakout to rail head (10 to 21 feet). Minor batter was observed on receiving end of head breakout (21 feet).

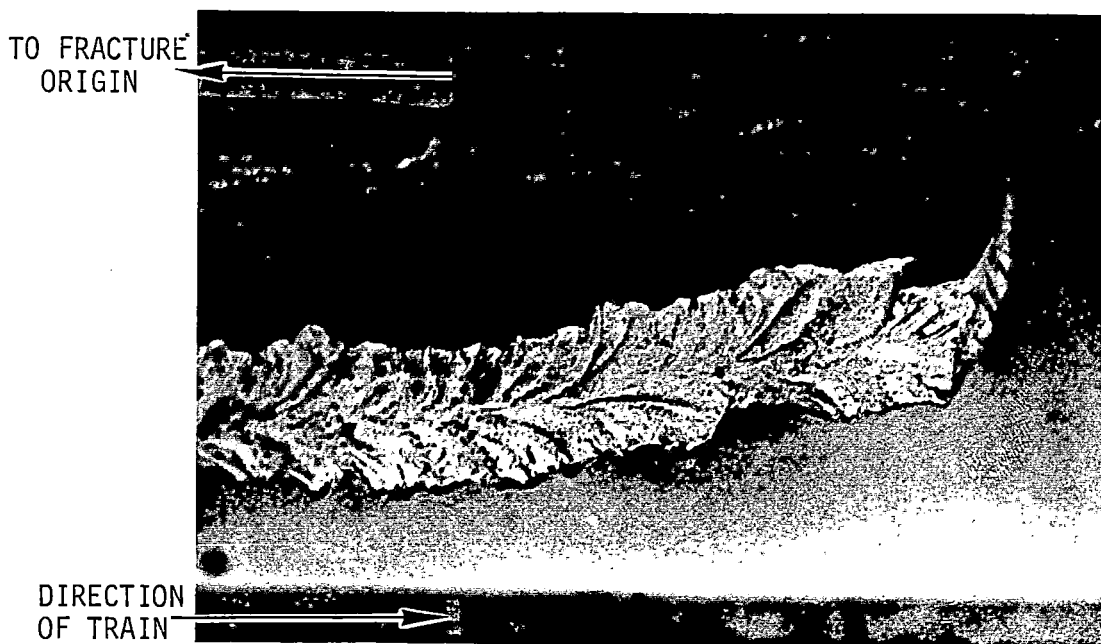
FIGURE B-5. PHOTO OF INCLINED FRACTURE SURFACE

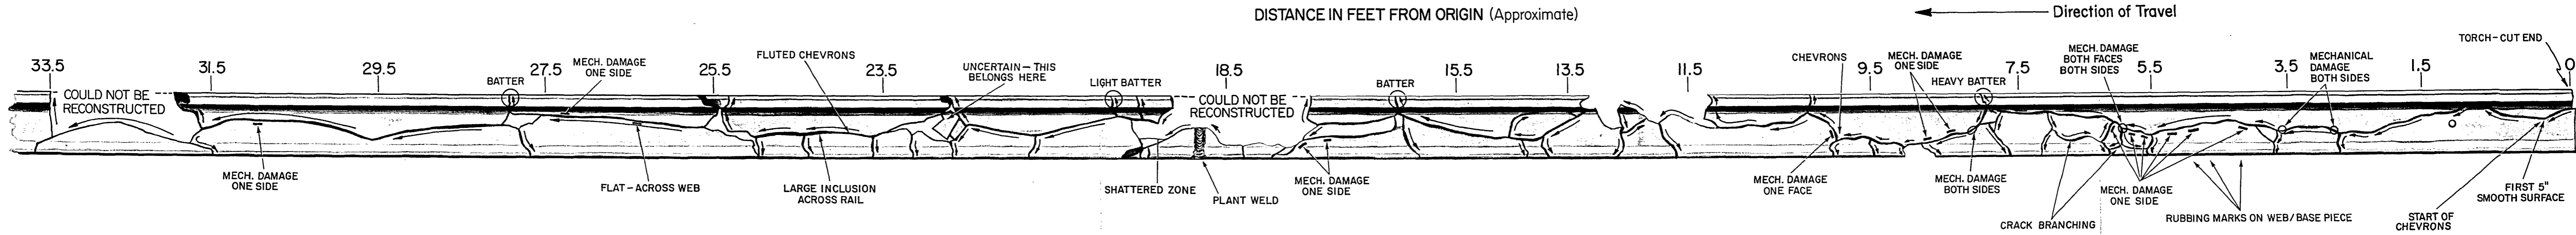
Figure B-6 Reconstruction of Subject Rail

A detailed fold-out diagram of the reconstructed subject rail is contained in Appendix B (Figure B-6). The fracture was about 33 feet long, and occurred primarily in the rail web. There were numerous occurrences of crack branching, in which the web crack separated into two parallel web cracks which later rejoined, or which formed separate branches which ran from the main web crack into the rail head and/or base. Virtually the entire fracture surface contained chevron markings characteristic of rapid breaking. Details of these observations appear in Appendix B, Figures B-2 through B-6.

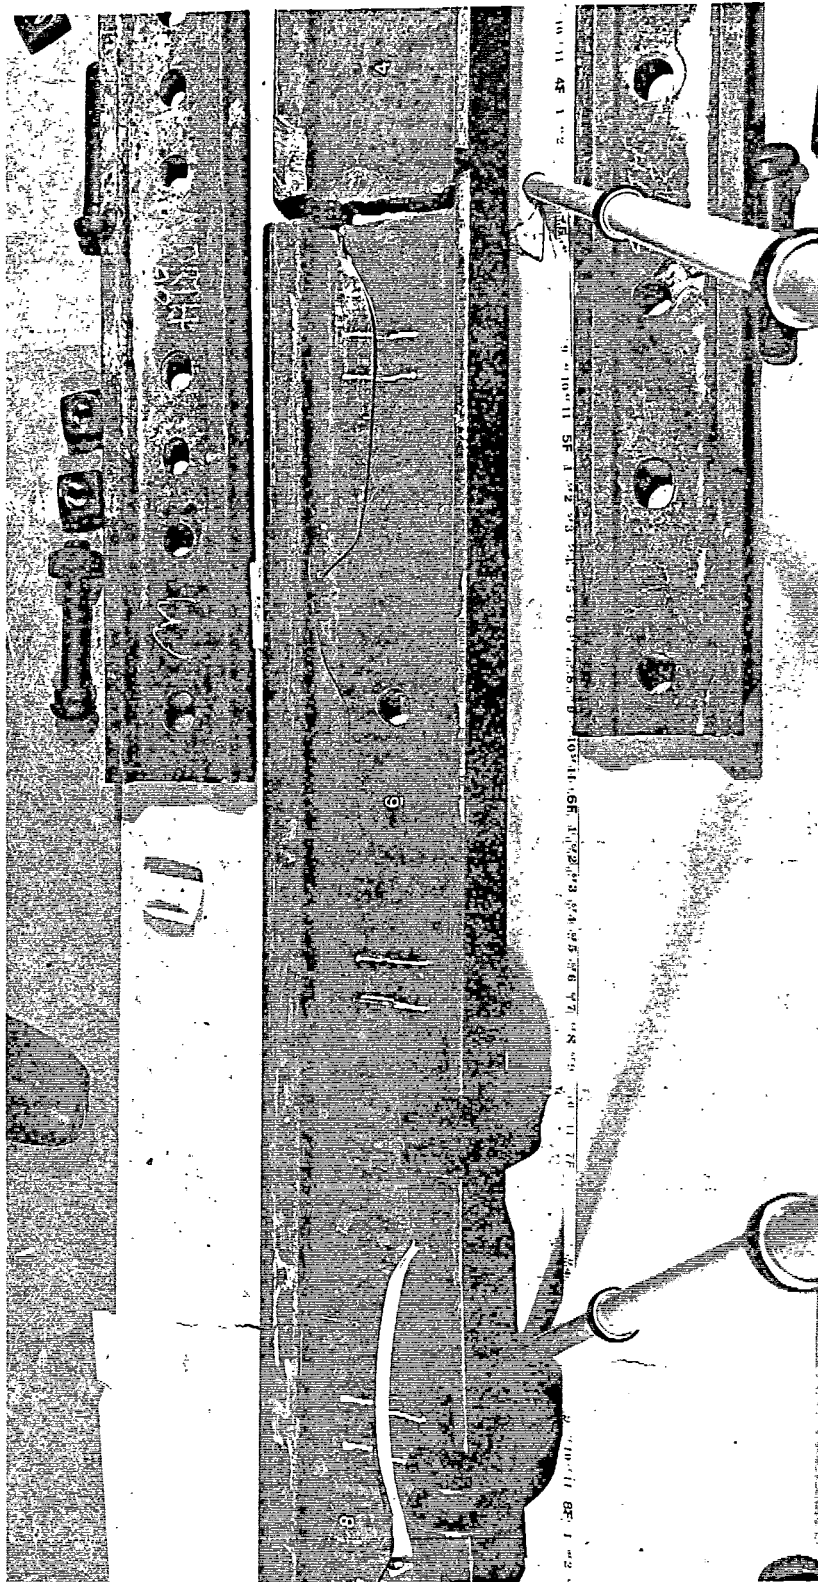
Figure 2.

- o The failed rail branding was marked "136 RE VT KRUPP 1981 llllllllll AL."
- o The failed rail shattered into more than 85 pieces within 38 feet. (Some pieces were not recovered.) Generally, the failure followed a longitudinal crack in the web of the rail, with secondary cracks progressing through the head and base of the rail.
- o The eastern end of the failed rail had been cut with a torch. A step or offset of approximately one-eighth inch in the cut was found approximately 2 inches below the tread surface of the rail. (See figure 2.)

East end of failed chrome-vanadium rail, adjoining west end of replacement rail sections at the right. Reconstructed, with joint bars removed.

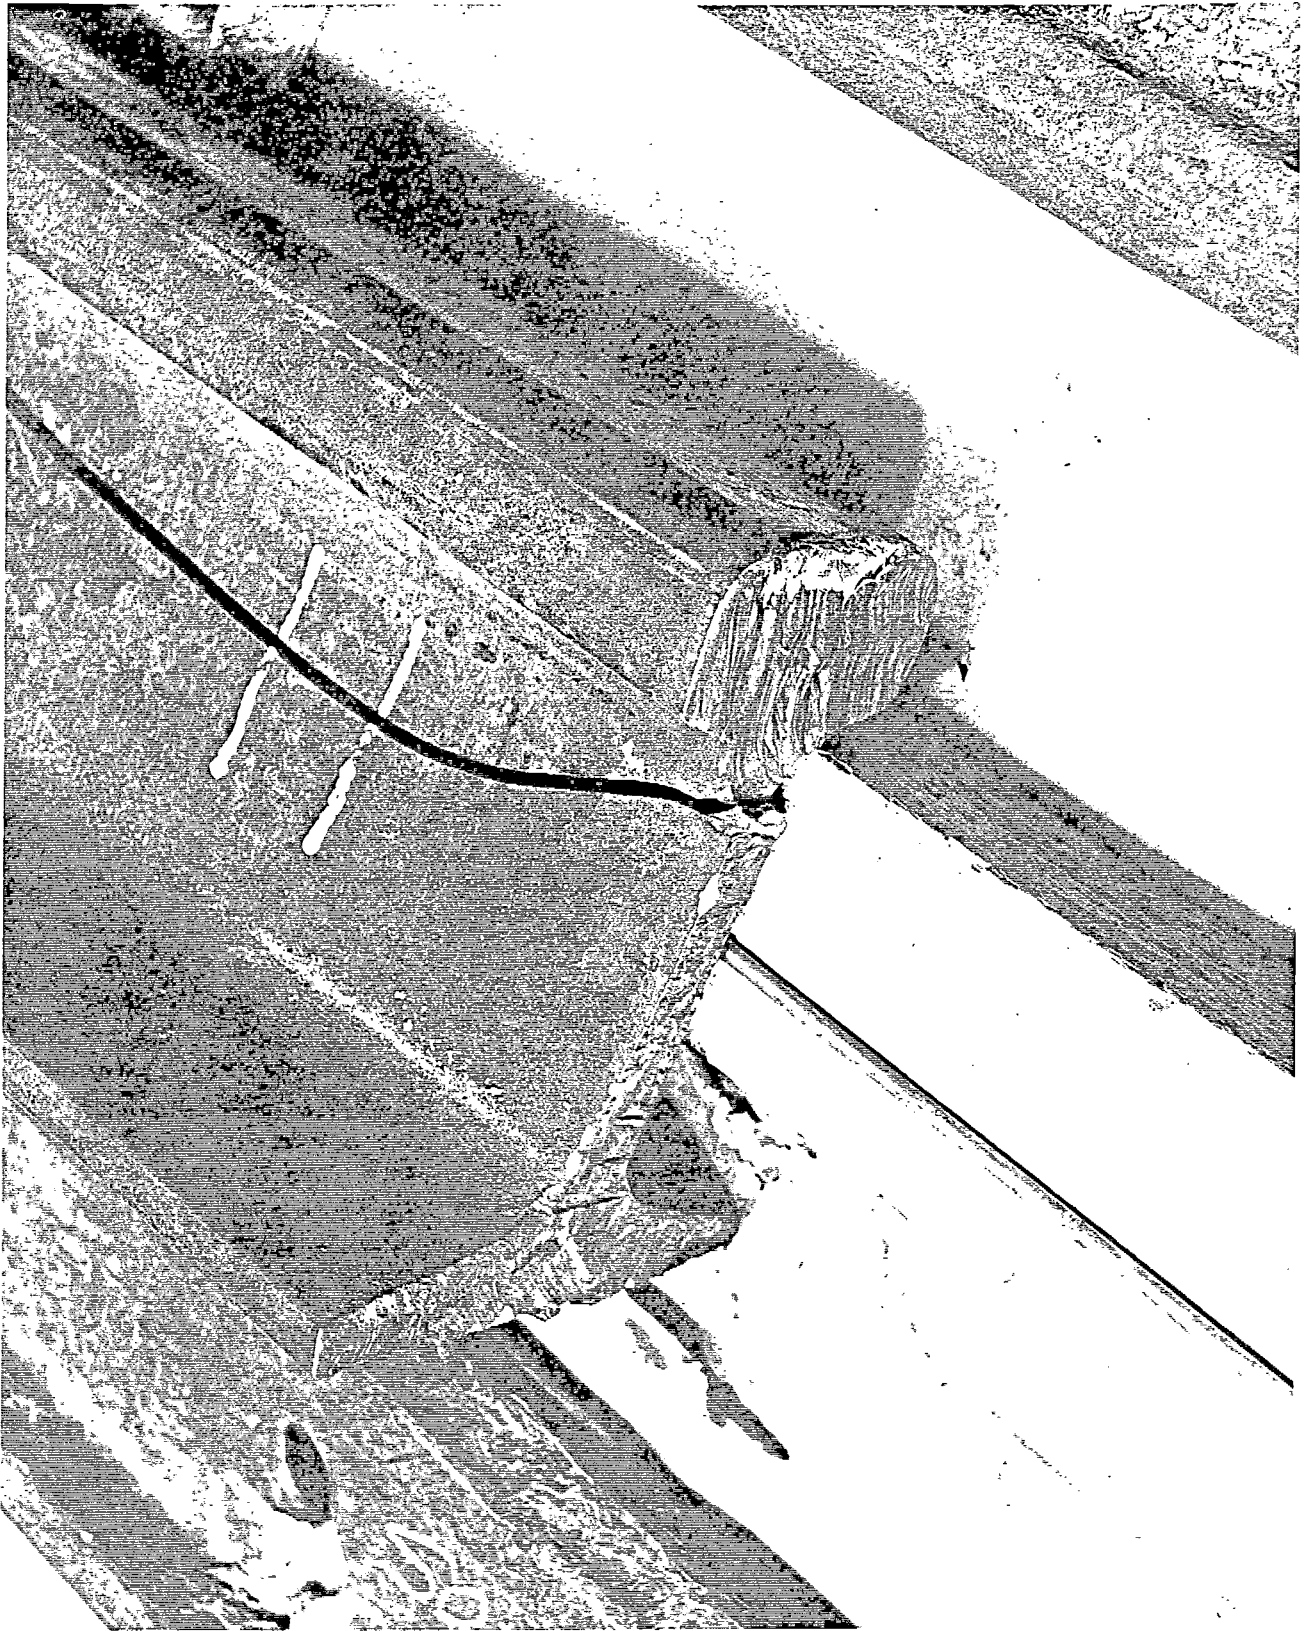
Figure 3.

East face of failed chrome-vanadium rail, reconstructed, showing torch cut, offset, and web crack through offset.

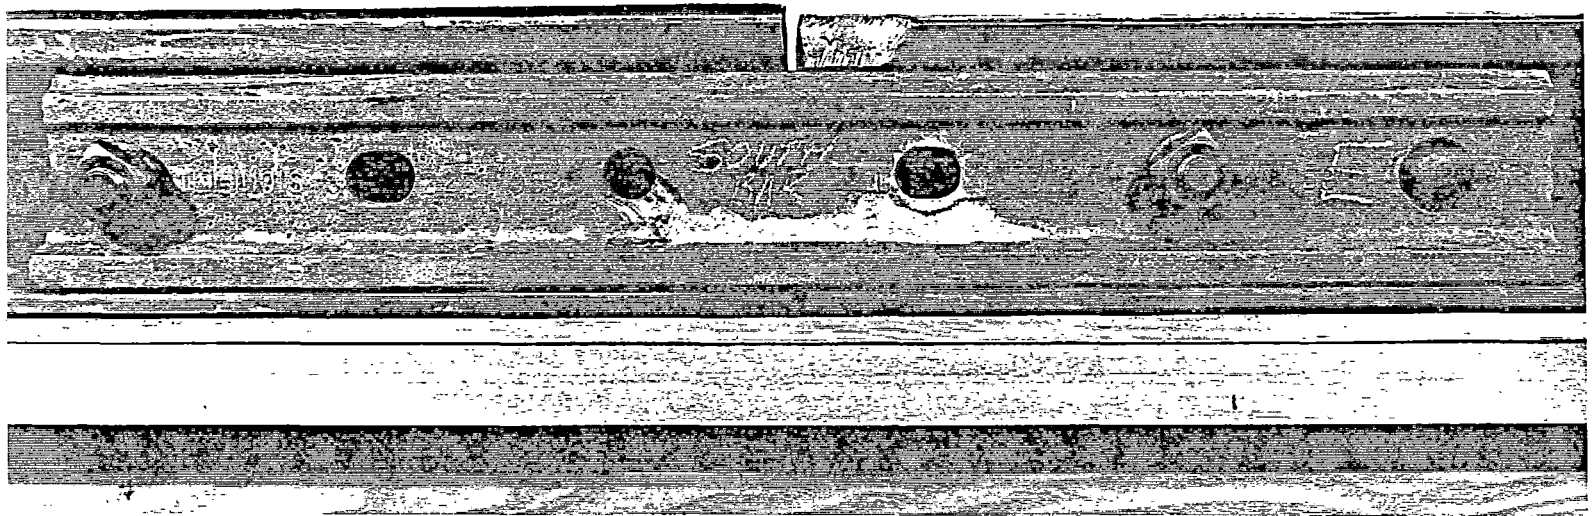
Figure 4.

Failed rail on the left, reconstructed, joined to west end of replacement rail section, showing bolting pattern and tread surface mismatch.
