NBSIR 85-3383

Report Number 13

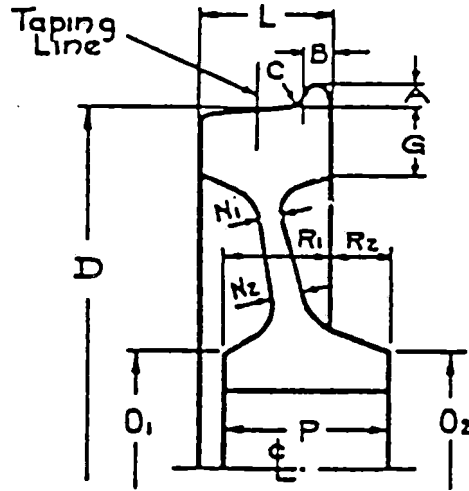
<u>Dimension</u>	<u>AAR Specification</u>	<u>Wheel F1</u>	<u>Wheel F2</u>
A	$1 \frac{1}{16}$	1-11/32*	1-10/32***
B	$1 \frac{5}{32} \frac{+1}{16}$	1-9/32	1-8/32
C	$1 \frac{1}{16} \frac{-1}{16}$	NA	NA
D	$3 \frac{6}{16} \frac{+1}{16}$	34-17/32**	NA
G	$2 \frac{3}{4}$ Min.	2-5/16*	2-7/16***
L	$5 \frac{1}{2} \frac{-1}{8}$	5-1/2	5-17/32
N ₁	$\frac{3}{4}$ Min.	13/16	7/8
N ₂	1 Min.	1-1/2	1-1/2
O ₁	$10 \frac{3}{4} \frac{+1}{0}$	11-9/32**	NA
O ₂	$10 \frac{3}{4} \frac{+1}{0}$	11-5/32**	NA
P	$7 \frac{1}{8}$	6-15/16	6-29/32
R ₁	$4 \frac{5}{16} \frac{-1}{8}$	4-5/16	4-9/32
R ₂	$2 \frac{11}{16} \frac{-1}{8}$	2-21/32	2-11/16
Max Finish Bore	$8 \frac{1}{2}$	7-31/32	NA
Min Hub Wall	$1 \frac{1}{8}$	1-1/2	1-1/2***

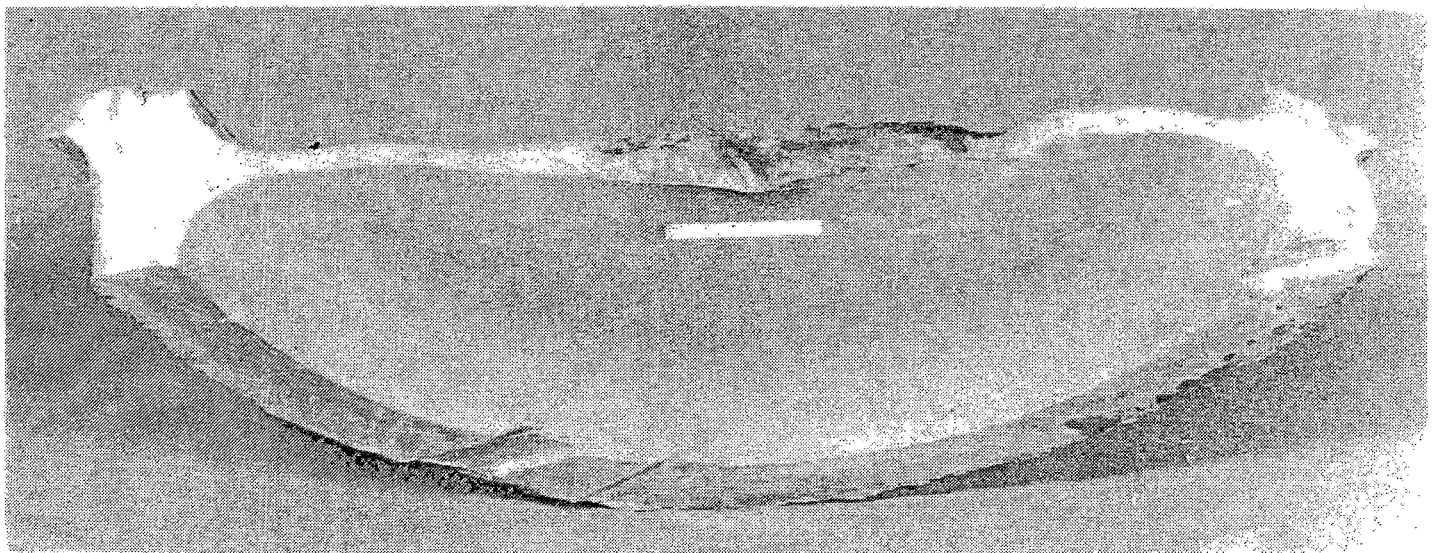
Figure 2. Part of the east wheel (F1) that had fractured from the main part of the wheel. This part is the mate to the part of the wheel shown on the right in figure 1.

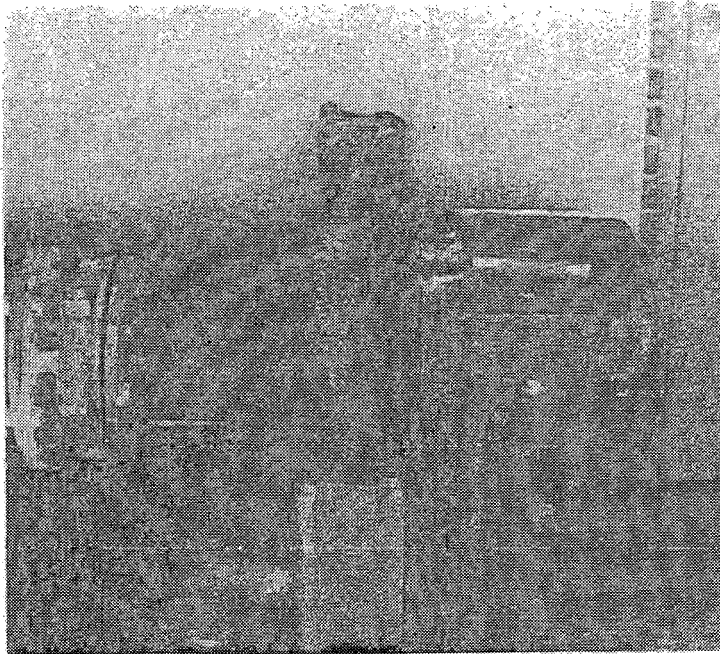
Figure 3. Wheel F1 as received at NBS showing the chordal fracture.

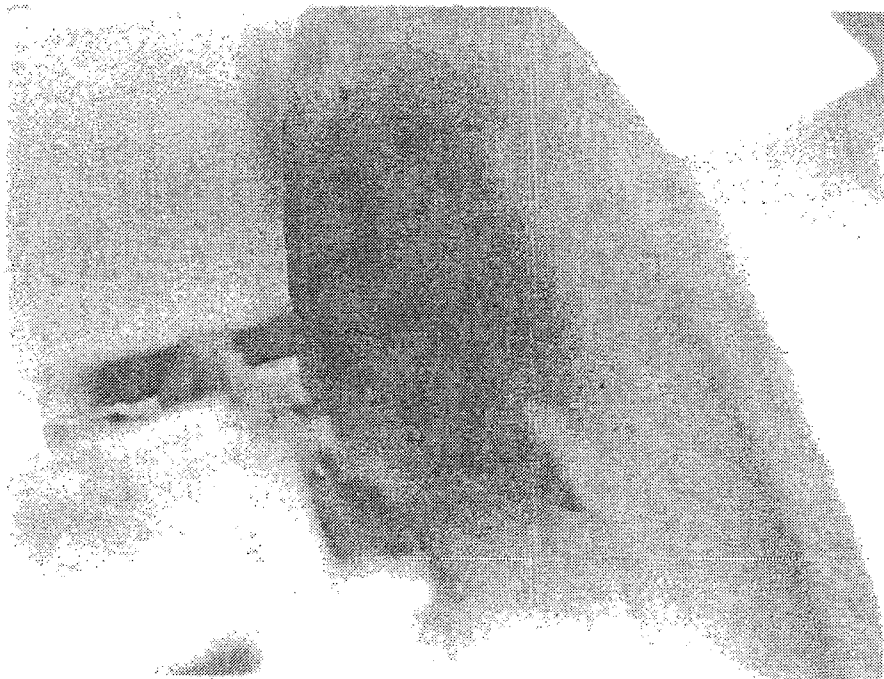
Figure 4. Wheel F2 as received at NBS showing the radial fracture.

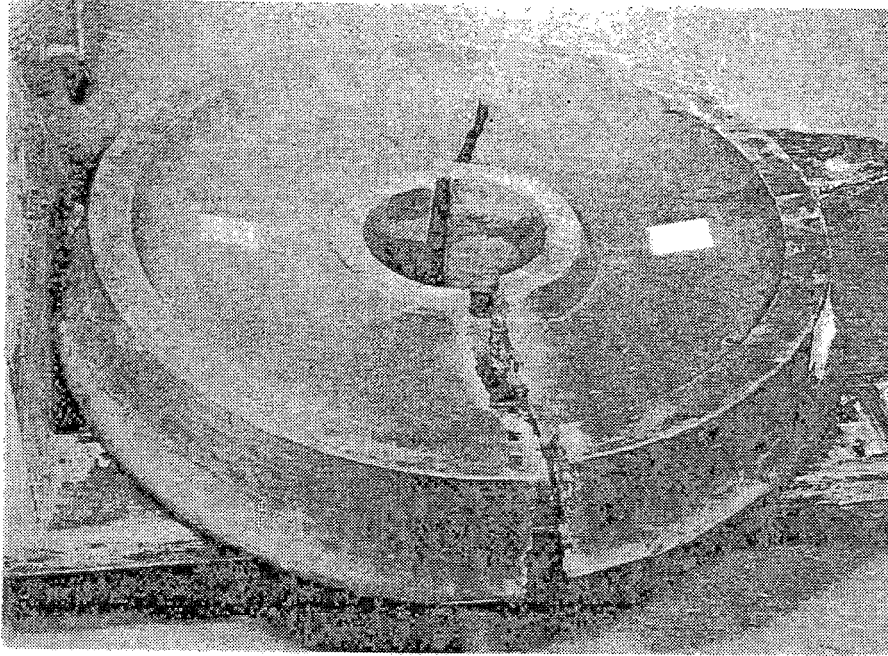
Figure 5. The two pieces of wheel F2 after torch cutting. Piece F2L is at the left and piece F2S is at the right.

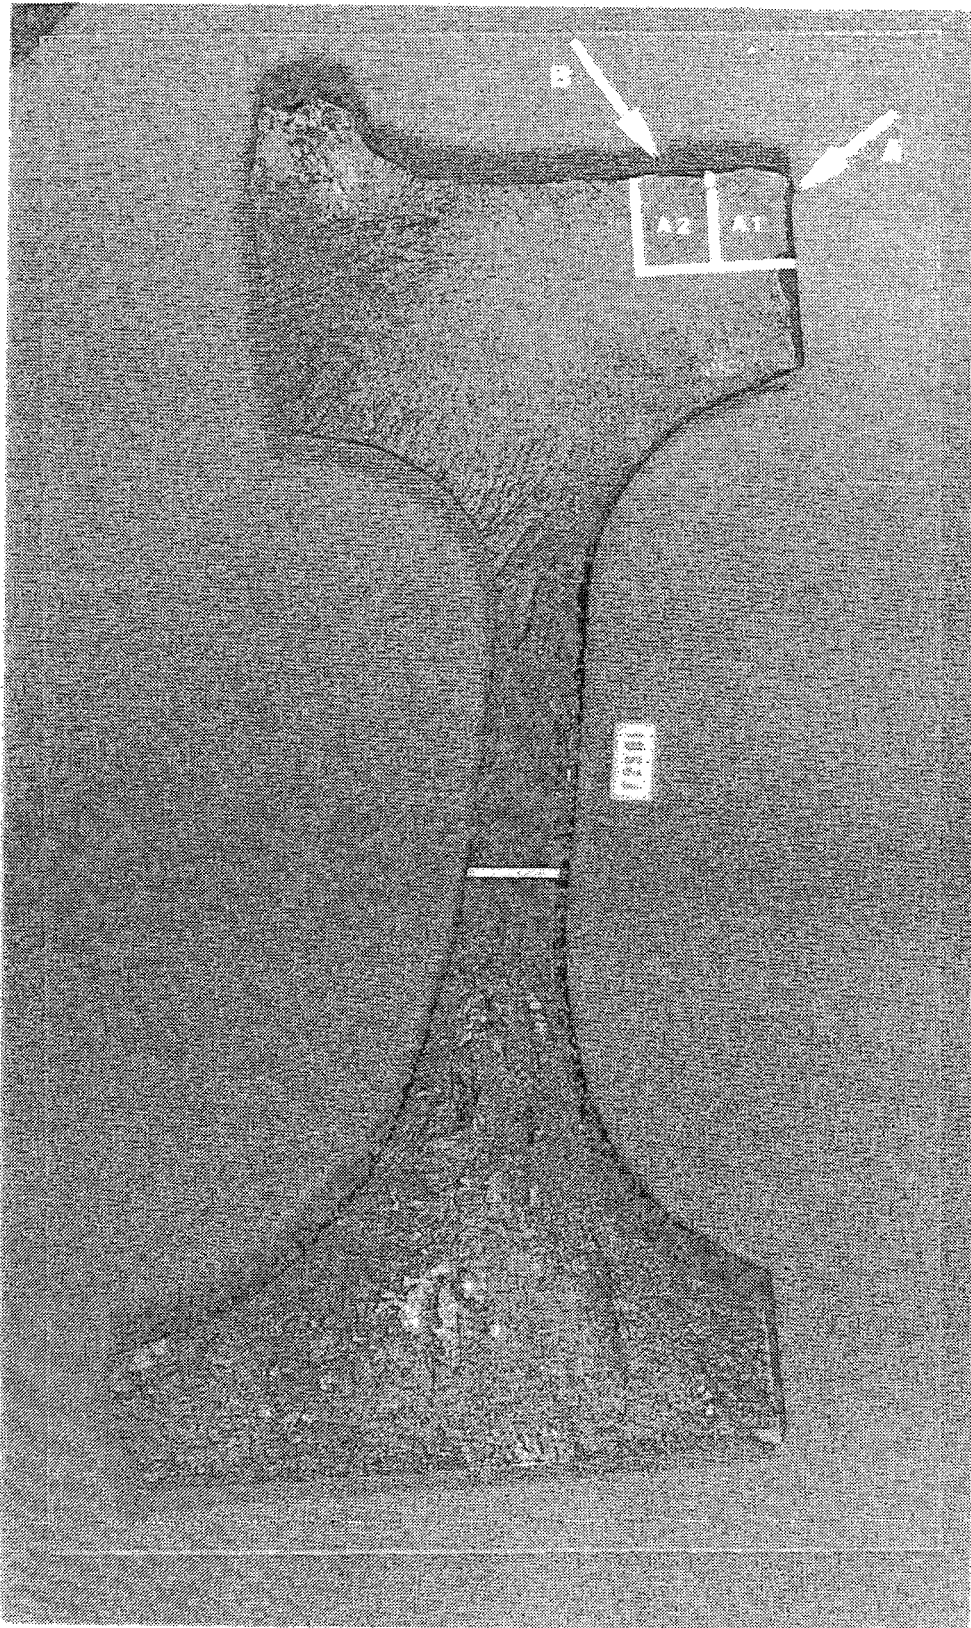
Figure 13. Fracture surface of wheel piece F2SB1 showing the location of sections A1 and A2, and the lower part which was returned to the FRA.

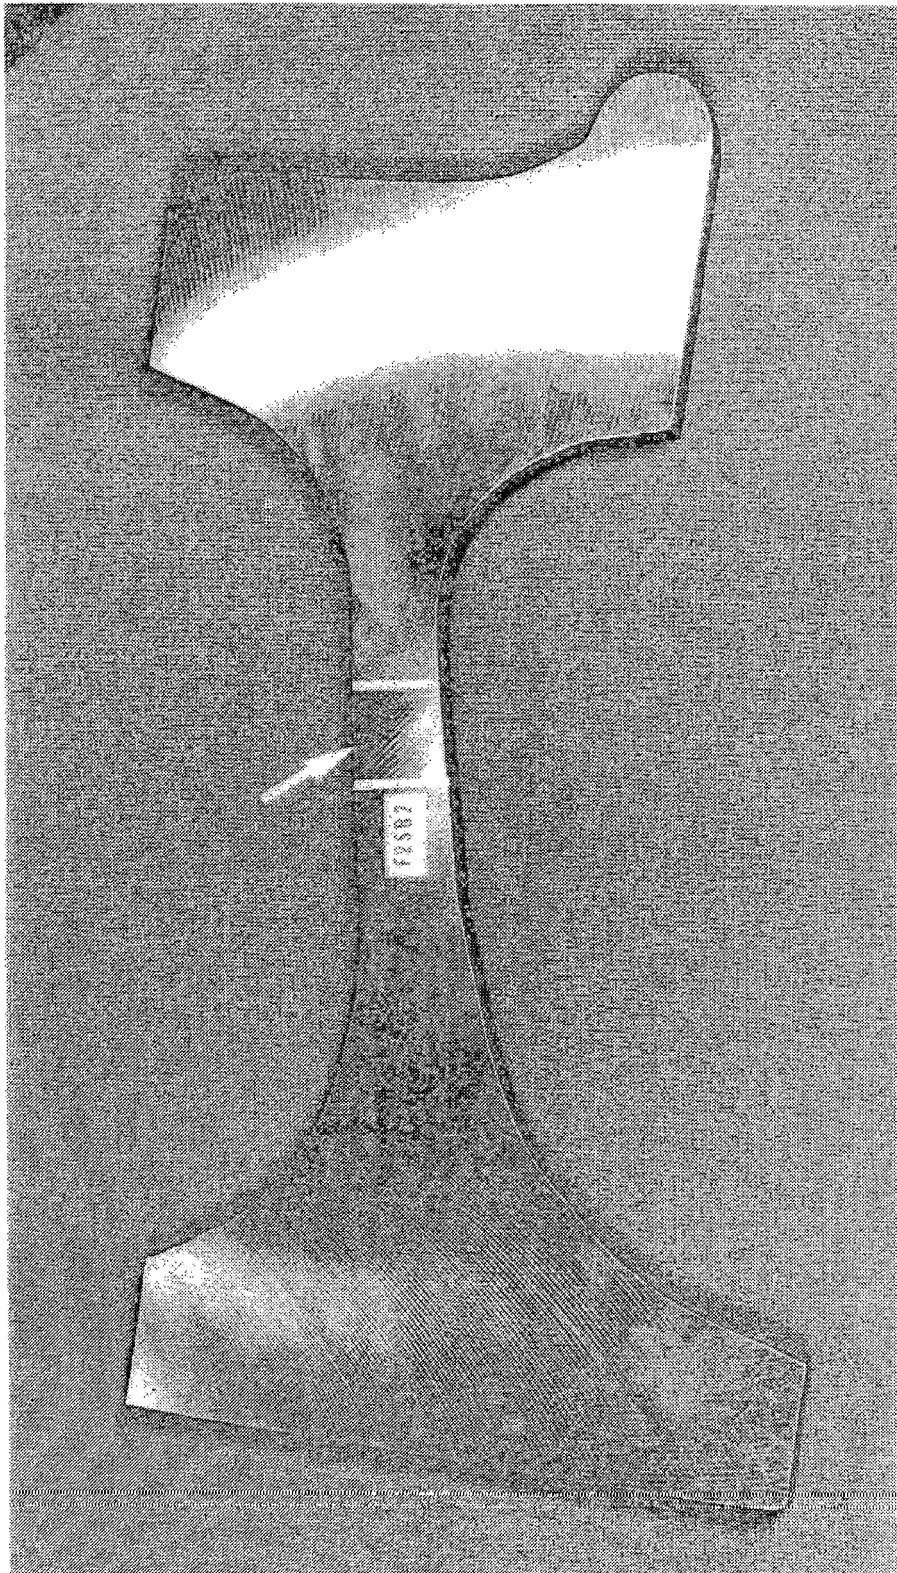
Figure 14. Wheel section F2SB2 showing the location of the sample taken for chemical analysis.

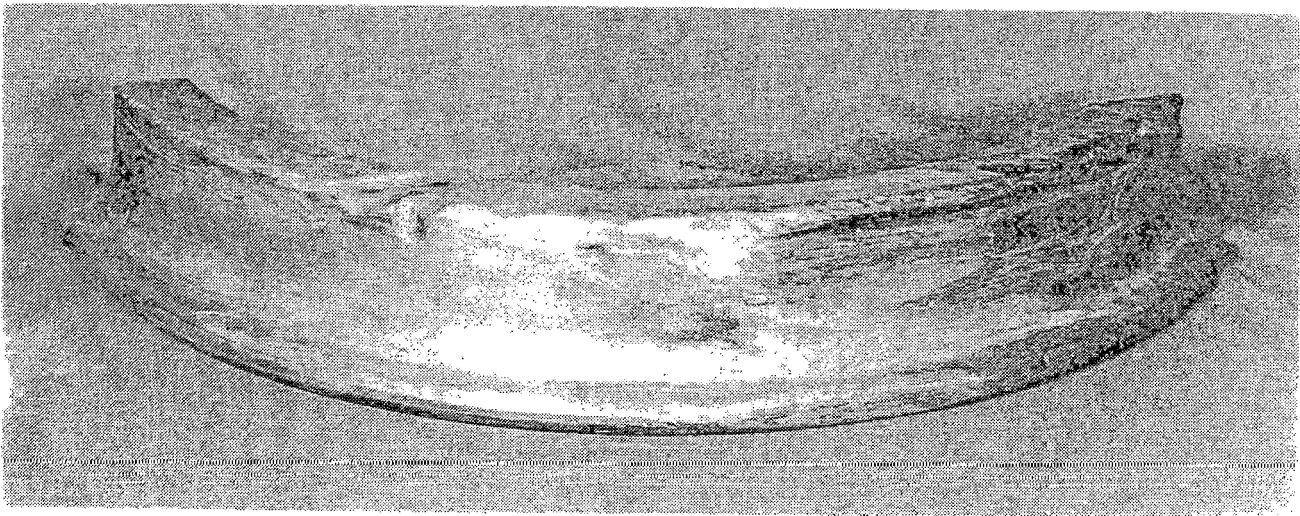
Figure 18. Wheel piece F1S with the outside of the wheel facing up showing mechanical damage to the tread and outside of the wheel adjacent to the tread.

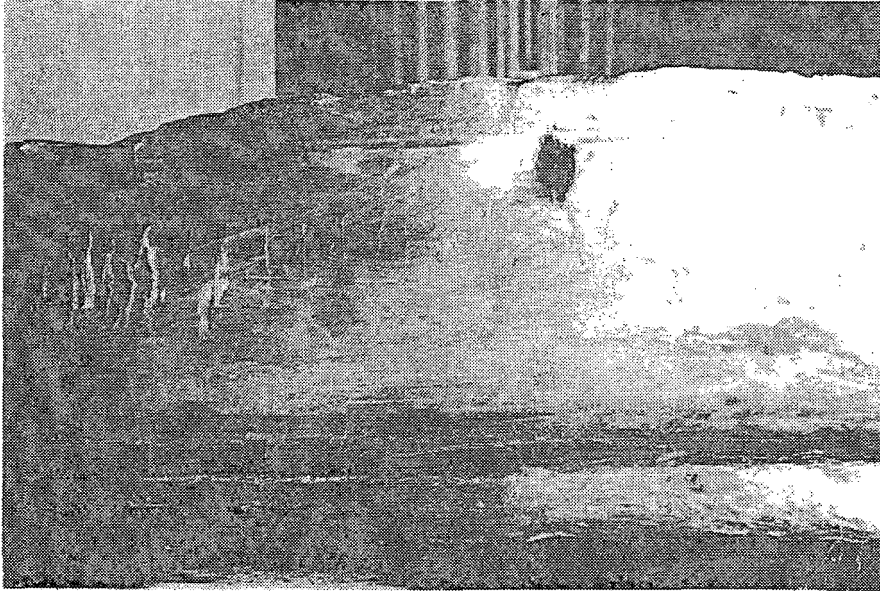
Figure 19. Region of the tread of wheel piece F1S exhibiting galling and gouging.

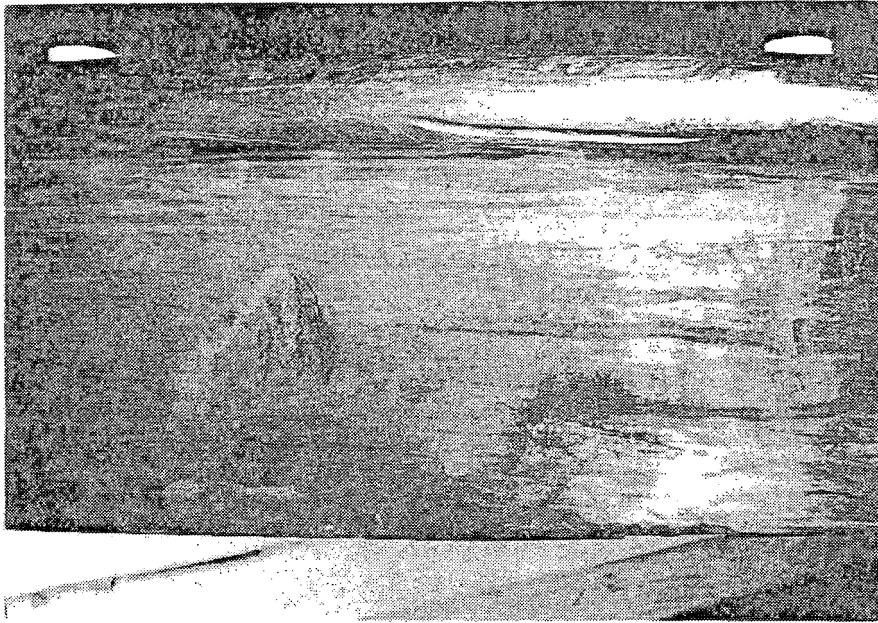
Figure 21. Example of mechanical damage on the tread of wheel piece F2L.

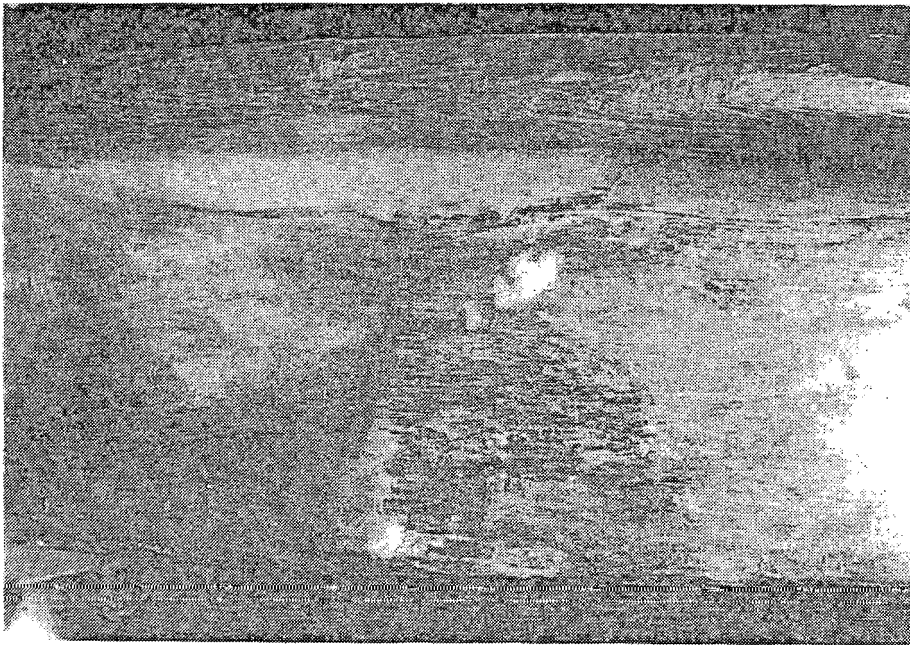
Figure 22. Mechanical damage on the tread of wheel piece F2S.

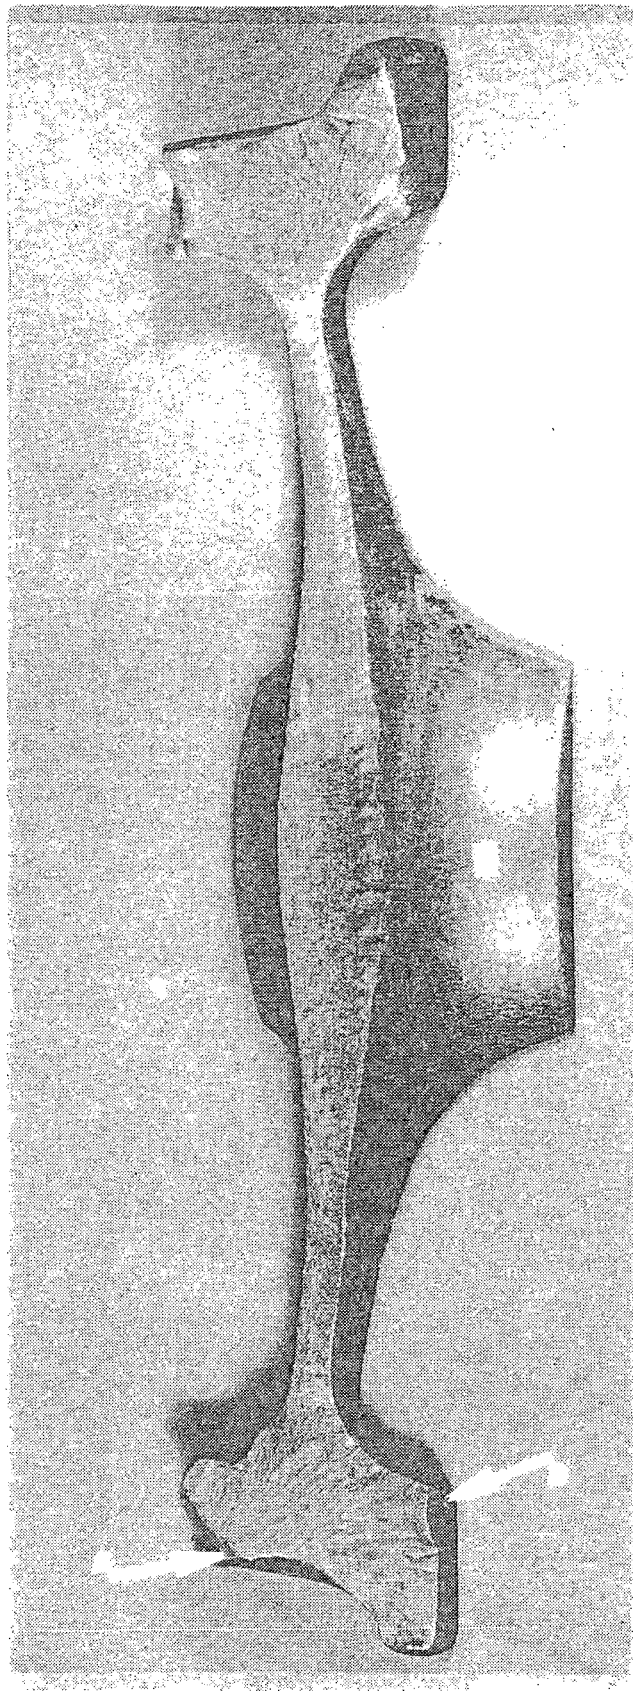
Figure 23. Fracture surface of wheel piece F1LB1. Arrow A indicates region of probable fracture initiation. Arrow B indicates depression common to both mating wheel pieces F1L and F1S.

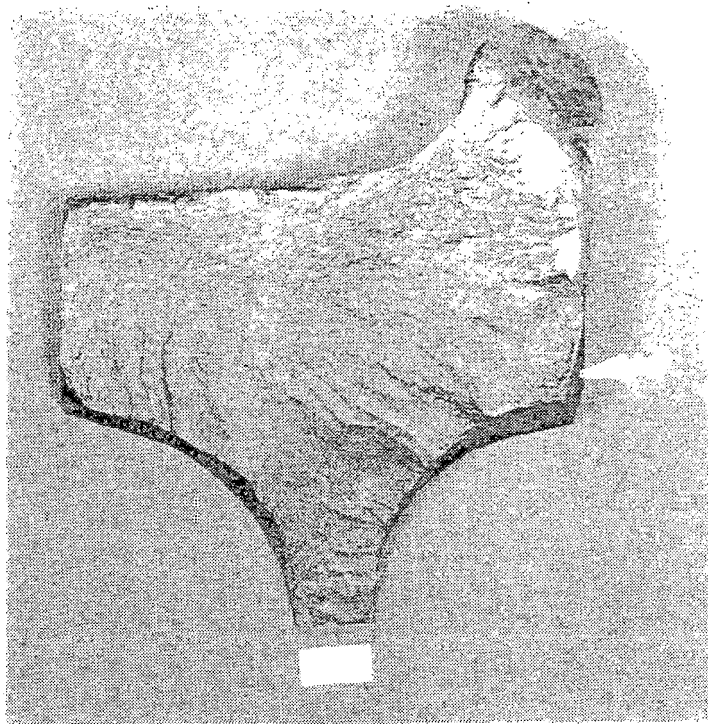
Figure 24. Wheel piece F1SA1 showing part of the fracture corresponding to the mating fracture shown in figure 21. The arrow indicates the depression that was exhibited by both fractured pieces F1L and F1S. X1/2

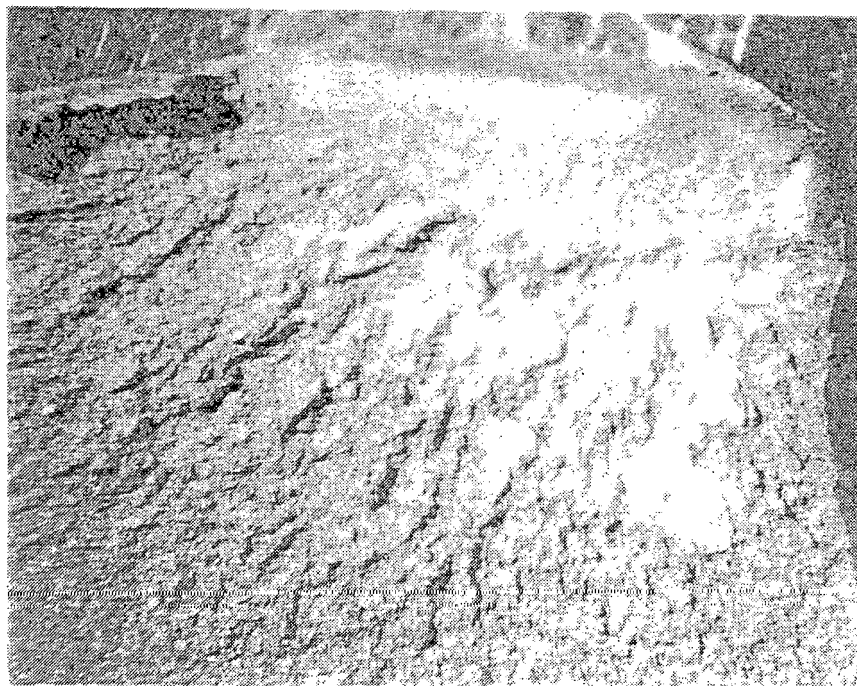
Figure 25. Fracture surface of specimen A1 from wheel piece F2SB1 in the region of the fracture initiation. X6

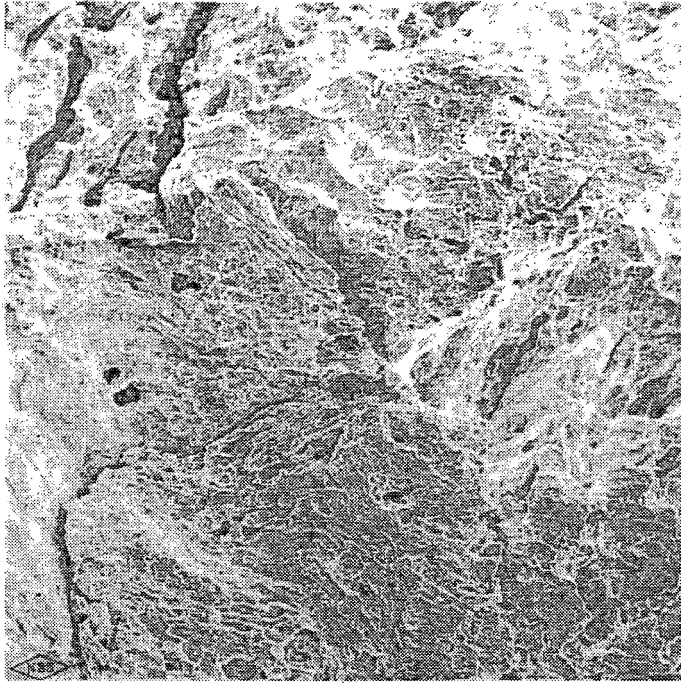
Figure 26. SEM fractograph of the "smeared" region of specimen A1 from wheel piece F2SB1. Grain boundary cracking is evident. X500

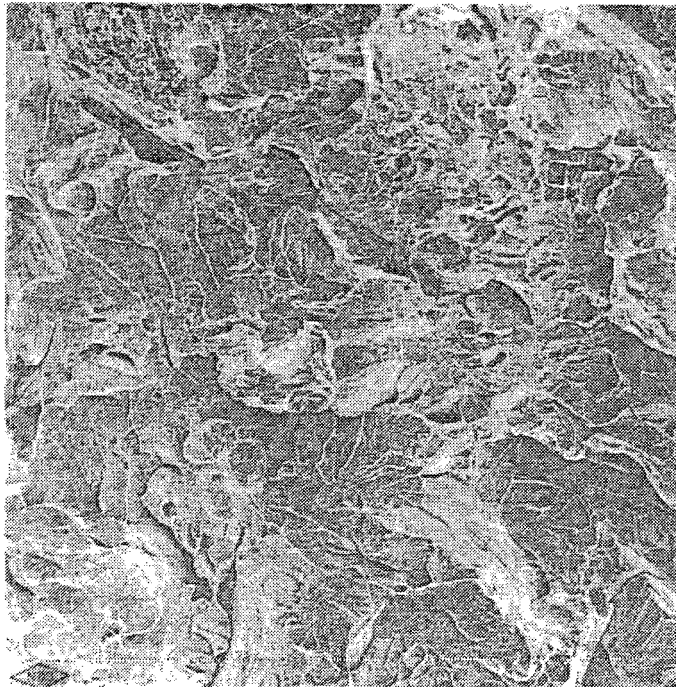
Figure 27. SEM fractograph of a region adjacent to the smeared region of specimen A1 from wheel piece F2SB1. Cleavage is the predominant fracture mode. X500

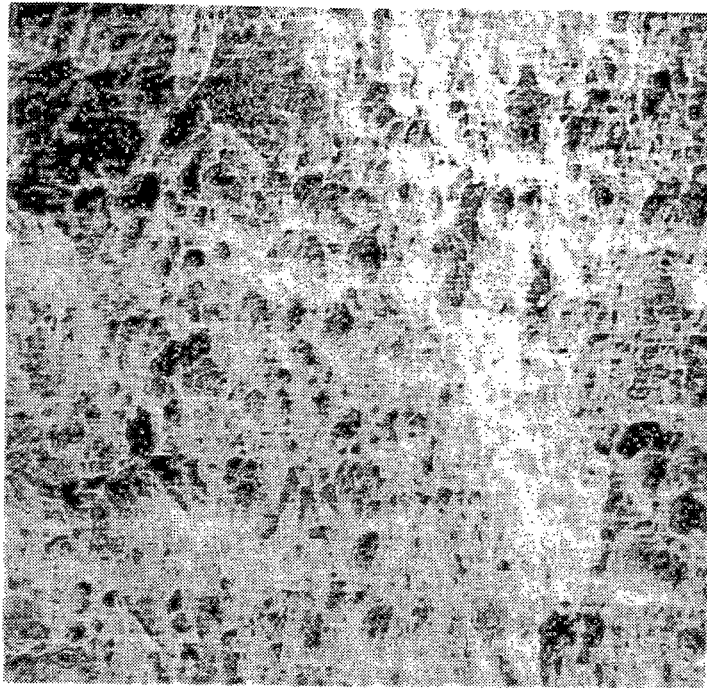
Figure 28. SEM fractograph representative of the heavily oxidized region of specimen A2 from wheel piece F2SB1. The effects of corrosion can be seen. X500

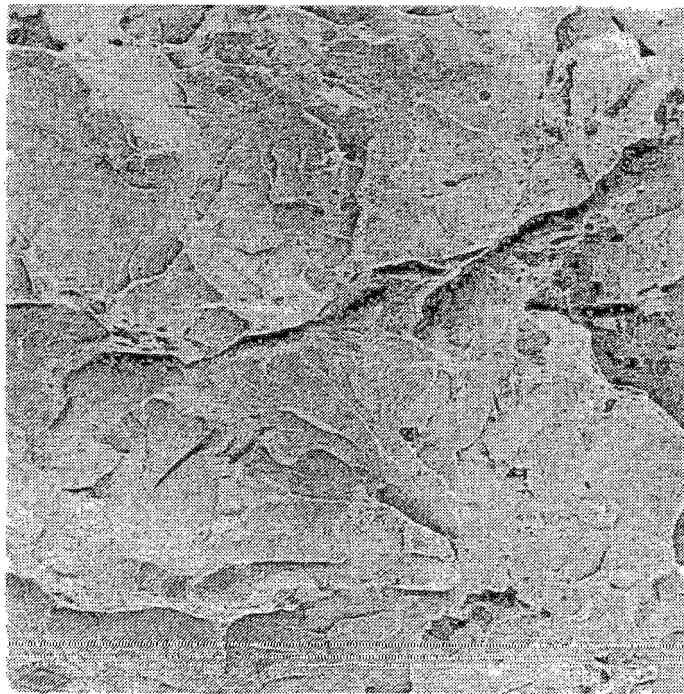
Figure 29. SEM fractograph from specimen A2 in a region near the tread, but removed from the heavily oxidized area. Cleavage is the predominant fracture mode. X500

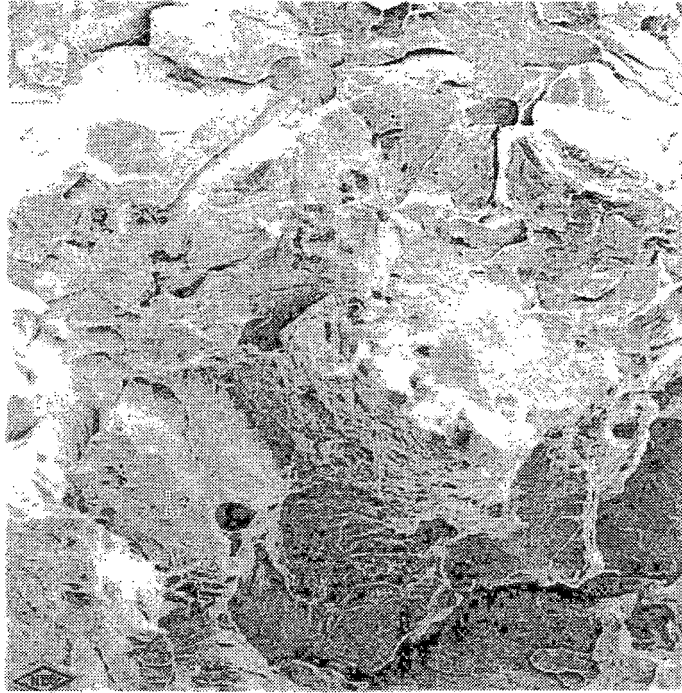
Figure 30. SEM fractograph in a region well removed from the tread of specimen A2 from wheel piece F2SB1. X500

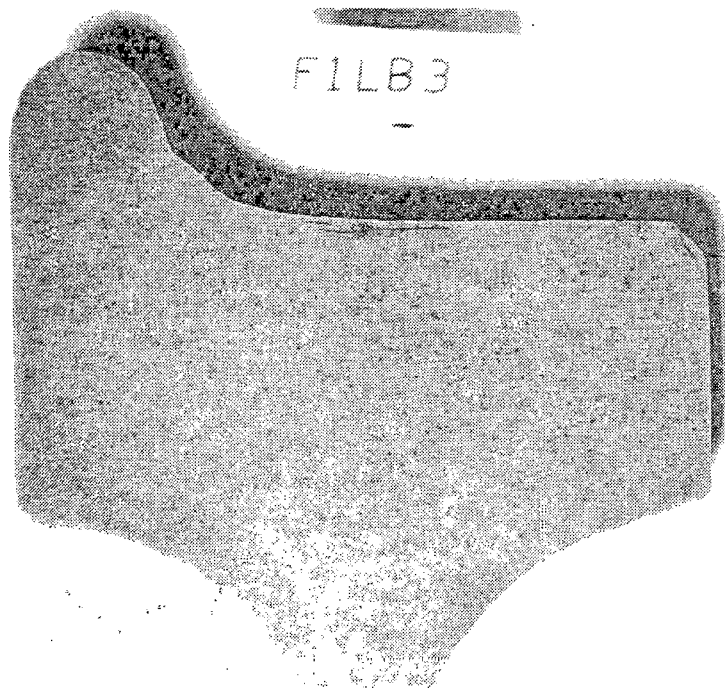
Figure 41. Wheel piece F1LB3 deep etched showing crack parallel and adjacent to the tread.
Etchant: Boiling 50% HCl, 50% H₂O

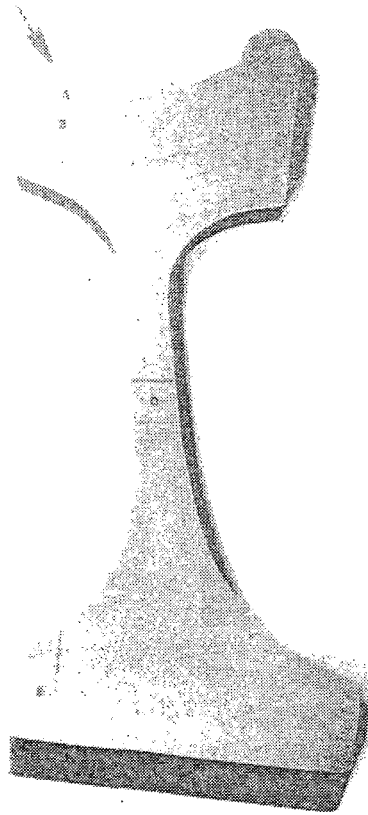
Figure 42. Wheel piece F2LA2 etched to reveal the region of the tread that had been overheated. Etchant: 2% nital

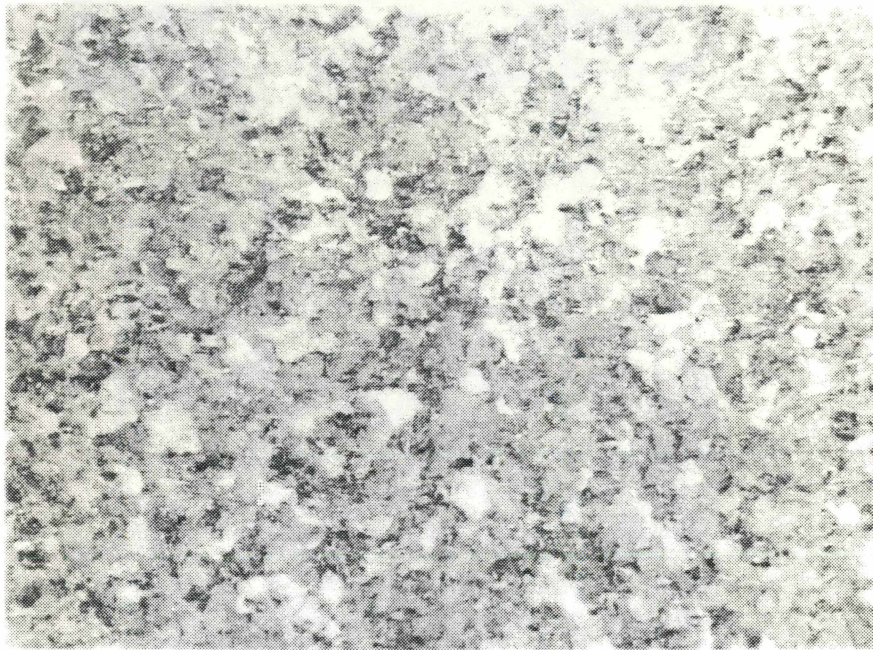
Figure 46. Representative microstructure of wheel piece F2LA2 away from the tread.
Etchant: 2% nital X100

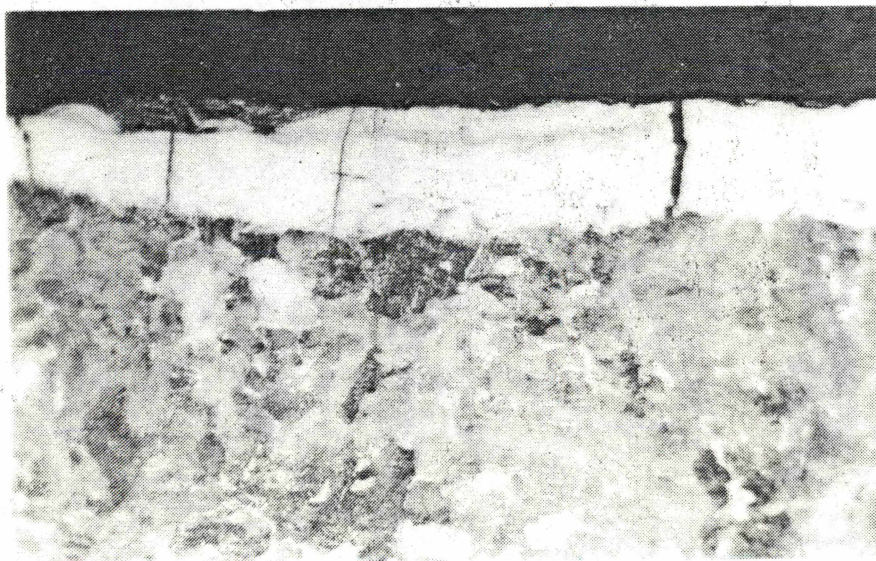
Figure 47. Microstructure of wheel piece F2LA2 at the hub showing an overheated area (white) with radial cracks.
Etchant: 2% nital X500
