Equipment testing and analysis: glazing impact test

An evaluation of two plastic and glass window systems subjected to projectile impacts

DOT/FRA/ORD-87

March, 1988
Final Report

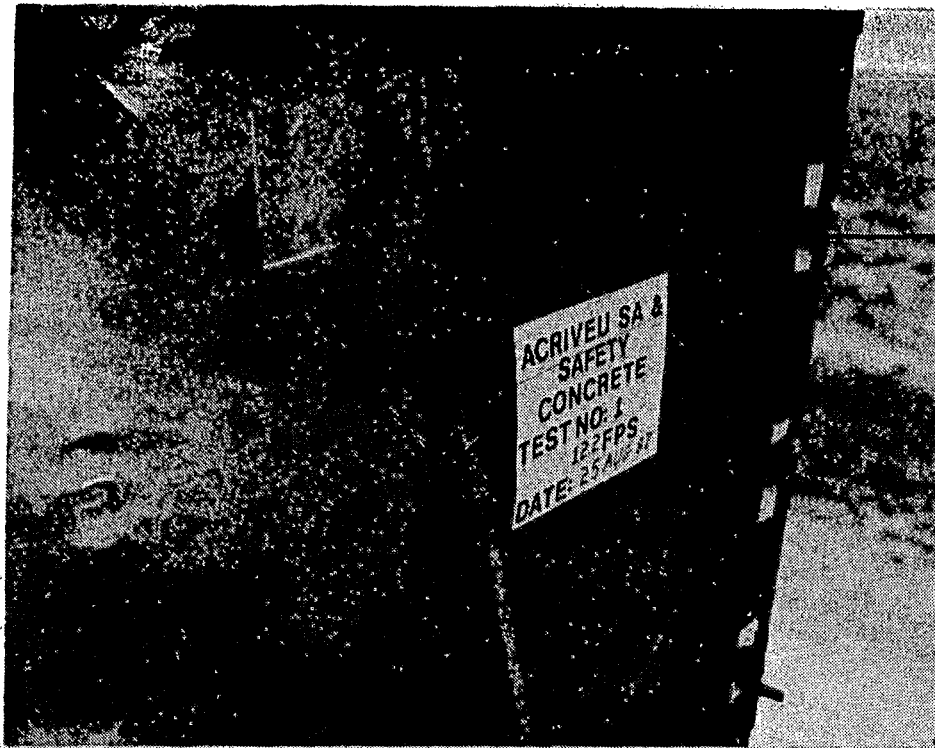
As the photographs show, the Acriveu SA glazing specimens received only localized abrasion or marring at the point of impact with the cinder blocks. No other damage was noted. The inner safety glazing from each test appeared untouched, and the aluminum witness plates were intact with no penetrations or dents visible. The Acriveu SA and Safety glazing system passed the Type II Large Object Impact test.

Figure A-4. Front view of Acriveu SA & Safety glazing system after the first 12 fps cinder block impact run.

- Test Type: Type II Large Object Impact (Test #1)
- Recorded Impact Velocity 8.3 mph (12.2 fps)
- Cinder Block Weight: 24.1 lbs

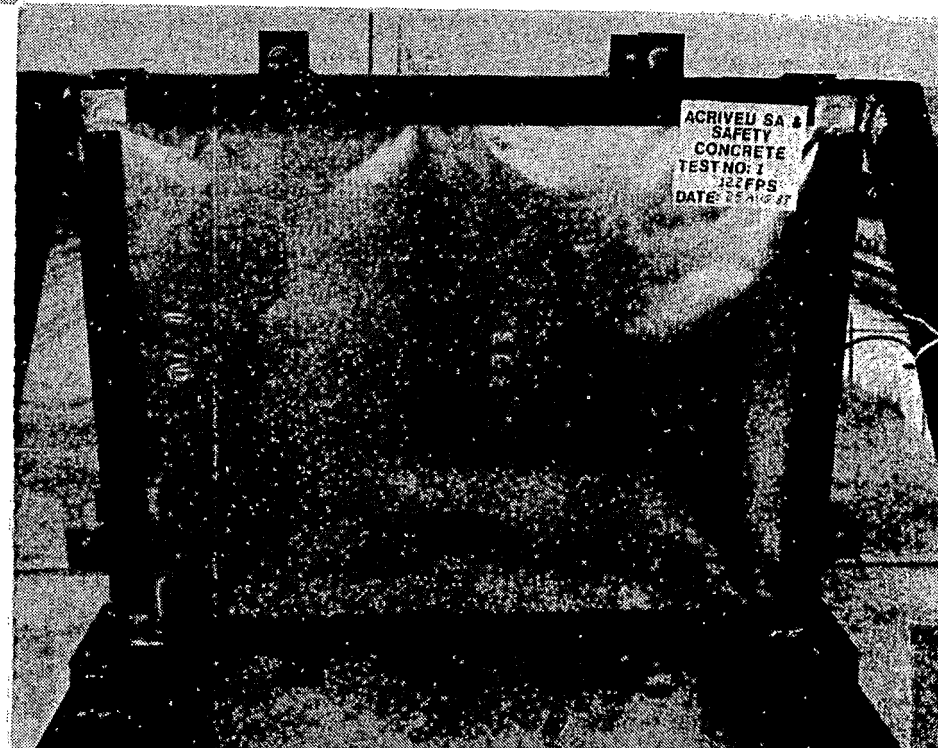
Figure A-5. Rear View of the witness plate -- no penetrations or dents.

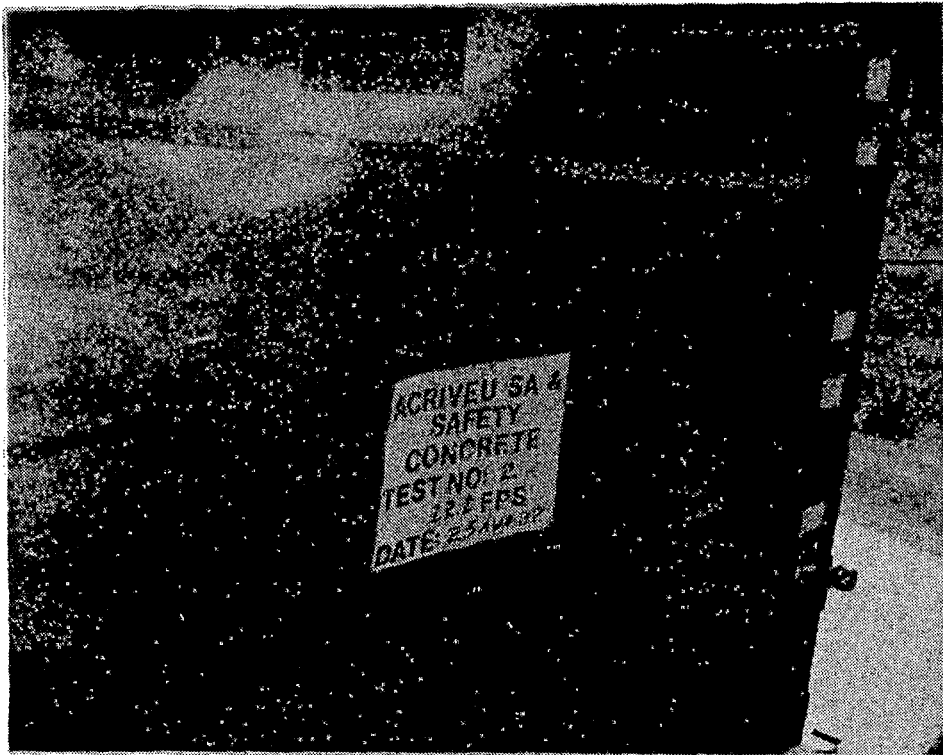
Figure A-6. Front view of Acriveu SA & Safety glazing system after the second 12 fps cinder block impact run.

- Test Type: Type II Large Object Impact (Test #2)
- Recorded Velocity: 8.7 mph (12.8 fps)
- Cinder Block Weight: 24.2 lbs

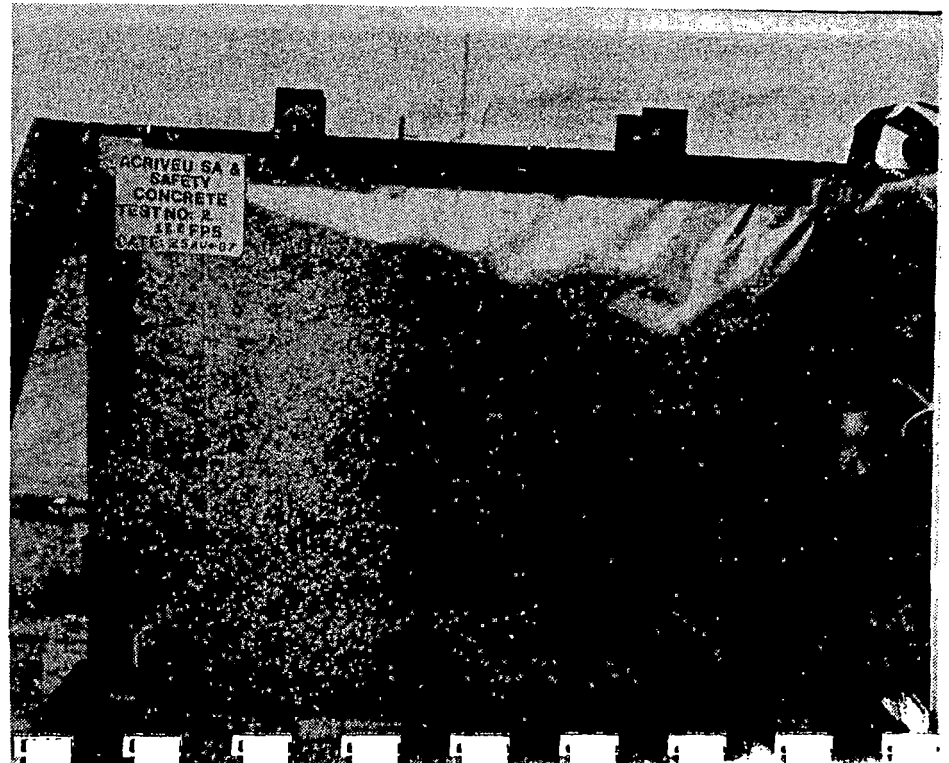
Figure A-7. Rear view of the witness plate -- no penetrations or dents.

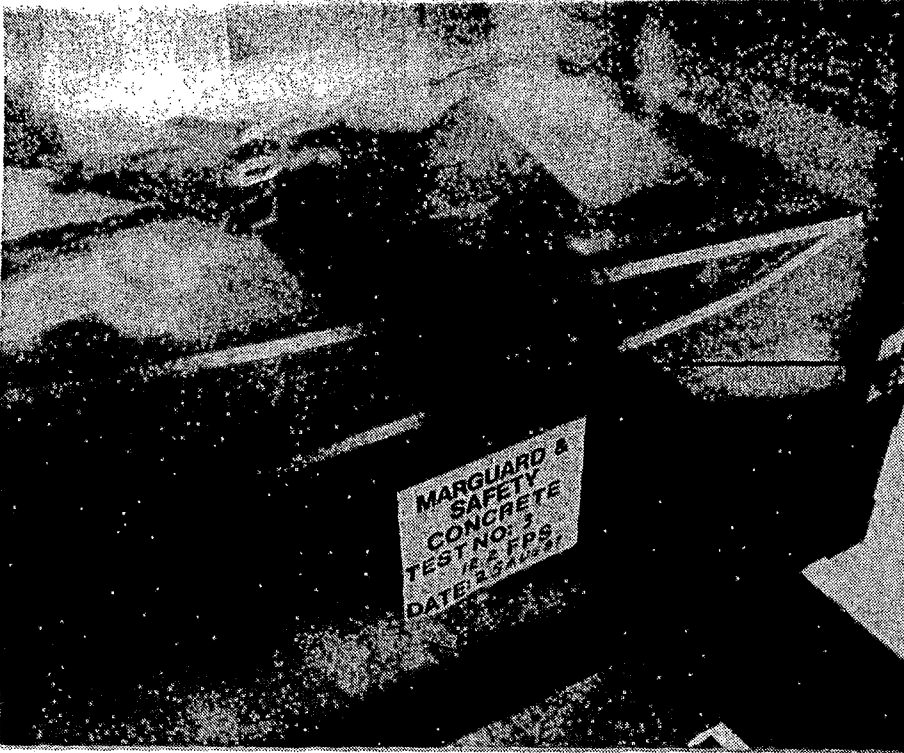
As seen in the photographs, the first test of Margard and Safety glazing specimens resulted in localized abrasion and marring at the point of impact. No other damage was observed and the witness plate was intact with no dents or penetrations. The second test resulted in the same localized damage to the plastic glazing, but the safety glass did not survive untouched, sustaining cracks and crazing across its surface. However, no dents or penetrations were seen on the witness plate and the Margard and Safety glazing system passed the Type II Large Object Impact tests.

- Test Type: Type II Large Object Impact
(Test #1)
- Recorded Velocity: 8.2 mph (12 fps)
- Cinder Block Weight: 24.3 lbs

Figure A-8. Front view of a Margard & Safety glazing system after the first 12 fps cinder block impact run.

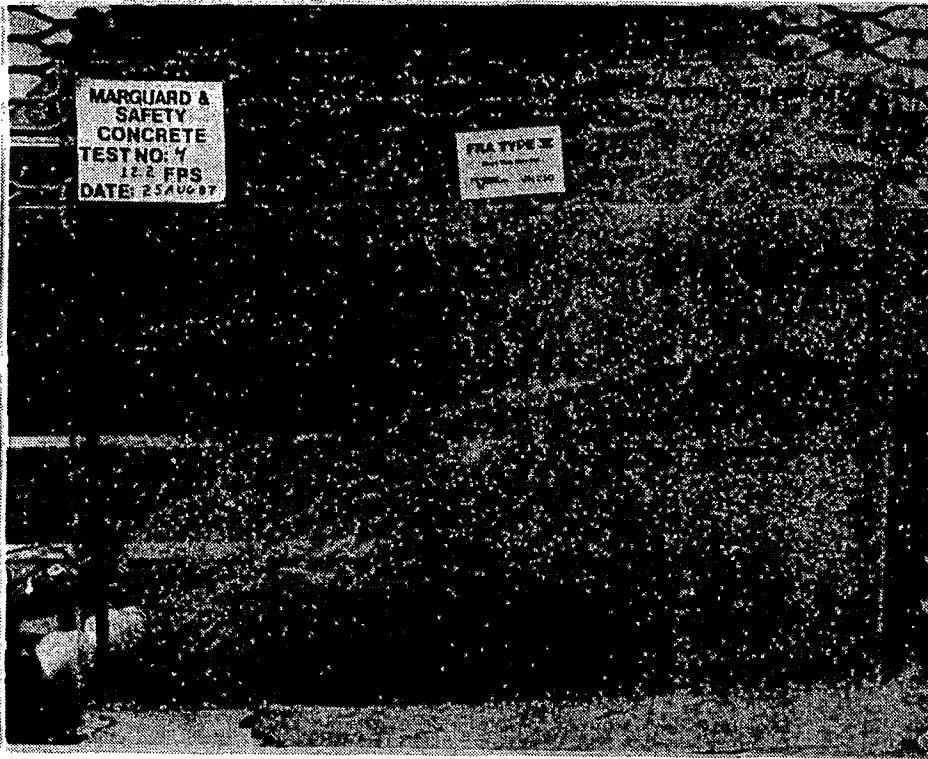
- Test Type: Type II Large Object Impact (Test #2)
- Recorded Velocity: 8.6 mph (12.6 fps)
- Cinder Block Weight: 24.4 lbs

Figure A-10. Front view of a Margard & Safety glazing system after the second 12 fps cinder block impact run.

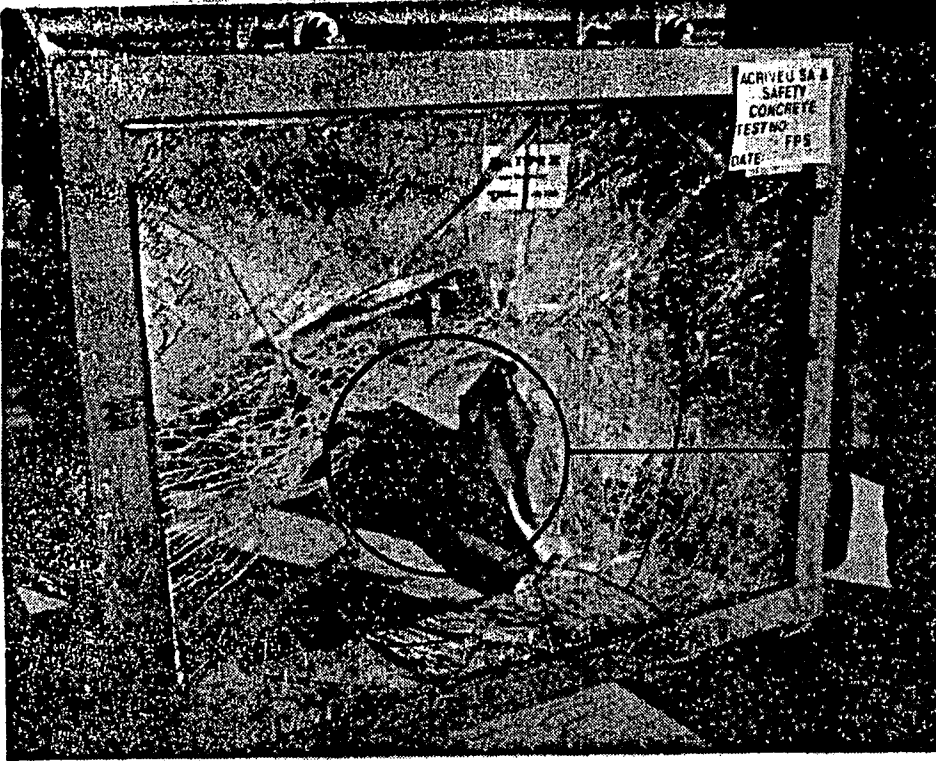
Results from the Type I Large Objects Impact test series (44 fps) on the Acriveu SA and Safety glazing system are presented in Figure A-12 through A-15. These photographs show complete failure in both tests, with each cinder block breaking and passing through the glazing system and witness plates. The plastic Acriveu SA material appears to have a brittle quality.

- Test Type: Type I Large Object Impact (Test #1)
- Recorded Velocity: 30.9 mph (45.3 fps)
- Cinder Block Weight: 24.2 lbs

Figure A-12. Front view of Acriveu SA & Safety glazing system after the first 44 fps cinder block impact run.

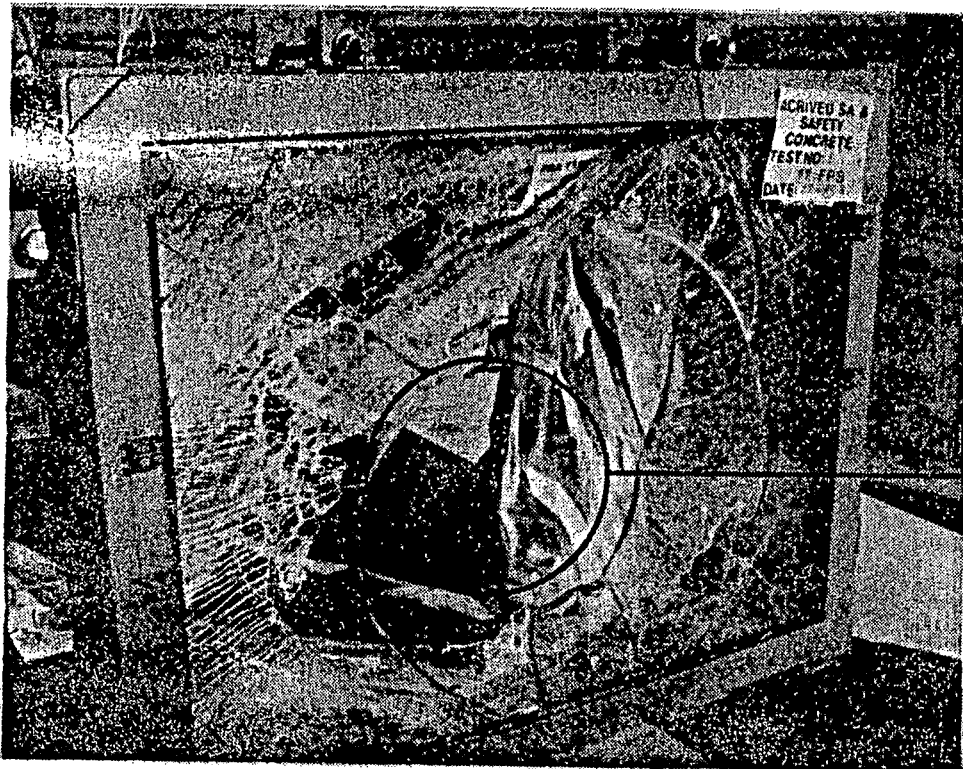
Figure A-14. Front view of Acriveu SA & Safety glazing system after the second 44 fps cinder block impact run.

- Test Type: Type I Large Object Impact (Test #2)
- Recorded Velocity: 31.2 mph (45.8 fps)
- Cinder Block Weight: 24 lbs

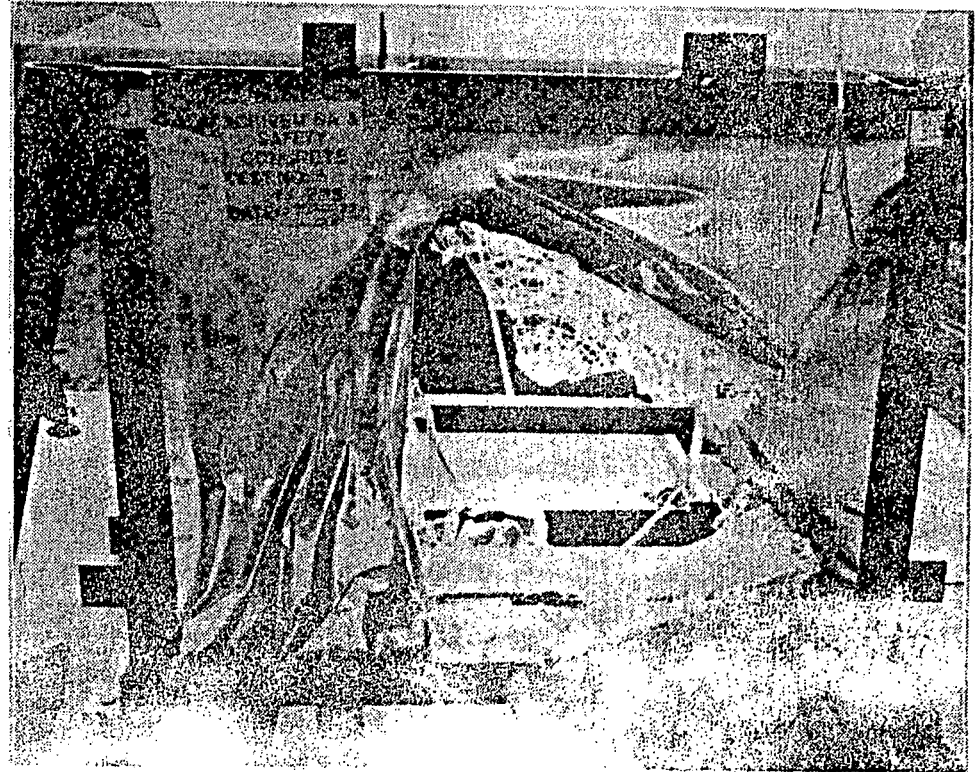
Figure A-15. Rear view of the witness plate -- cinder block passed through.

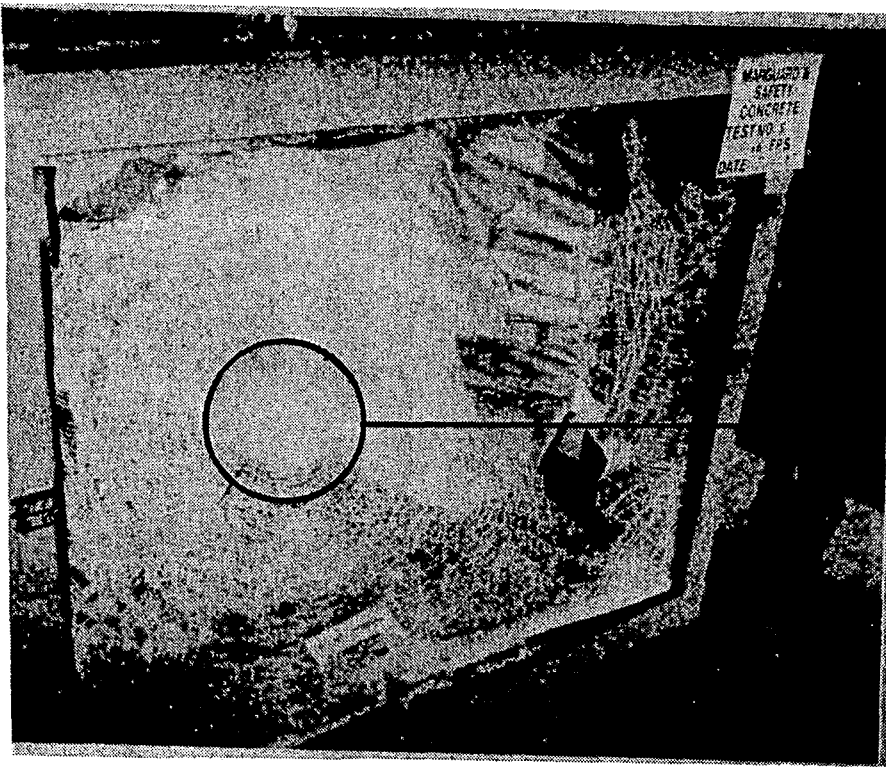
One additional large object impact test was conducted on the Margard and Safety glazing system to determine the impact-to-fail threshold velocity, as in the Acriveu SA and Safety test. The impact speed was increased from 44 fps to 66 fps (44 mph). It was expected that the cinder block would push the Margard out of the frame, or somehow break through it.

- Test Type: Impact-to-Fail (one test only)
- Recorded Velocity: 46.4 mph (68.1 fps)
- Cinder Block Weight: 24 lbs.

Figure A-22. Front view of a Margard & Safety glazing system after the "impact-to-fail" cinder block impact run.

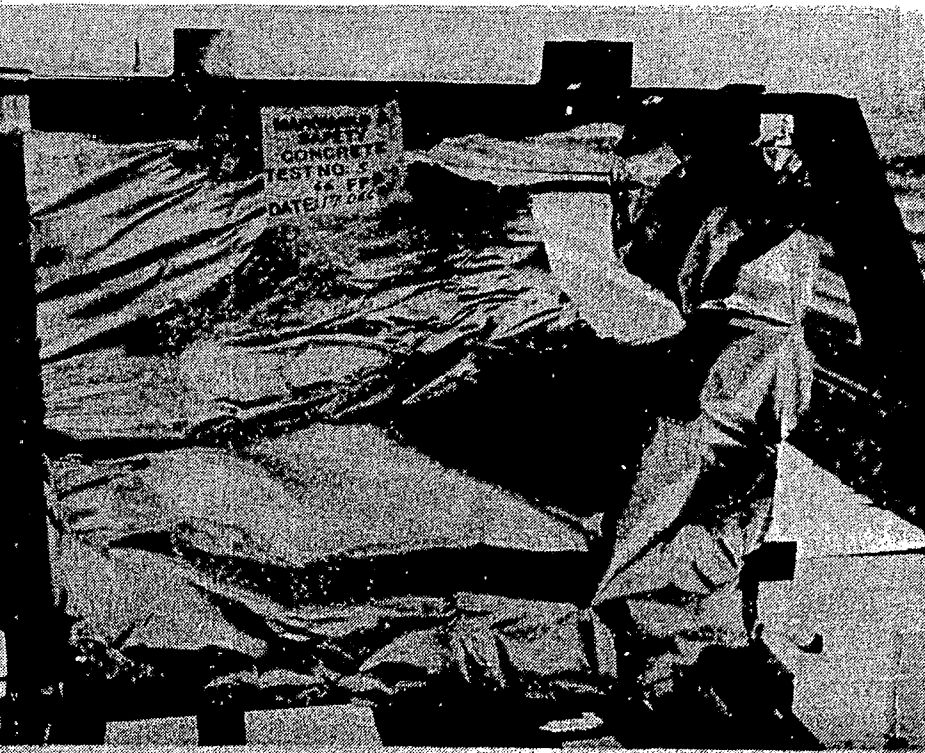
Figure A-23. Rear view of the witness plate -- safety glass broken, pieces gone, witness plate torn; Margard intact.

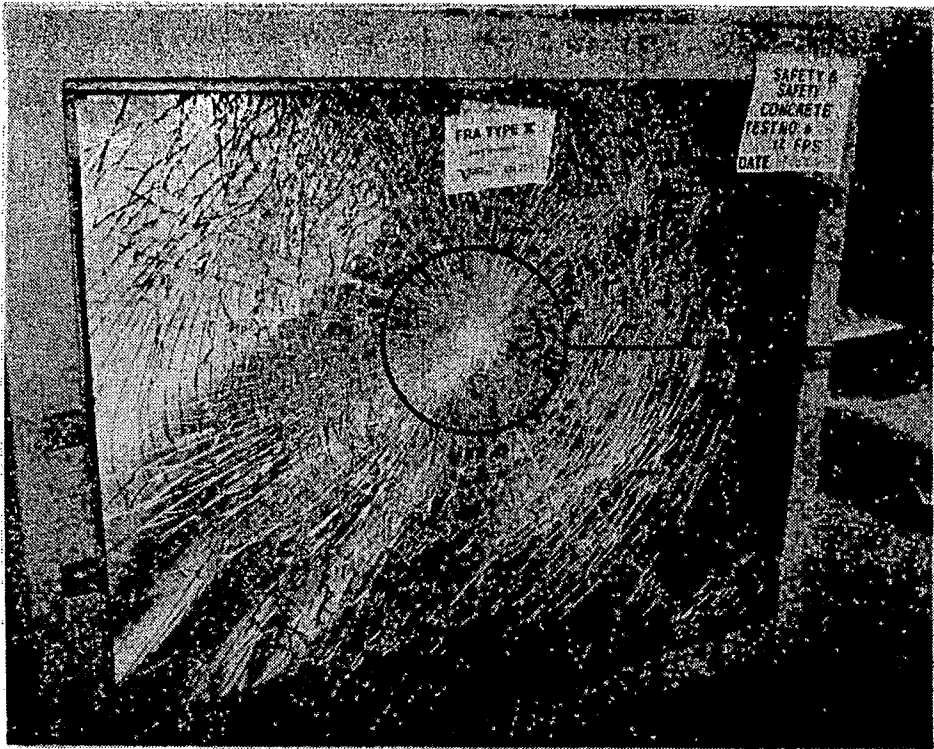
One Type II Large Object Impact test (12 fps) was conducted (see Figures A-24 and A-25). As seen in the photographs, the impact of the cinder block resulted in spalling of the outer glass and crazing of both safety glass specimens. However, no penetrations or dents were visible in the witness plate.

Figure A-24: Front view of a Safety & Safety glazing system after the single 12 fps cinder block impact run.

- Test Type: Type II Large Object Impact (single test)
- Recorded Velocity: 8.4 mph (12.3 fps)
- Cinder Block Weight: 24 lbs

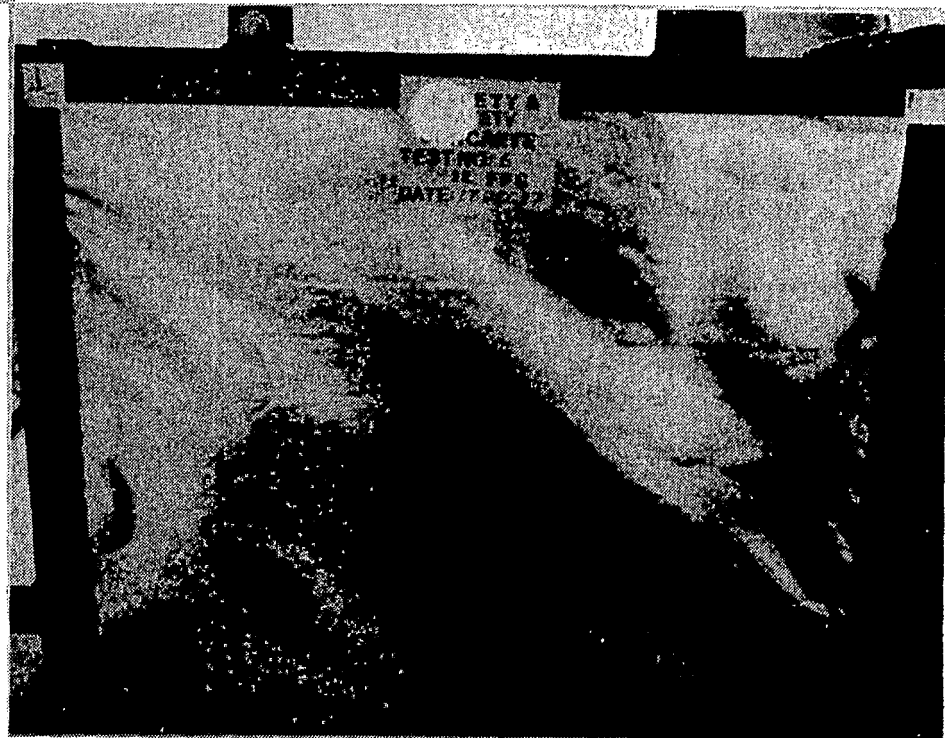
Figure A-25. Rear view of the witness plate -- no penetrations or dents.

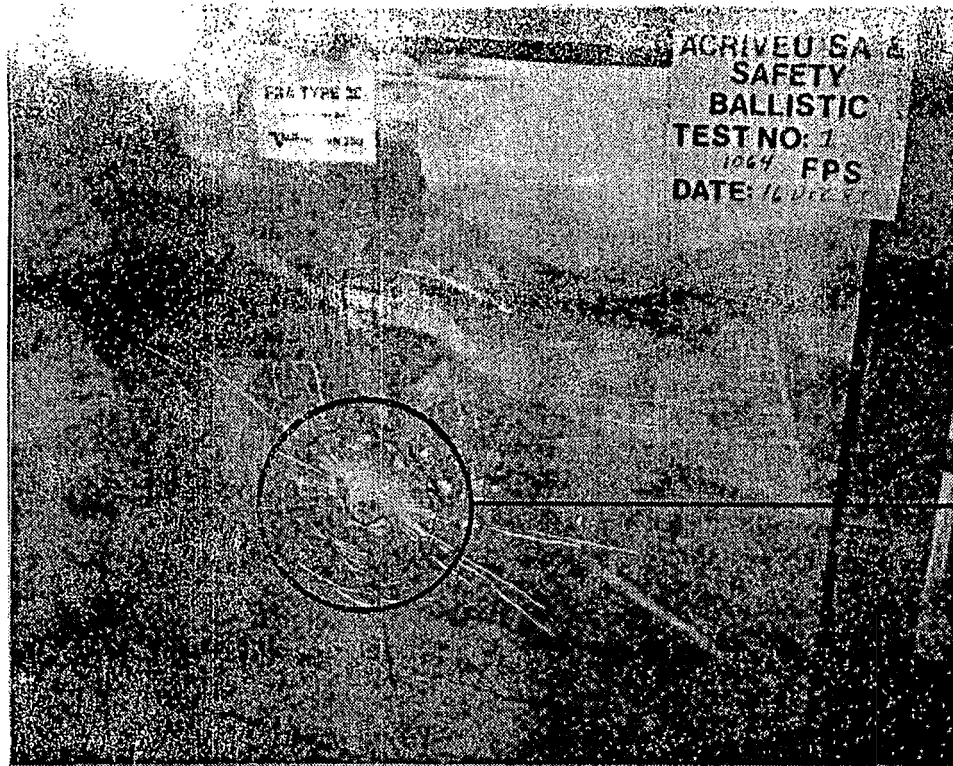
The two photographs taken after the first ballistic impact (Figures A-29 and A-30) clearly show the impact area at the center of the glazing specimen, and the localized, dimpled pattern on the witness plate. The bullet passed through the plastic material and impinged onto the safety glass. Some fragments of the safety glass (approximately 6) passed through the witness plate, while others only created bumps or a dimpled effect. The cracks or crazing which are evident in the glazing material occurred primarily in the safety glass. The Acriveu SA and Safety glazing system failed the first of three ballistic impact tests.

Figure A-29. Front view of the Acriveu SA & Safety glazing system after the first bullet impact.

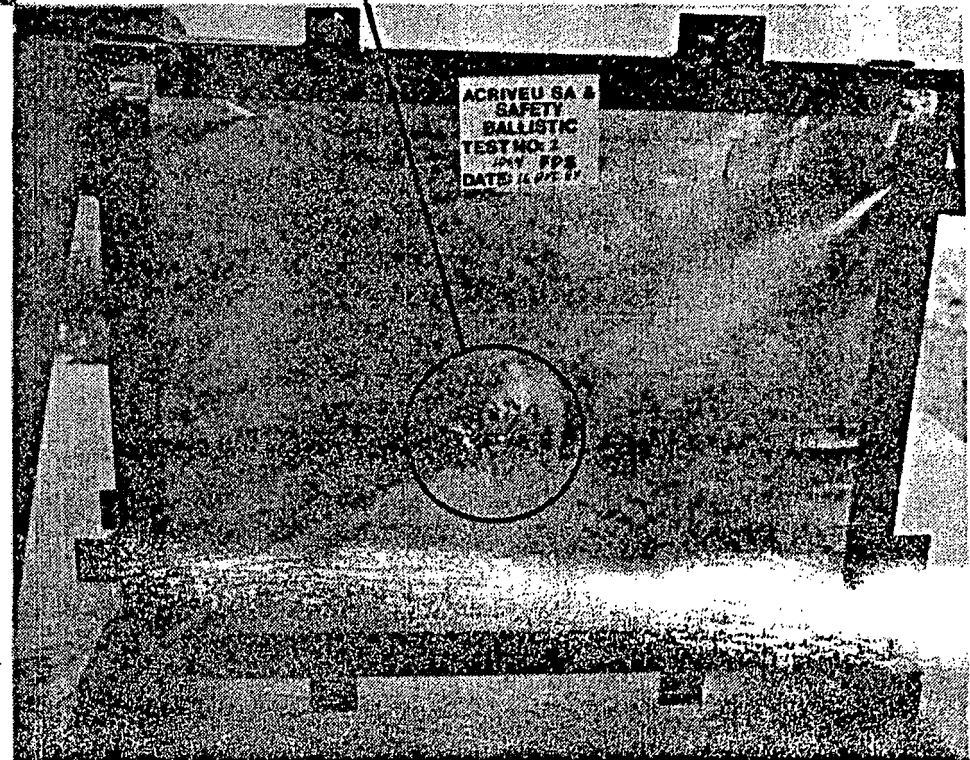
Cluster of small penetrations and dents

Figure A-30. Rear view of the witness plate -- several small penetrations and dents from glass fragments.

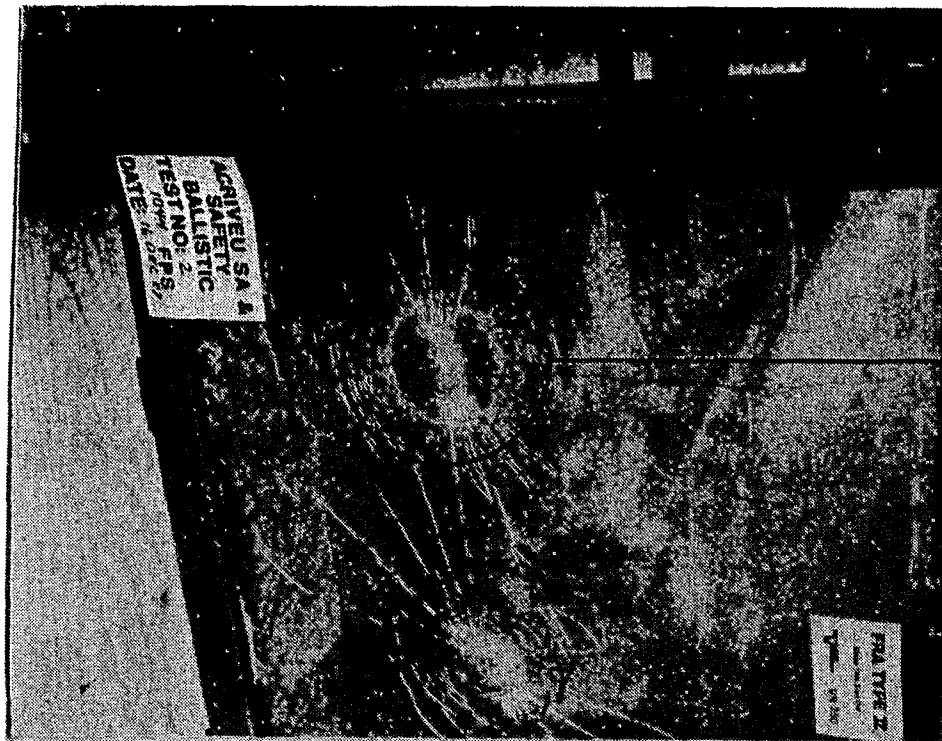
Figure A-31. Front view of the Acriveu SA & Safety glazing specimen after incurring the second (left of center) bullet impact.

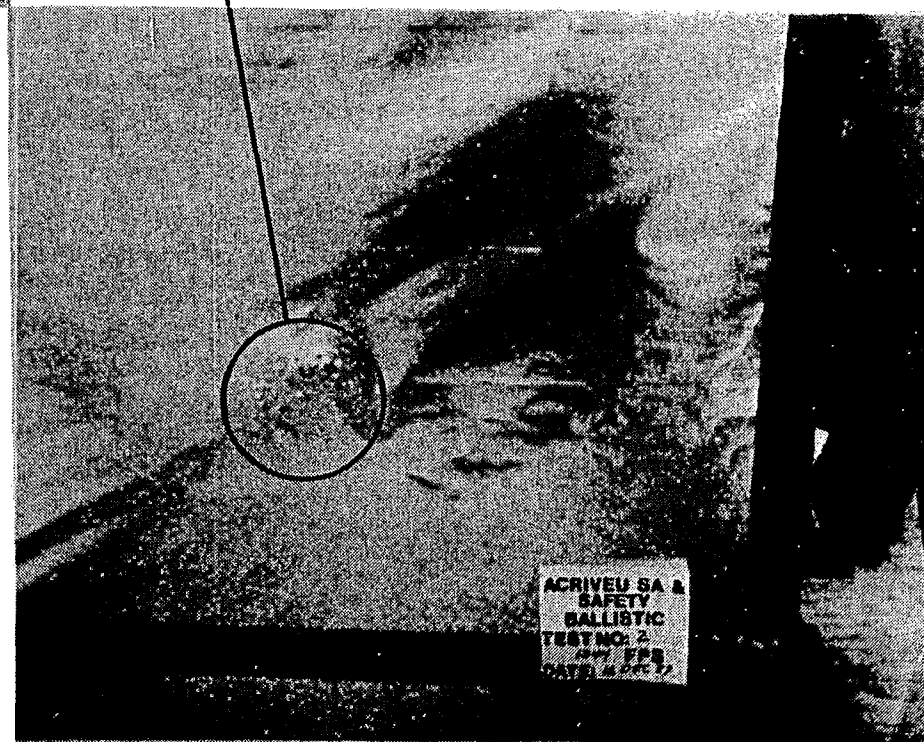
Cluster of small dents only.

Figure A-32. Rear view of the witness plate -- several small dents but no penetrations.

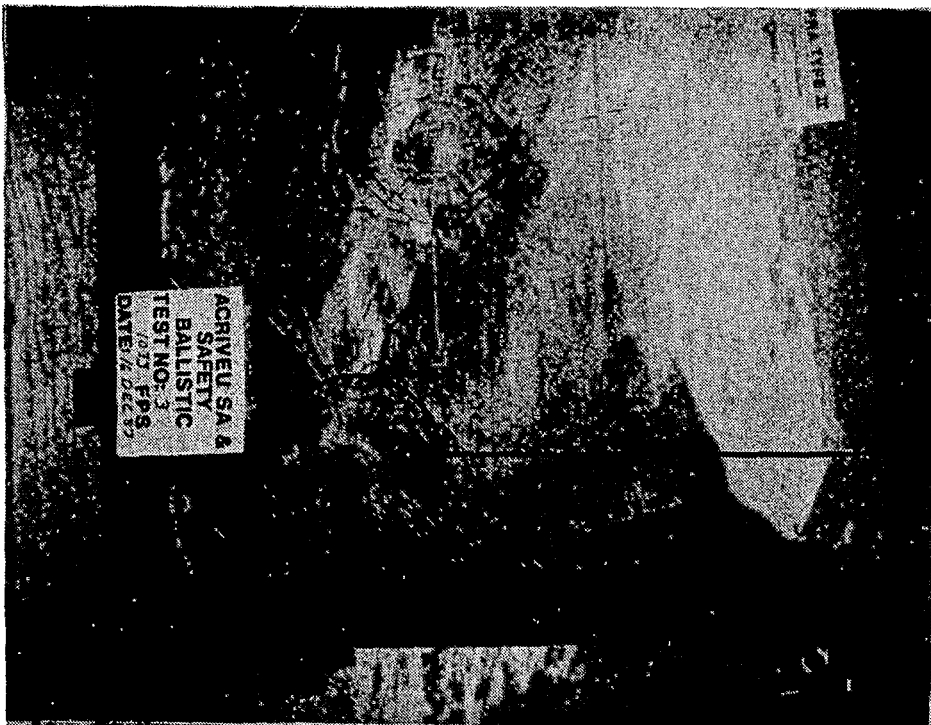
Figure A-33. Front view of the Acriveu SA & Safety glazing specimen after incurring the third (right of center) bullet impact.

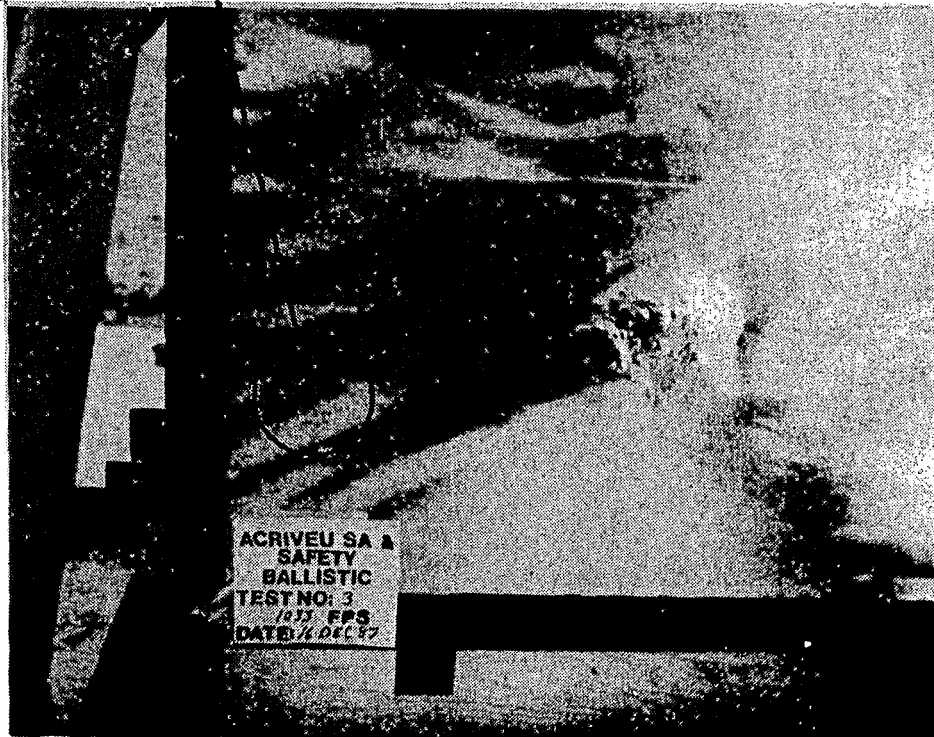
Figure A-34. Rear view of the witness plate -- 12 small dents but no penetrations.

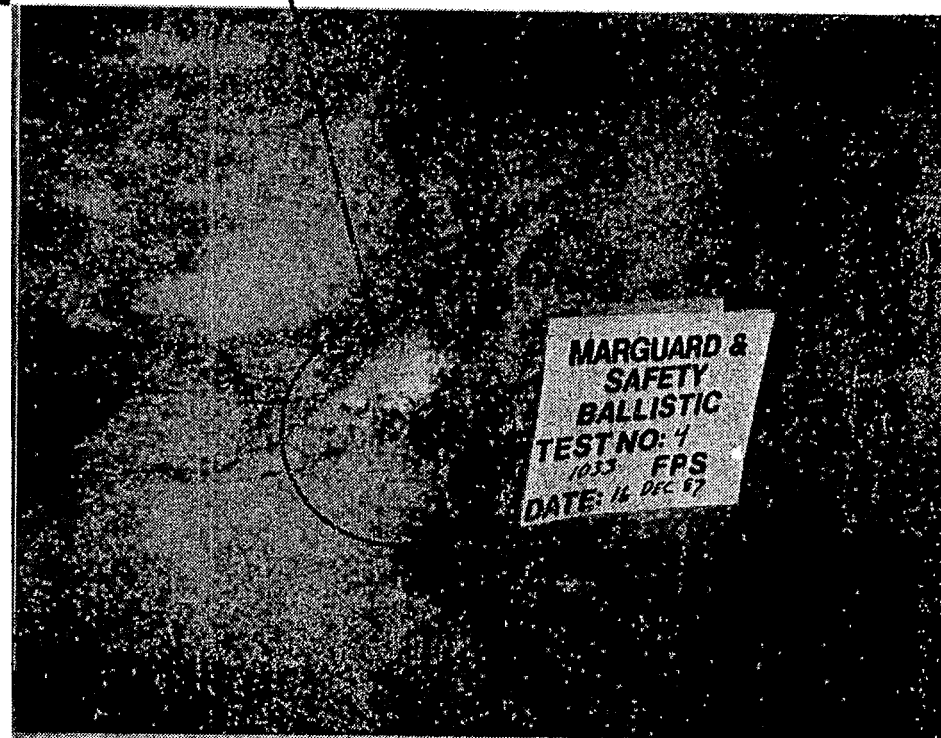
Results from the Types I and II Ballistic Impact test series are presented in Figures A-35 through A-40. In all three tests, the bullet penetrated the plastic Margard material and impinged on the Safety glass. The cracked or crazing pattern in the Safety glass was similar in the three tests, and small penetrations were seen in each of the witness plates (between 3 and 6 were counted in each test). Several dents were also visible in each witness plate as can be seen in the photographs.

Figure A-36. Rear view of the witness plate -- 3 or 4 small penetrations and several dents.

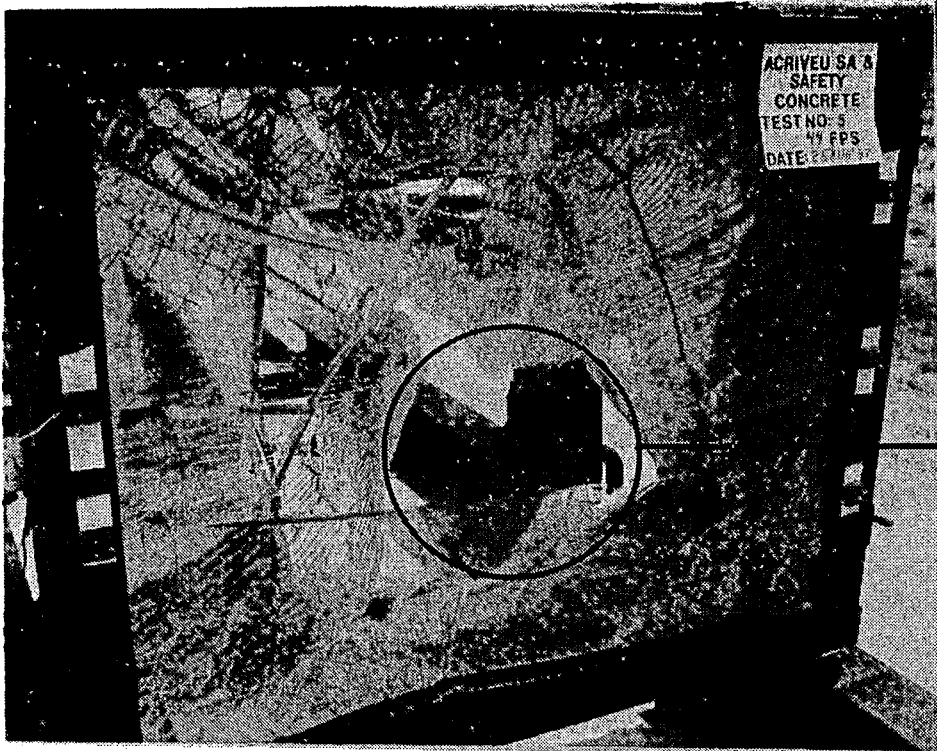
A full "Appendix A" test series of Acriveu SA/Safety and Margard/Safety glazing systems was conducted initially with the Safety glazing installed backwards. This was done mistakenly, without the knowledge that the safety glass is designed to face an impact from one designated side only. The manufacturer of the safety glass claims that installing the glazing backwards will cause it to spall and splinter much more easily when subjected to an impact. This in fact, seems to be the case.

- Test Type: Type I Large Object Impact (Test #1)
- Recorded Velocity: 32.7 mph (48.0 fps)
- Cinder Block Weight: 24.2 lbs

Figure C-1. Front view of an Acriveu SA & Safety glazing system, Safety Glass installed backwards, after the first 44 fps cinder block impact run.

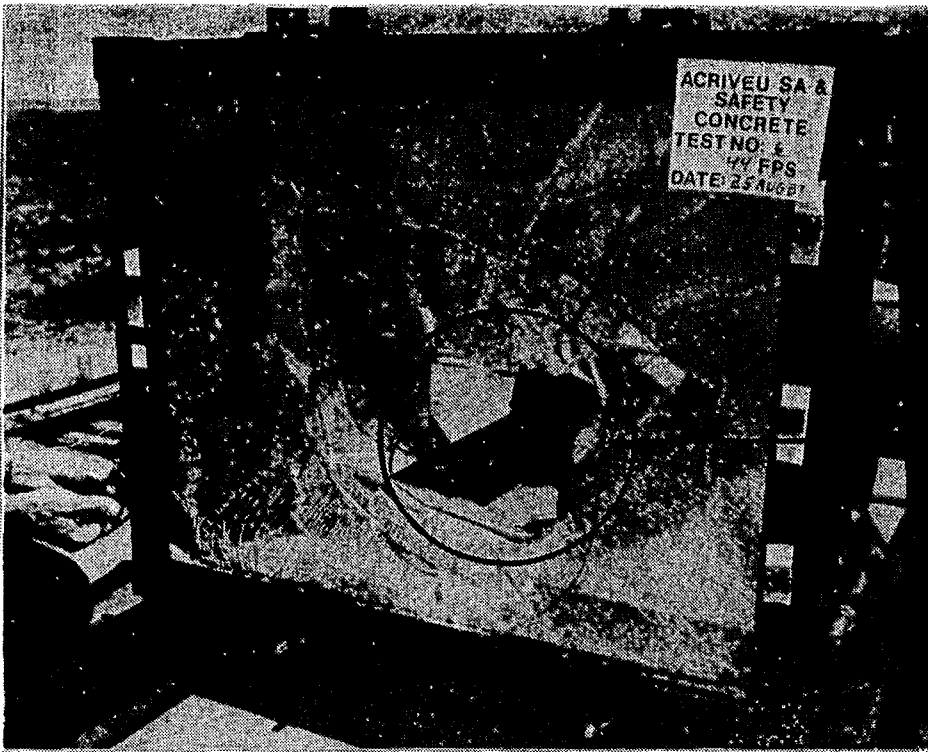
- Test Type: Type I Large Object Impact
(Test #2)
- Recorded Velocity: 31 mph (45.5 fps)
- Cinder Block Weight: 24.3 lbs

Figure C-3. Front view of an Acriveu SA & Safety glazing system, Safety Glass installed backwards, after the second 44 fps cinder block impact run.

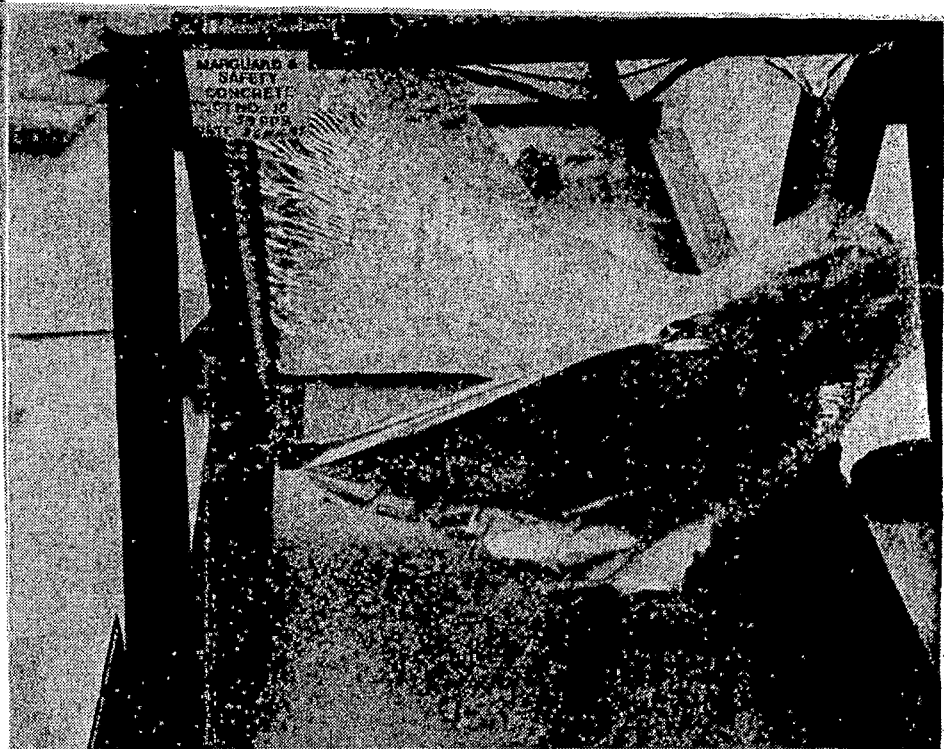
Figure C-10. Rear view of the witness plate -- safety glass broken apart and witness plate almost torn away. Margard remained intact but was pushed out of the frame at the top and left side.
