**FAST/HAL RAIL PERFORMANCE  
EXPERIMENT AND OVERVIEW**

**AAR REPORT R-796  
FRA/ORD-91/24**

***Facility for Accelerated Service Testing  
Heavy Axle Load Program***

**November 1991**

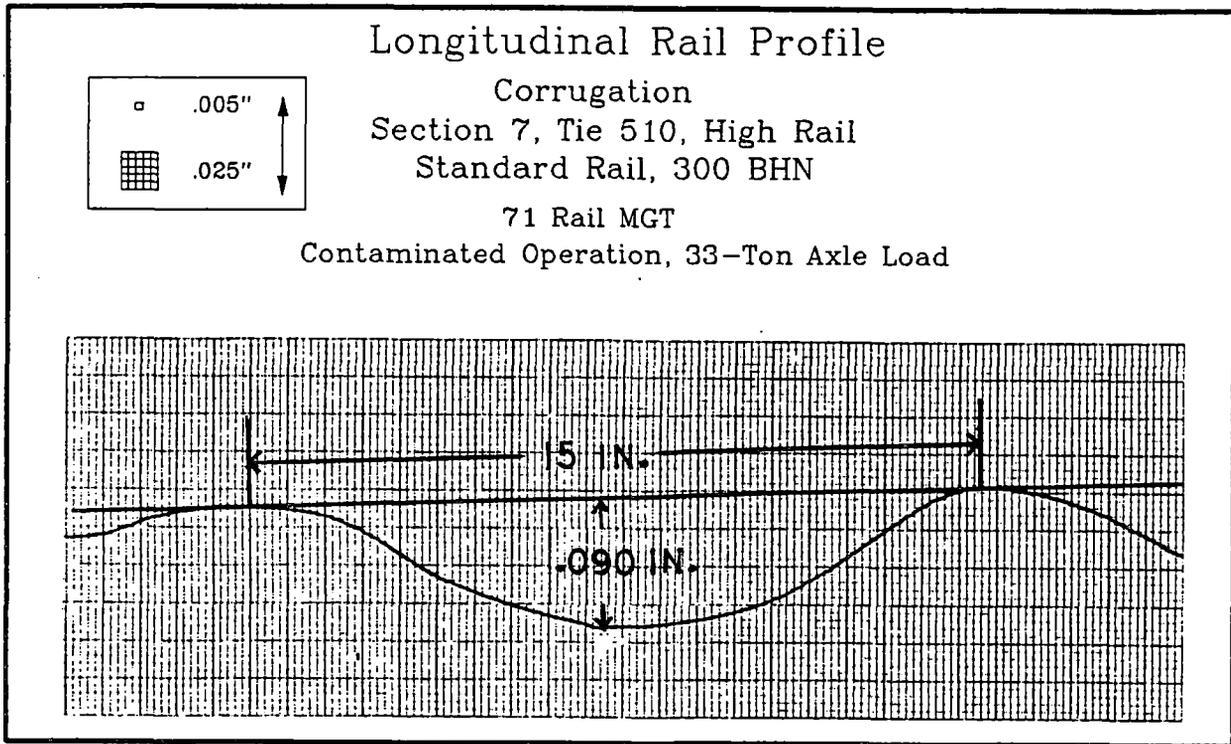
Throughout the history of the HTL, Section 07 has been susceptible to corrugations on the high rail of the curve. During operation of the 33-ton axle load test, these corrugations were observed to begin at a joint or a battered weld in standard rail and then to carry through the remainder of the rail as tonnage was accumulated. There are no exact records of corrugation development, but the longer the rail remained in service, the deeper the corrugations became until the rail eventually had to be ground. Corrugations were also noticed in HH rails, but they were light and did not become worse with tonnage. A strip chart recording from the LRP machine is shown in Figure 5. This LRP was taken on standard carbon rail after 71 MGT of contaminated 33-ton axle operation and was the only corrugation data taken during the period. The test site chosen had the deepest corrugations. Assuming the corrugations began to develop immediately with train operations, and a corrugation depth of .09 inches after 71 MGT, the growth rate is .0013 in/MGT.

Figure 5. Corrugation Strip Chart 33-ton Axle Load

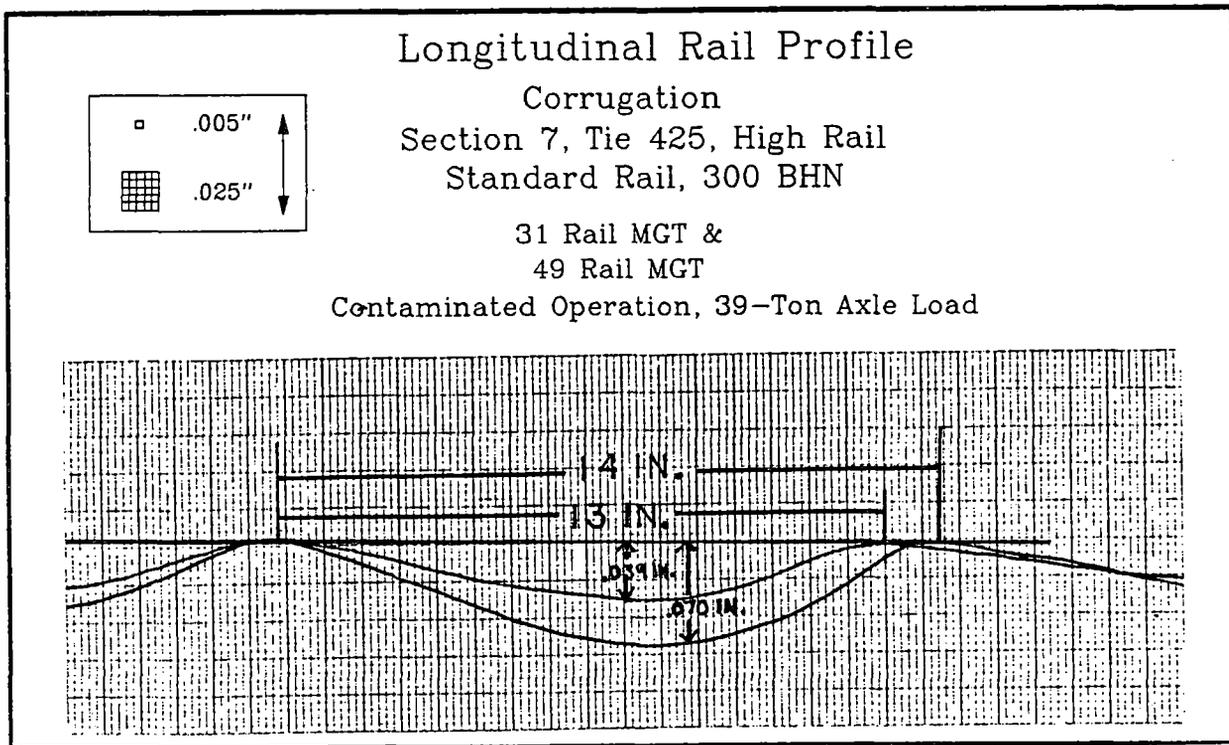
Figure 6. Corrugation Strip Chart 39-ton Axle Load

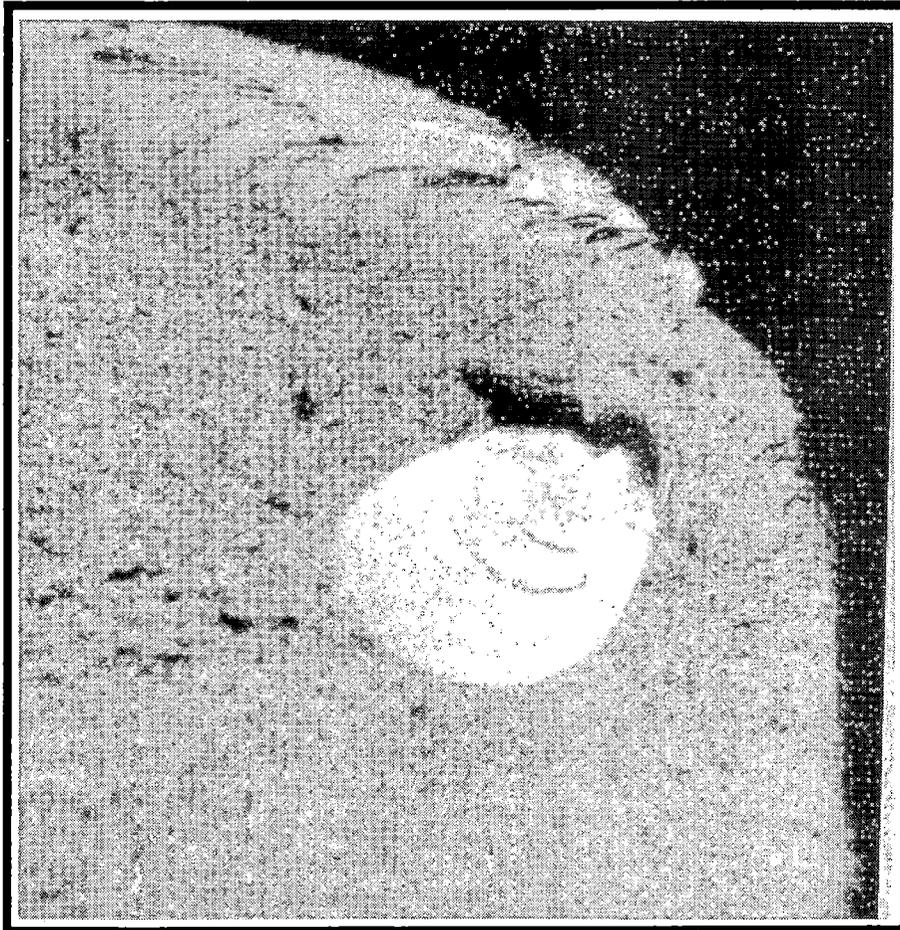
**Figure 16. Bi-planar Shell/DF Occurring Beneath Gage Corner of the Asymmetrically Ground Rail**

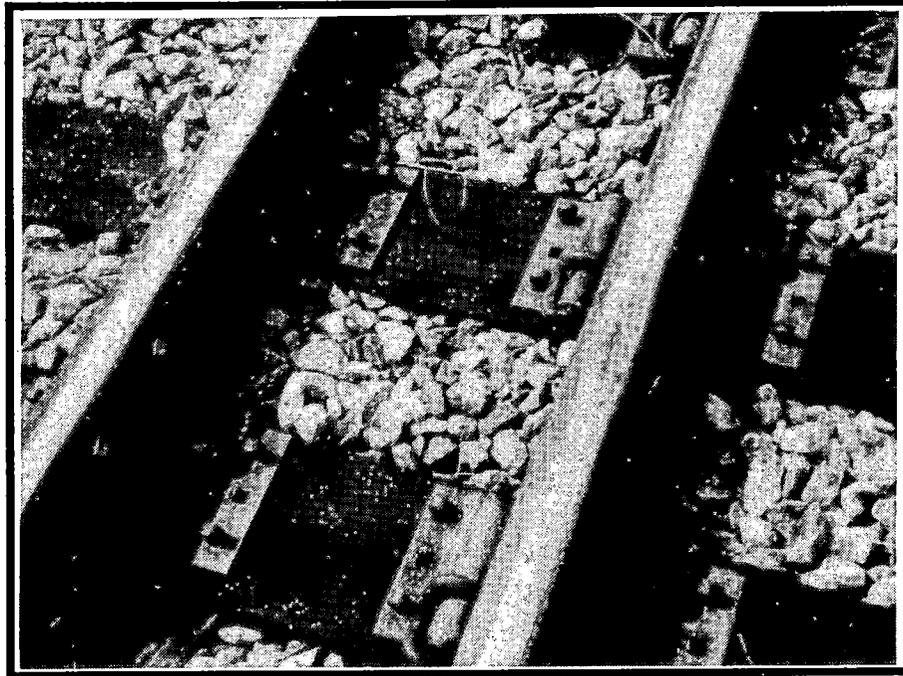
**Figure 11. Typical Welded Rail Joint Batter**

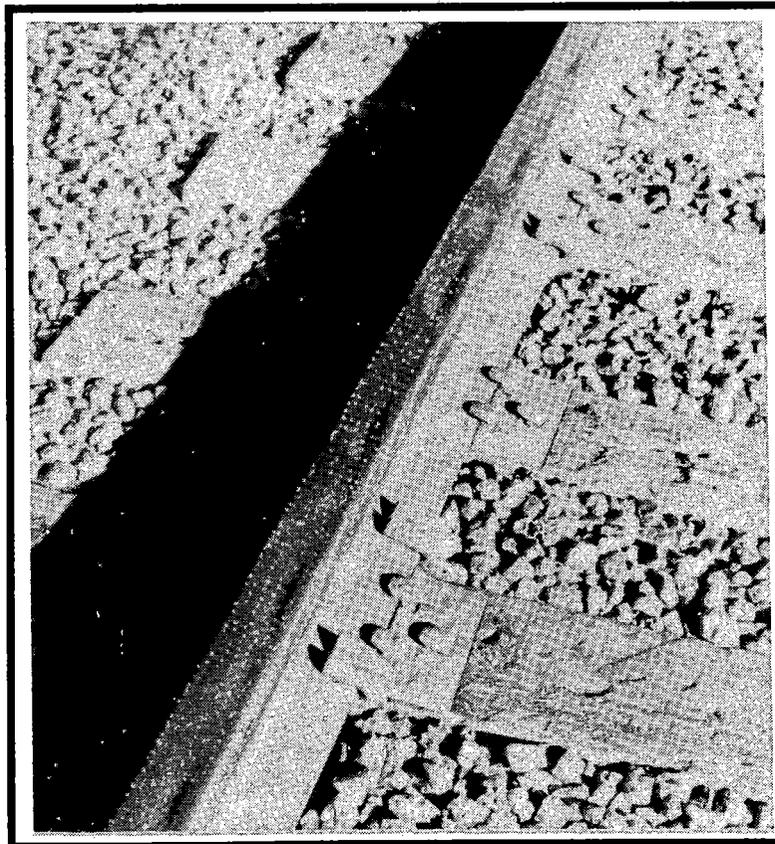
**Figure 12. Typical Corrugations**

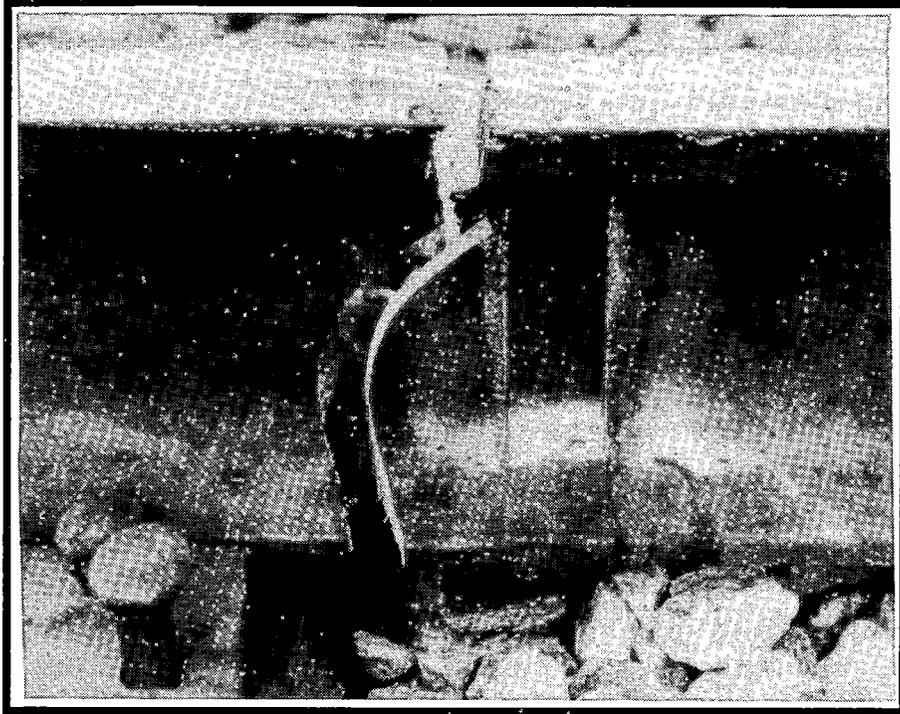
Field weld failures (Figure 13) played an important part in the efficiency of operation during the HAL Test. Frequent failures, which were not observed during the 33-ton phase, resulted in a significant impact to train operations. The need for improved quality control during the welding process as well as improved welding techniques and materials to withstand the heavier axle loads was noted. The standard mix content of most field welds often lead to excessive batter, especially when used on 300 Brinell hardness (Bhn) and heat treated rails of standard chemistry.

**Figure 13. Typical Broken Field Weld**

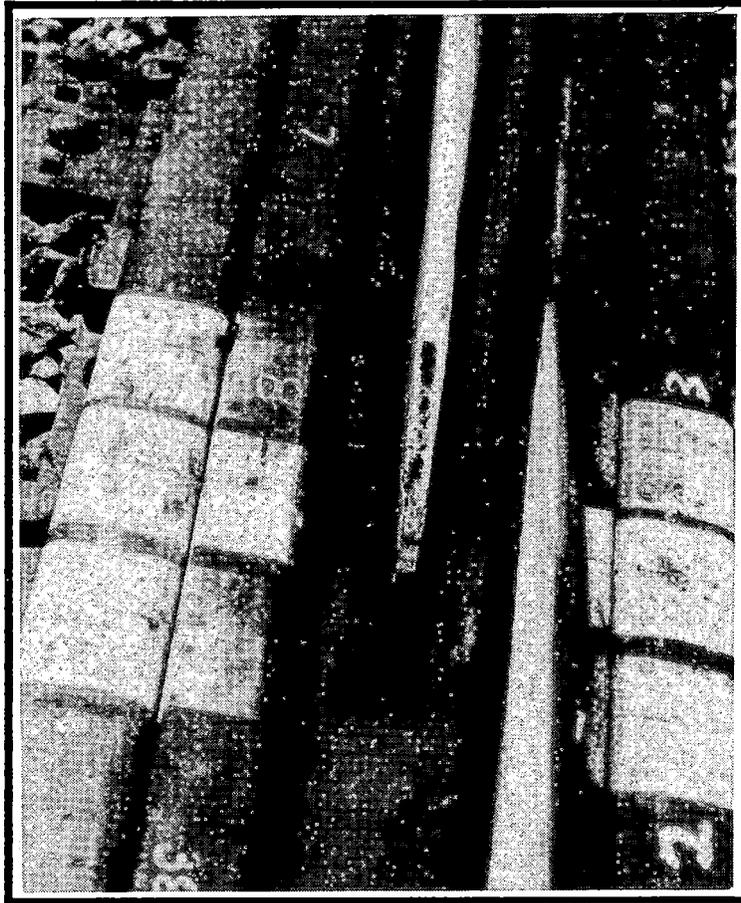
Under the HAL train operation, turnouts were second to field weld failures in the area of increased track maintenance. As with conventional field weld material, standard rail and frog components exhibited the shortest life and highest amount of maintenance and repair (Figure 14). Overall, turnouts required a significant increase in spot maintenance, grinding, and buildup requirements.

**Figure 14. Typical Worn Frog Components**
