WHEEL-PEELING EXPERIMENT- ANALYSIS OF COMMUTER RAIL WHEEL THERMAL CRACKS

6. AUTHOR(S) Cameron Stuart				
7. PERFORMING ORGANIZATION NAME(S) AND ADDRESS(ES) ENSCO, Inc. 5400 Port Royal Road Springfield, Virginia 22151			8. PERFORMING ORGANIZATION REPORT NUMBER DOT-FR-94-04

9. SPONSORING/MONITORING AGENCY NAME(S) AND ADDRESS(ES) Department of Transportation Federal Railroad Administration Office of Research and Development 400 7th Street, SW Washington, DC 20590			10. SPONSORING/MONITORING AGENCY REPORT NUMBER FRA/ORD-94/13

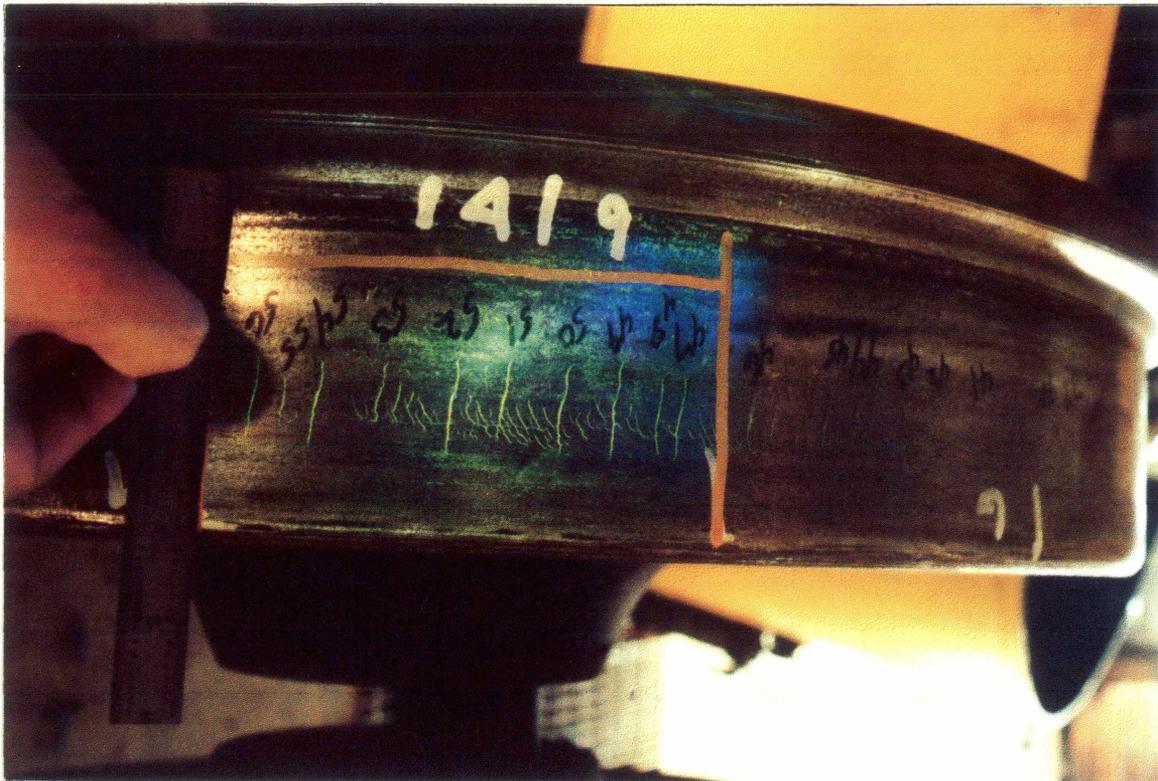
Photograph 1: Wheel #1419

Photographs 1 and 2 capture both wheels during the crack census portion of the experiment. Differences between wheel #1501 and wheel #1419, in terms of thermal crack population density and length, are well illustrated in these photographs. Wheel #1419 had fewer visible thermal cracks than wheel #1501, but their overall length was greater. Of the 69 total cracks measuring greater than 0.5" on wheel #1419, ninety per cent of these were between 0.7" and 1.15" in length. On wheel #1501 though, ninety percent of the over 160 thermal cracks that were observed were between 0.5" and 0.8" long. The maximum measured crack length on wheel #1419 was 1.1" and on wheel #1501 was 0.9". Wheel census data of the measured thermal cracks on each wheel is given, in tabular and graphical form, in Appendix 1 of this report.

Wheel #1419 also had numerous smaller crack indications between the longer thermal cracks within the crack band. During the peeling process these smaller cracks were not seen to propagate within the rim bulk and flaked off during the machining process. These indications were therefore considered to be heat checks.

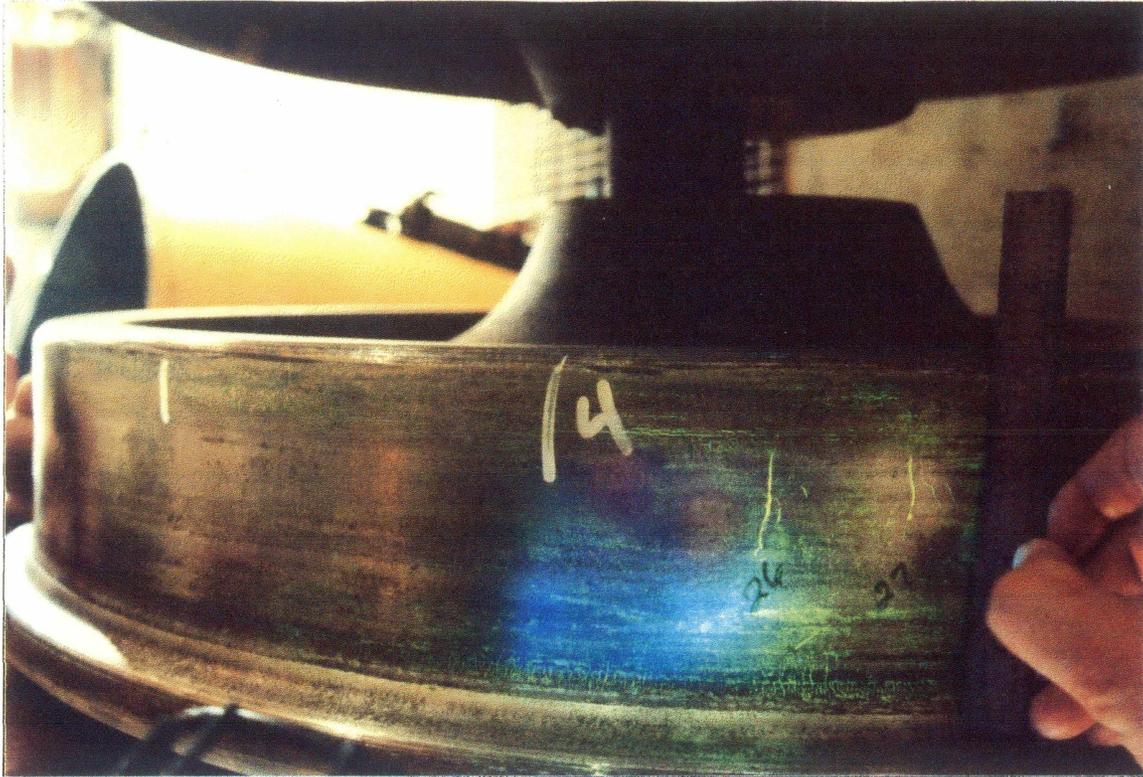
Photograph 3: Wheel #1419 Crack-Free Section

Another observation made during the census procedure was that the thermal cracks on both wheels appeared to be relatively evenly spaced along the circumference of each wheel. The most notable exception to this rule was a 10 inch-long section of tread on wheel #1419 which contained no visible thermal cracks. A portion of this section of wheel #1419 is shown in Photograph 3. No immediate explanation for this phenomena was made from observations of the

wheel. More information regarding the service life of this wheel may yield clues as to why this crack-free section exists. As of the end of the wheel peeling procedure no firm action items regarding the further investigation of this wheel were made.

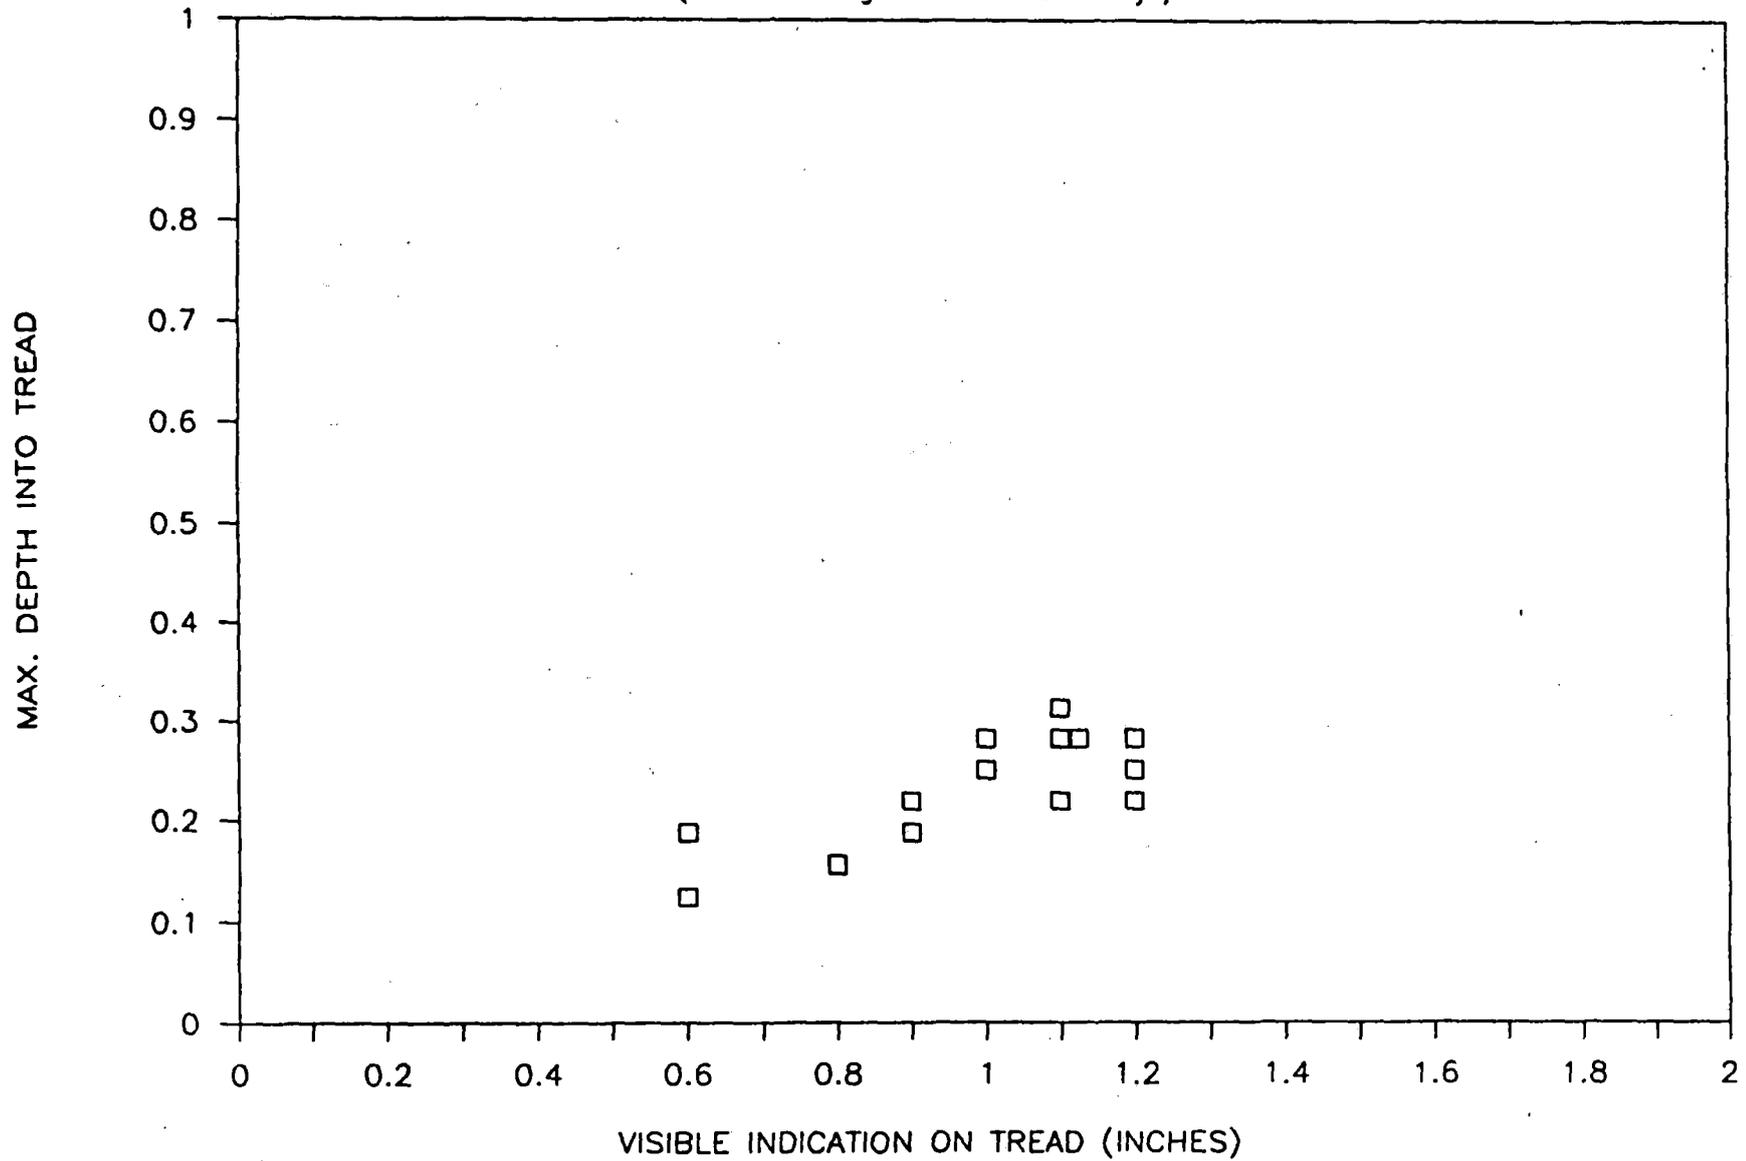
1419 VISIBLE INDICATION VS. MAX. DEPTH

The wheel peeling procedure produced consistent results from each wheel. Observations were made of all visible crack indications in the wheel rim bulk after each wheel peeling increment, but depth measurements were limited to only those cracks which were marked in the defined area of interest on the tread surface and a few of the longest cracks elsewhere on the wheels. Our original hypothesis that crack propagation into the rim bulk would be approximately one-half that of the measured length on the tread proved to be inaccurate. The overall ratio of depth propagation-to-tread length was approximately 1:3 instead of 1:2. The maximum depth of crack propagation into the rim was 0.325".
