Seismic Damage Assessment of Rail Structures in Japan after the January 1995 Kobe Earthquake

**Parsons Brinckerhoff Quade & Douglas, Inc.
San Francisco, California**

April 1995

**U.S. Department of Transportation
Federal Railroad Administration
Office of Research and Development
Washington, DC 20590**

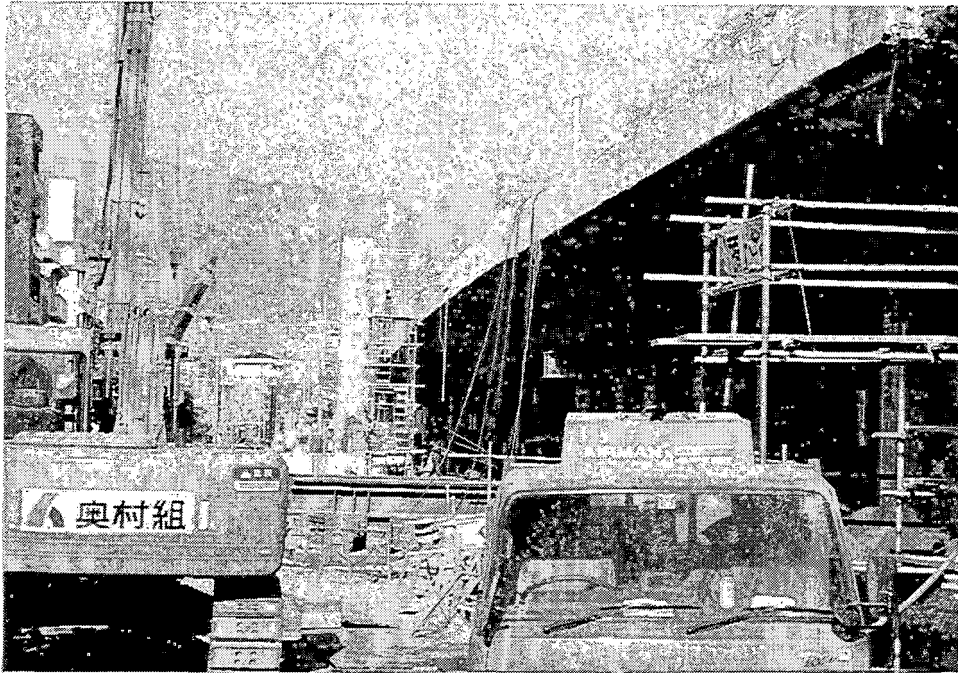
JRT-43. Viaduct under repair for more hundreds of meters.

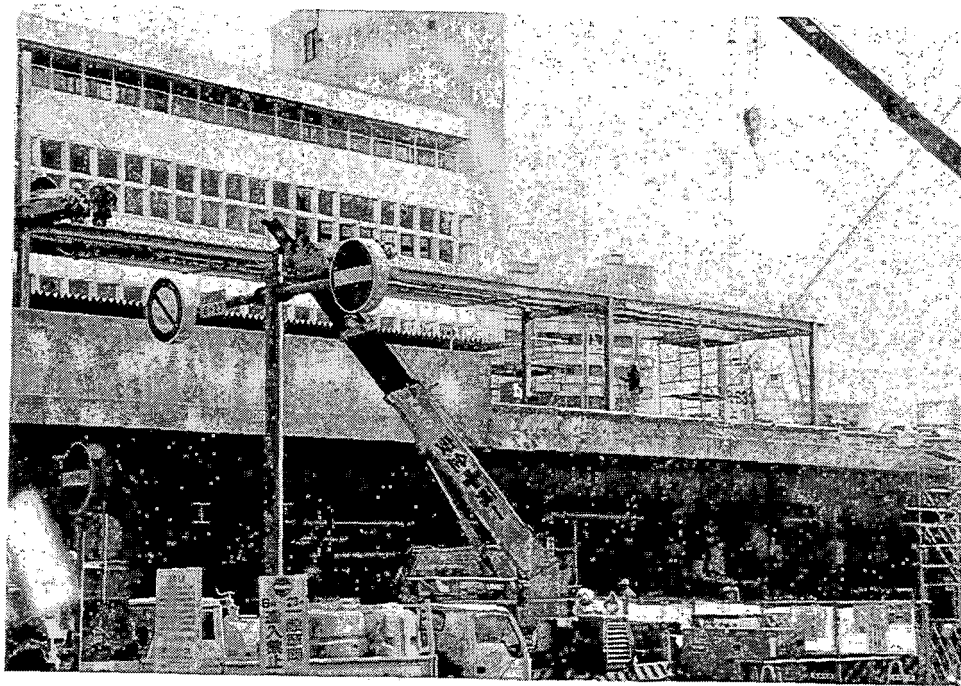
JRT-45. Rokkomichi Station replacement.

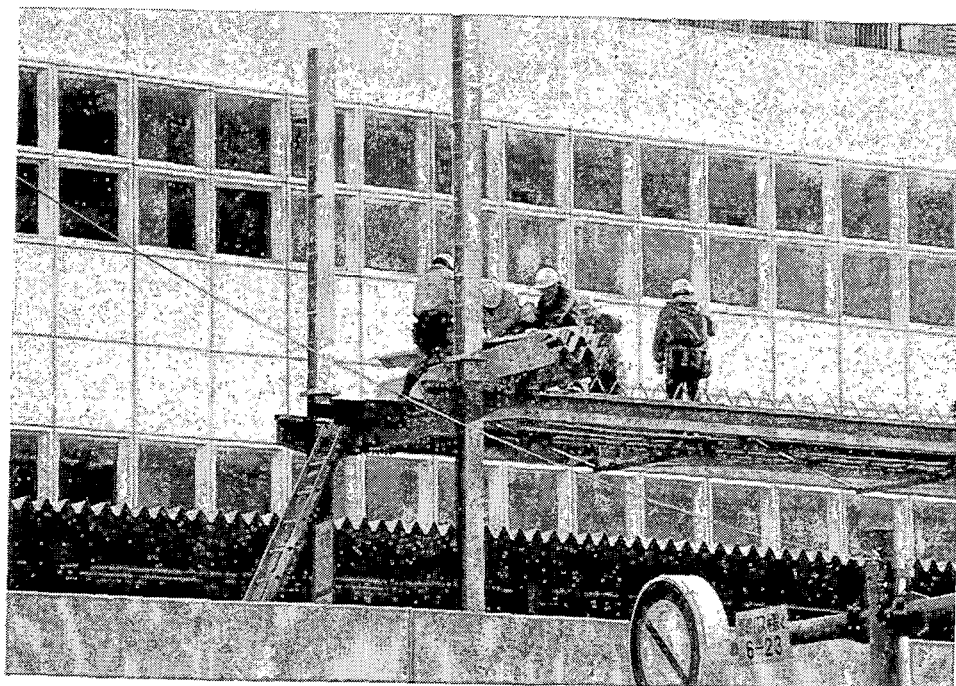
JRT-46. Construction of the new platform for Rokkomichi Station.

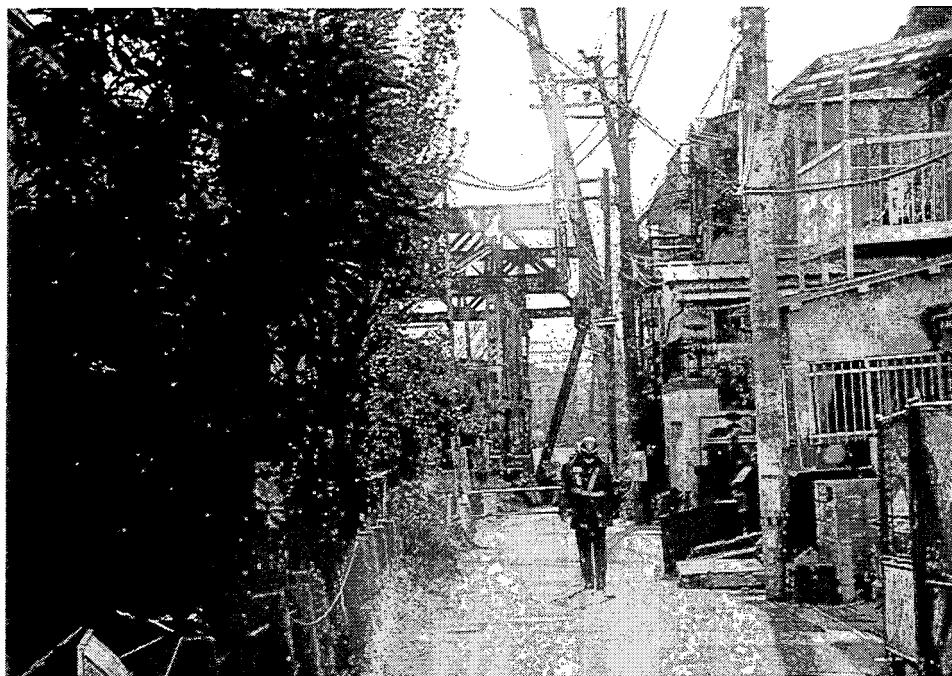
JRT-47. Housing adjacent to the viaduct was damaged but still standing. The viaduct partially collapsed in this area. Note the jacking frames in the background.

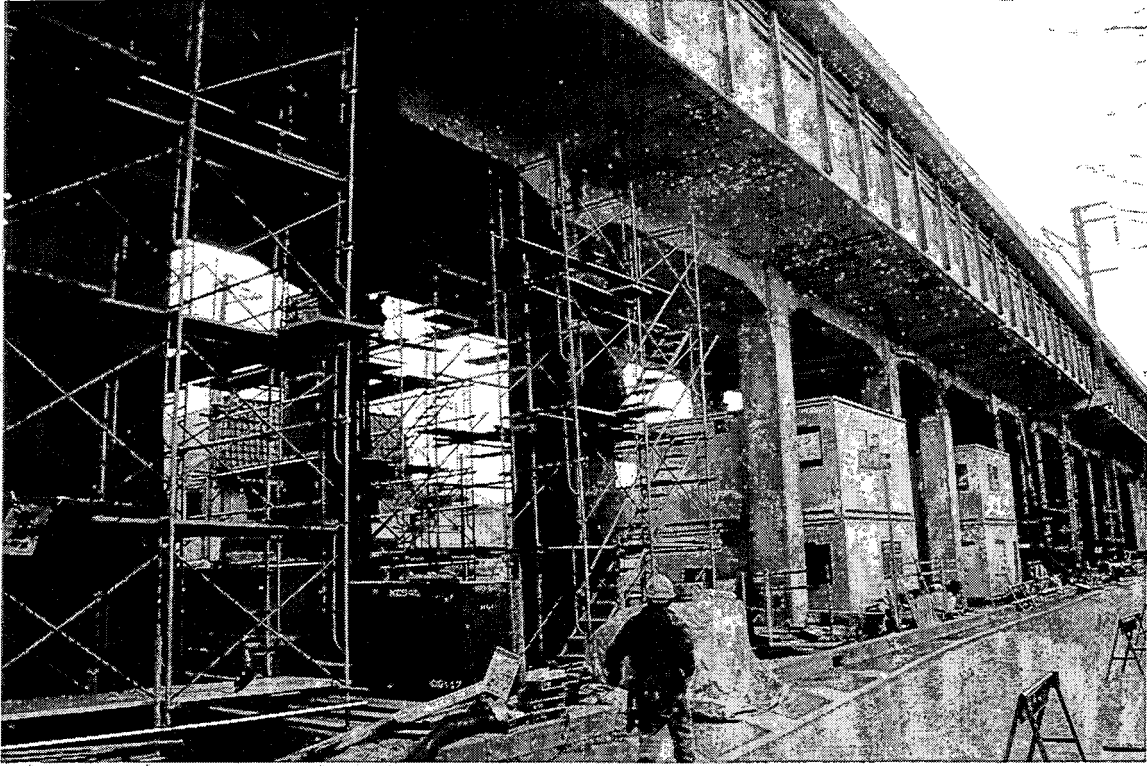
JRS-1. Many consecutive columns were damaged.

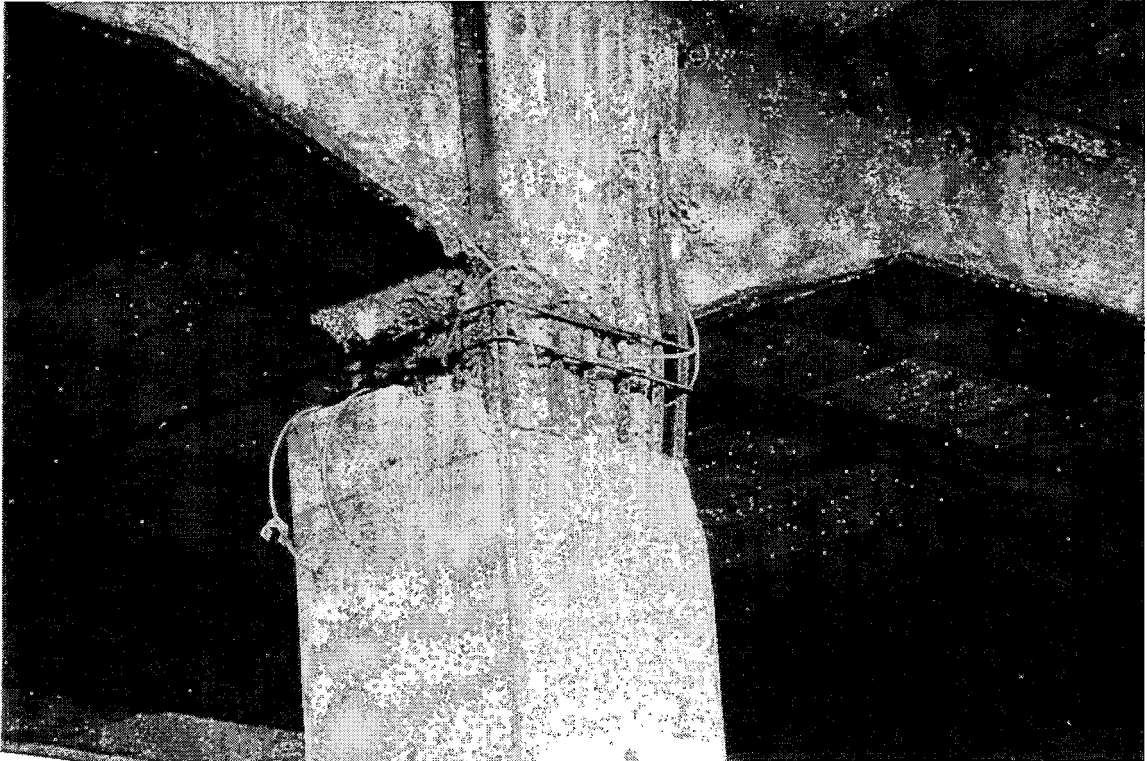
JRS-2. Another column damaged and grouted

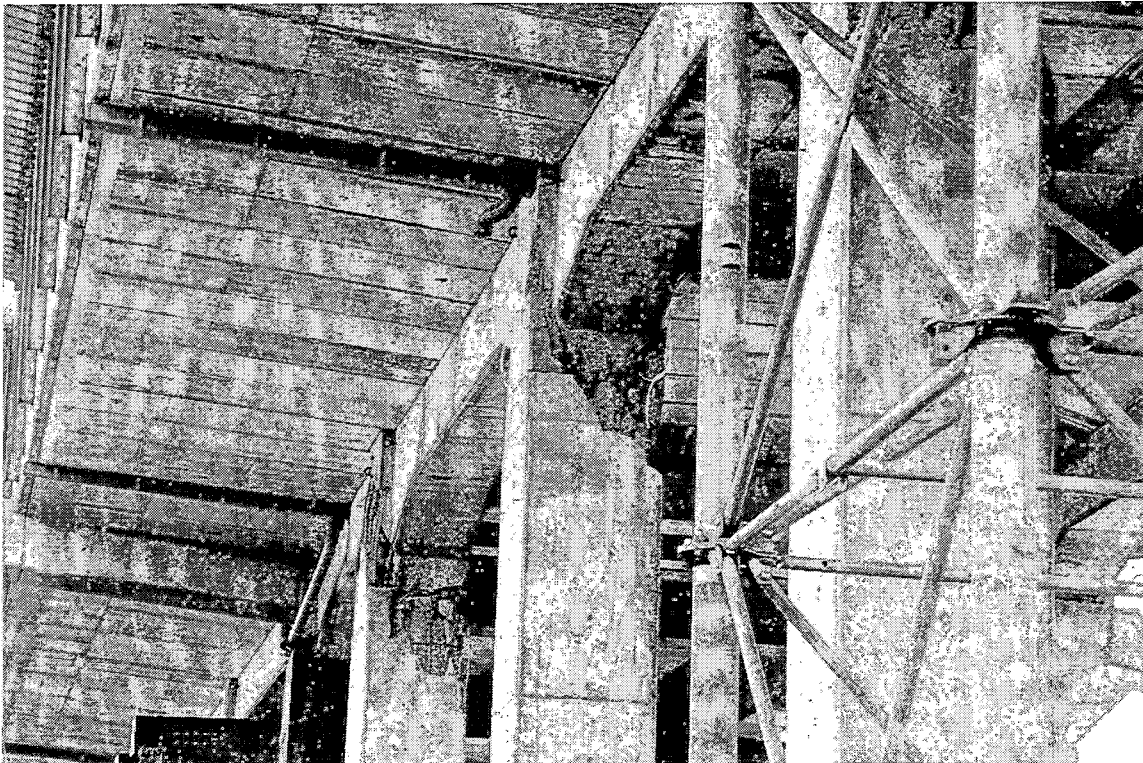
JRS-4. These columns show primarily transverse damage, but also some horizontal spalling.

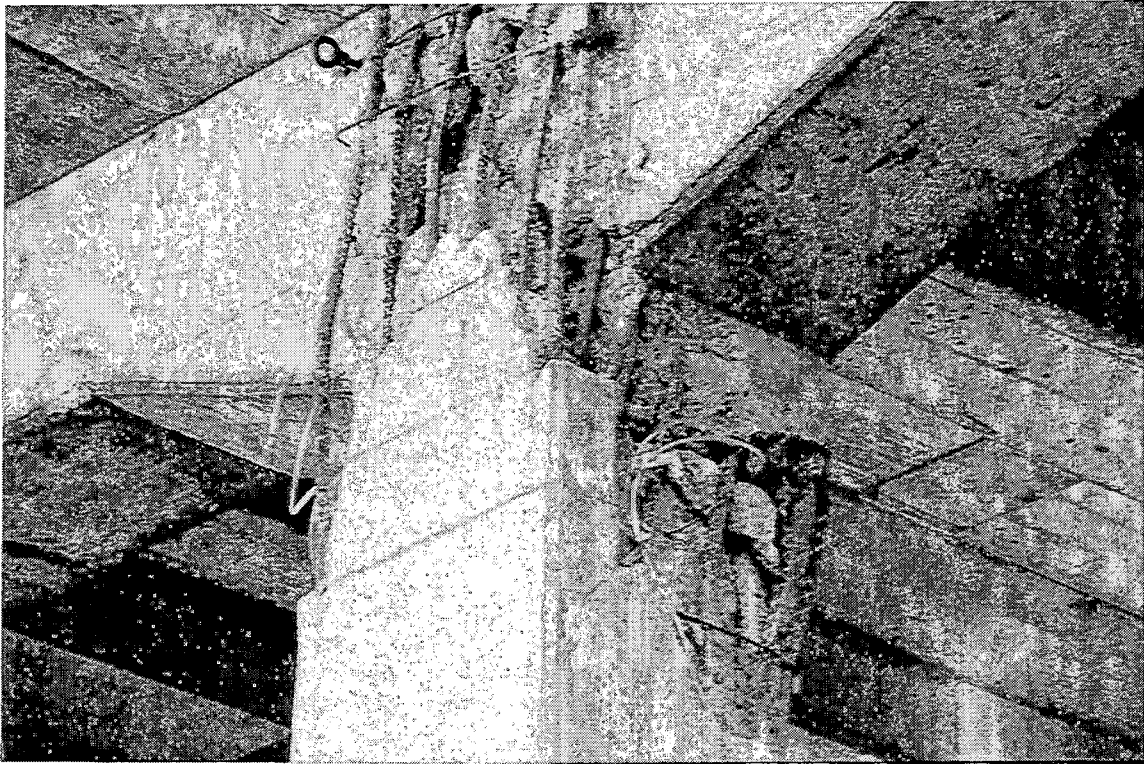
JRS-5. Column very close to collapse with diagonal cracks through the joint zone and ties ruptured; the joint is badly deteriorated.

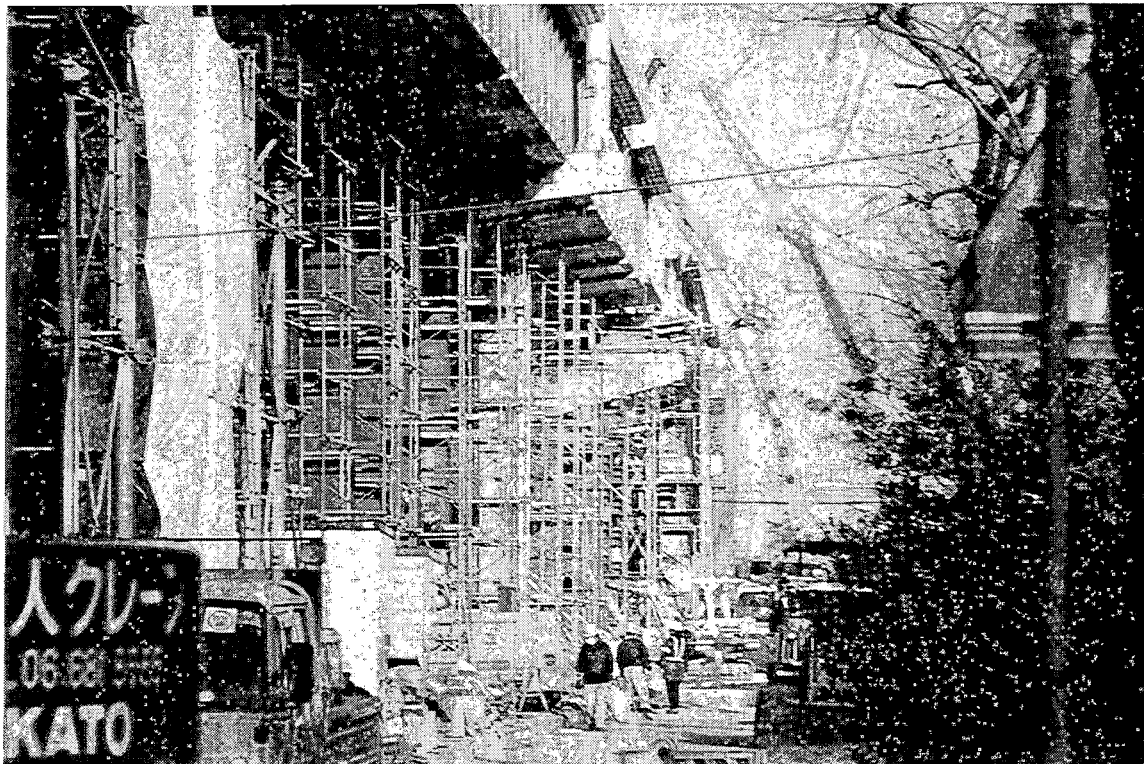
JRS-6. A long section under repair

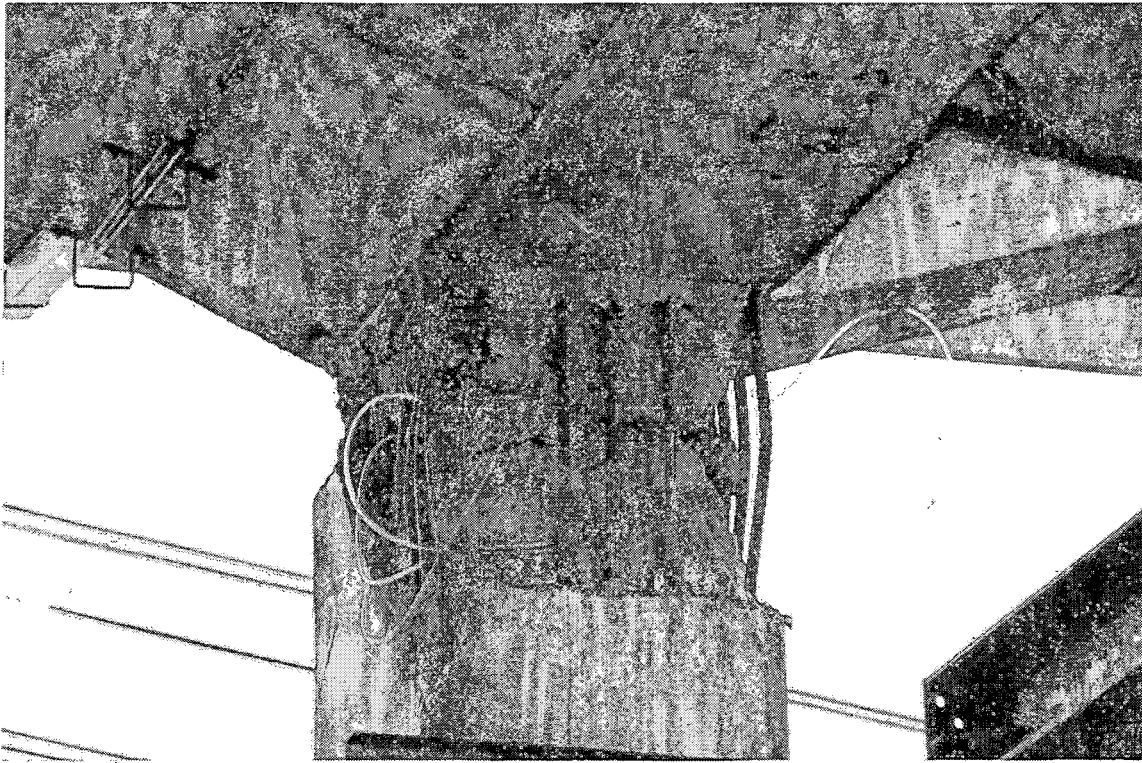
JRS-7. Another column near collapse with buckled reinforcing ties gone with no cross ties.

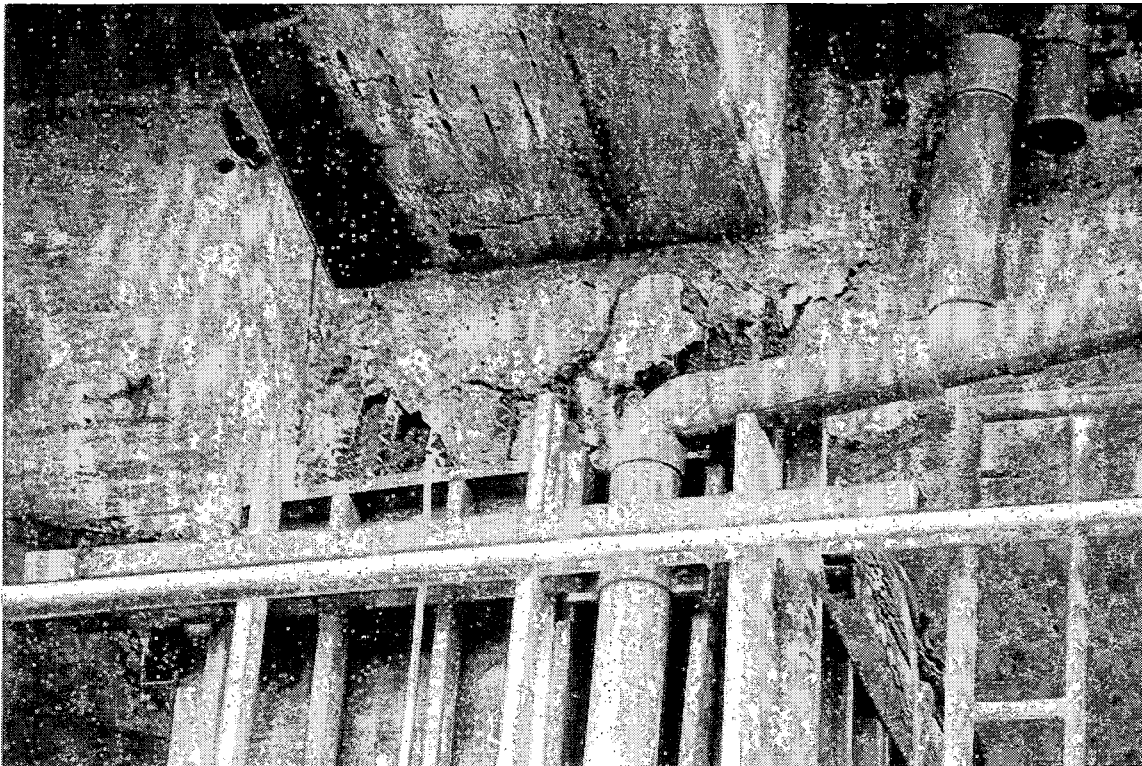
JRS-8. The cracking in this joint is limited to the zone below the confining catenary support beam at the top of the photo and the top of the column.

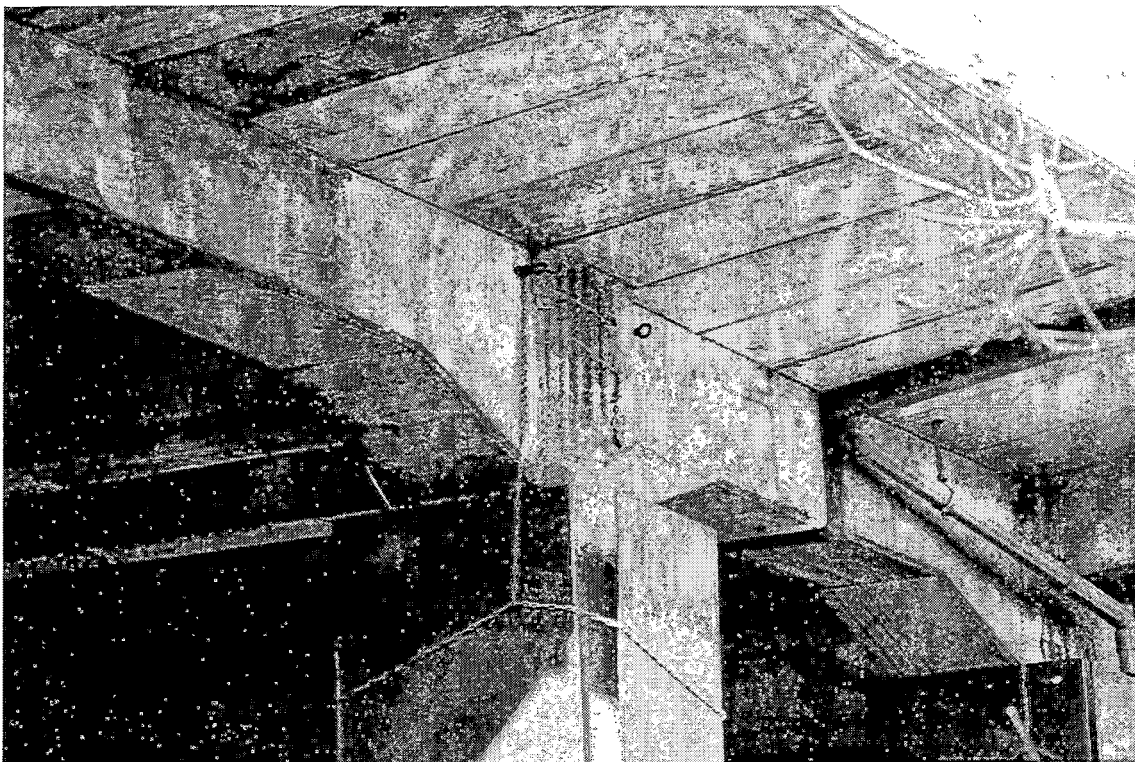
JHS-9. A steel plate jacket installation; note the column bars exposed in a joint zone. A joint repair method was not observed. The column had almost no moment capacity in this transverse direction.

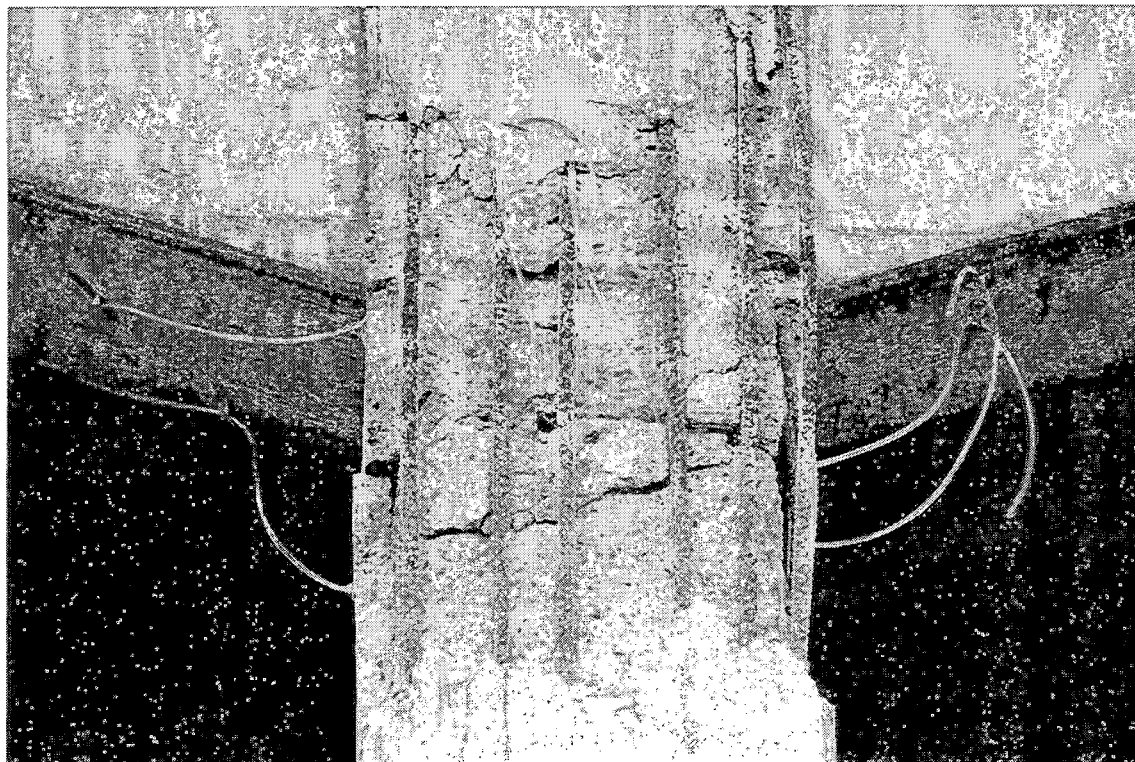
JRS-10. Damage at the top of column and into the unconfined joint zone; the ties are no longer present. The cracks are being epoxy grouted.

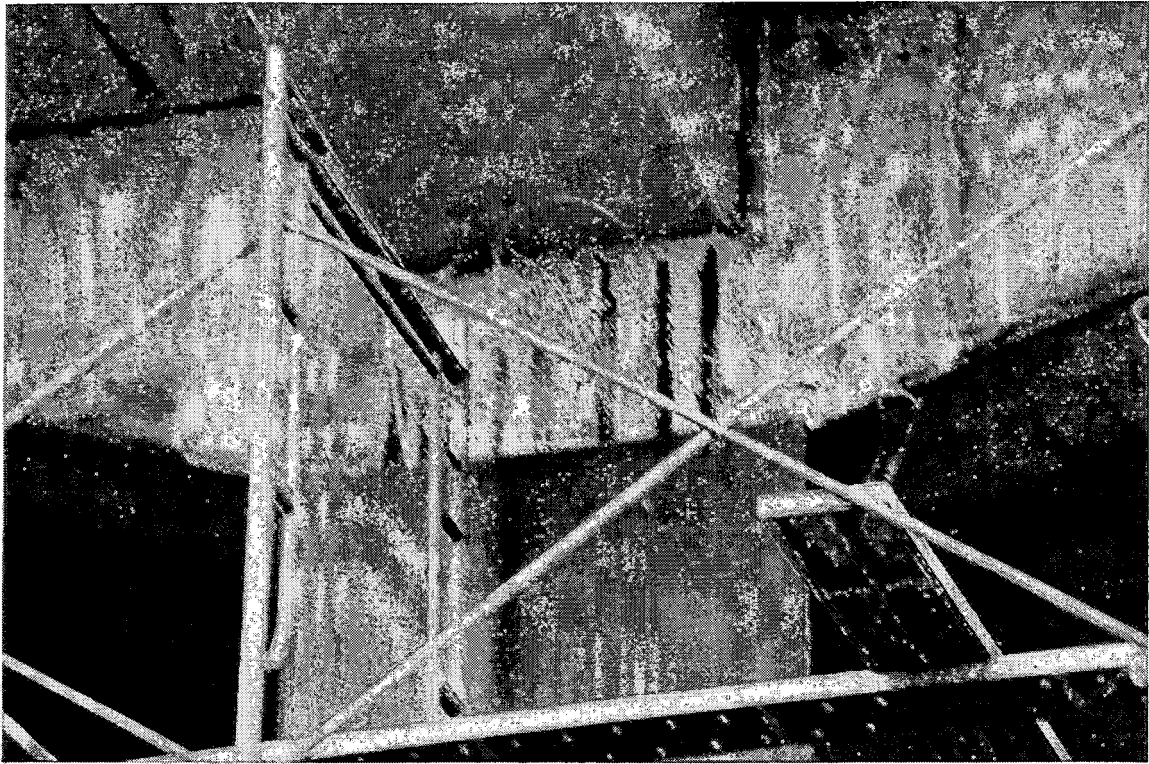
JRS-11. Catenary support beam provides some confinement to the joint zone. The joint has degraded from the top of the column.

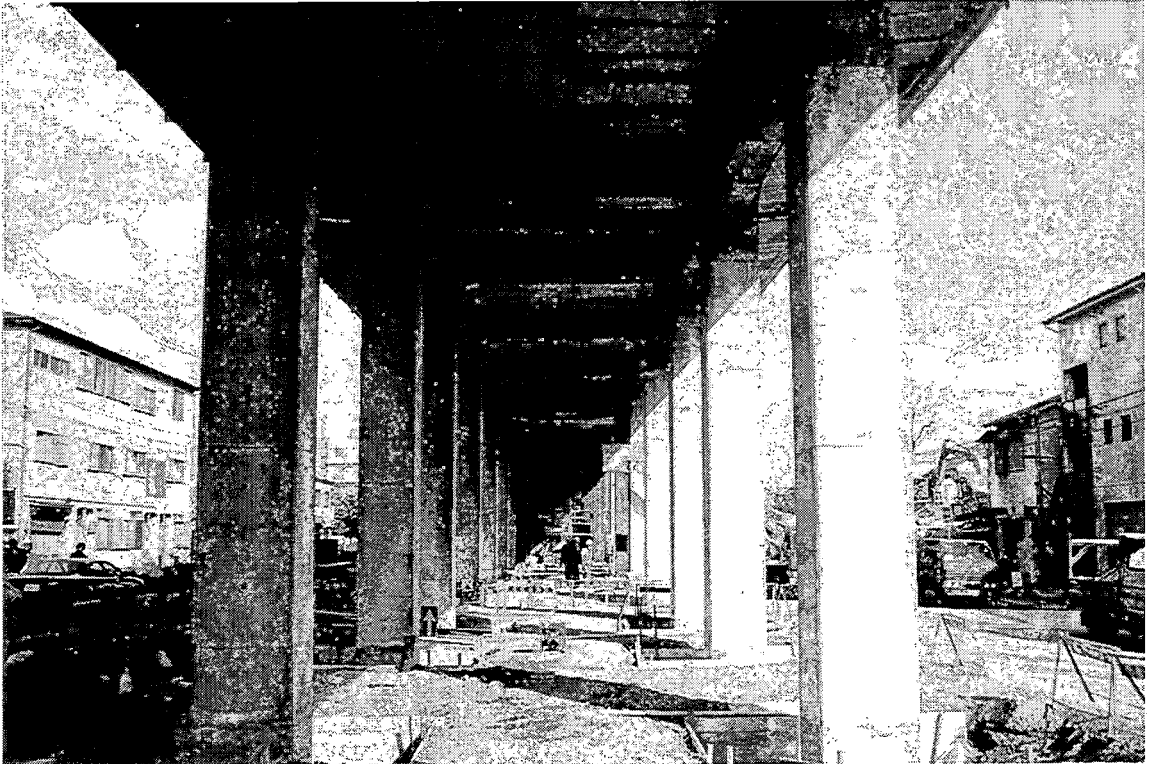
JRS-12. Damage to the tops of consecutive column in the longitudinal direction.

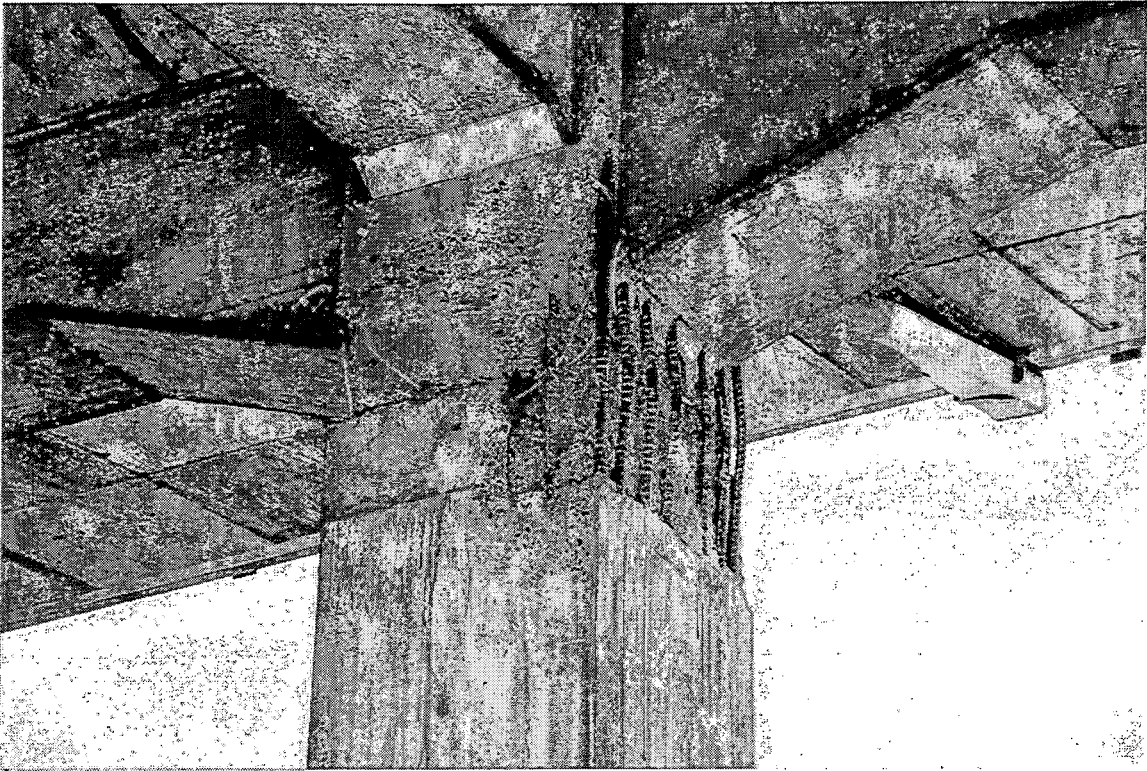
JRS-13. Column damage in the longitudinal direction

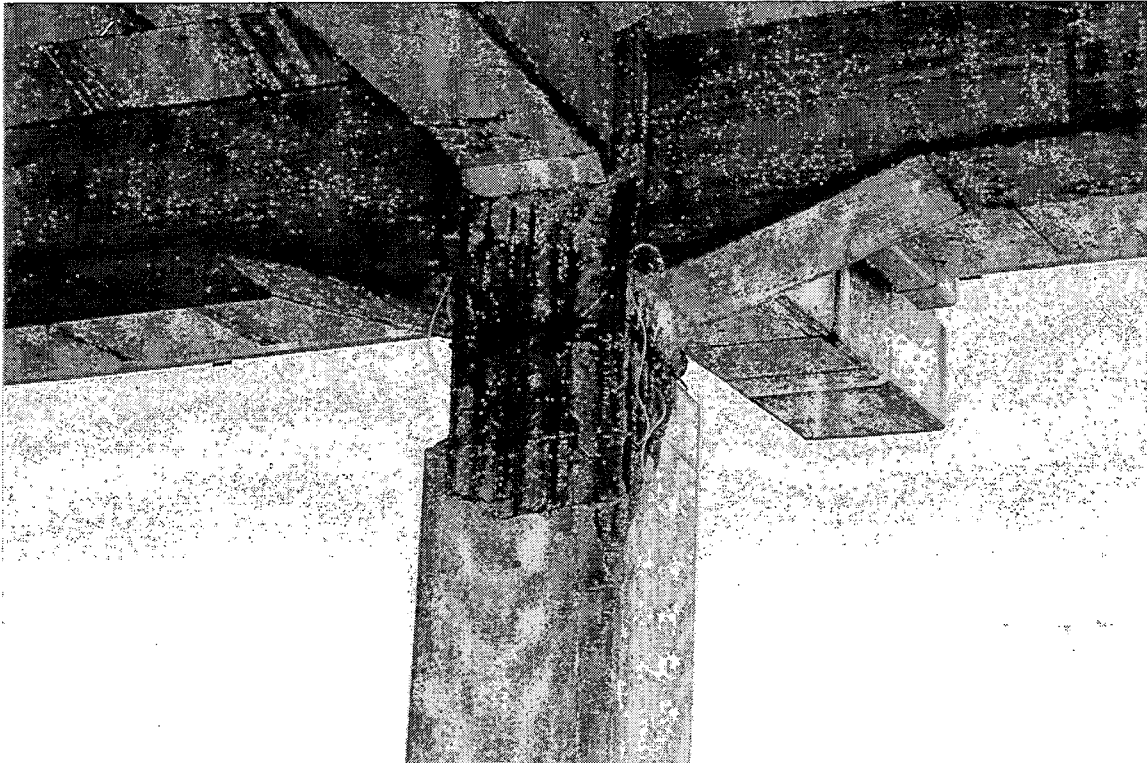
JRS-14. Column is damaged in both directions in addition to joint damage.

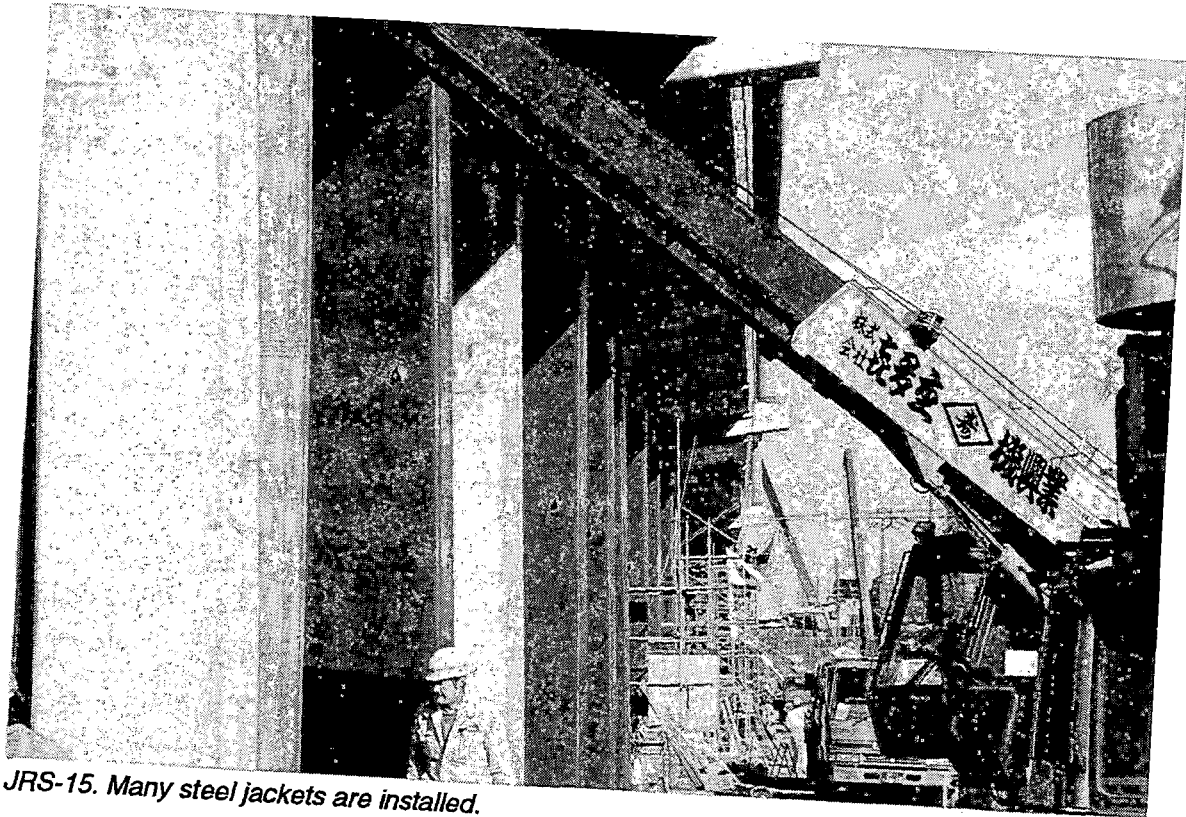
JRS-15. Many steel jackets are installed.

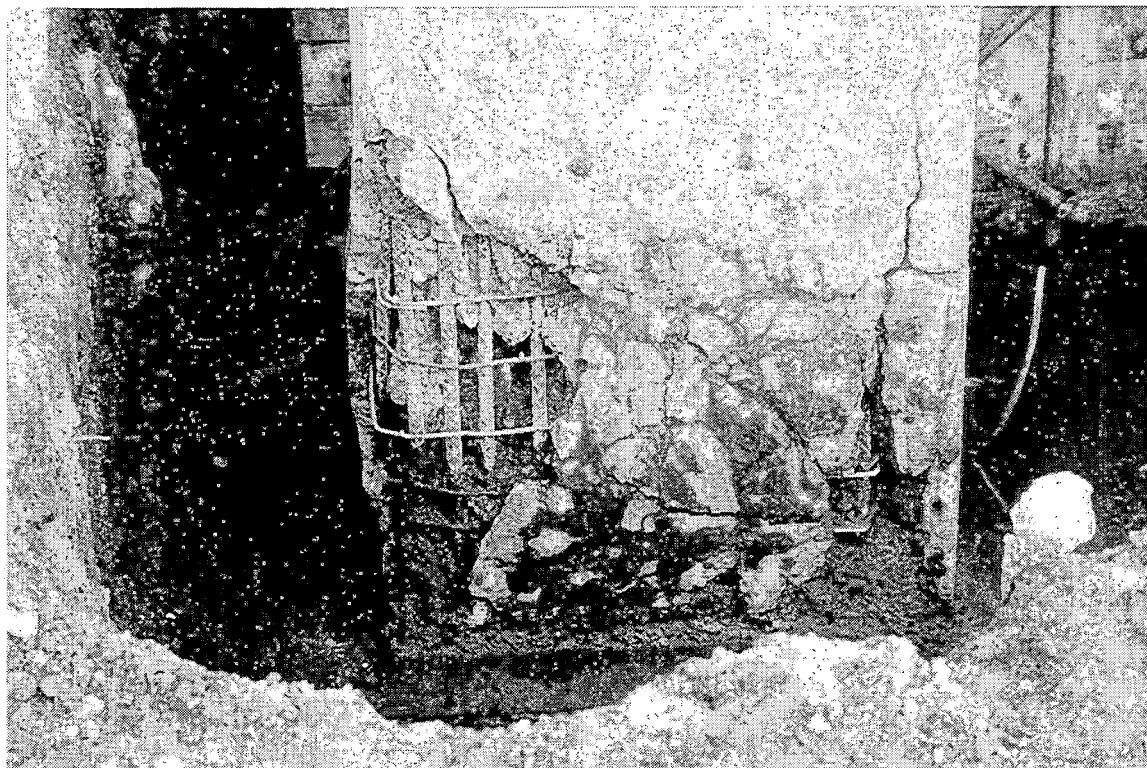
JRS-18. Some spalling is evident at the bottom of this column. Note the tie size and spacing.

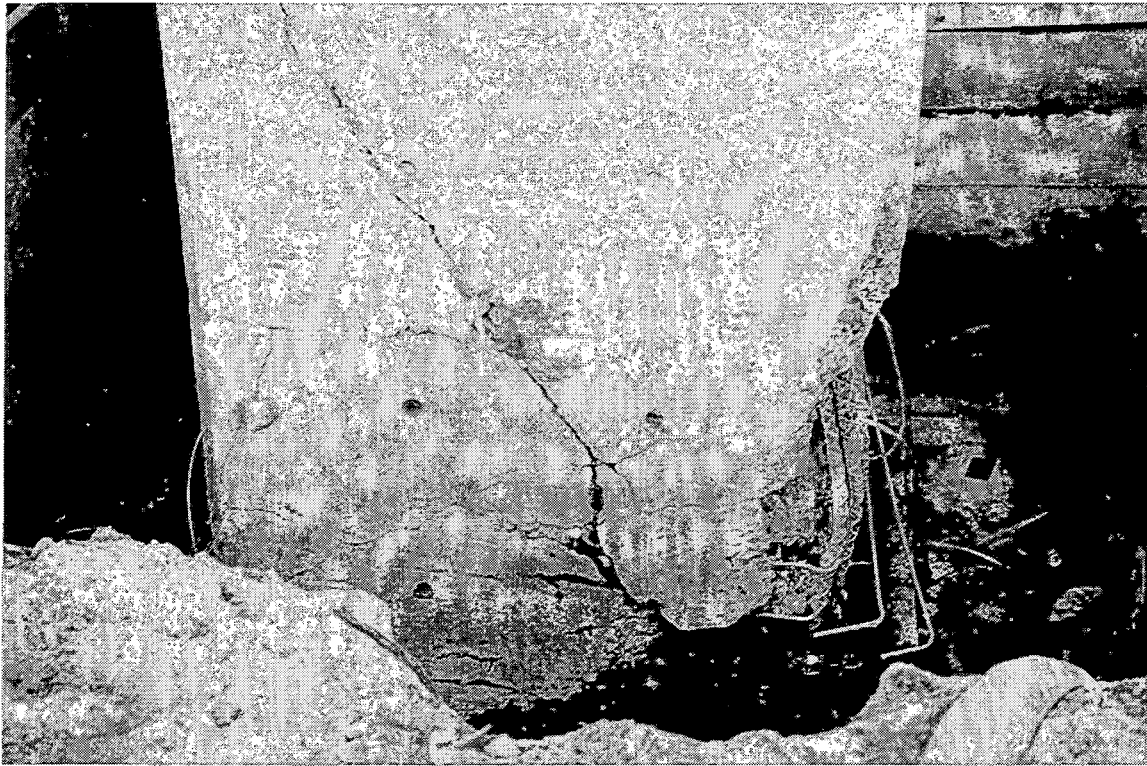
JRS-19. This column was close to failure. The ties are opening, main bars are buckled and the shear crack is opened. Note the angle of the shear crack is more vertical than 45 degrees. Response was in the longitudinal direction.

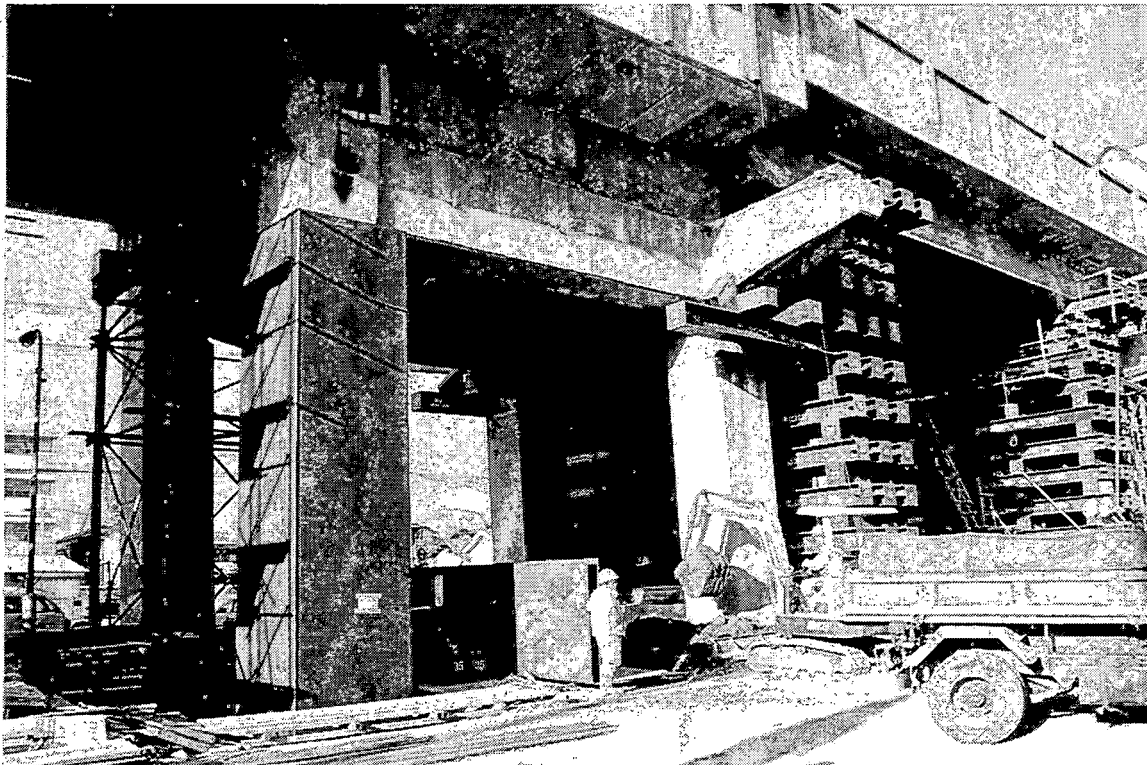
JRS-20. The drop in span on the right was lifted off the ground and relocated on the piers. The adjacent spans were stiffened with the additional girder. Steel jackets were applied to columns.

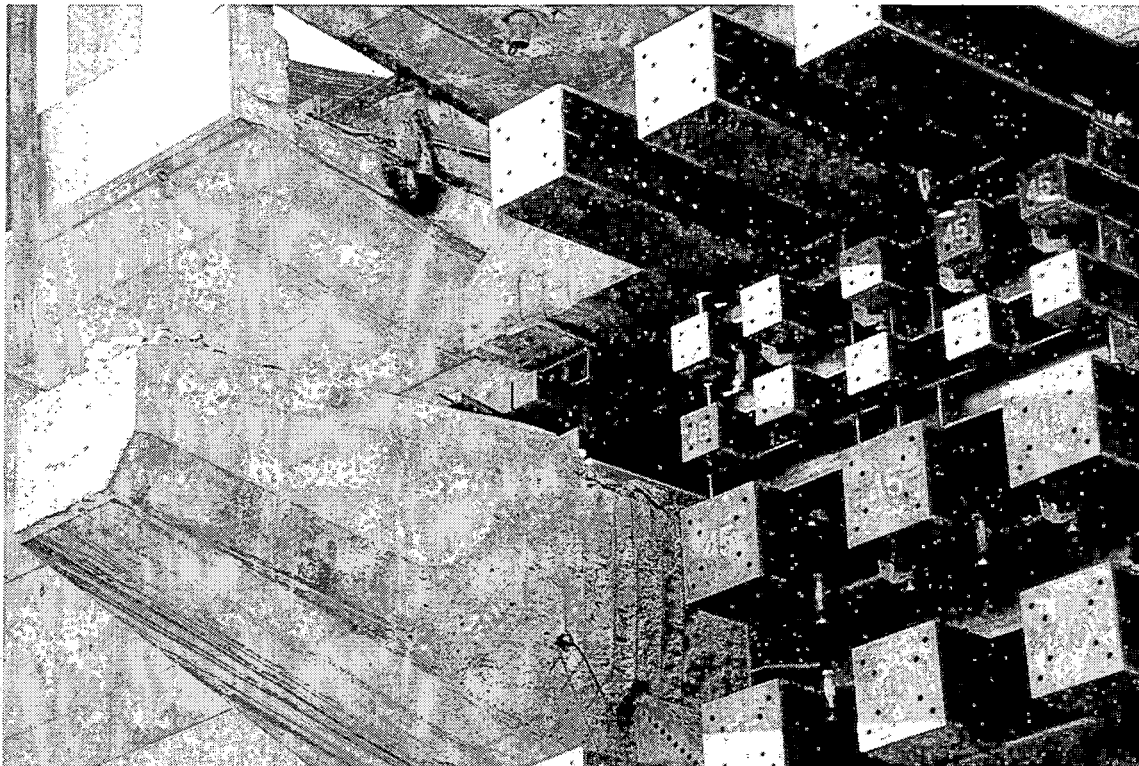
JRS-21. The precast-prestressed concrete drop-in girder to the right is supported while the pier and adjacent span is repaired.

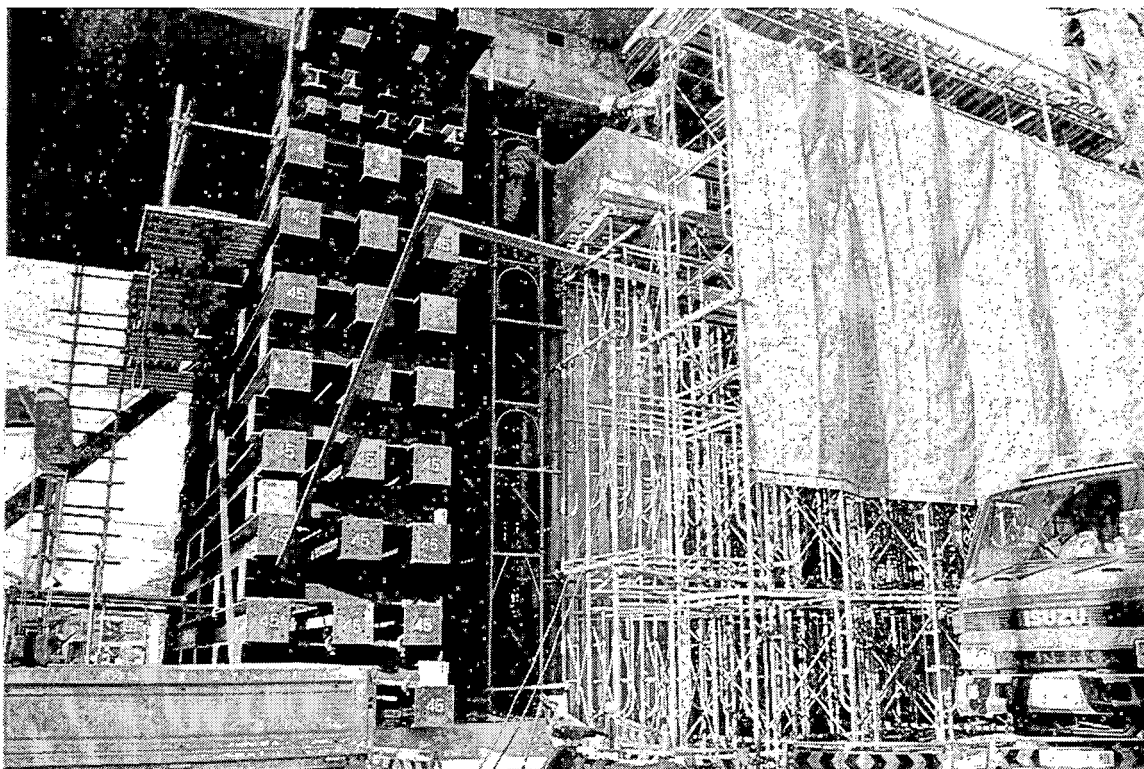
JRS-22. Temporary supports are on the left of the drop-in span, and falsework is on the left.

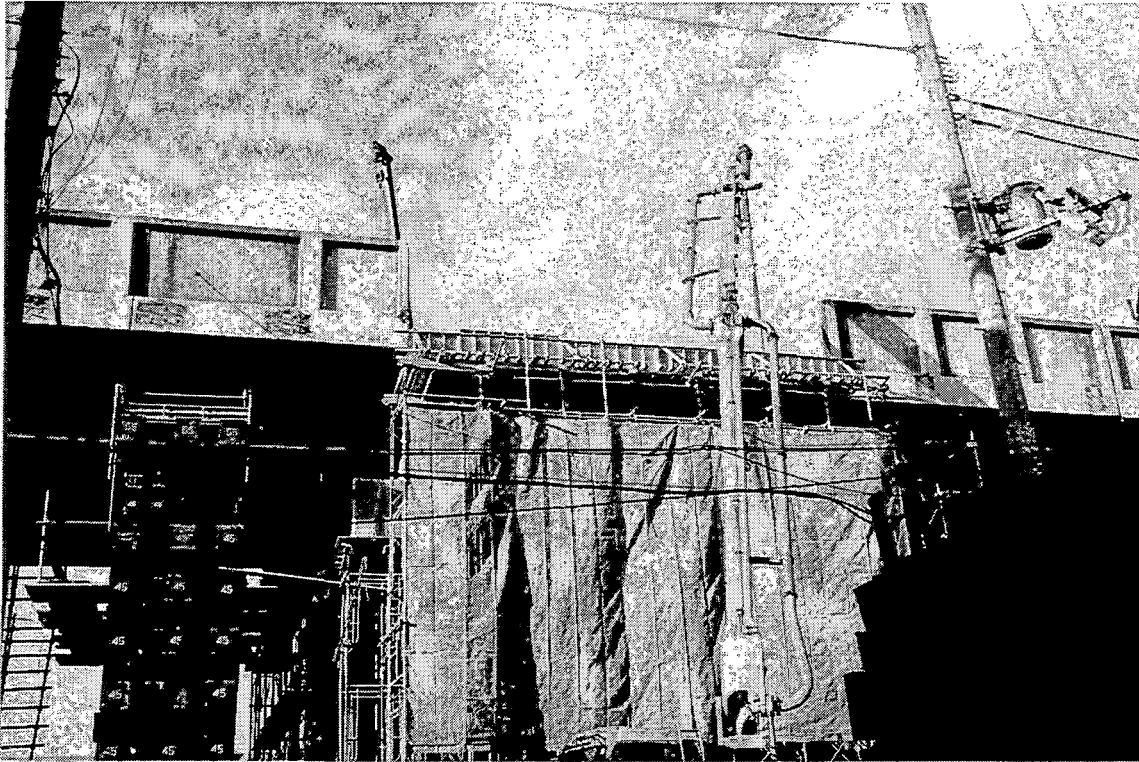
JRS-23. The deck of this drop-in span is being replaced.

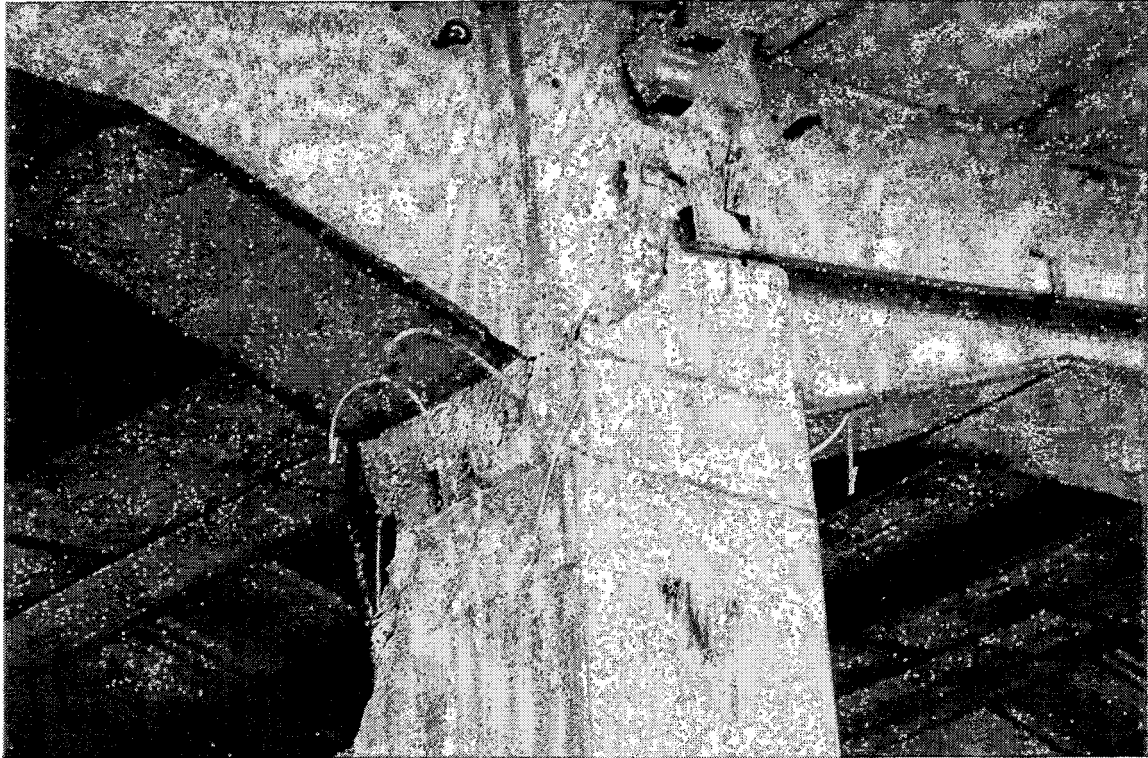
JRS-25. The cracks have been epoxy grouted. The external spalling still needs repair.

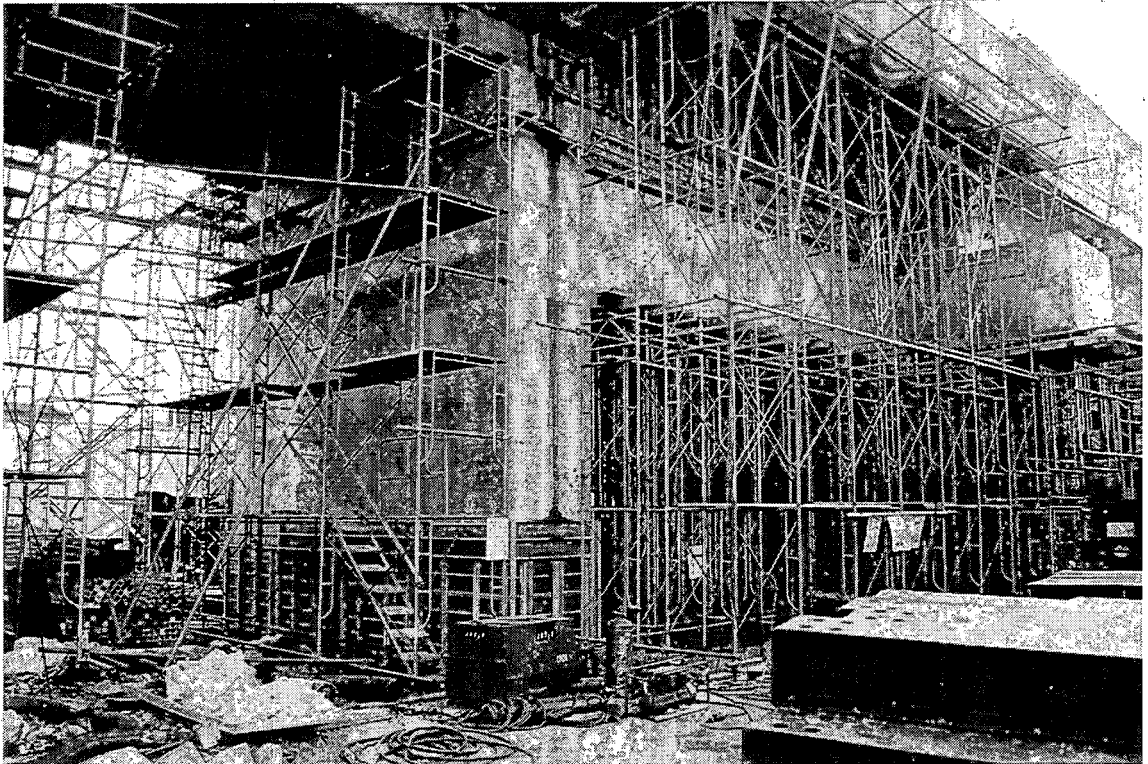
JRS-26. A new stiffened pier to resist longitudinal forces
