Seismic Damage Assessment of Rail Structures in Japan after the January 1995 Kobe Earthquake

**Parsons Brinckerhoff Quade & Douglas, Inc.
San Francisco, California**

April 1995

**U.S. Department of Transportation
Federal Railroad Administration
Office of Research and Development
Washington, DC 20590**

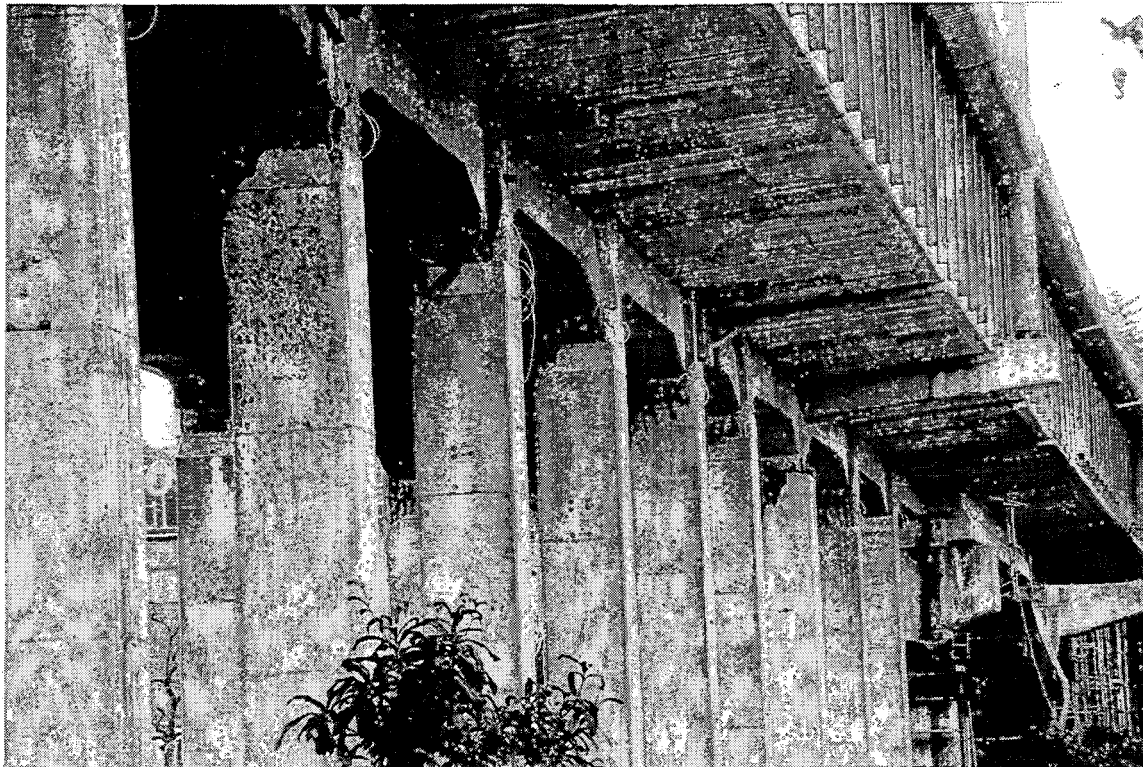
JRS-28. Longitudinal response is shown by the damage in consecutive columns. There is minimal transverse damage.

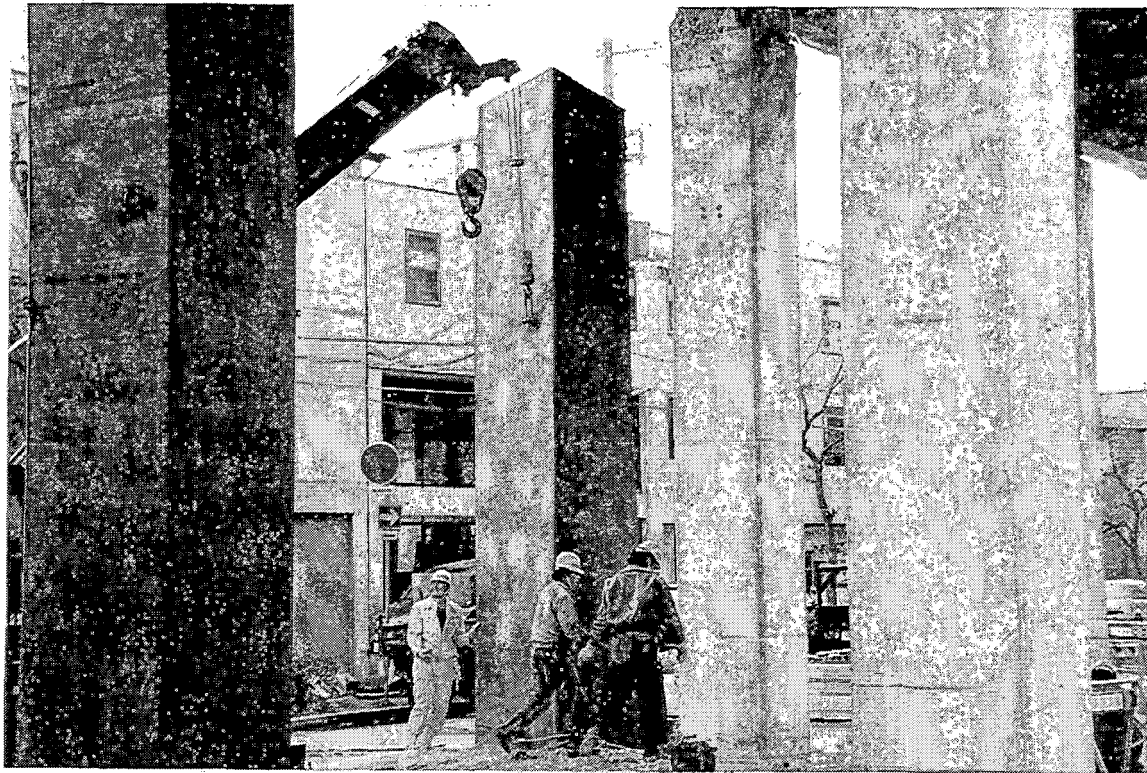
JRS-29. Steel plate jacket installation; note damage at the top of column.

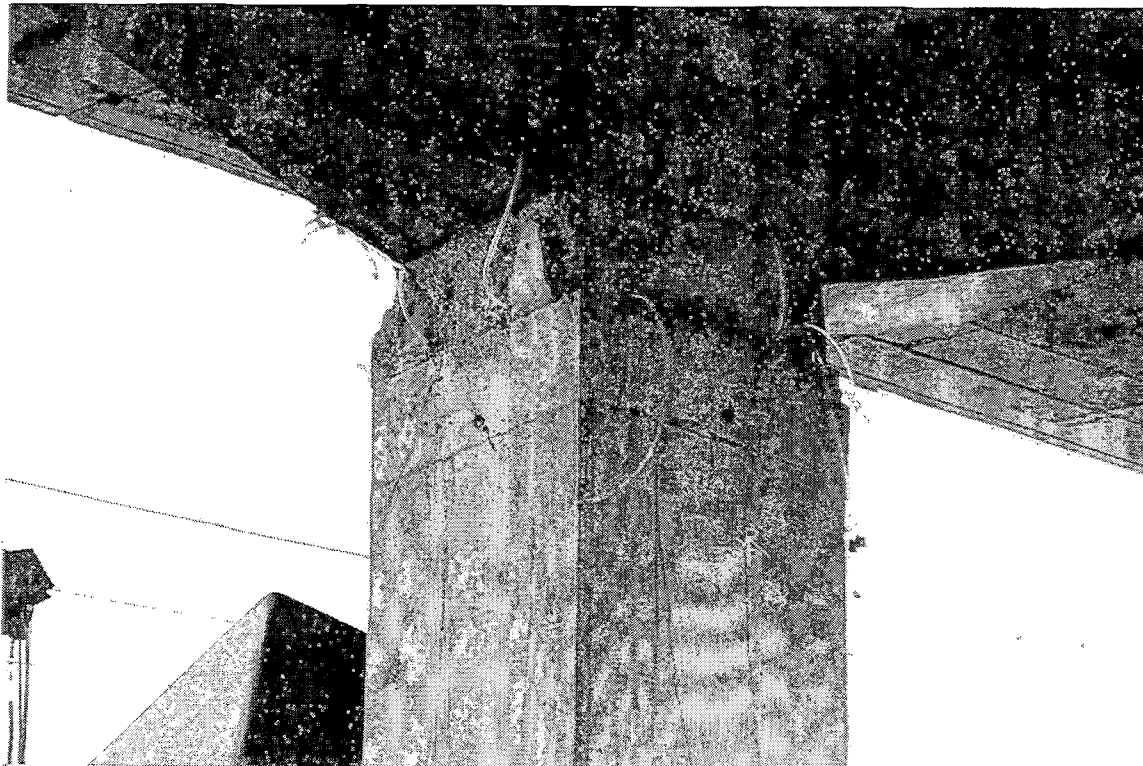
JRS-30. A close up photo of minor longitudinal damage on the column

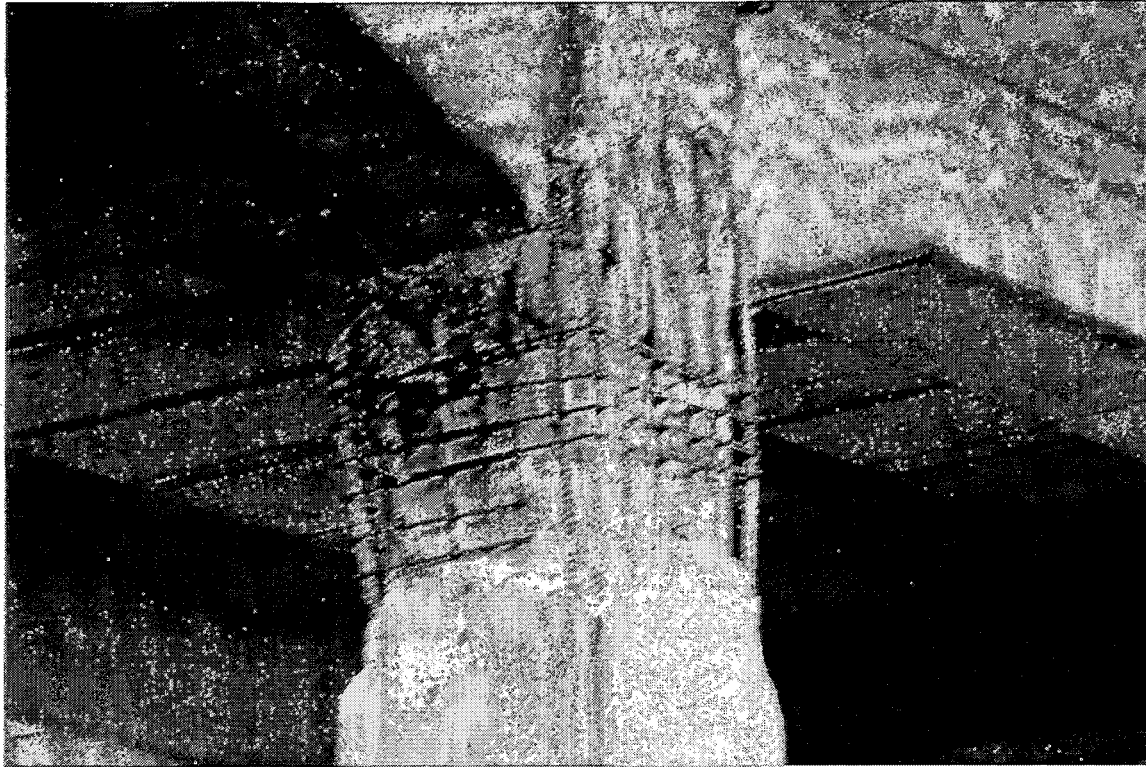
JRS-31. Damage at top of column and into the joint; note the column ties and their spacing and their lack of cross ties

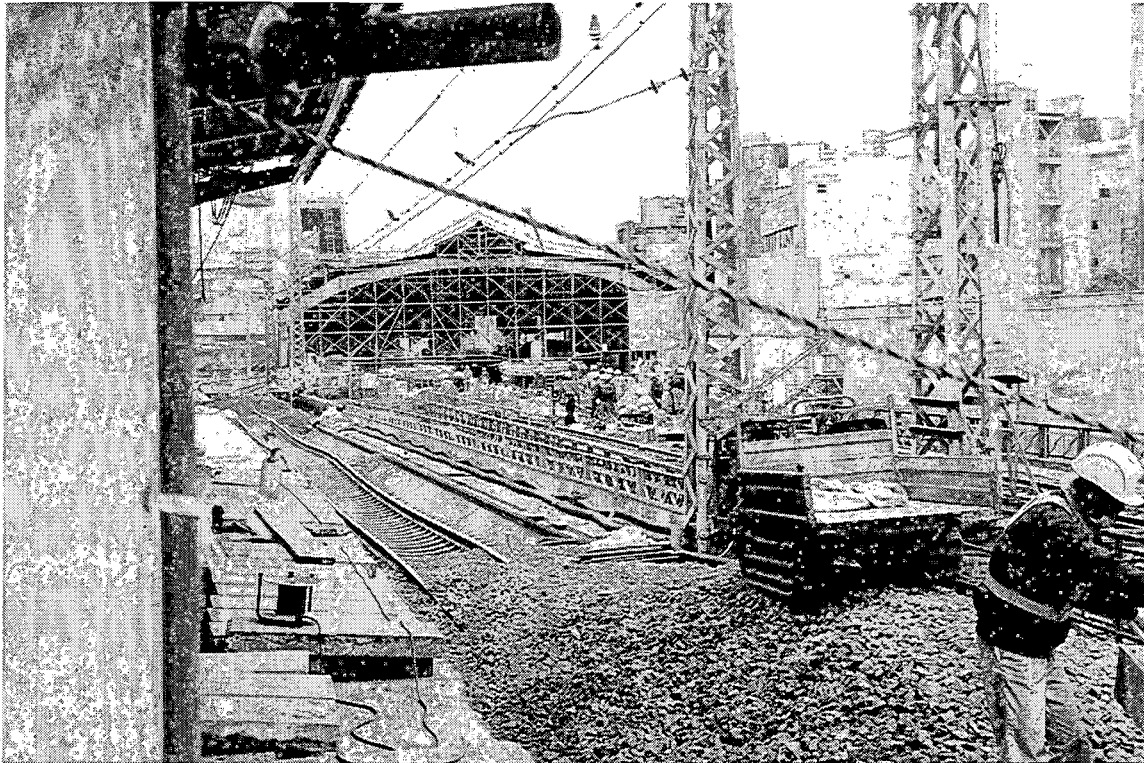
SS-1. A train derailed as it entered Sannomiya Station from the west. The rail displacement was either caused by the derailment or it caused the derailment. The building in the background is a maintenance facility.

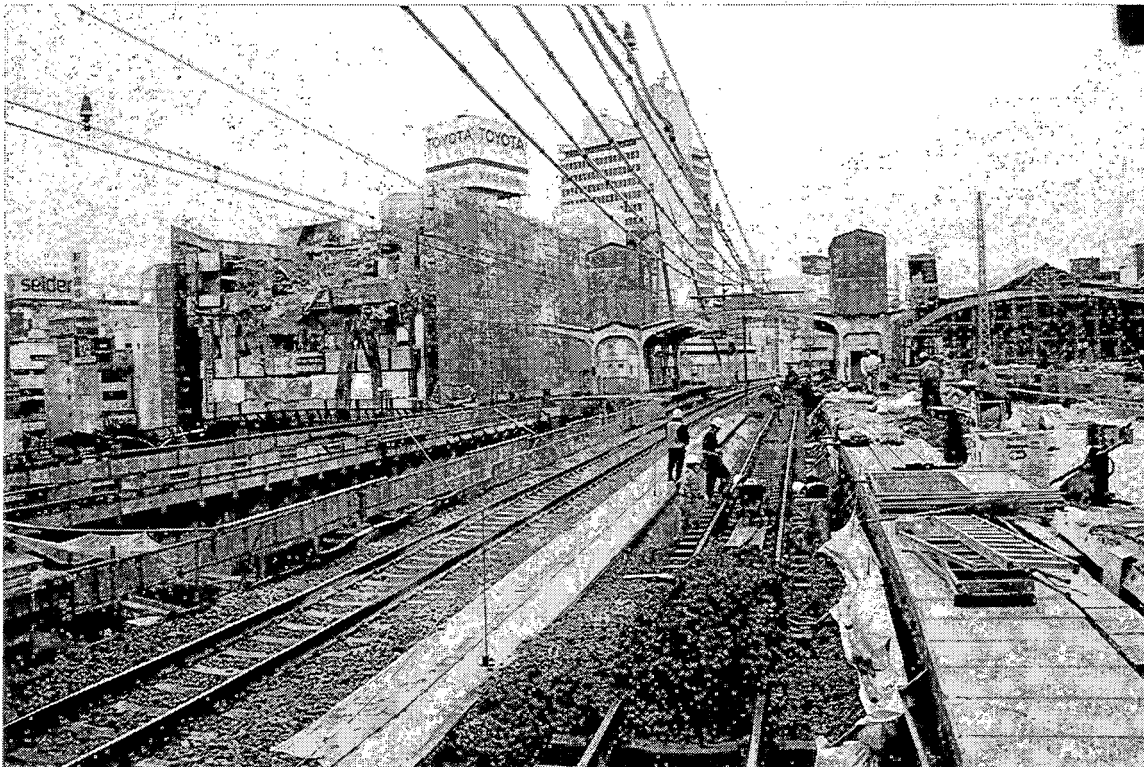
SS-2. The ballast is being replaced and recompactd on the westbound track. Note the damage to the building to the left.

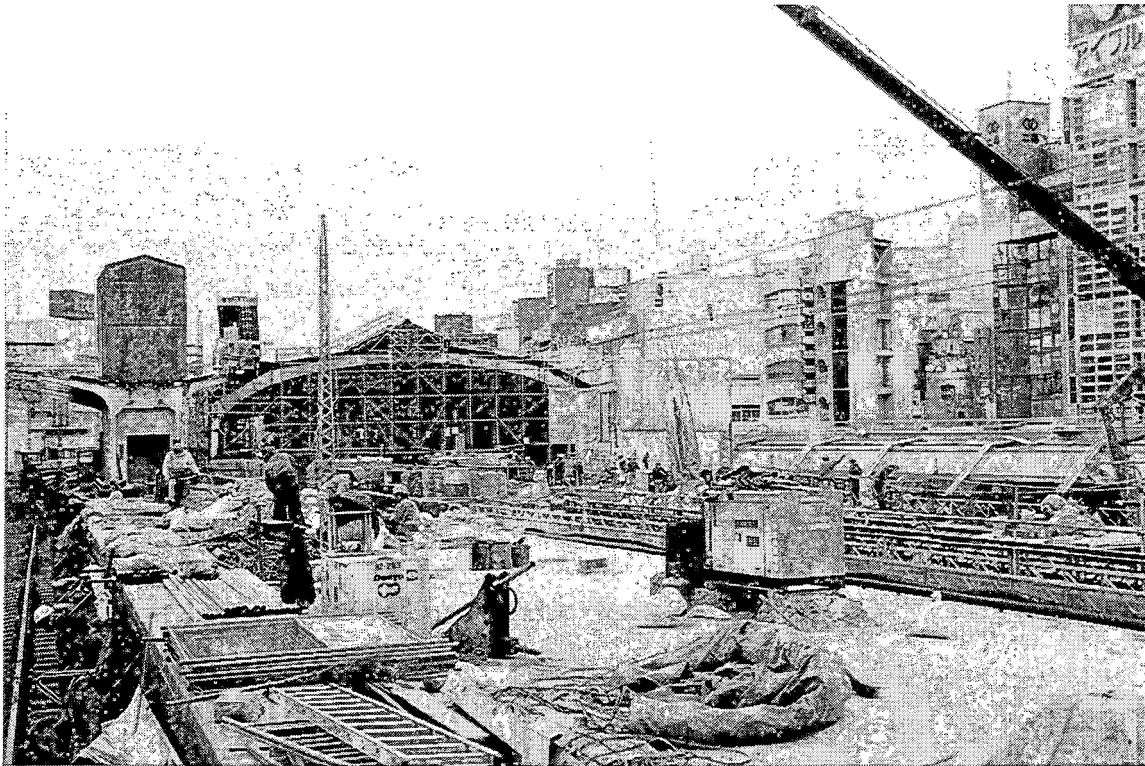
SS-3. The ballast and trackwork has been replaced on the turnouts leading into the maintenance facility. The supporting girders fell to the street.

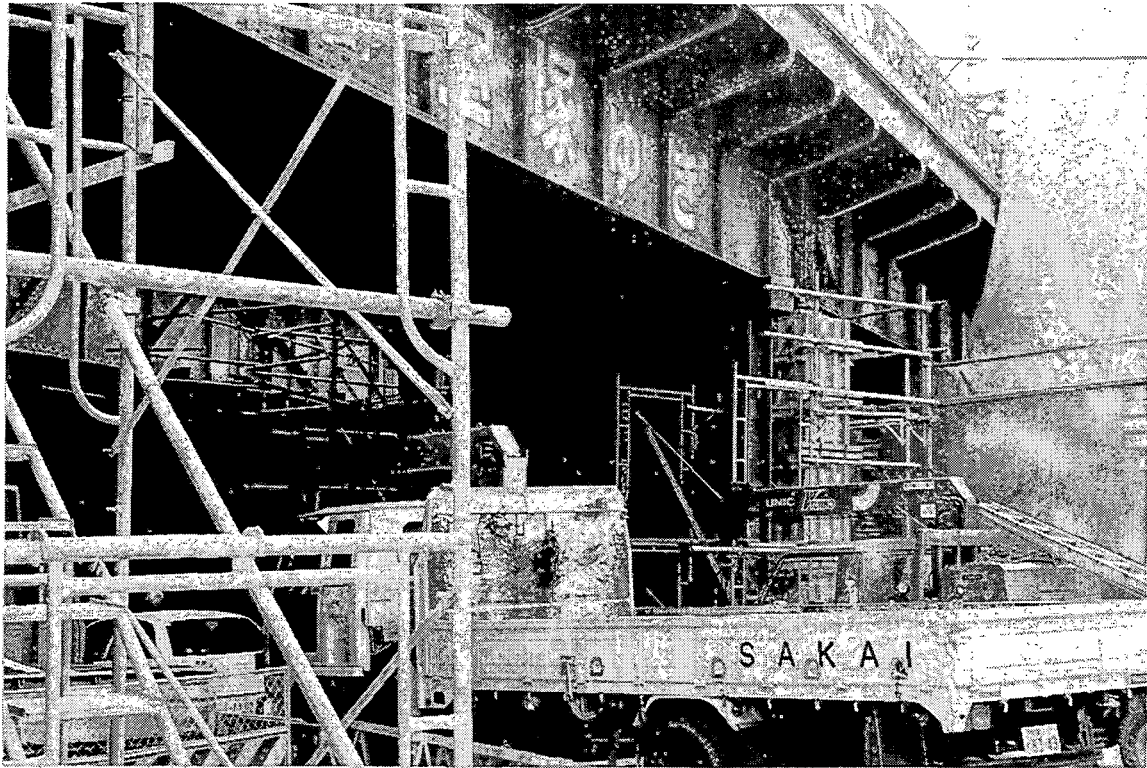
SS-5. The new girders are supported in place while the substructure is being repaired and the trackwork above is completed.

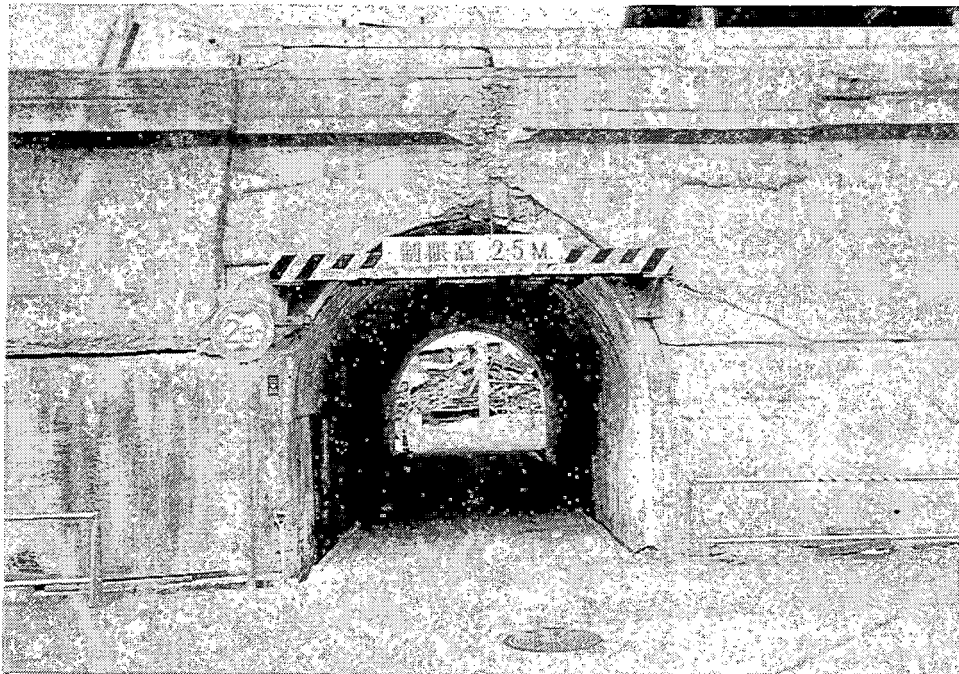
HER-6. The crown of this arch culvert shows some distress.

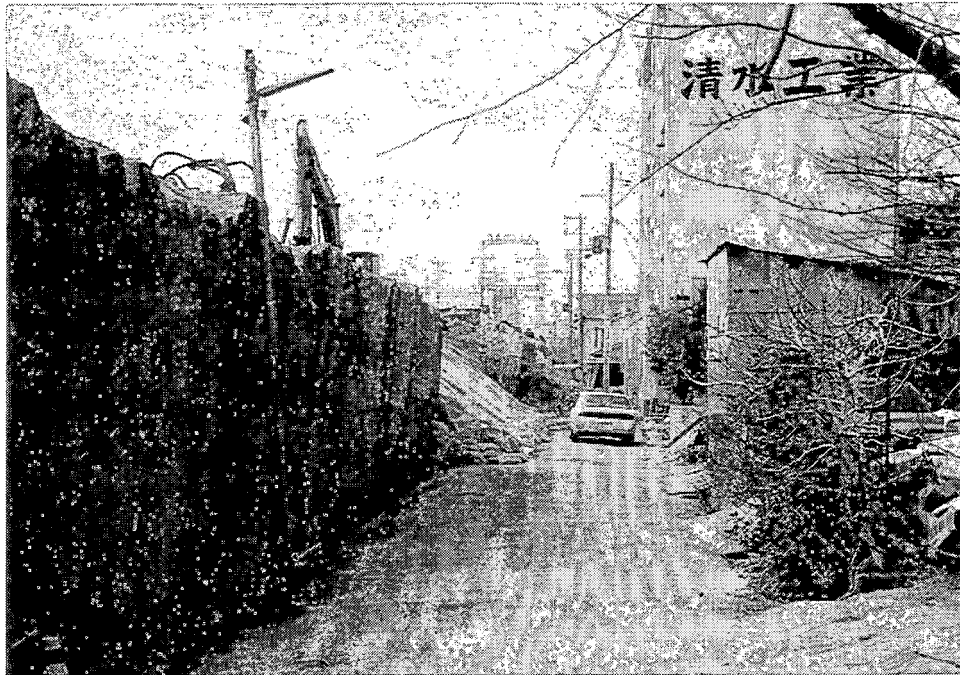
HER-8. Another retaining wall failure

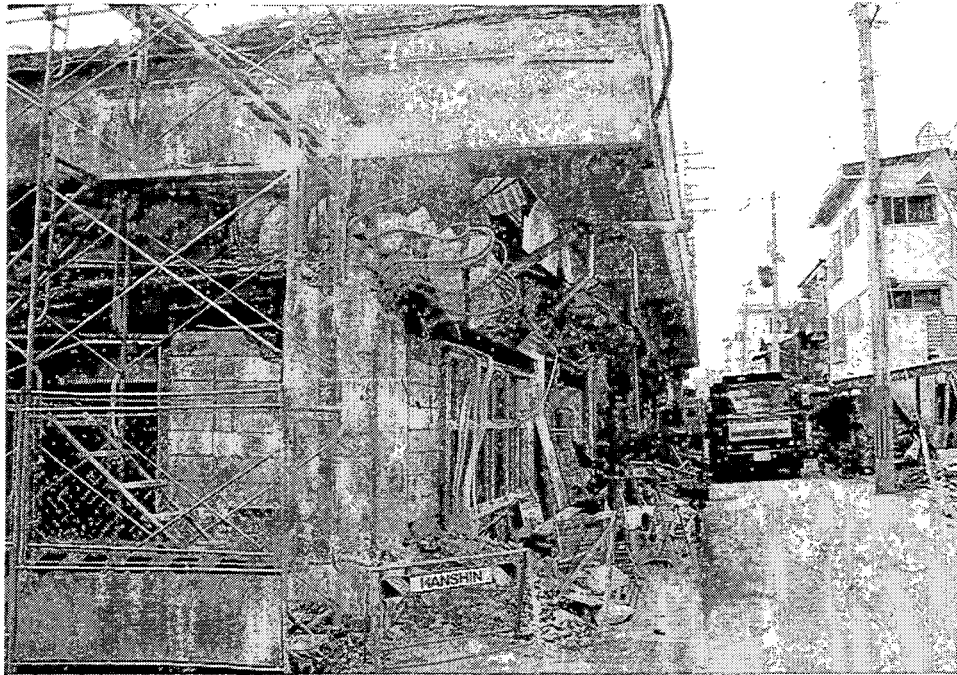
HER-17. Another section that collapsed above the steel beams; the fore span was a steel girder street crossing that fell and was removed. The truck at the right is being used to clear rubble so construction equipment can gain access.

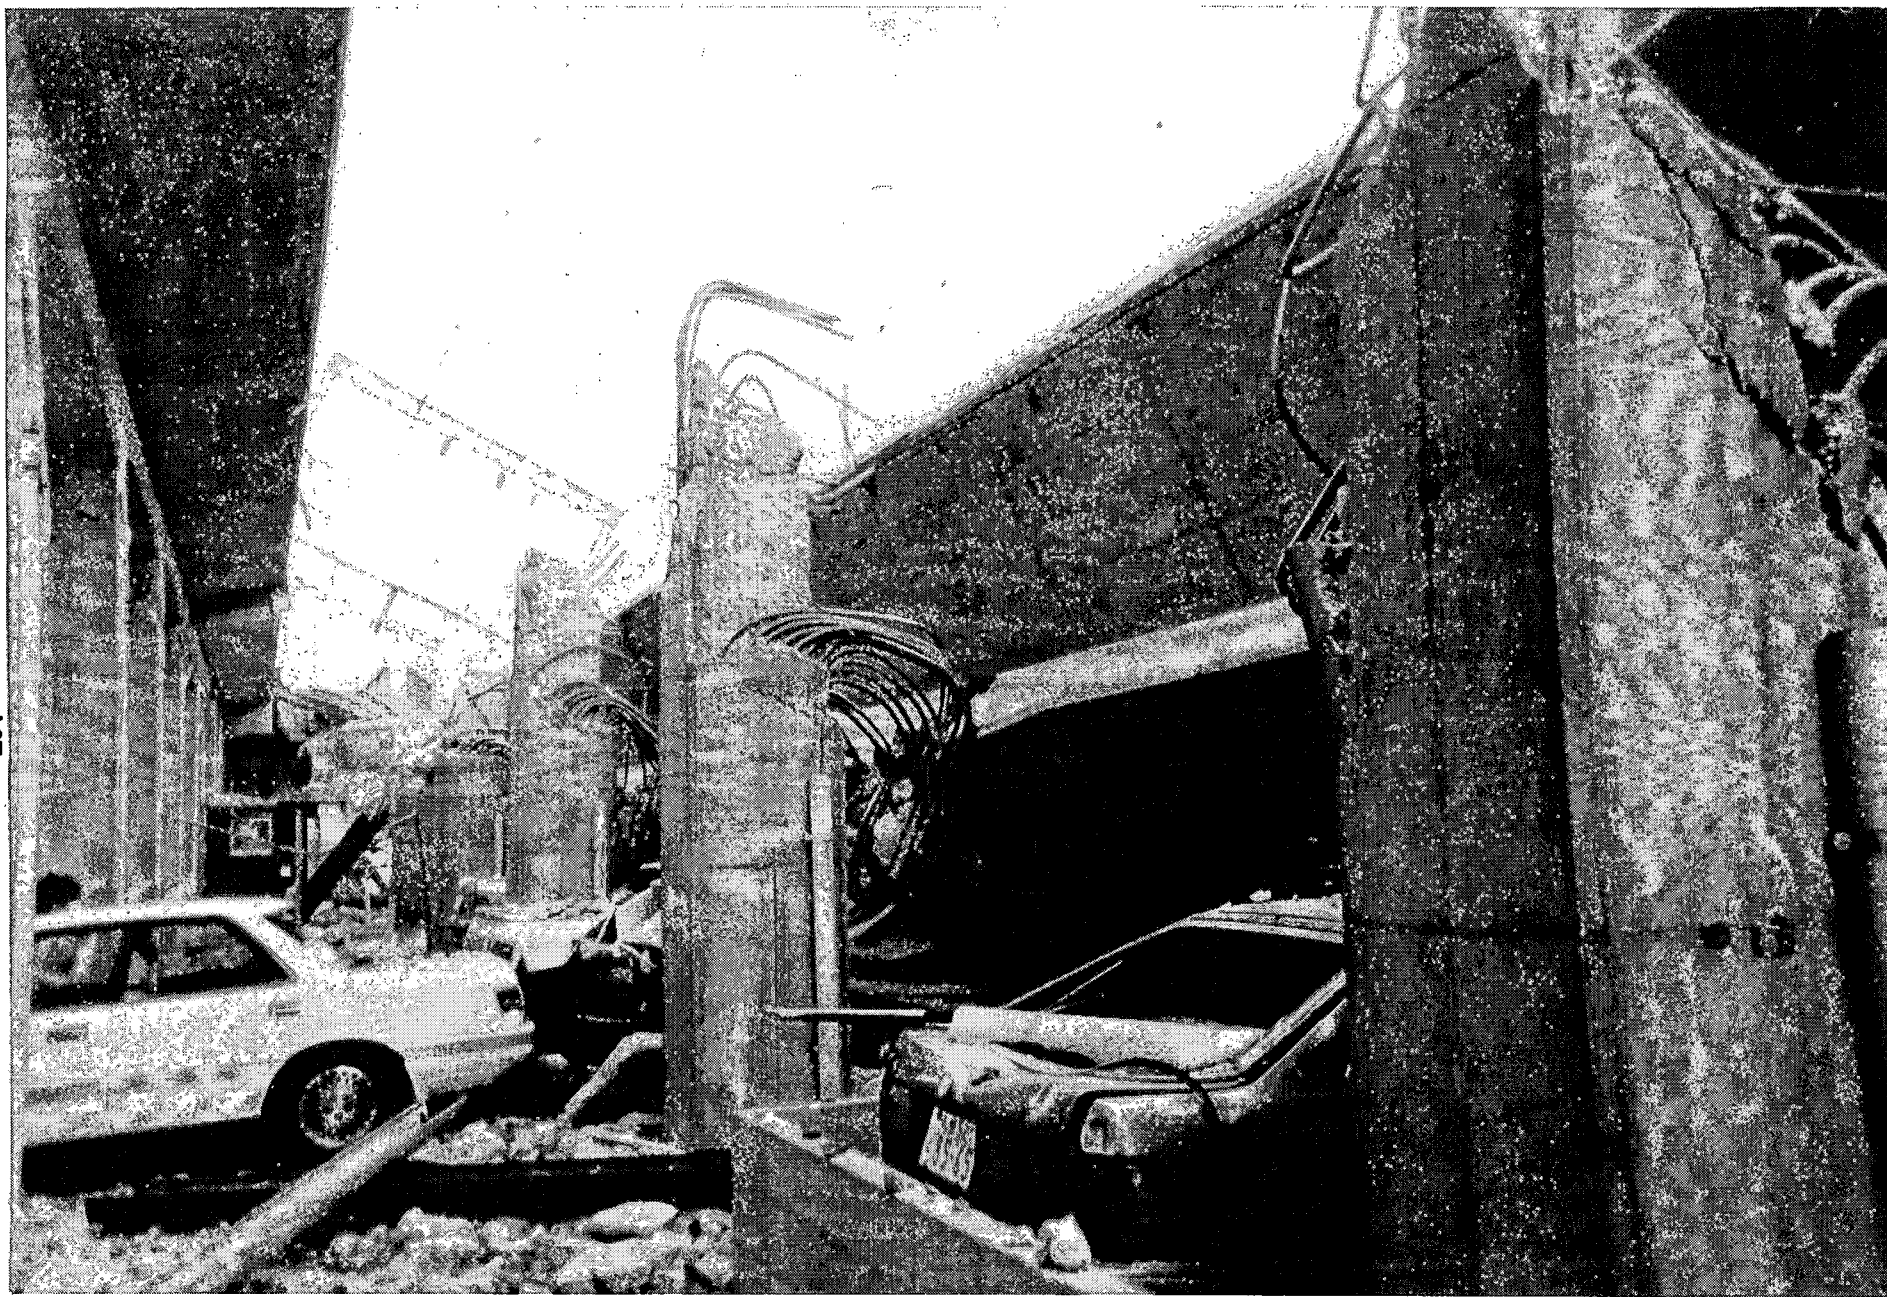
HC-1. Hankyu parallel concrete viaducts. Northern viaduct was more heavily damaged. The joint between viaducts appears smooth and clean as there was no restraint between structures, or any pounding damage. (photo courtesy of M. Yashinsky)

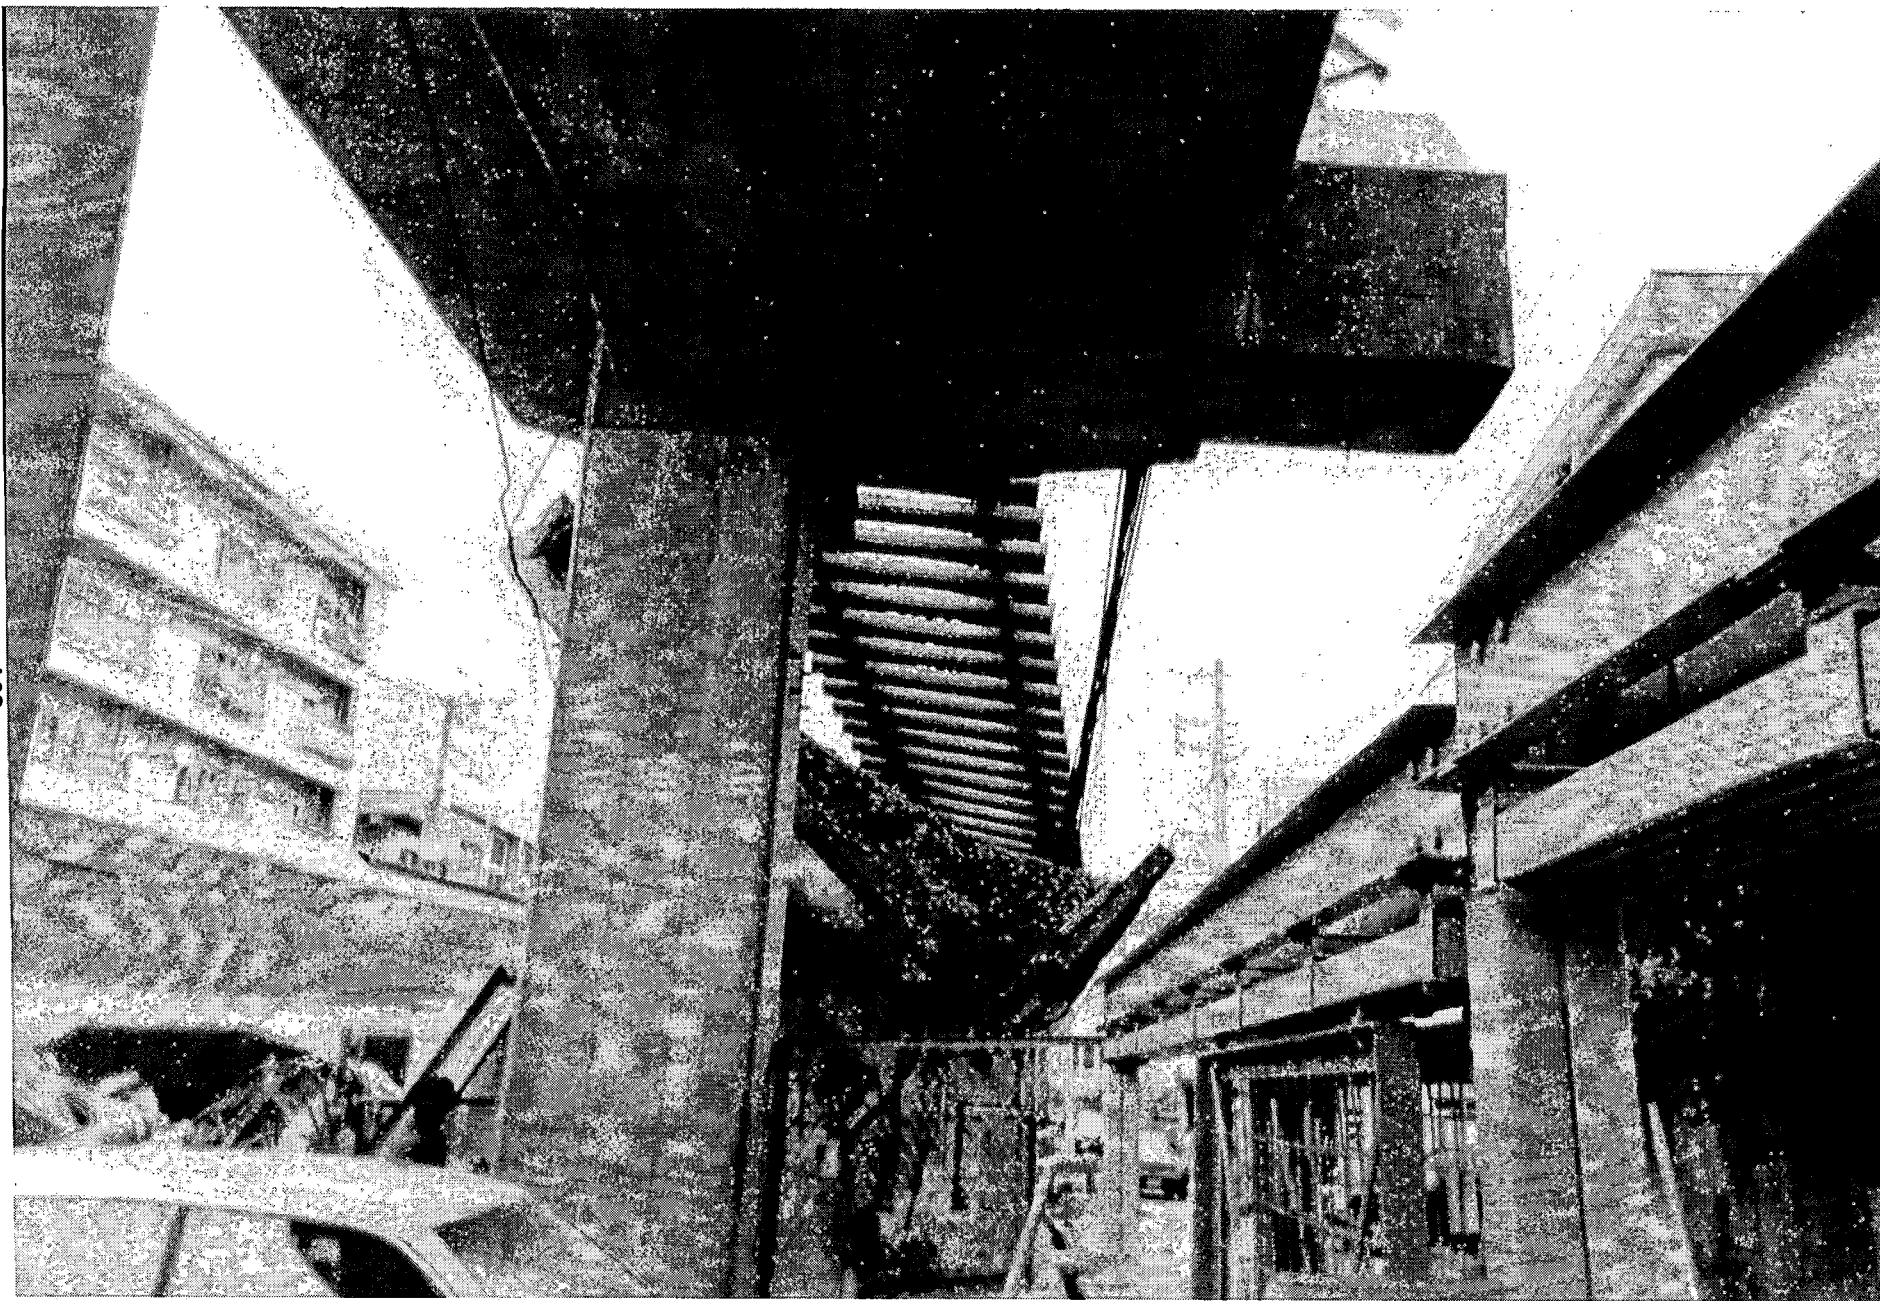
A68

HC-2. Once again the northern viaduct is totally collapsed. The southern viaduct is collapsed at an expansion joint. Notice the ballast and track have provided no restraint. (photo courtesy of M. Yashinsky)

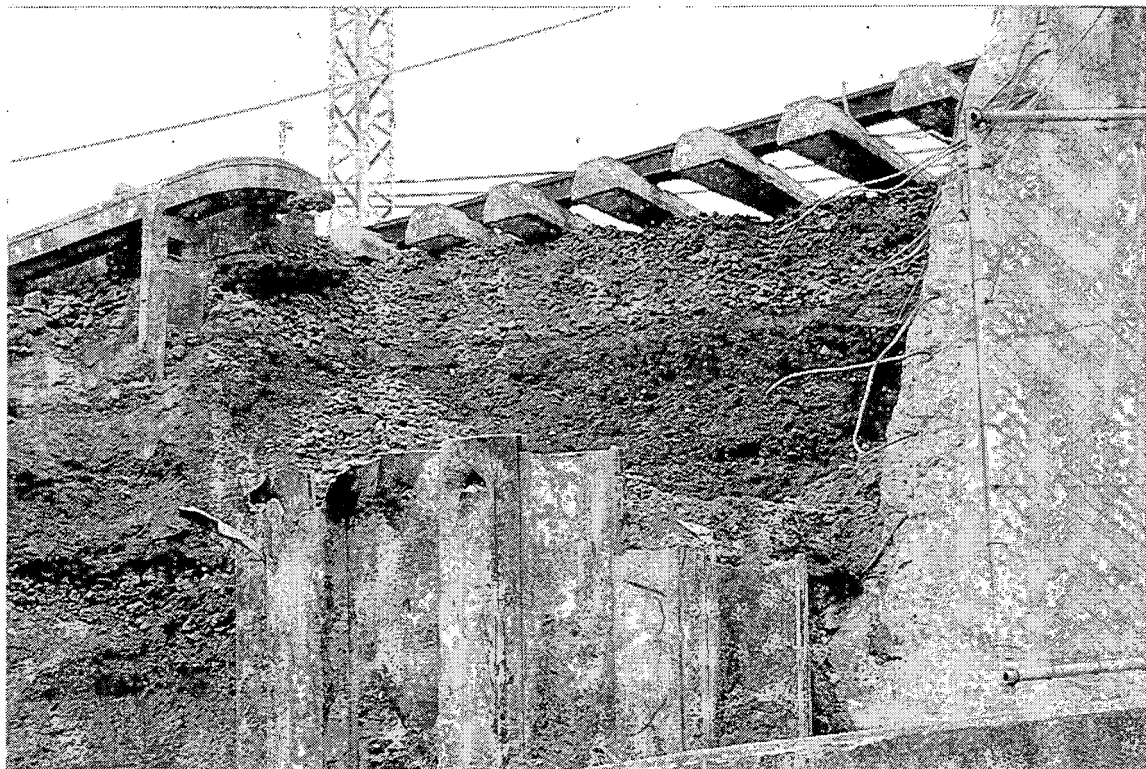
HC-5. Embankment failure undercutting concrete ties at an abutment near Nishinomiya Station

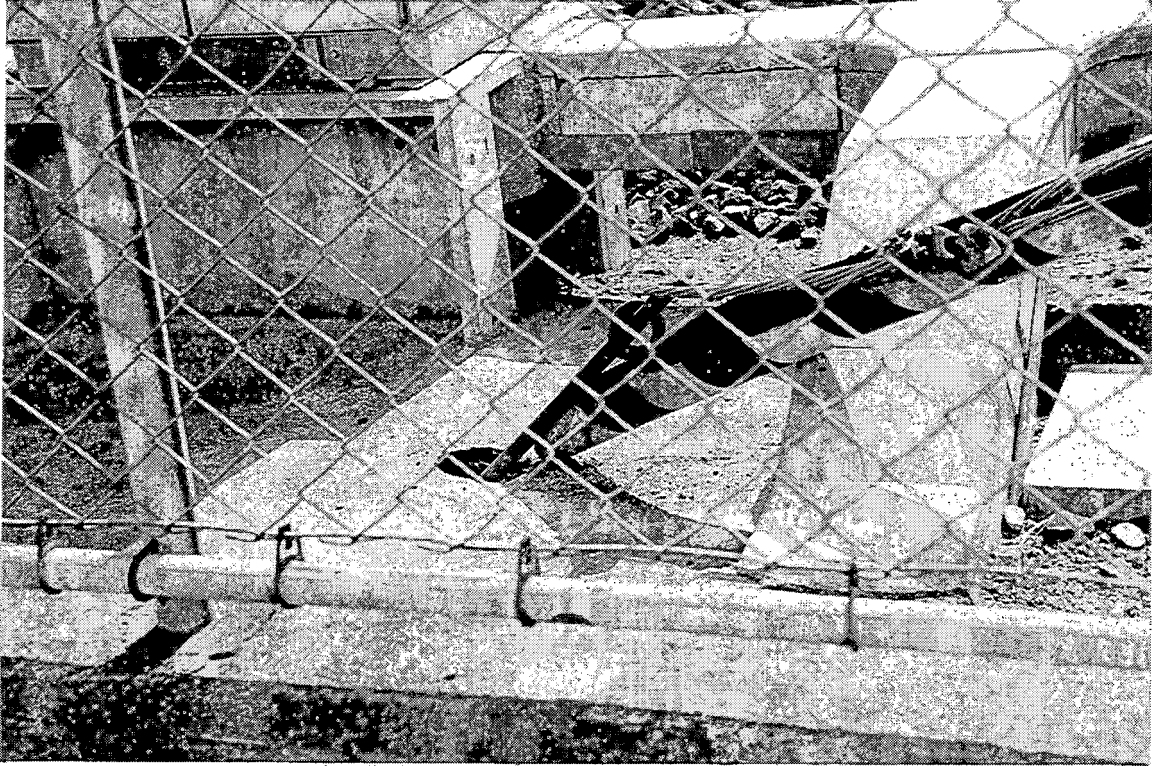
HC-6. Anchors pulled out of this electrification support stay allow the support tower to sway freely.

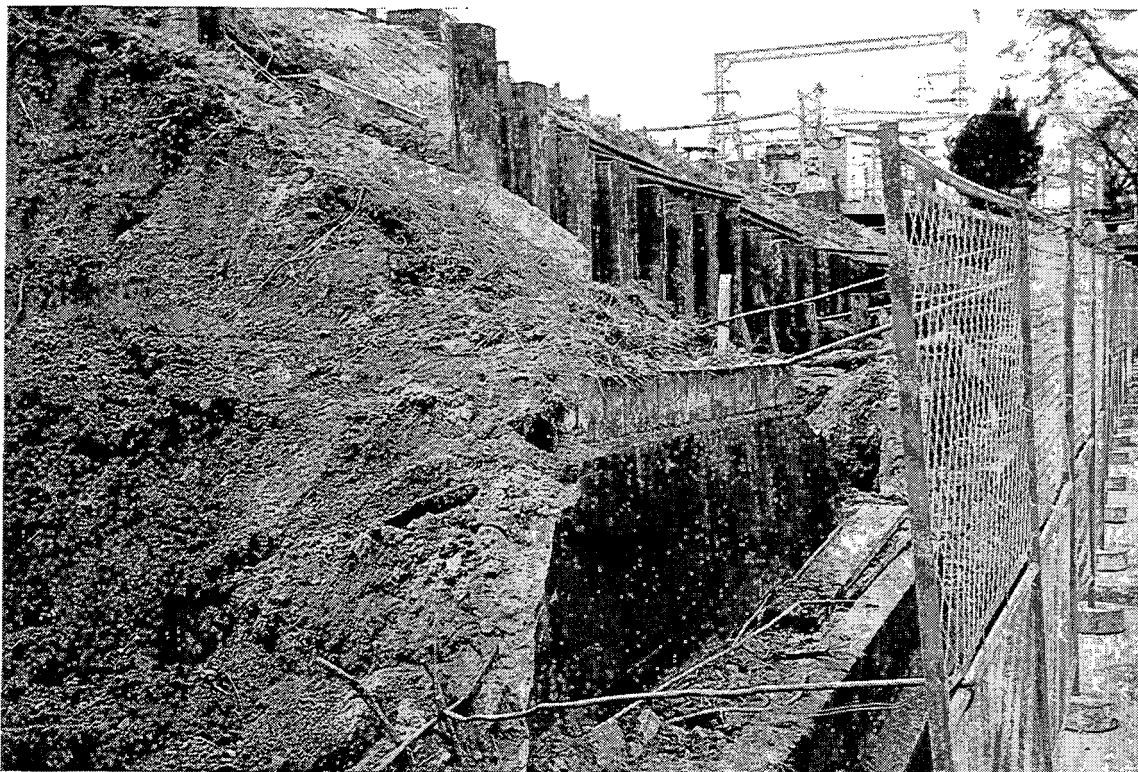
HC-10. Failed retaining walls near Shukugawa Station

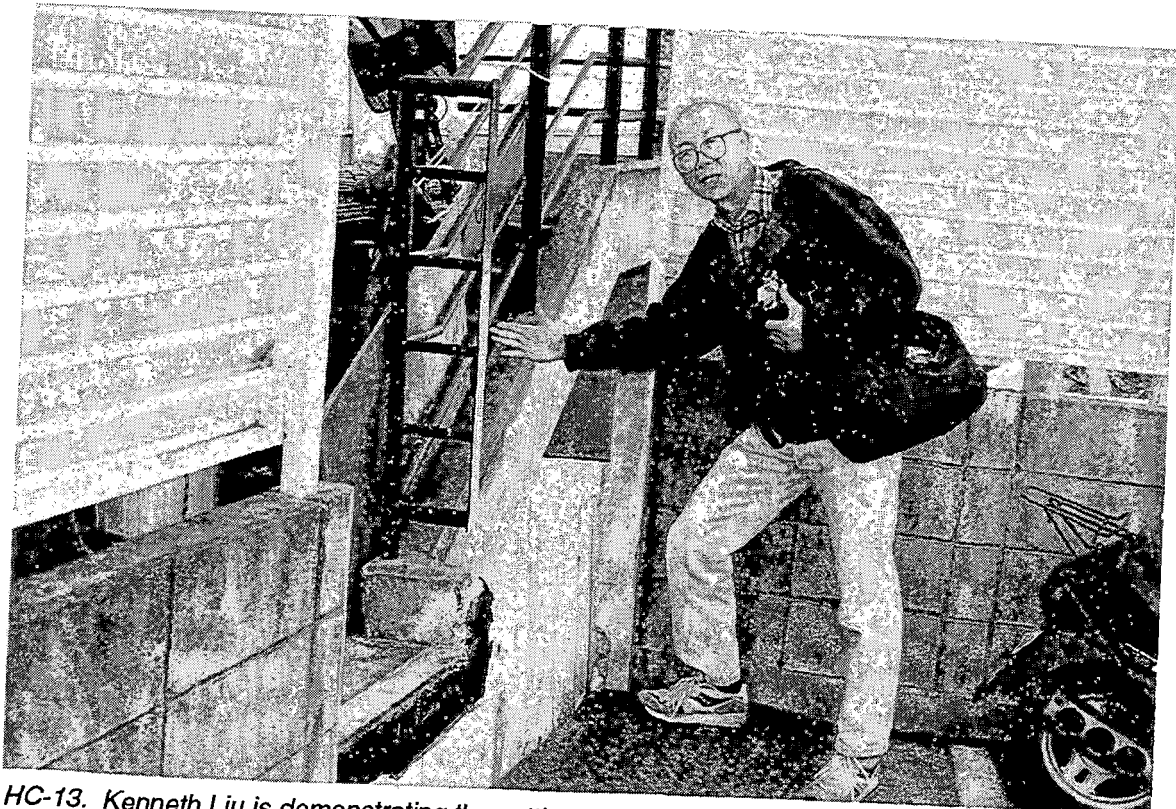
HC-13. Kenneth Liu is demonstrating the settlement and displacement caused by the earthquake at Shukugawa Station. The settlement is nearly 300 mm and the displacement is 400 mm.

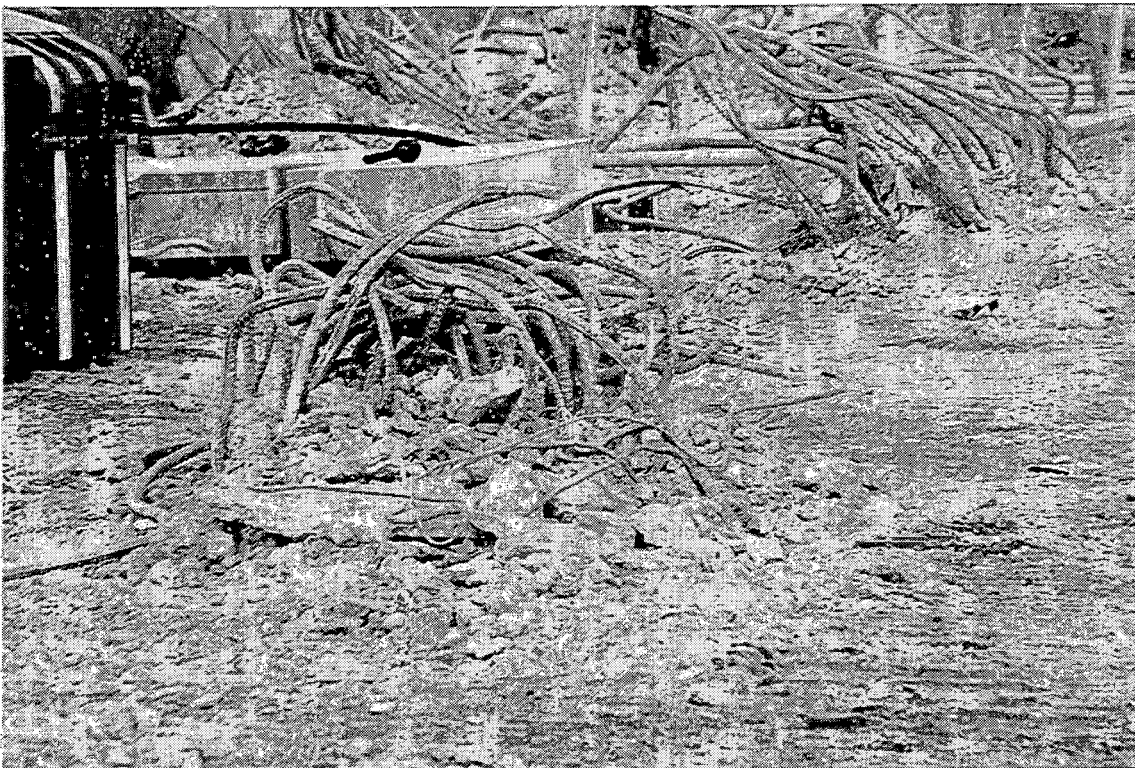
HC-17. Remnants of the failed viaduct

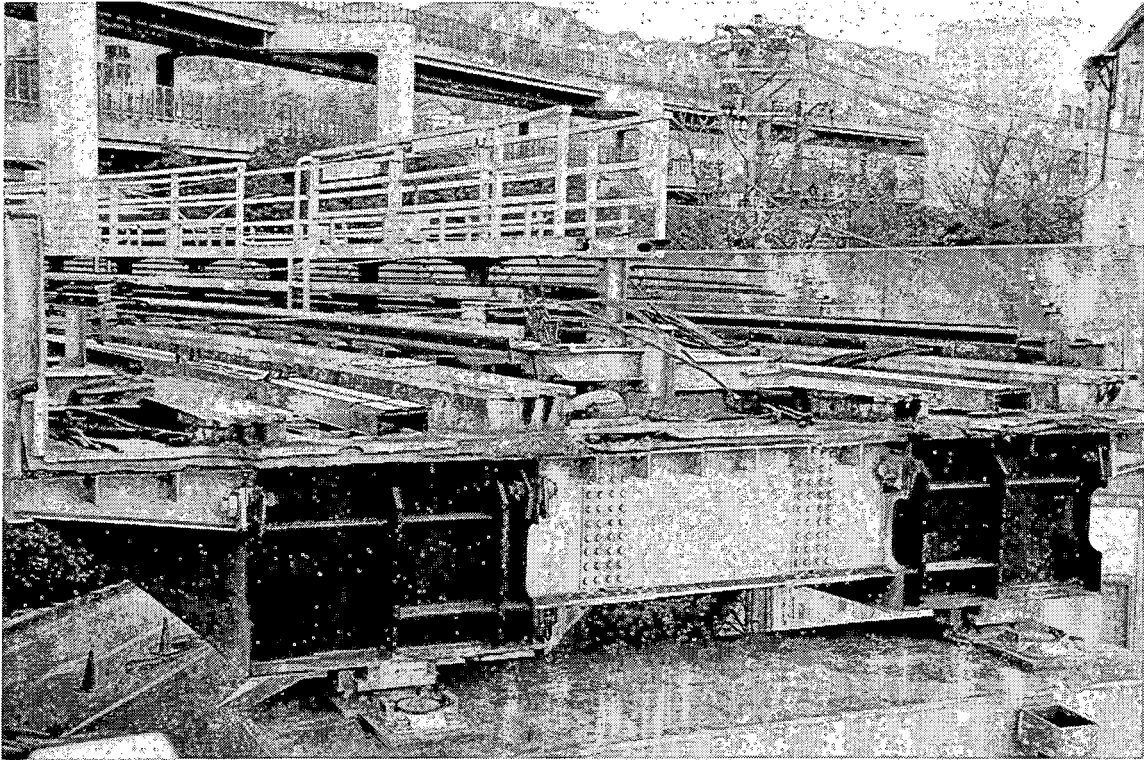
PI-1. This shows a typical section of the peplemover guideway. Unfortunately, the 300 meters south of this pier were destroyed and removed.

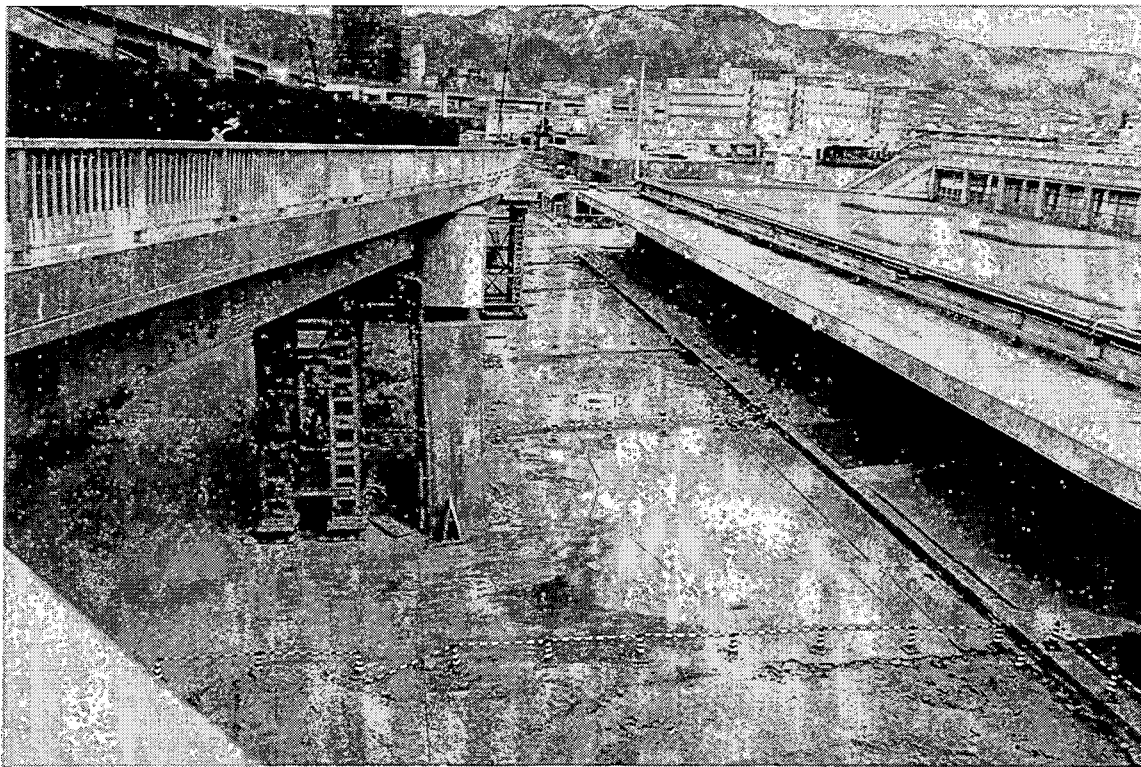
PI-5. The foundations like the bolt circle in the center are all that remain of the Port Island peplemover. A pedestrian bridge is to the left. Downtown Kobe is in the background.

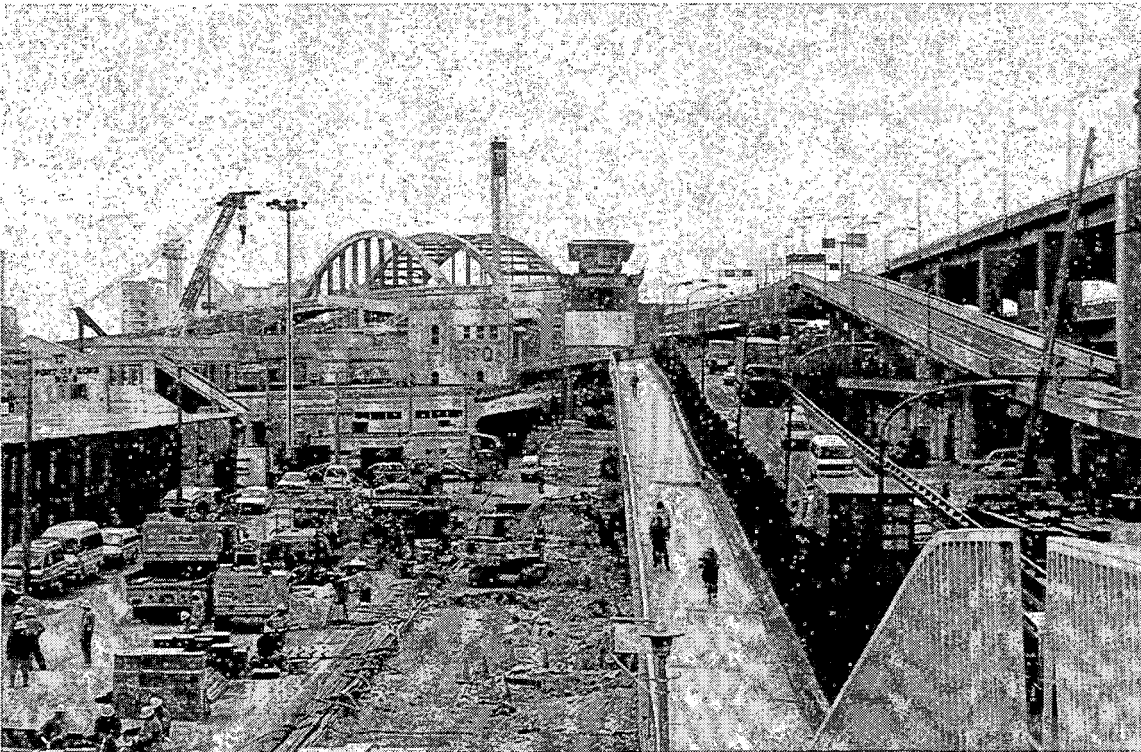
PI-8. After a missing 300 meters, the peplemover resumes at the tower in the center. Port Island is in the background.

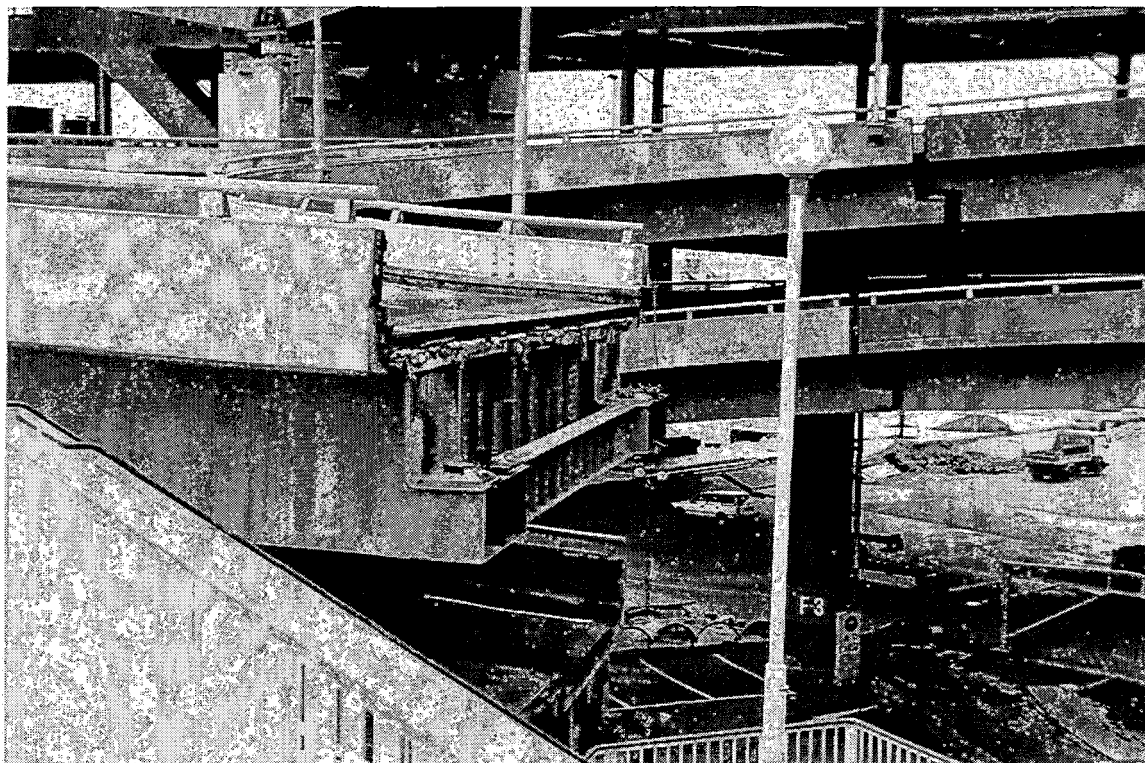
PI-14. These spans of the double deck highway bridge fell from the short span bridge seats. The arch bridge pier is at the top.
