Seismic Damage Assessment of Rail Structures in Japan after the January 1995 Kobe Earthquake

**Parsons Brinckerhoff Quade & Douglas, Inc.
San Francisco, California**

April 1995

**U.S. Department of Transportation
Federal Railroad Administration
Office of Research and Development
Washington, DC 20590**

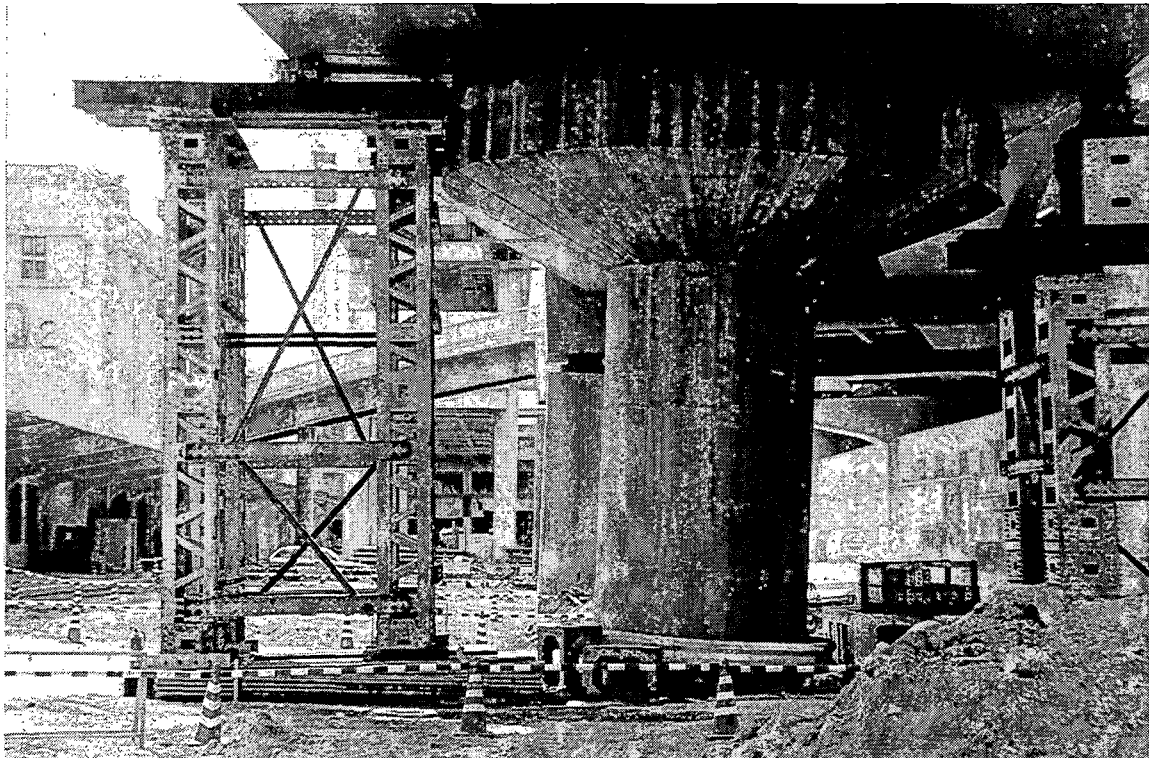
PI-16. Adjacent to the failed peoplemover is an immense stiff pier supporting roadway and pedestrian bridges. Note the lean in the successive piers. Some foundation failure is evident.

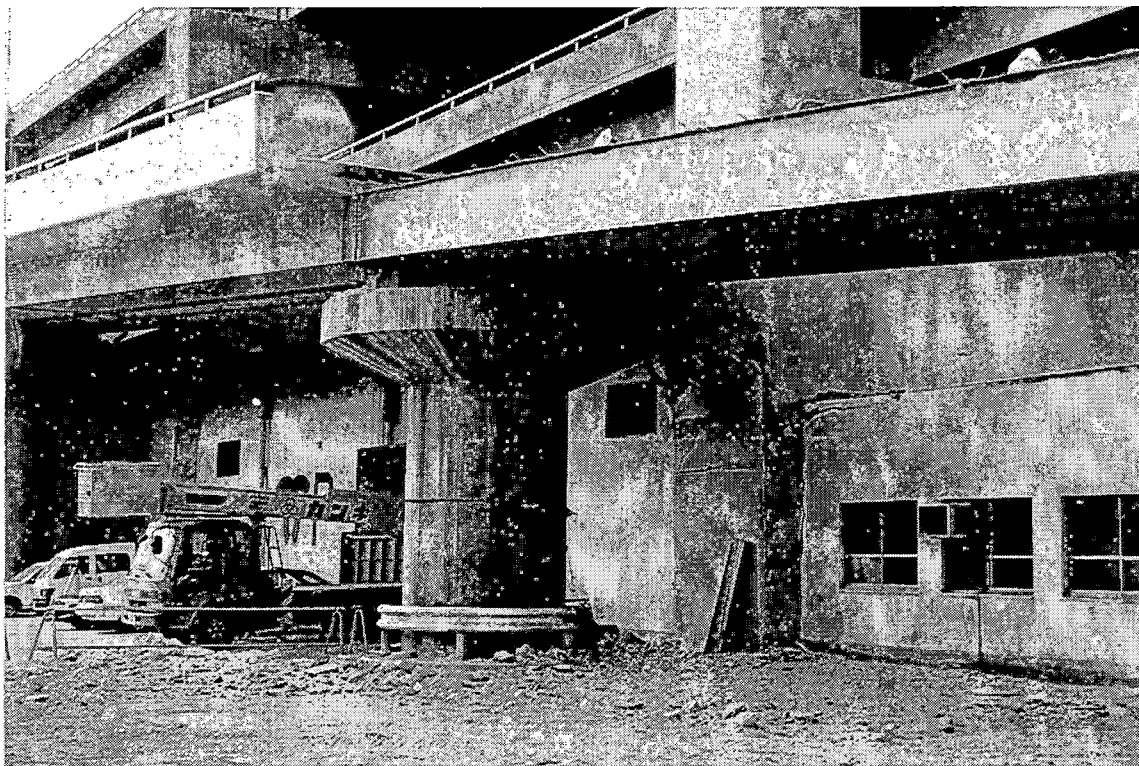
PI-17. This highway ramp adjacent to the peplemover appears to be supported on a seismic isolation bearing. The deck was damaged here and demolished. The concrete substructure of the double viaduct sustained significant damage.
