**Federal Railroad
Administration**

Locomotive Fuel Vapor Reclamation System Field Evaluation and Cost-Benefit Analysis

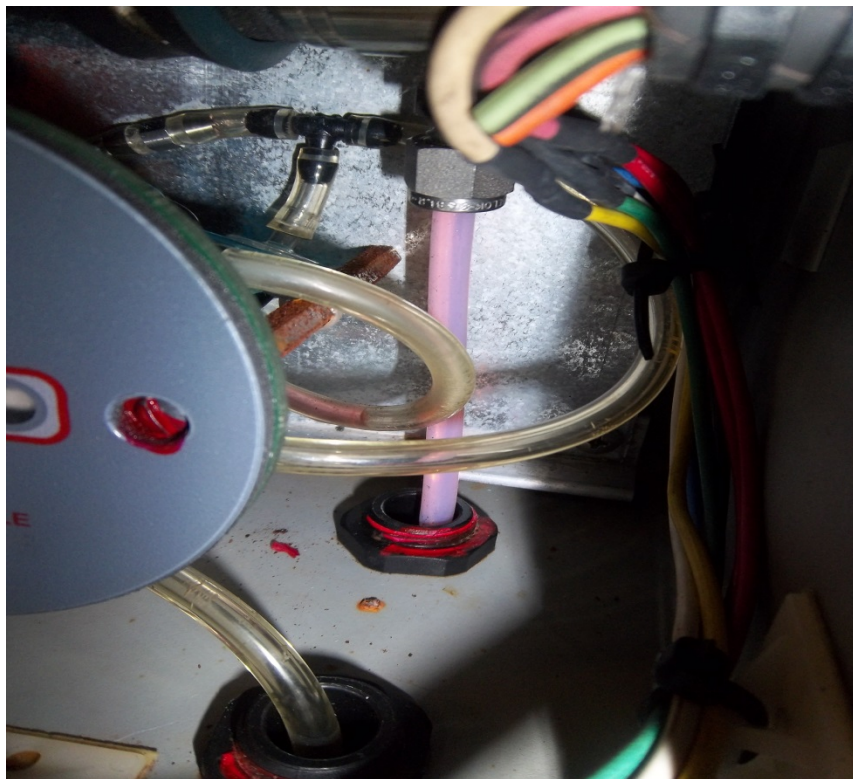
Figure 26. Overfilled diesel fuel in MSA vapor sampling tubing inside electronics box

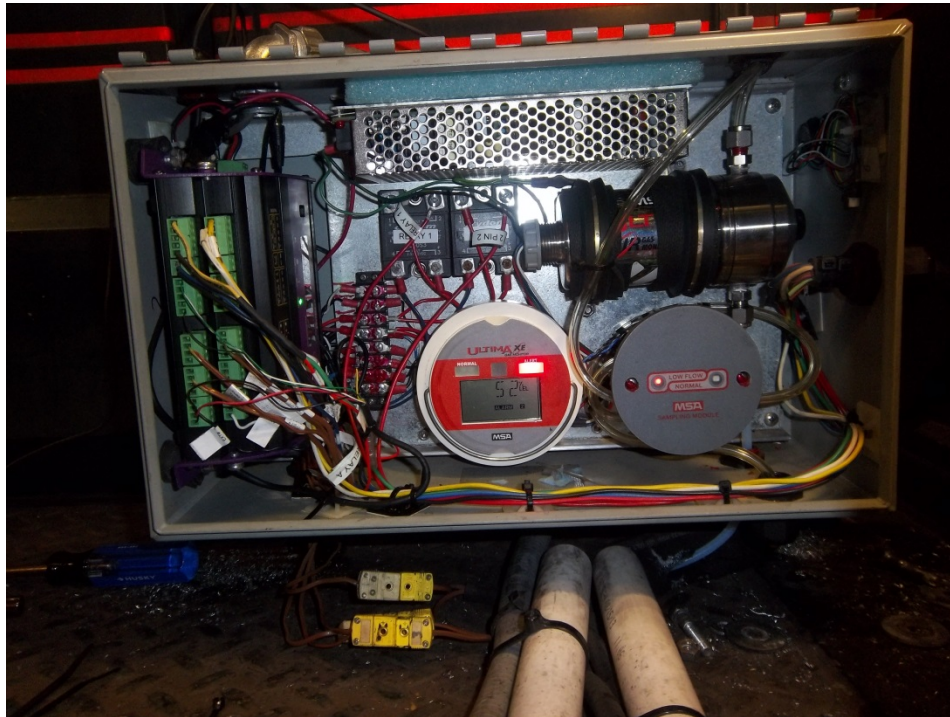
Figure 27. Powered electronics control box following maintenance at Glendive

On completion of the cleanup and maintenance of the electronics control box, as well as setting up the converter within the cab, the QNA team powered up the DVRU electronics control box and confirmed the sensors and display units were functional, as seen in Figure 27. They also watched the pump of the Condensed Fuel Measuring Unit (CFMU) start pumping fuel from its container with the Data Taker indicating 227 mL of fuel pumped out. Next, they cleaned up the collected dirt from the vapor suction fan and the chiller surfaces and tested their functionality by switching 'ON' the inverter located within the cab. The BNSF electrician who was present near the main switch board found the switchgear fittings were loose and tightened them prior to switching 'ON' the inverter. For some unknown reason, at powering 'ON', the inverter got instantly burnt. QNA team tried to locate a replacement inverter at Glendive, but in vain. Just to ascertain if the fan and the chiller got adversely affected during the inverter burning process, they isolated them from the inverter and then powered them separately from a different source to check their functionality. Figure 28 shows the power cables drawn from a different source to the chiller unit for its functional test. Fortunately, both the fan and the chiller were found to be fully functional. They installed an additional waterproof plastic cover to protect the electronics box against a power wash hazard in the absence of QNA team.

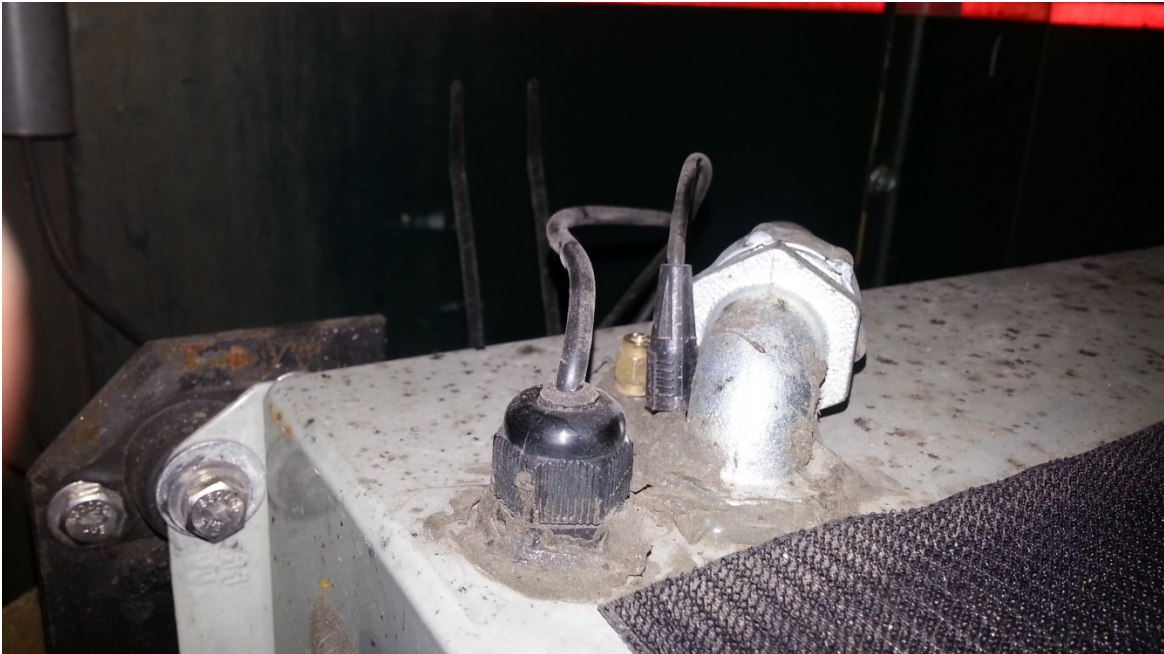
Figure 32. Broken cell phone antenna cable joint found outside the electronics control box
