***Federal Railroad Administration
Office of Railroad Safety
Accident and Analysis Branch***

***Accident Investigation Report
HQ-2015-1075***

***BNSF Railroad Co. (BNSF)
Culbertson, MT
July 16, 2015***

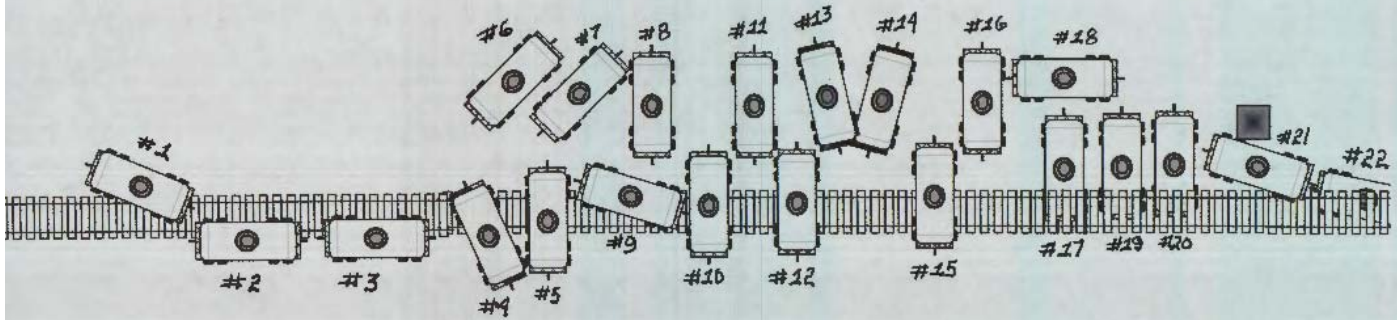
Sketch

| #1 STAX 10495 | DERAILED UPRIGHT | {A-END OF CAR DERAILED} |
| #2 STAX 10215 | DERAILED LAYING ON ITS SIDE | |
| #9 STAX 10808 | DERAILED LAYING ON ITS SIDE | {LEAKED 8,763 GALS OF PRODUCT} |
| #12 STAX 10314 | DERAILED LAYING ON ITS SIDE | {LEAKED 752 GALS OF PRODUCT} |
| #15 STAX 10049 | DERAILED LAYING ON ITS SIDE | {LEAKED 10,388 GALS OF PRODUCT} |
| #16 STAX 10396 | DERAILED LAYING ON ITS SIDE | {LEAKED 7,338 GALS OF PRODUCT} |
| #20 STAX 10396 | DERAILED LAYING ON ITS SIDE | {LEAKED 10 GALS OF PRODUCT} |
| #21 STAX 10213 | DERAILED LAYING ON ITS SIDE | {LEANING AGAINST SIGNAL CASE AT MILEPOST 167.24} |
| #22 STAX 10399 | DERAILED UPRIGHT | {B-END OF CAR DERAILED} |
