***Federal Railroad Administration
Office of Railroad Safety
Accident and Analysis Branch***

***Accident Investigation Report
HQ-2015-1003***

***BNSF Railroad Co. (BNSF)
Larimore, ND
January 15, 2015***

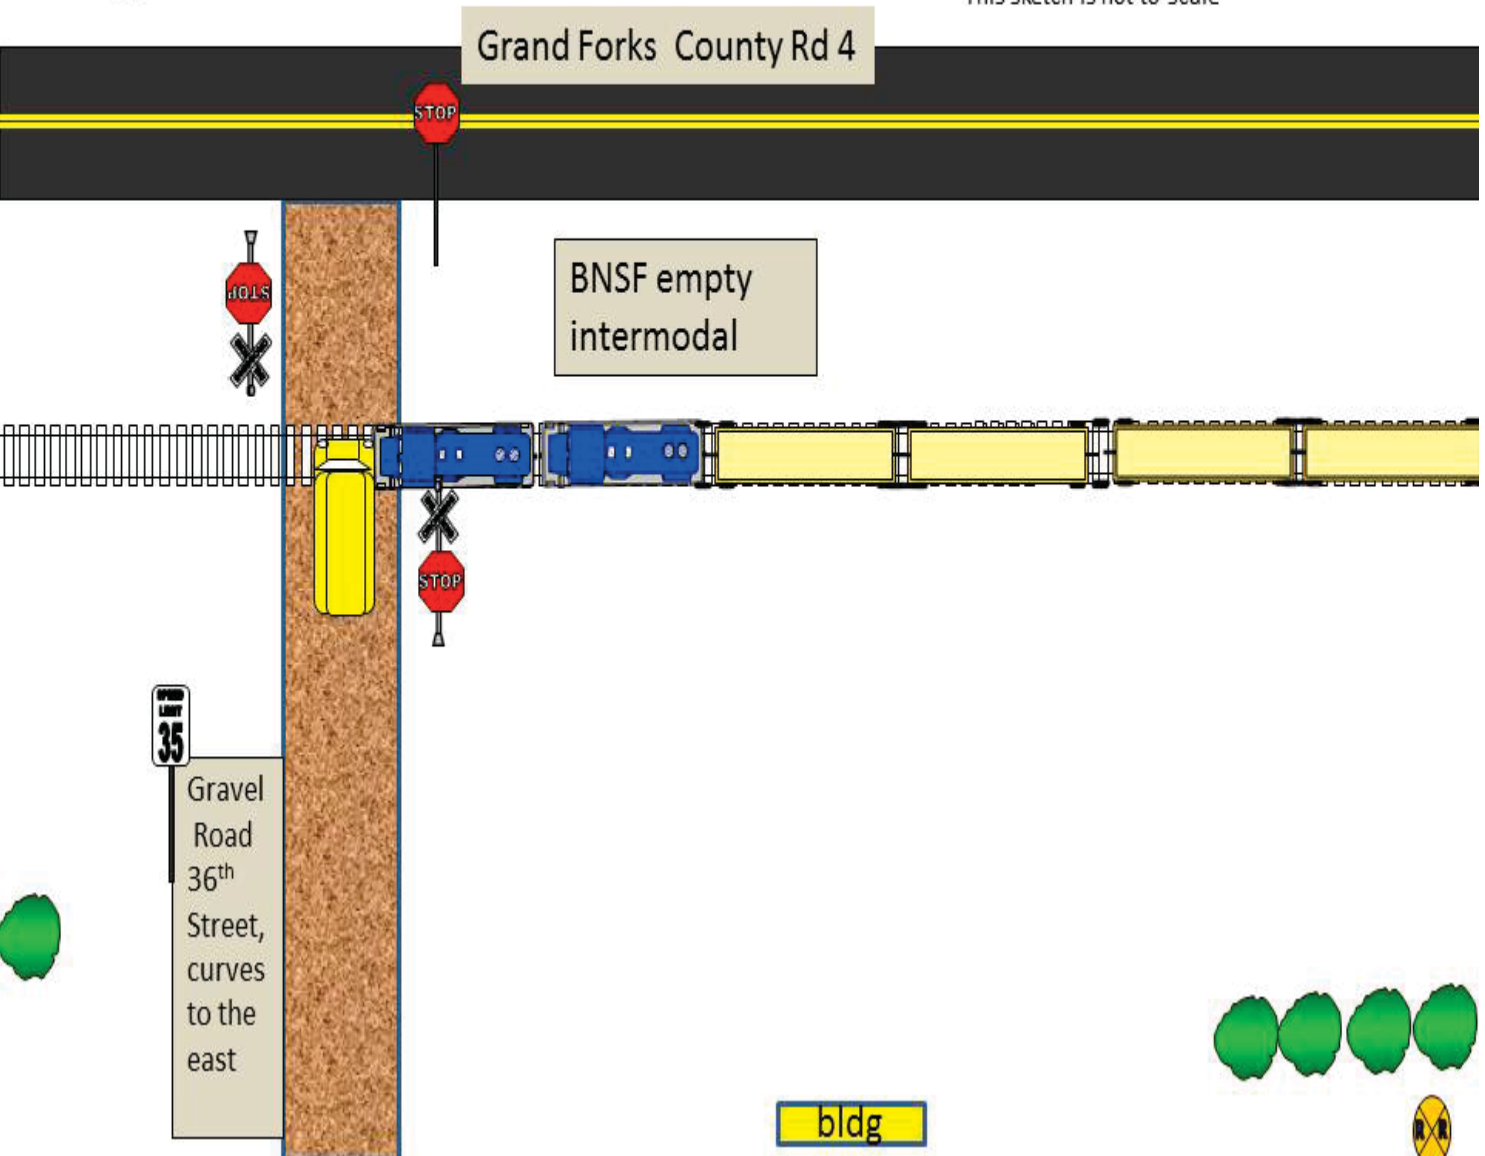
BNSF School Bus collision
DOT 086787N MP 23.51
1.5.2015

The school bus was traveling north on 36th Street NE. According to the Locomotive Engineer, the school bus driver failed to stop for the stop sign and slid to a stop on top of the public crossing (DOT Crossing Number 086787N). A report filed by the North Dakota Highway Patrol's Crash Reconstruction Team estimated the driver was traveling between 19 mph and 22 mph by analysis of skid marks and recreating the skid marks before it came to a stop on top of the crossing.

The train struck the front right side of the bus near the service door. The bus rotated counterclockwise and again made contact with the south side of the locomotive. The bus slid approximately 75 feet into the southwest ditch of the intersection facing north on its wheels. The lead locomotive came to a stop about 1,378 feet west of the point of collision.

The school bus did not stop at the crossbuck and stop sign and continued onto the tracks and skidded to a stop with the front of the bus on top of the north rail. According to the North Dakota Highway Patrol report, the bus did not display its amber lights or red lights, and the service door remained closed the entire time while approaching the crossing and when the school bus stopped on the crossing. After the train stopped the Conductor went back to the scene and assisted the crash victims and proceeded to cut the crossing.
