***Federal Railroad Administration
Office of Railroad Safety
Accident and Analysis Branch***

***Accident Investigation Report
HQ-2015-1070***

***Norfolk Southern Railroad Co. (NS)
Dublin, VA
July 14, 2015***

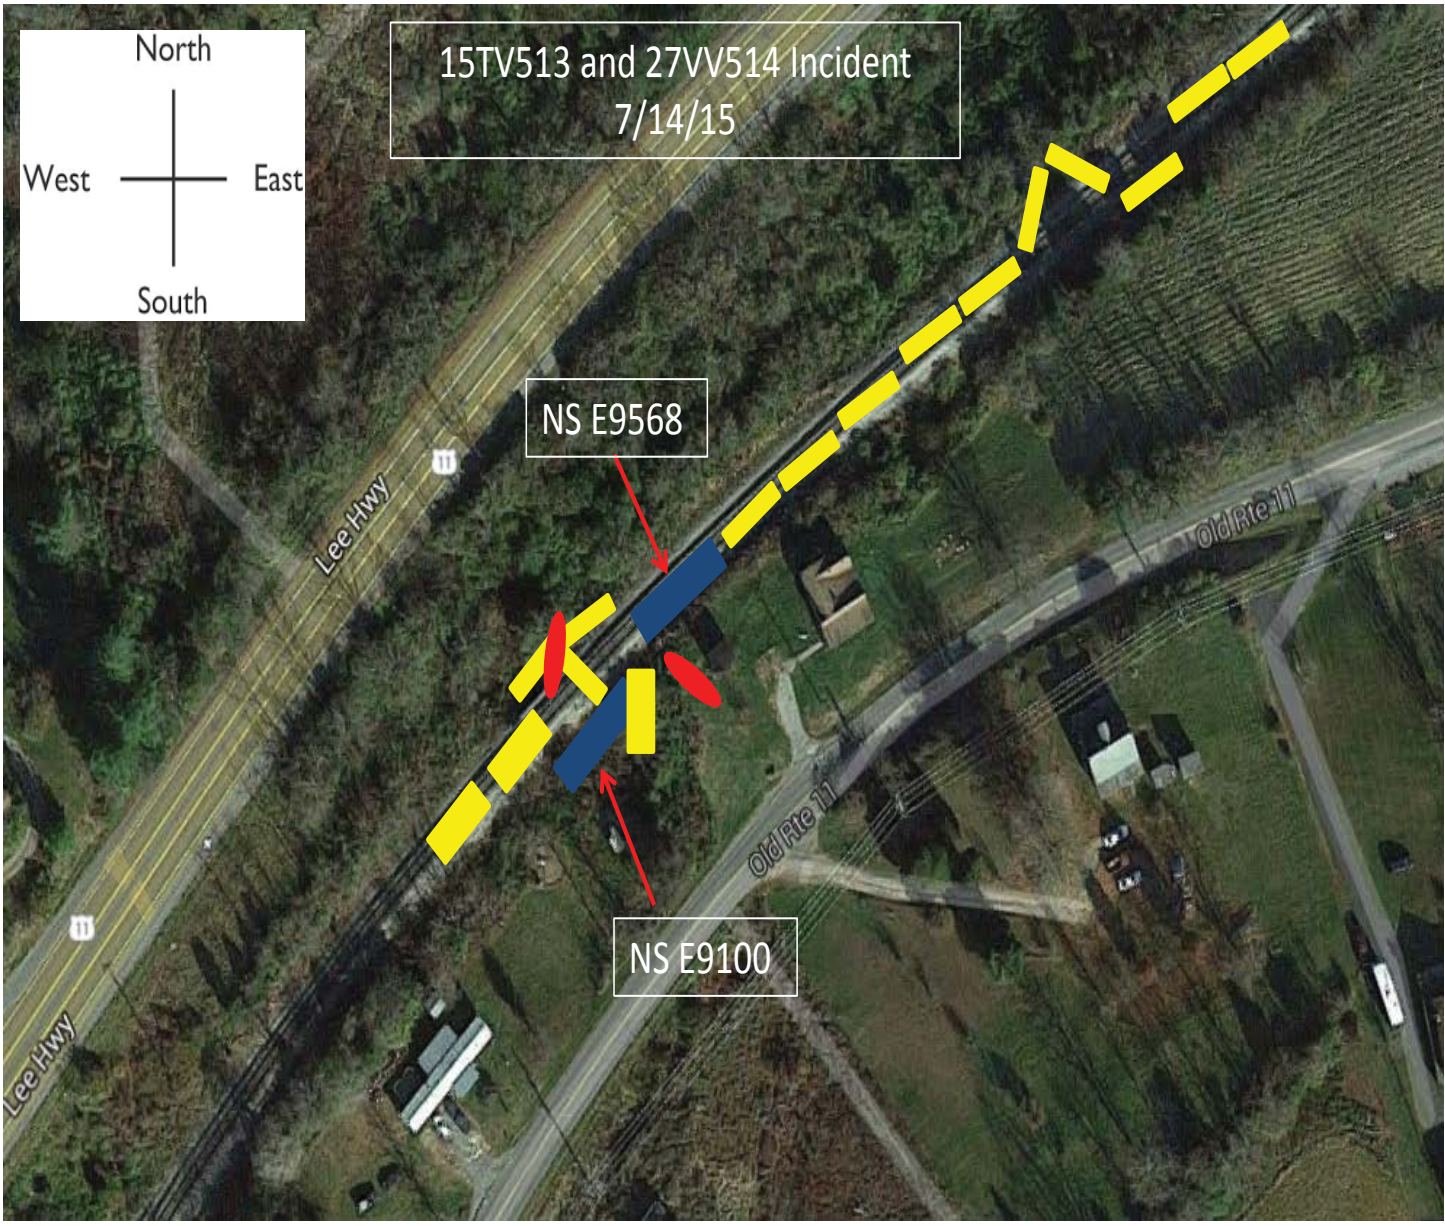
HQ-2015-1070 NS Aerial View of car layout

As a result of the collision, 2 locomotives and 10 cars from Train 27VV514 derailed. The rear 8 cars of Train 15TV513 derailed. Equipment damages were reported as \$1,161,351 for Train 27VV514 and \$466,645 for Train 15TV513. Damage to track, signal, wayside and structures was reported as \$101,138. Both crew members of Train 27VV514 were treated for minor injuries and released from Pulaski Memorial Hospital. The crew members of Train 15TV513 were not injured. A tank car containing lube oil was among those derailed and it was breached leaking approximately 20,000 gallons. An empty HAZMAT car containing Sodium Hydroxide was also derailed but not breached. There was no fire. State Route "Old 11" was closed for approximately 30 hours, due to the derailment. An evacuation of four people was initiated due to the derailment being in close proximity to three homes, one storage building was also destroyed during the derailment. The evacuation was lifted after approximately 22 hours.
