***Federal Railroad Administration
Office of Railroad Safety
Accident and Analysis Branch***

***Accident Investigation Report
HQ-2015-1102***

***Union Pacific Railroad Company (UP)
Union, OR
December 29, 2015***

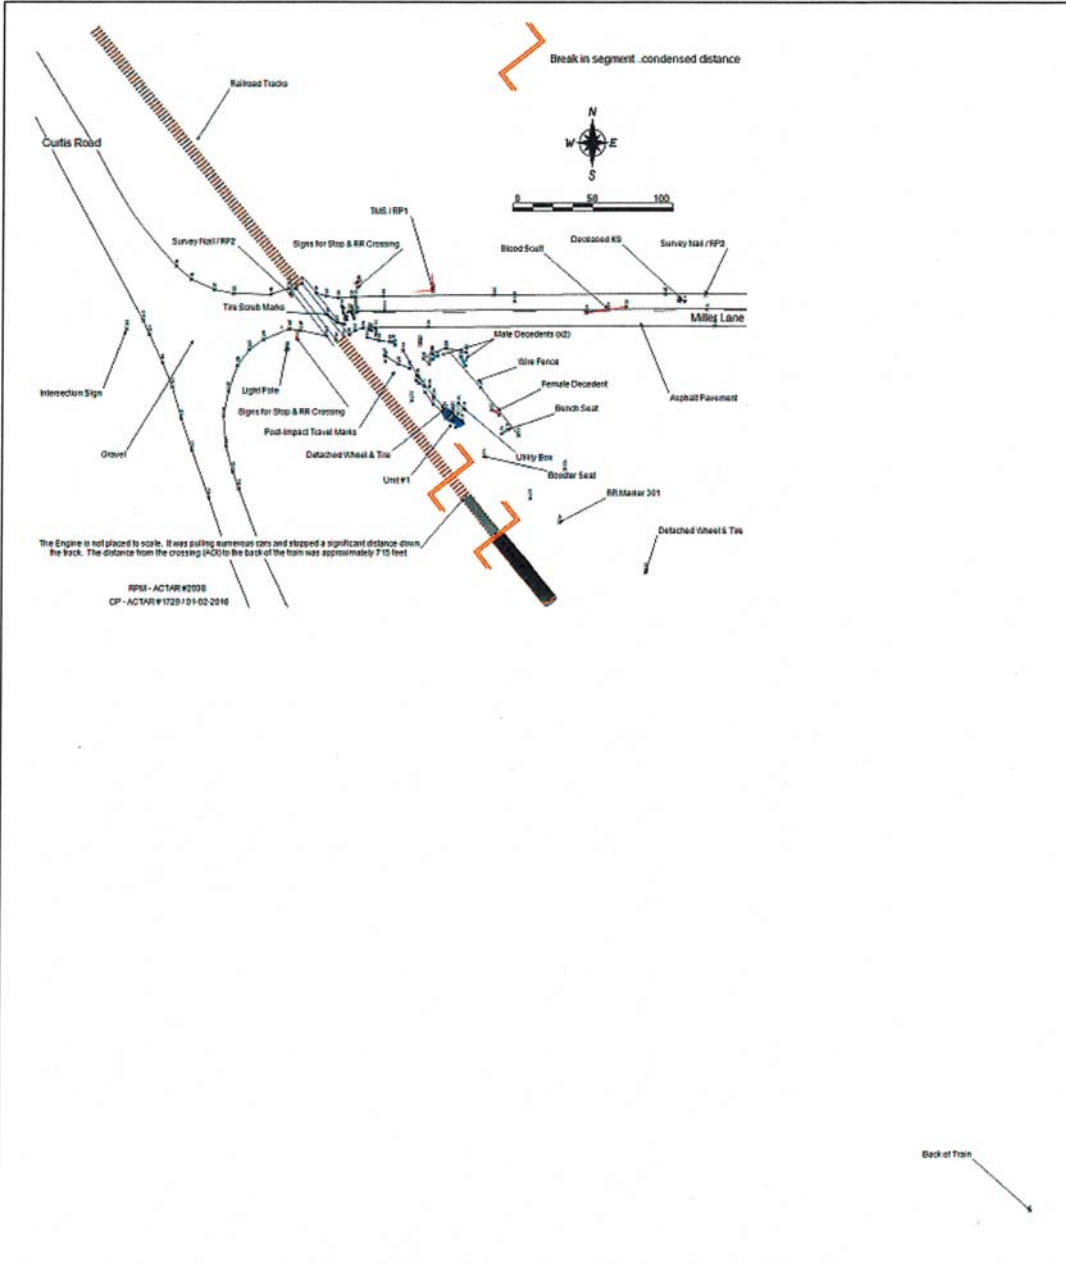
Sketch

Oregon State Police		Case Name	DIAGRAM w/ POINTS
	Drawn By	Senior Trooper Ryan P. Morehead	Case Number	SP15-402596
	Date Drawn	December 30, 2015	Incident Date	12/29/2015 2:54 PM
	Scale	NA	Location	Curtis RD & Miller LN UNION COUNTY, OR

The SUV was traveling east on Curtis Road turning north onto Miller Lane. According to the Locomotive Engineer, the SUV slowed, but failed to stop for the stop sign of the public crossing (DOT Crossing Number 809372G) on Miller Lane when the collision occurred.

The train struck the left rear side of the SUV. The vehicle rotated and slid approximately 50 feet down the railroad right-of-way and came to a stop facing west. The lead locomotive came to a stop approximately 4,224 feet east of the point of collision.
