***Federal Railroad Administration
Office of Railroad Safety
Accident and Analysis Branch***

***Accident Investigation Report
HQ-2014-8***

***Montana Rail Link (MRL)
Alberton, MT
July 3, 2014***

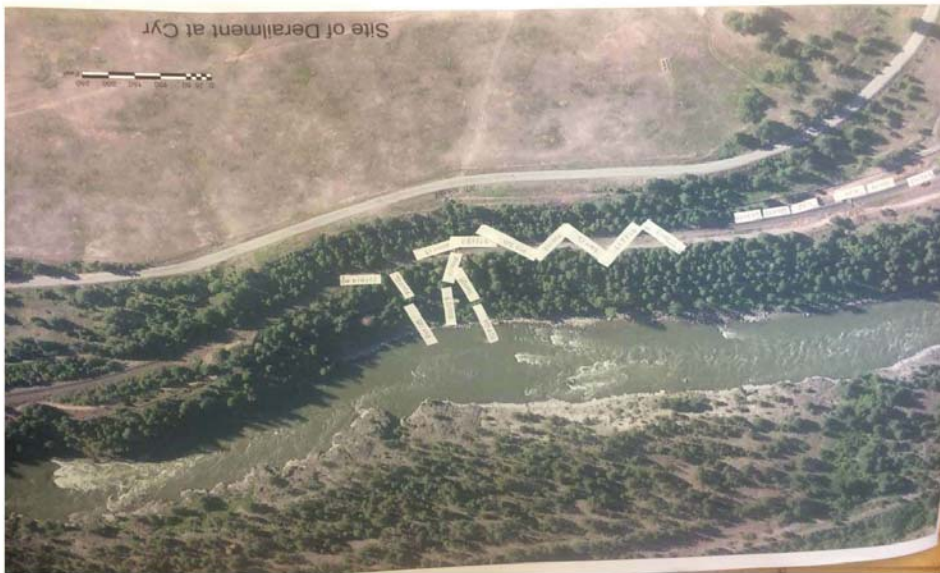
HQ-2014-08

Sketch of MRL derailment on July 3, 2014 of westward MRL train H-KCKSPO1-28A on main track approximately ten miles west of Alberton, Montana

Montana Rail Link Fourth Subdivision: Approximate location of derailment from MP 164.3 to MP 164.5
Superior, MT: West of derailment site at MP 183.6
Lothrop (Alberton), MT: East of derailment site at MP 150.8

Line 6: TILX 642143	Line 16: MTTX 978950
Line 7: TEIX 30058	Line 17: MTTX 978660
Line 8: TLEX 1034	Line 18: BNSF 800039
Line 9: TLEX 1195	Line 19: BNSF 800129
Line 10: TILX 642273	Line 20: BNSF 800034
Line 11: TILX 642640	Line 21: MTTX 981187
Line 12: TBCX 777004	Line 22: BNSF 800029
Line 13: MTTX 978649	Line 23: BNSF 800127
Line 14: BNSF 800022	Line 24: BNSF 800026
Line 15: BNSF 800103	Line 25: TBCX 777019
