***Federal Railroad Administration  
Office of Railroad Safety  
Accident and Analysis Branch***

***Accident Investigation Report  
HQ-2014-11***

***Union Pacific Railroad Company (UP)  
Galva, KS  
September 25, 2014***

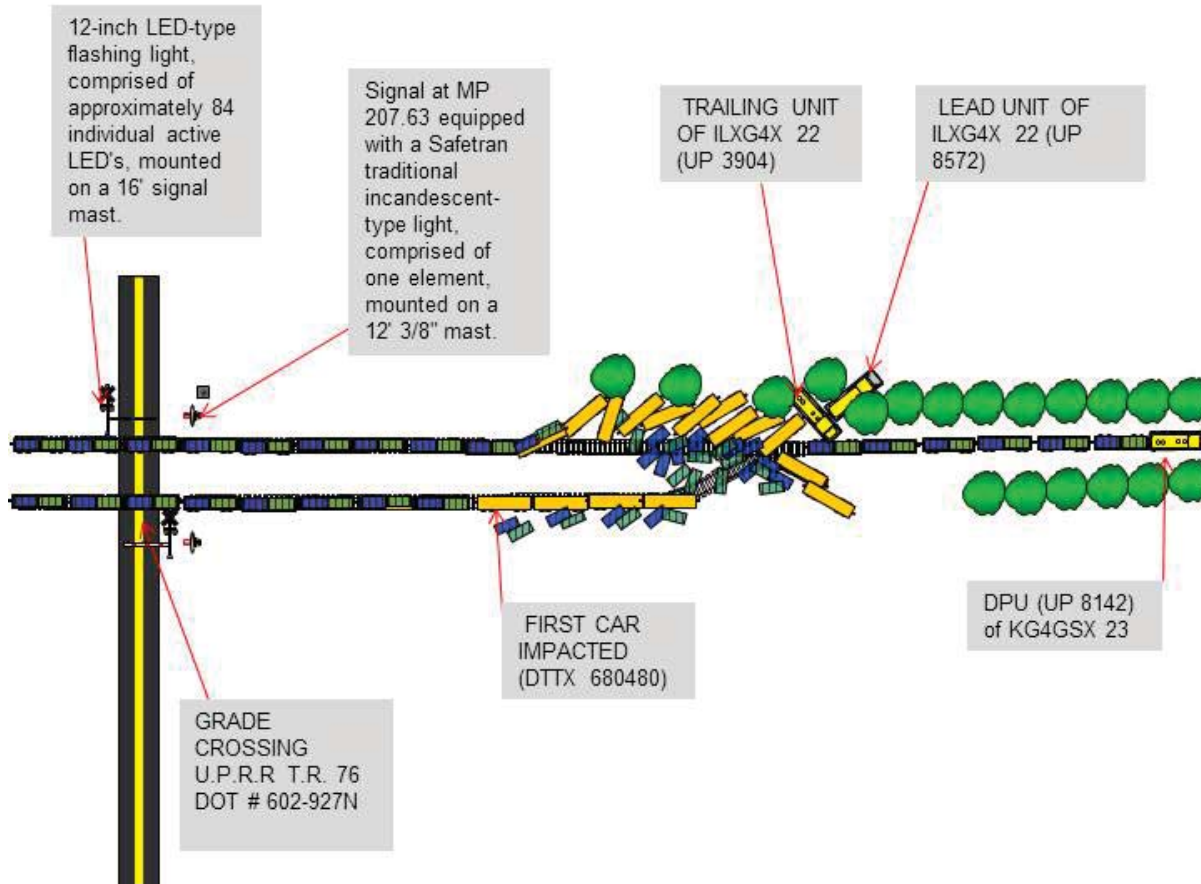
HQ-2014-11 Sketch

Eastbound direction of travel for IXLG4X22
