***Federal Railroad Administration
Office of Railroad Safety
Accident and Analysis Branch***

***Accident Investigation Report
HQ-2014-1032***

***Canadian Pacific Railway Company (CP)
Skyline, MN
November 27, 2014***

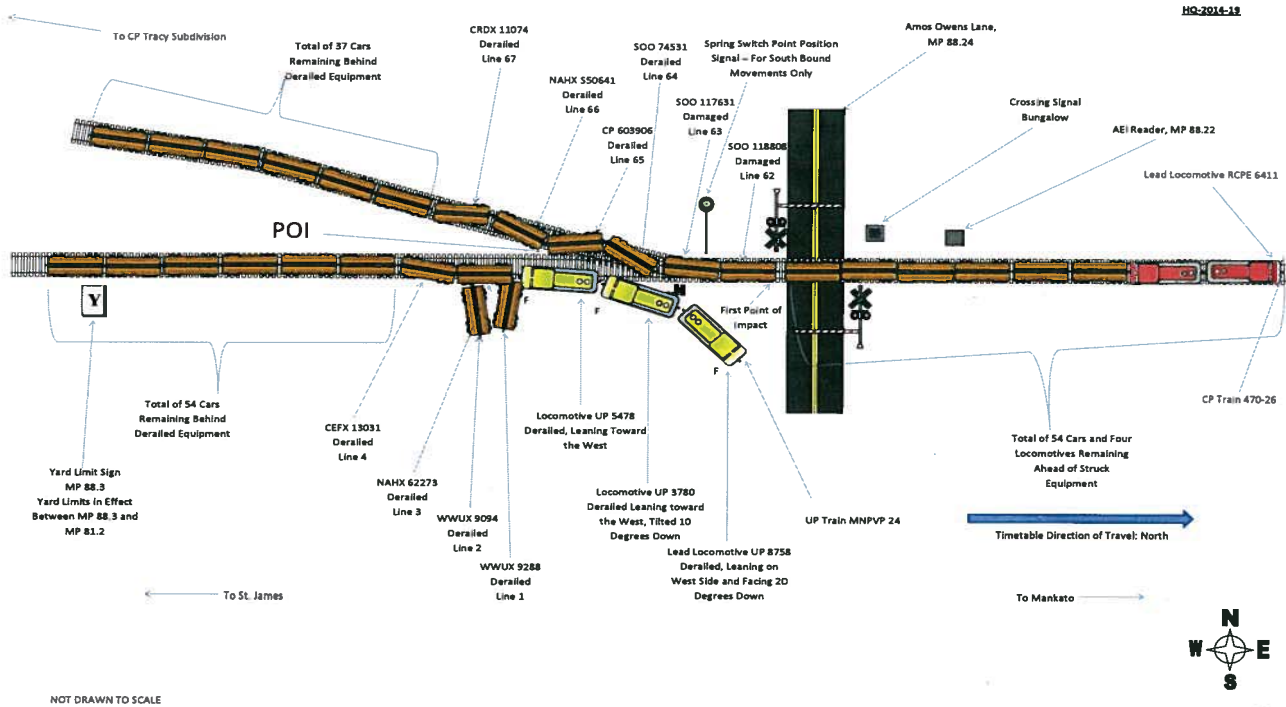
FRA Sketch of Collision Site

On November 27, 2014, at 2:31 a.m., CST, a northbound Union Pacific Railroad (UP) train, MNPVP, impacted the side of Car 55 of northbound Canadian Pacific Railway (CP) Train CP 470. The collision occurred in Skyline, Minnesota, at Milepost (MP) 88.2.

While traveling at 38 mph, the train was placed into an emergency air application by the FIT from the locomotive control stand. At 2:31:44, while operating at 17 mph, Train MNPVP impacted the side of northbound Train CP 470 as it was entering through the spring switch at MP 88.25. The impact caused Train CP 470 to separate between Cars 54 and 55, and derailed Cars 57, 58, 59, and 60. The impact caused Train MNPVP's three locomotives and head four cars to derail to the east of the movement.
