***Federal Railroad Administration
Office of Railroad Safety
Accident and Analysis Branch***

***Accident Investigation Report
HQ-2014-1042***

***Canadian National - North America (CN)
Joilet, IL
December 13, 2014***

**CANADIAN NATIONAL REAR END
COLLISION**
CN TRAIN A-404 AND CN TRAIN U-738
JOLIET, ILLINOIS-DECEMBER 13, 2014

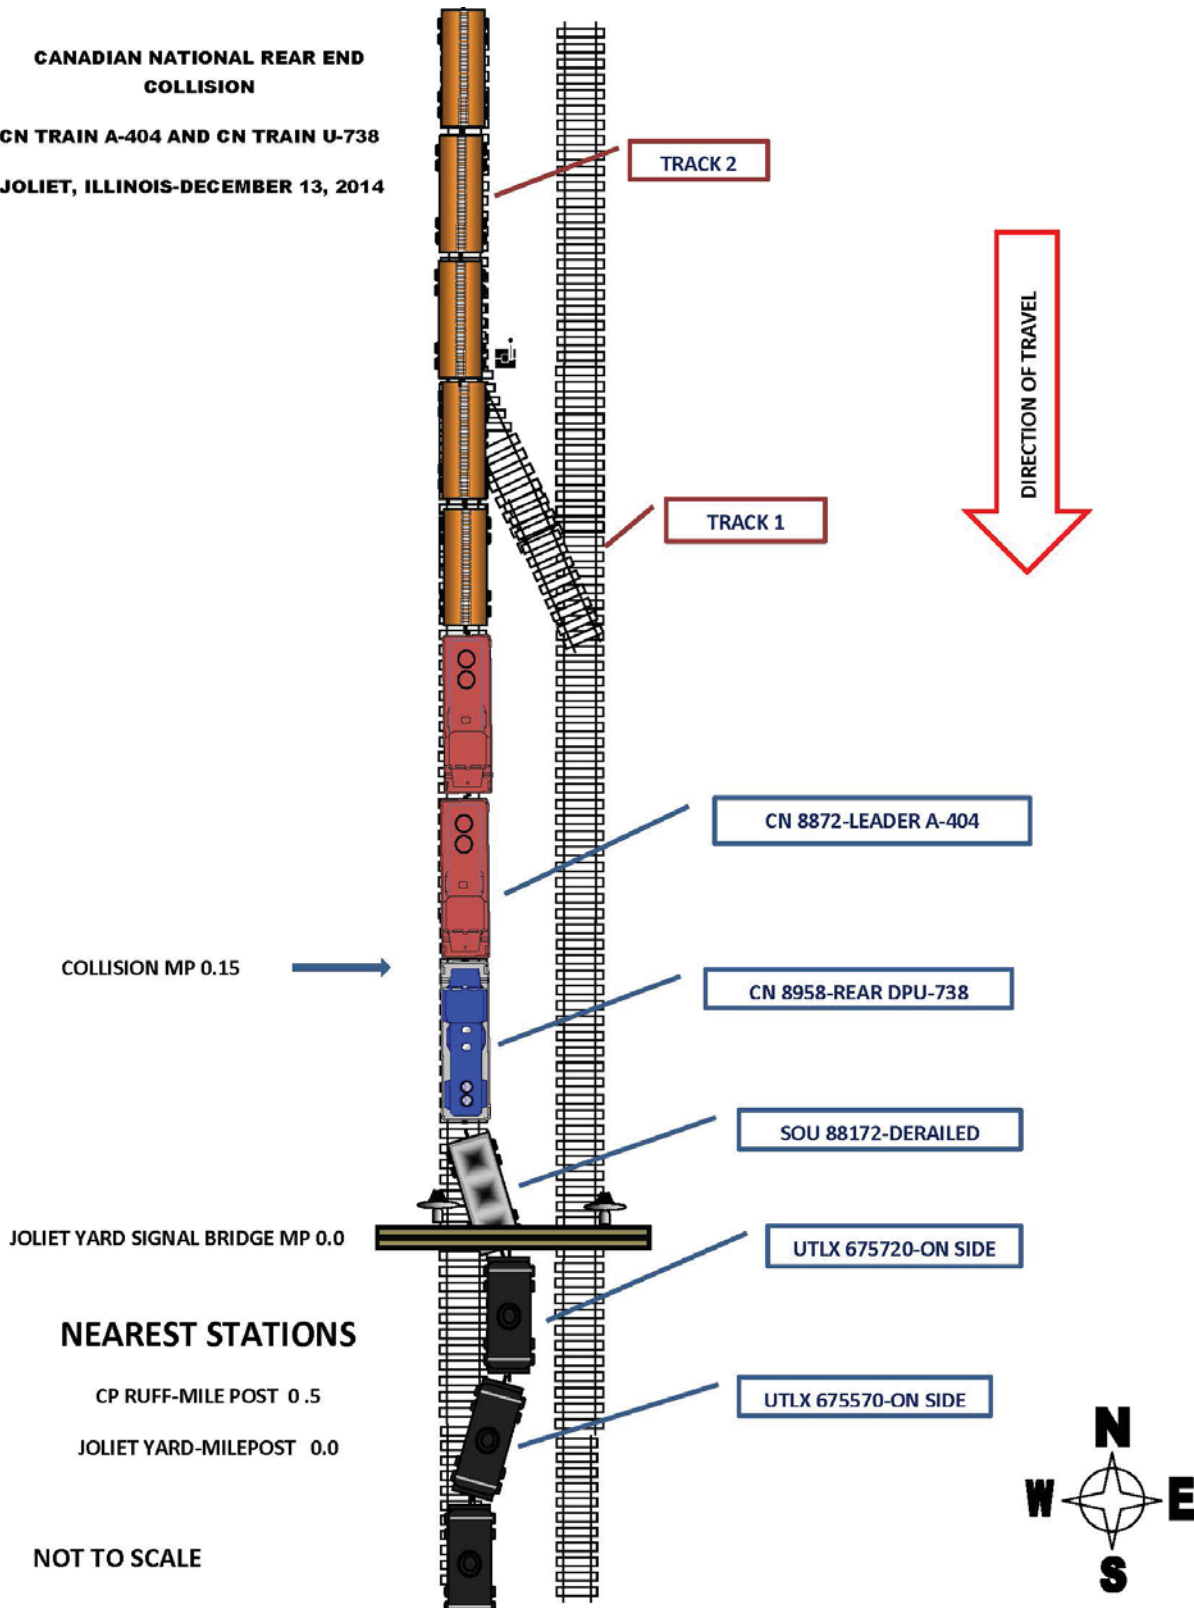
HQ-2014-21 Sketch

At 9:37 a.m. CST, on December 13, 2014, Canadian National Railway (CN) A404-81-11, (A404), southbound train, loaded with 111 cars of mixed freight, passed a restricting signal at Milepost 0.5 Control Point (CP) Ruff and impacted the rear Distributive Power Unit (DPU) locomotive of CN U738-51-07 (U738) at Milepost 0.15.

Train U738, southbound, consisting of 98 loaded tank cars of non-Bakken crude and 2 loaded buffer cars was stopped on the Leighton Subdivision, Main Track No. 2. The recorded speed of the collision was 17 mph. As a result of the collision, the rear DPU locomotive, one buffer car, and three tank cars were derailed. Two tank cars were on their sides, however, none of the tank cars were breached and no explosion occurred. These tank cars are DOT 111S -100W1 built in 2013.
