***Federal Railroad Administration
Office of Railroad Safety
Accident and Analysis Branch***

***Accident Investigation Report
HQ-2014-15***

***Union Pacific Railroad Company (UP)
Winterhaven, CA
November 1, 2014***

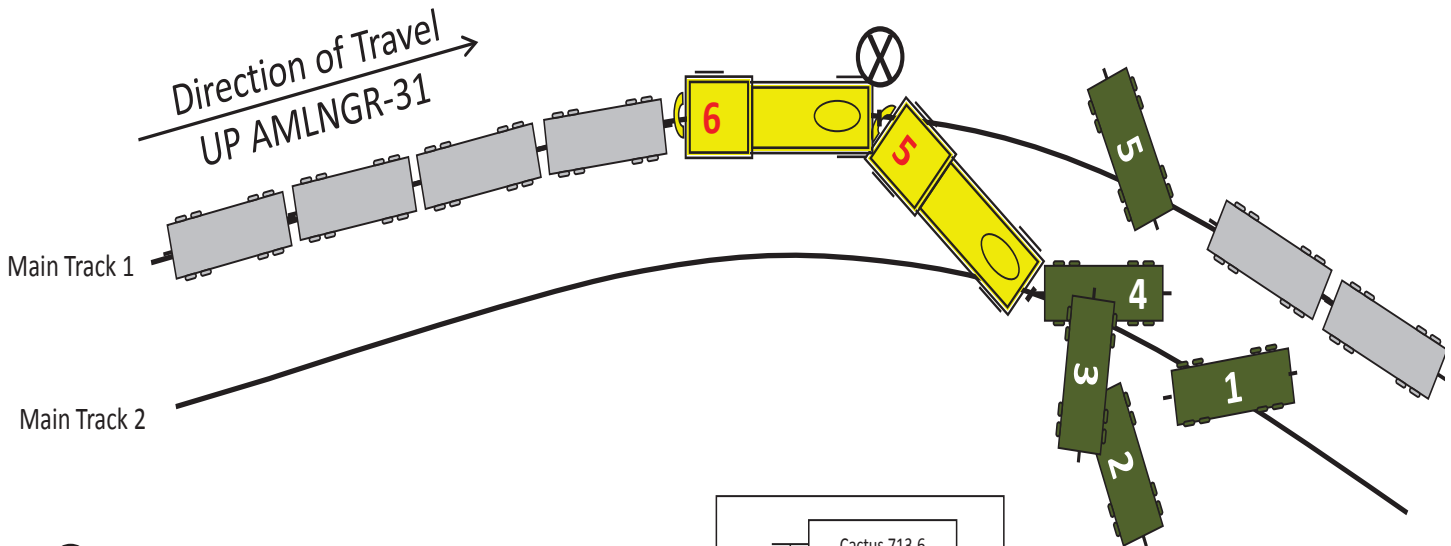
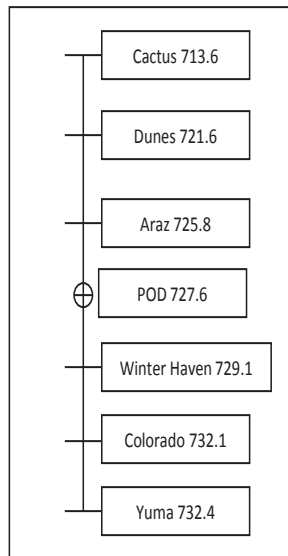
HQ-2014-15
Winterhaven, CA
11/01/2014

Point of Derailment – MP 727.6

UP AMLNGR-31

5 - UP Locomotive 5136
6 - UP Locomotive 4927
74 Empties

UP ZLCAI-01

4 Locomotives
1- Well Car Derailed
2- Well Car Derailed
3- Well Car Derailed
4- Well Car Derailed
5- Well Car Derailed
Total 92 Loads
