***Federal Railroad Administration
Office of Railroad Safety
Accident and Analysis Branch***

***Accident Investigation Report
HQ-2014-20***

***Union Pacific Railroad Company (UP)
Belden, CA
November 25, 2014***

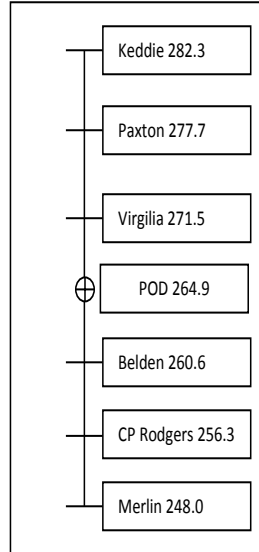
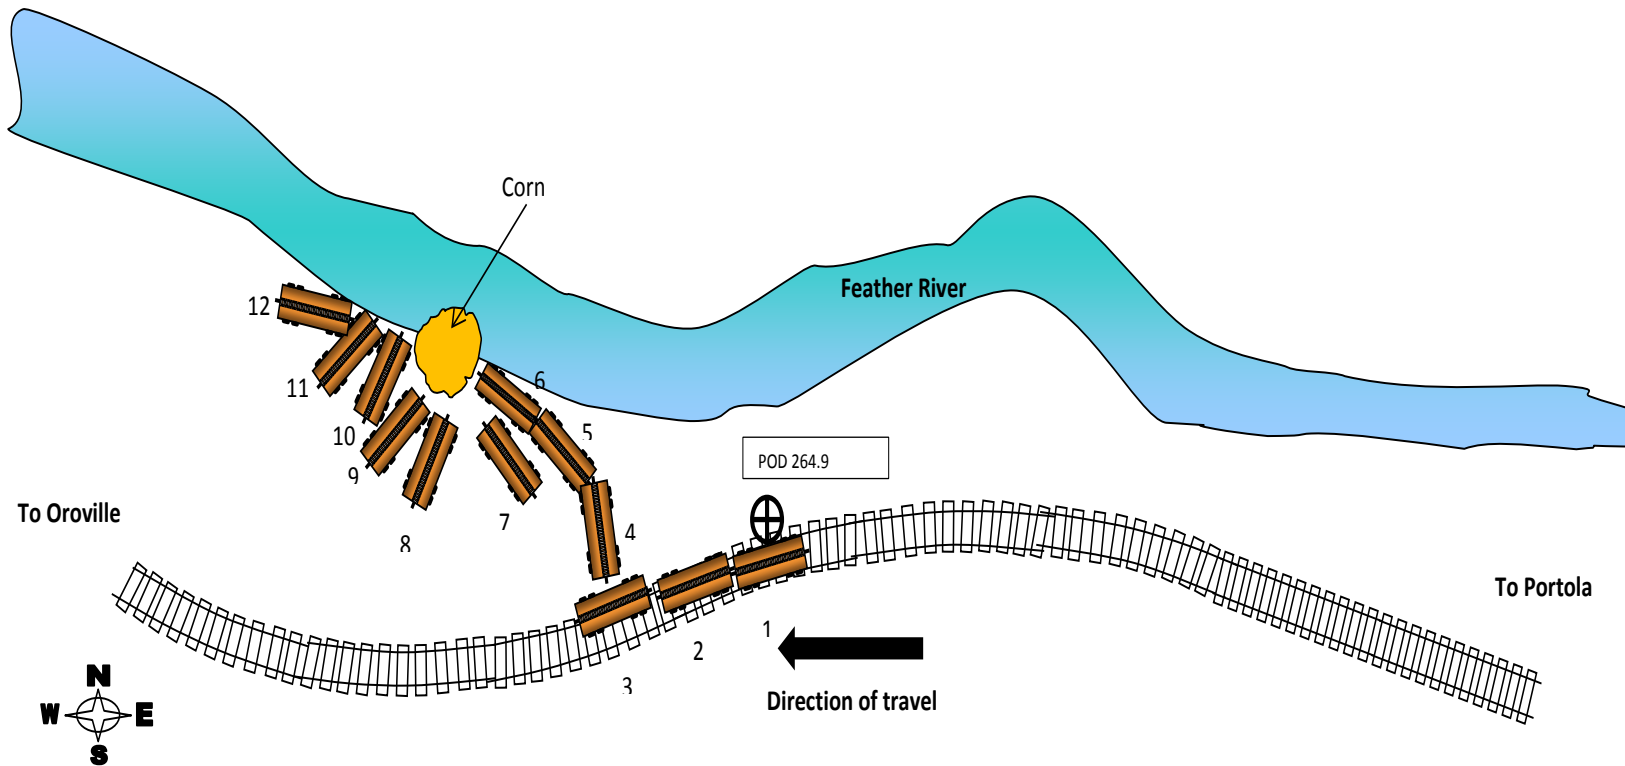
Belden HQ-2014-20

1. AOK 67160
2. CHTT 720577
3. CITX 701124
4. CNW 174769
5. UP 92509
6. CMO 21215
7. UP 221401
8. CTRN 100366
9. CMO 21687
10. CTRN 100030
11. CHTT 720905
12. UP 93401

Twelve cars, lines 36 through 47 from the head end of the train, derailed. Nine of the 12 derailed cars rolled down the embankment towards the Feather River. One car was upright, and two cars were leaned on their side. At least one car released a quantity of feed corn into the river. The train derailed on a 2-degree, 22-minute curve. The superelevation on the curve was 3/4 of an inch. This track is listed in the timetable as Class 2 with a maximum speed of 25 mph for freight trains.
