***Federal Railroad Administration
Office of Railroad Safety
Accident and Analysis Branch***

***Accident Investigation Report
HQ-2013-31***

***BNSF Railway Company (BNSF)
Casselton, ND
December 30, 2013***

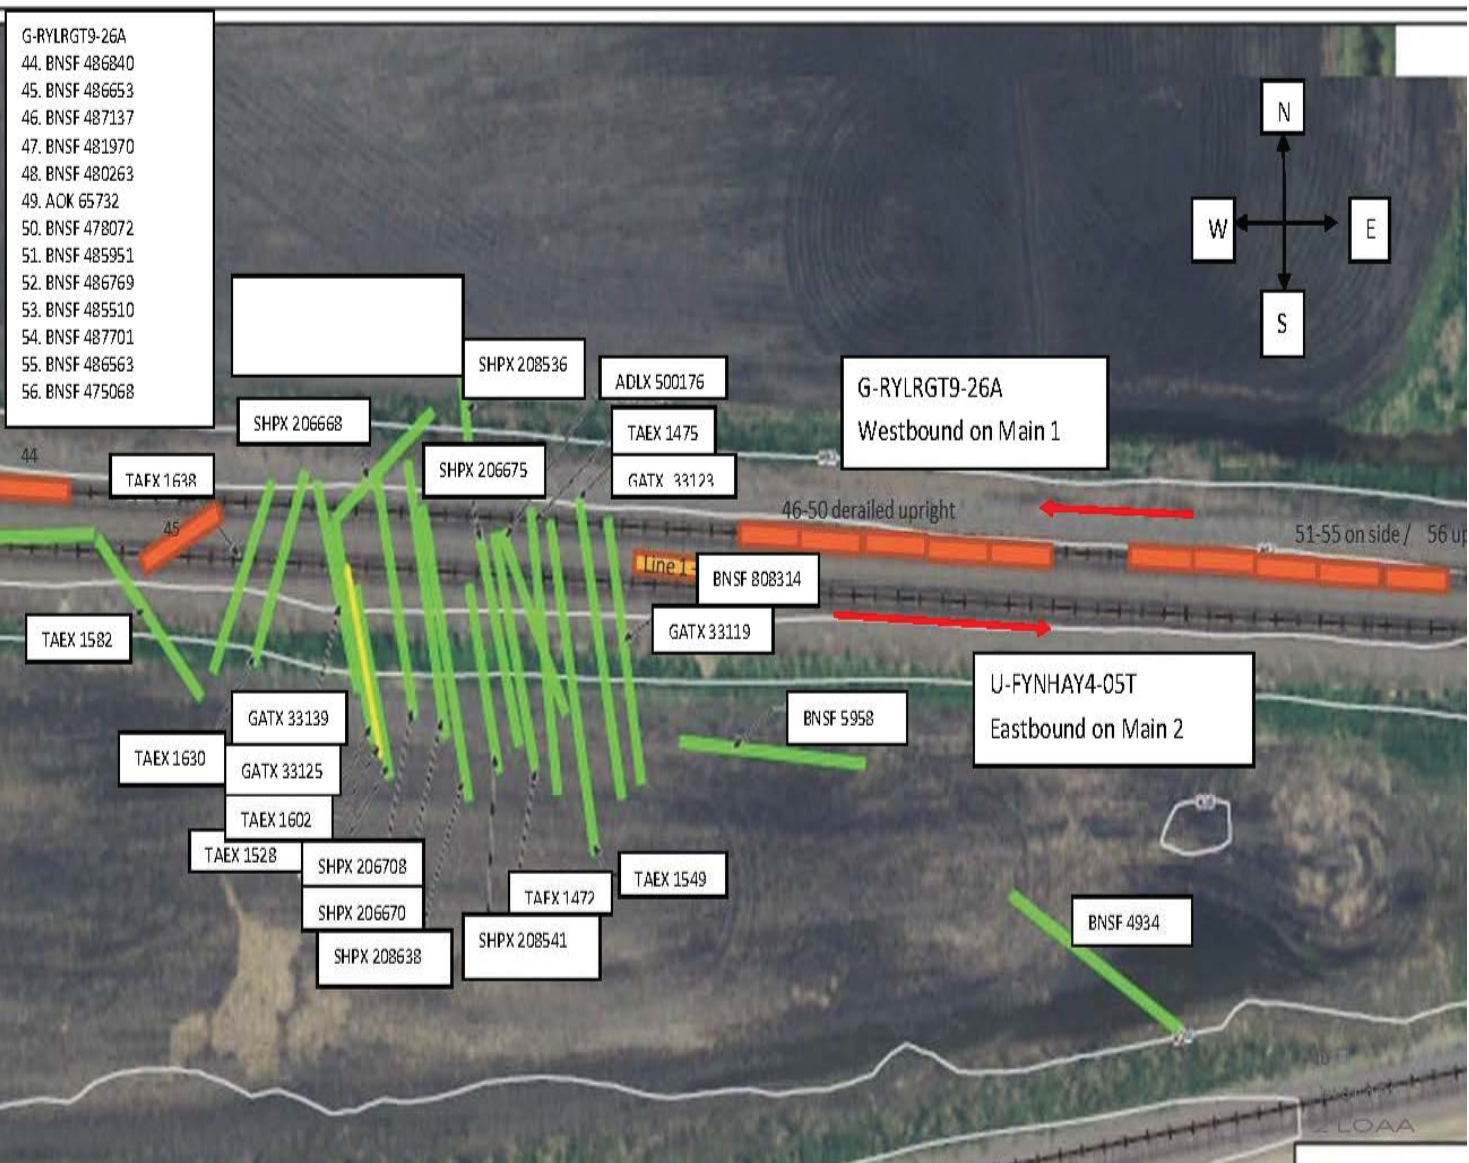
HQ-2013-31 Sketch

1.) The derailment occurred approximately 20 miles west of Fargo, North Dakota, at Milepost 28.5 on the BNSF's KO Subdivision, of the Twin Cities Division in the town of Casselton. The derailment occurred in the middle of the train resulting in one of the grain cars, the 45th railcar (BNSF 486653), which was in consist position 47, derailling in the foul of Main Track 2.

2.) A few seconds after railcar BNSF 486653 derailed and fouled Main Track 2, an eastbound BNSF Crude Oil Train, U-FYNHAY4-05T, consisting of two head-end locomotives, one rear DPU, and 106 loaded cars collided with BNSF 486653 and derailed the two leading locomotives, as well as 21 trailing cars (consist positions 3 through 23). After the collision, an estimated 474,936 gallons of Petroleum Crude Oil, UN 1267, PG 1 (petroleum crude oil) was released from 18 loaded tank cars fueling a fire which caused subsequent explosions as the loaded oil tank cars burned.

FRA's inspection determined that the Point-Of-Derailment was 96'6" east of the switch point on Main Track One at MP 28.5. The inspection also determined there were no visible track defects which would have contributed to the derailment.
