***Federal Railroad Administration
Office of Railroad Safety
Accident and Analysis Branch***

***Accident Investigation Report
HQ-2015-1016***

***Southern California Regional Rail Authority (SCAX)
Oxnard, CA
February 24, 2015***

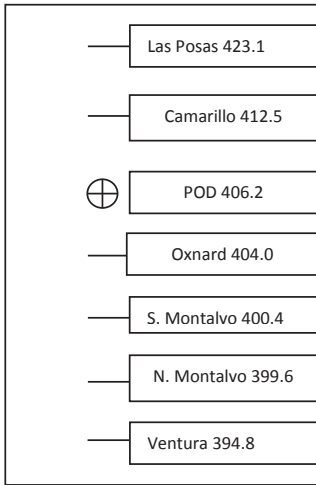
MetroLink Oxnard PDF

Direction of Pick-up truck and utility trailer making a right-hand turn.

Direction of Train
RR South

1. SCAX 645
2. SCAX 206
3. SCAX 211
4. SCAX 263
5. SCAX 870
