U.S. Department
of Transportation
**Federal Railroad
Administration**

RR 17-07 | May 2017

INDUSTRY SURVEY OF BOLSTERS AND SIDE FRAMES REMOVED FROM SERVICE

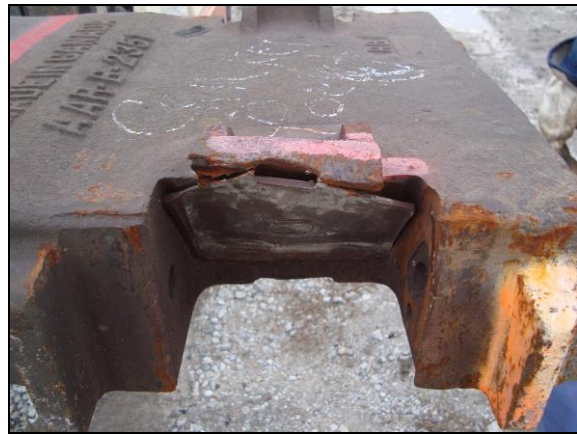
For bolsters, the survey found the most common problem area was the pocket. Worn pockets and cracked pockets accounted for almost 60 percent of the defects severe enough for removal from service. Figure 1 shows a cracked pocket in a bolster.

Figure 1. Cracked pocket in a bolster removed from service

Reducing the top two or three scrap causes would eliminate more than 50 percent of the scrapped components recorded in this research. Eliminating cracked pockets or reducing pocket wear would greatly reduce bolster scrap.

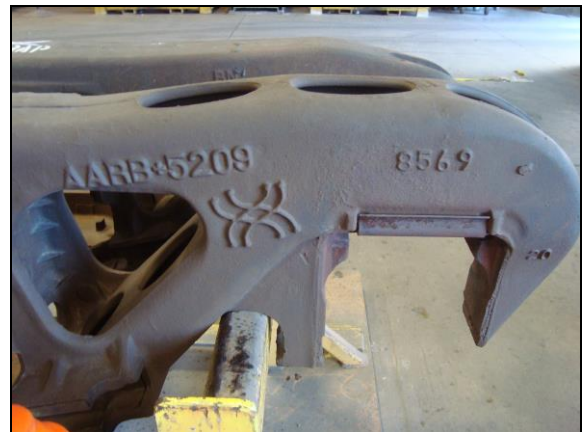
Approximately 70 bolsters and 55 side frames were examined for this survey. In a few cases, multiple defects were evident in one casting. Figure 2 shows the cracked pedestal jaw area of a side frame removed from service.

Figure 2. Cracked pedestal jaw of a side frame removed from service

The side frames had cracked pedestal jaws and bent pedestals that accounted for 50 percent of the defects. The pedestal jaws usually experience the highest loads during service.

Eliminating side frame defects of cracked pedestal jaws and bent pedestals would greatly reduce side frame scrap.

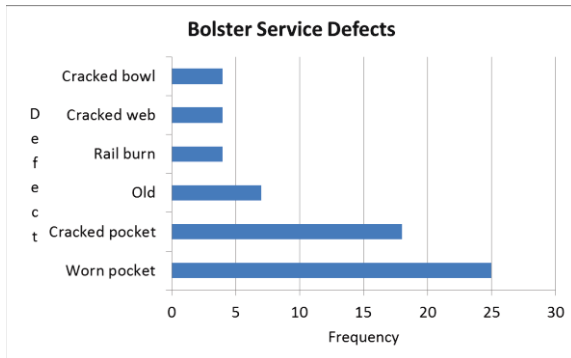
For bolsters being analyzed, TCCI personnel recorded 12 types of defects during the survey. Figure 3 shows the top six occurring defect types for bolsters; they accounted for 83 percent of the defects in bolsters examined for this survey.

Figure 3. Top six bolster defects

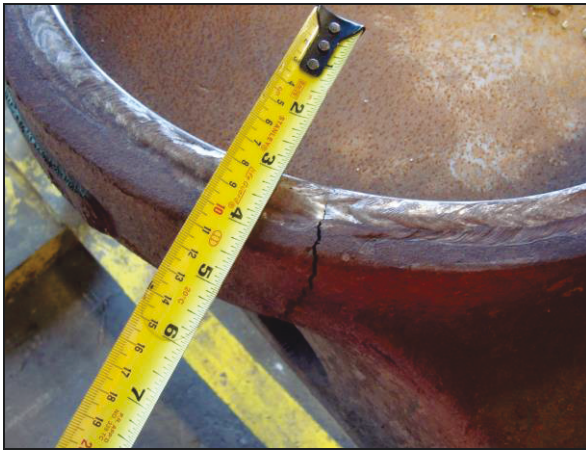
The majority of the bolster defects were cracked pockets and worn pockets. Old castings, rail burns, cracked webs, and cracked bowls were the other leading defects in bolsters. Figure 4 shows a cracked bowl in a bolster.

Figure 4. Cracked bowl in bolster removed from service

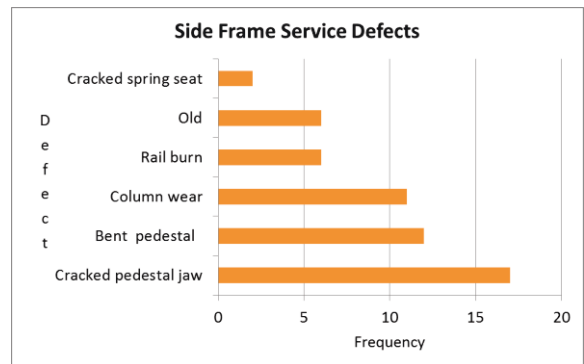
For the side frames, nine types of defects were recorded during the survey. Figure 5 shows the top six side frame defects, which represent 93 percent of the defective side frames examined.

Figure 5. Top six side frame defects
