***Federal Railroad Administration  
Office of Railroad Safety  
Accident and Analysis Branch***

***Accident Investigation Report  
HQ-2015-1005***

***CSX Transportation (CSX)  
Martin, SC  
January 27, 2015***

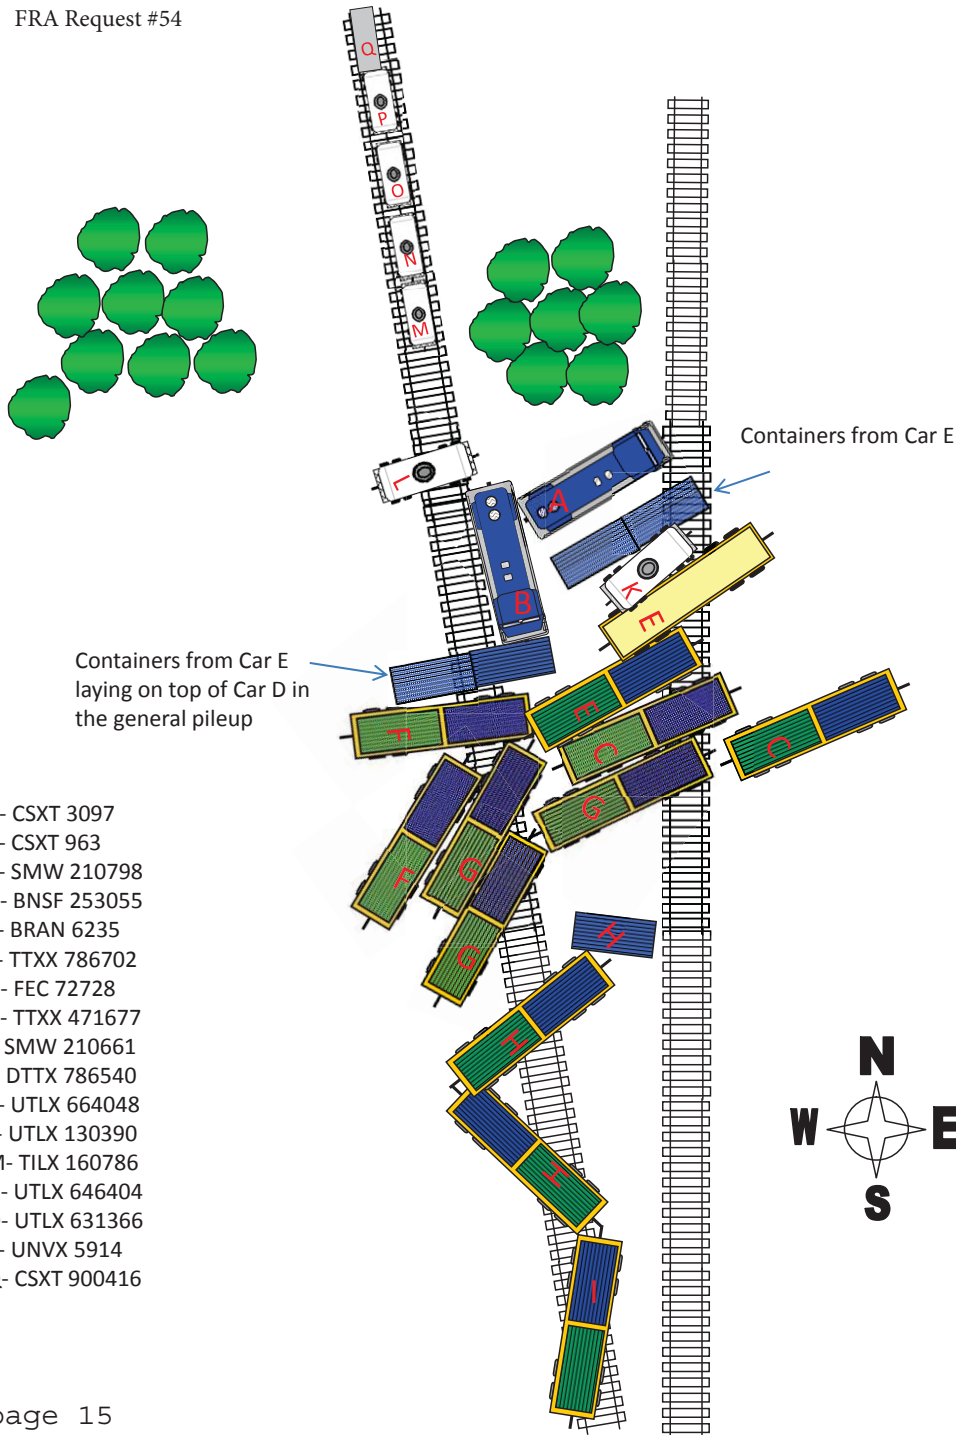
Accident Sketch

The accident was caused by vandalism to the main line switch located at MP AMH 489.20. The Sandoz Spur switch had been lined and locked in the reverse position and the switch target turned to show a normal mainline move to the approaching train.
