***Federal Railroad Administration
Office of Railroad Safety
Accident and Analysis Branch***

***Accident Investigation Report
HQ-2016-1116***

***Altamont Commuter Express Authority (ACEX)
Sunol, CA
March 7, 2016***

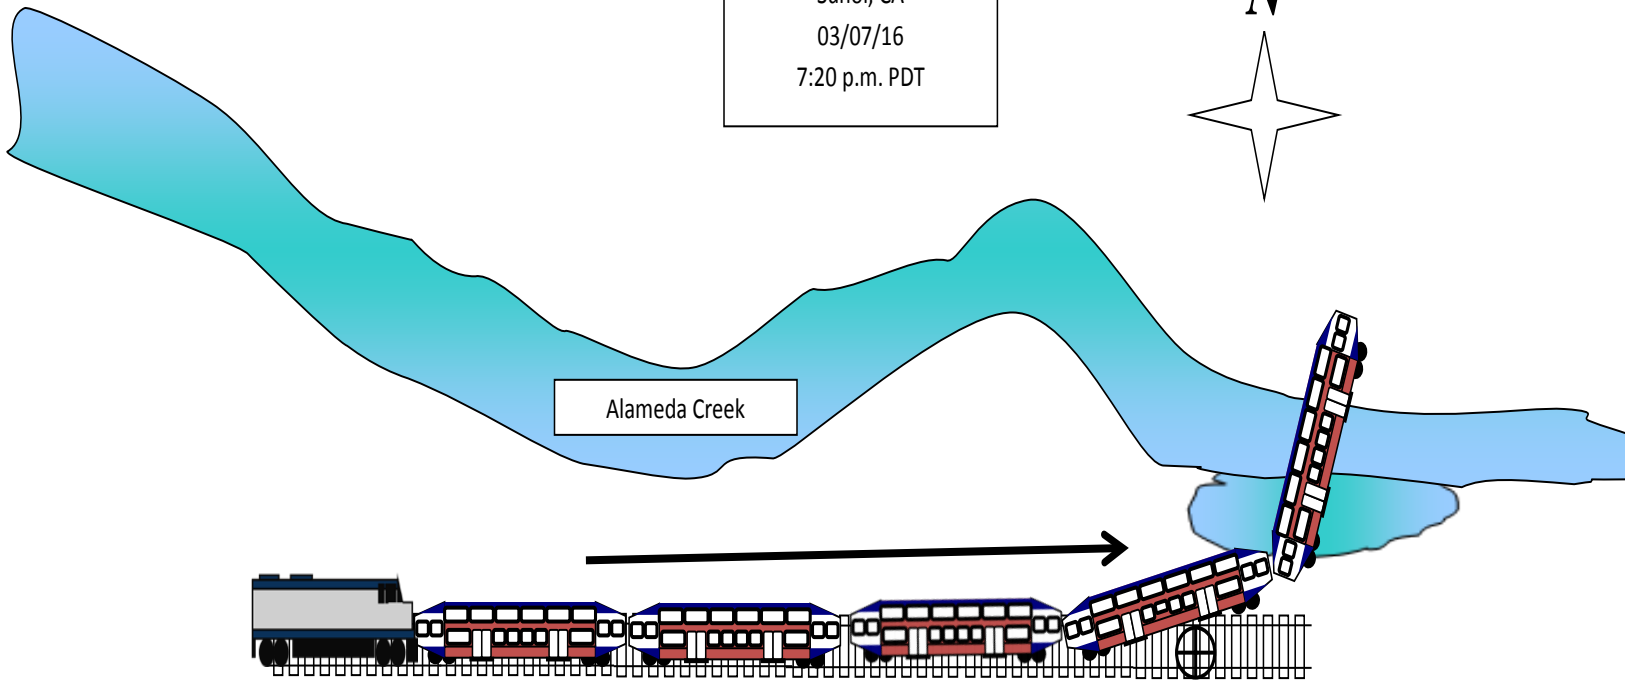
ACE Sunol Sketch

HQ-2016-1116
Sunol, CA
03/07/16
7:20 p.m. PDT
