## Appendix A.1: Equipment Interactions

## Appendix A.2.1: Additional Detail on Structural Damage to Passenger Locomotive and Cars

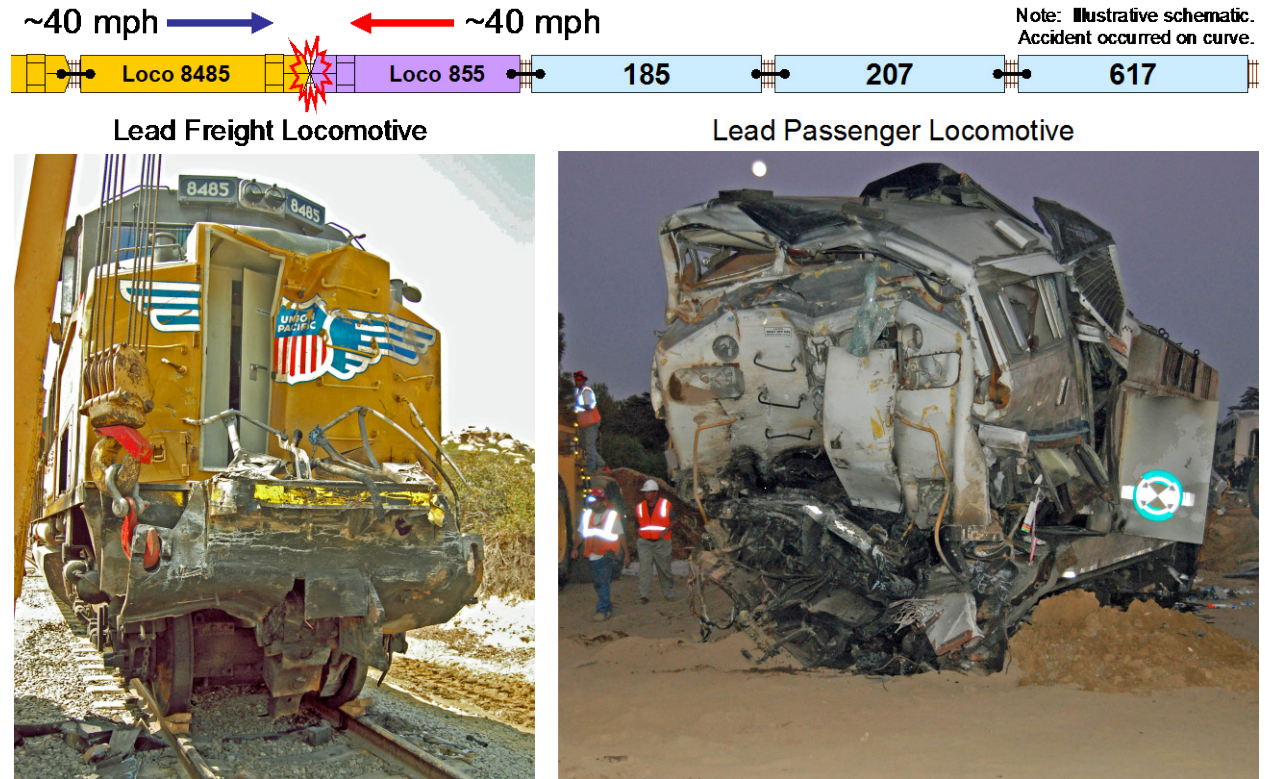
**Figure A.1-1. Lead Freight and Passenger Locomotives, Impact Ends**

Figure A.1-1 shows the impact ends of the lead passenger and freight locomotives. The freight locomotive sustained substantially less damage than the passenger locomotive. Damage to the freight locomotive includes separation of the plow, the breast plate bent up under the underframe, damage to the short-hood door and sheet metal. The draft gear box is largely destroyed, and the draft gear and broken coupler shank can be seen hanging down in the photograph. The collision posts remain essentially intact, and the truck is attached. The passenger locomotive is shown after it has been up-righted. While the shape of the cab appears recognizable, the cab has been pushed back over the rotating equipment, eliminating the operator's survival space. The collision posts have been separated from their attachments to the underframe, and the lead truck is not under this locomotive.

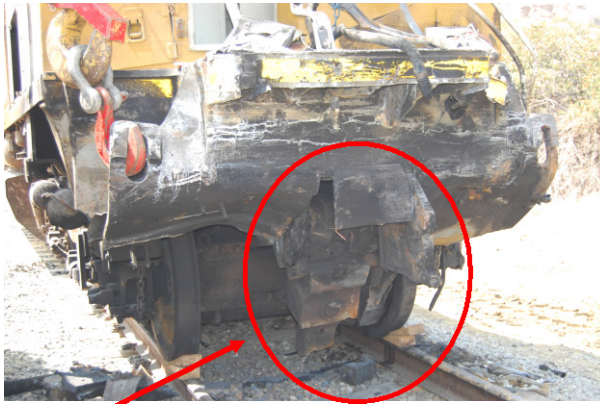
**Figure A.1-2. Coupler and Draft Gear Damage, Lead Freight and Passenger Locomotives**

Broken coupler shank. Coupler draft pocket deformed and oriented downward.

Pilot fractured and tore away. Sides of draft gear pocket fractured.

Coupler and draft gear pocket fractured off of locomotive underframe.

Figure A.1-2 shows the remains of the coupler pockets and draft gear housings of the lead freight and passenger locomotives. Both are substantially damaged. Most of the draft gear housing has been separated from the passenger locomotive and the draft gear, yoke, and coupler are missing from the photograph. The freight draft gear housing also appears to be largely missing, but the draft gear, yoke, and broken coupler shank are hanging, and appear trapped by the bent breast plate.

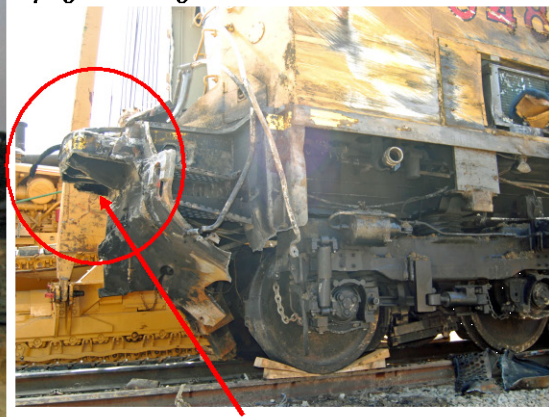
**Figure A.1-3. Anti-climber Engagement of Lead Freight and Passenger Locomotives**

Passenger Locomotive Anti-climber Engages Beneath Freight Locomotive Anti-climber.

Freight Locomotive Anti-climber Engages Above Passenger Locomotive Anti-climber.

Figure A.1-3 shows the anti-climbers on the lead freight and passenger locomotives. The anti-climbers appear to have functioned as intended, helping to keep one locomotive from climbing the other. The anti-climber of the passenger locomotive appears to have locked under the anti-climber of the freight locomotive. The freight anti-climber appears to have speared through the short hood of the passenger locomotive, near its attachment to the underframe.

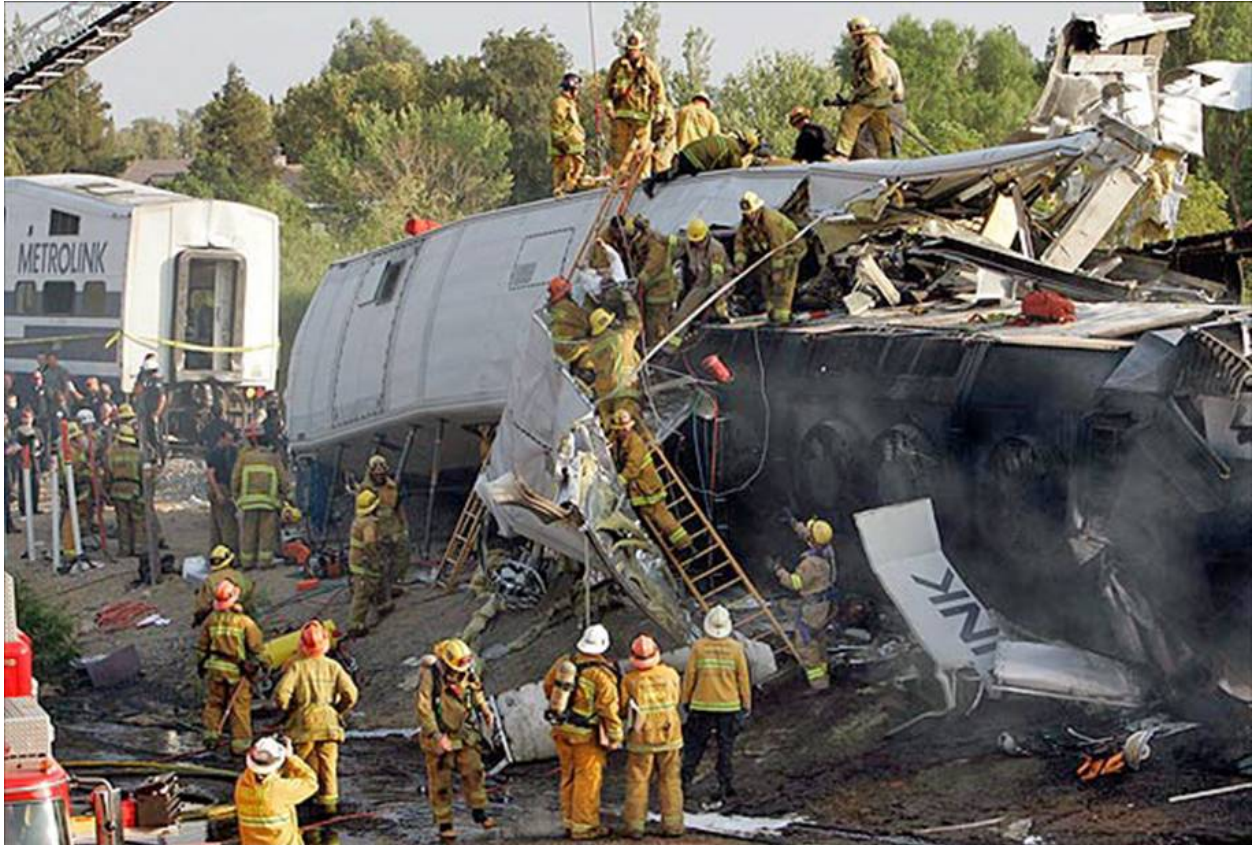
**Figure A.1-4. Interaction of Passenger Locomotive and First Passenger Car**

Figure A.1-4 shows the interaction of the passenger locomotive and the first passenger car. There was extensive structural damage to the passenger car, while there appears to be little damage to the trailing end of the locomotive. The photograph shows the locomotive telescoped into the passenger car. The locomotive is on its side, while the passenger car is not quite fully on its side. (Note: the photograph shows the cars in reverse position from the schematic above that illustrates the relative position of cars in the collision).

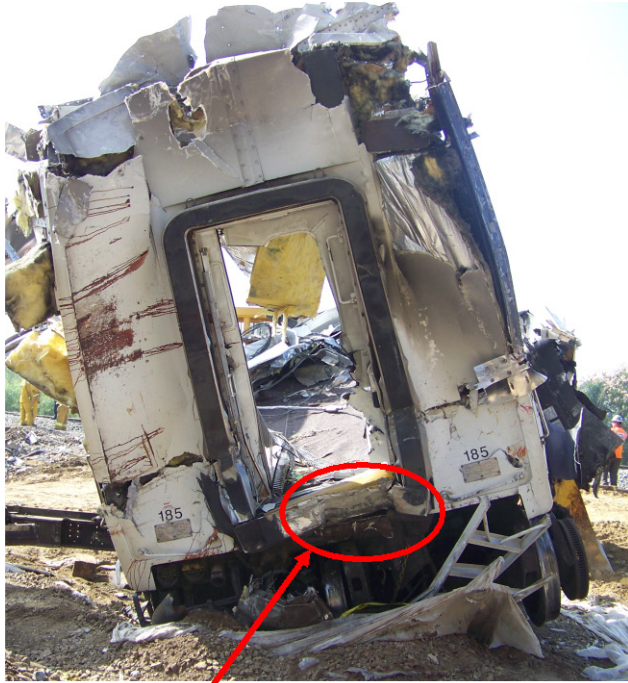
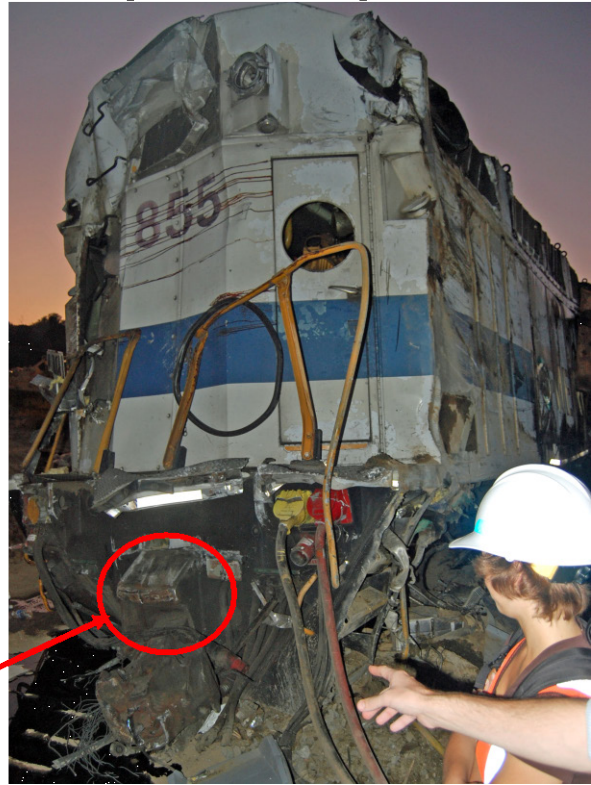
**Figure A.1-5. First Passenger Car Lead End Frame Interaction with Locomotive Trailing End Bellmouth**

Indentation from  
Locomotive Bellmouth

Figure A.1-5 shows the lead end structure of the first passenger car, after it has been extracted from the body of the car. The collision and corner posts are essentially intact. There is a large dent in the underside of the end beam, circled in red. The shape of this dent corresponds to the shape of the bellmouth on the trailing end of the locomotive, which is also circled. This dent suggests that the rear of the passenger locomotive applied an upward vertical force to the front of the passenger car, as the front of the passenger car was also pitching downward.

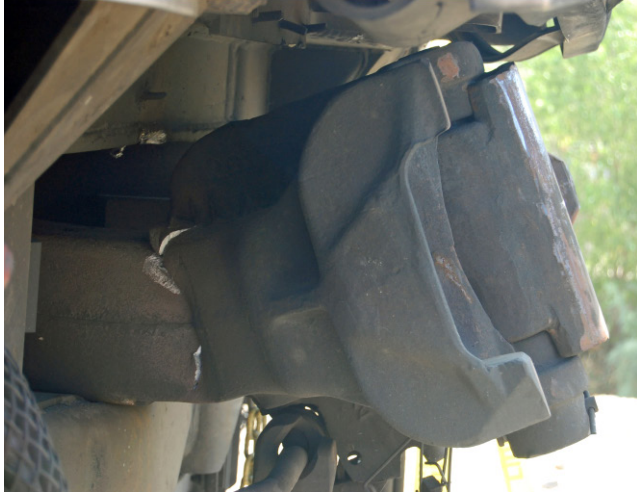
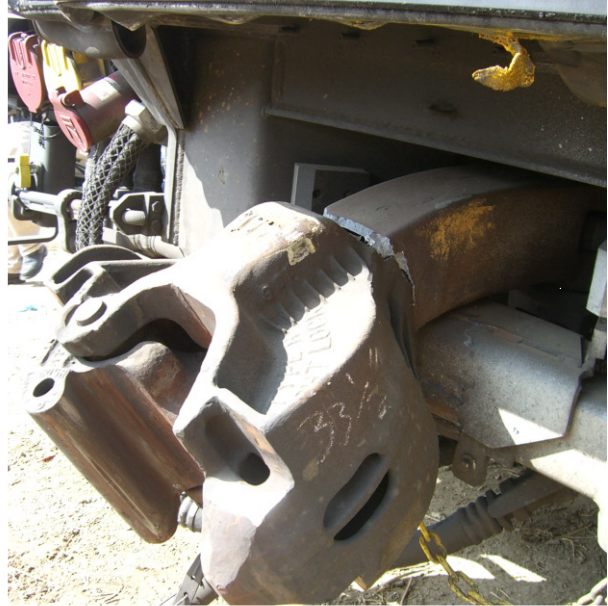
**Figure A.1-7. Trailing Coupler of Lead Passenger Car and Leading Coupler of Second Passenger Car**

Figure A.1-7 shows the trailing coupler of the lead passenger car and the leading coupler of the second passenger car. At some point during the accident, the cars became uncoupled, but the extent of damage suggests that the cars remained coupled for most of the impact, including the pitching forward discussed in relation to Figure A.1-5. There is significant material failure near where the head blends into the shank in both couplers. This damage suggests that the lead car tried to override the second car.

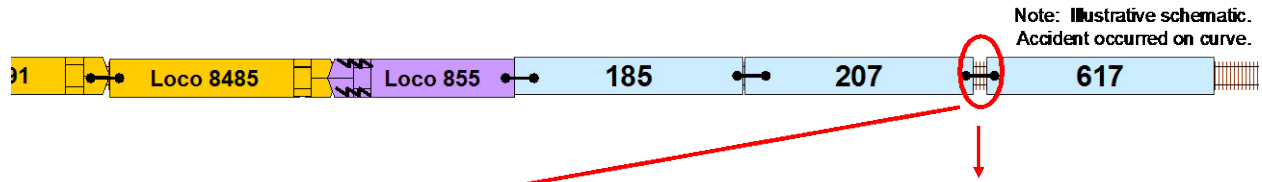
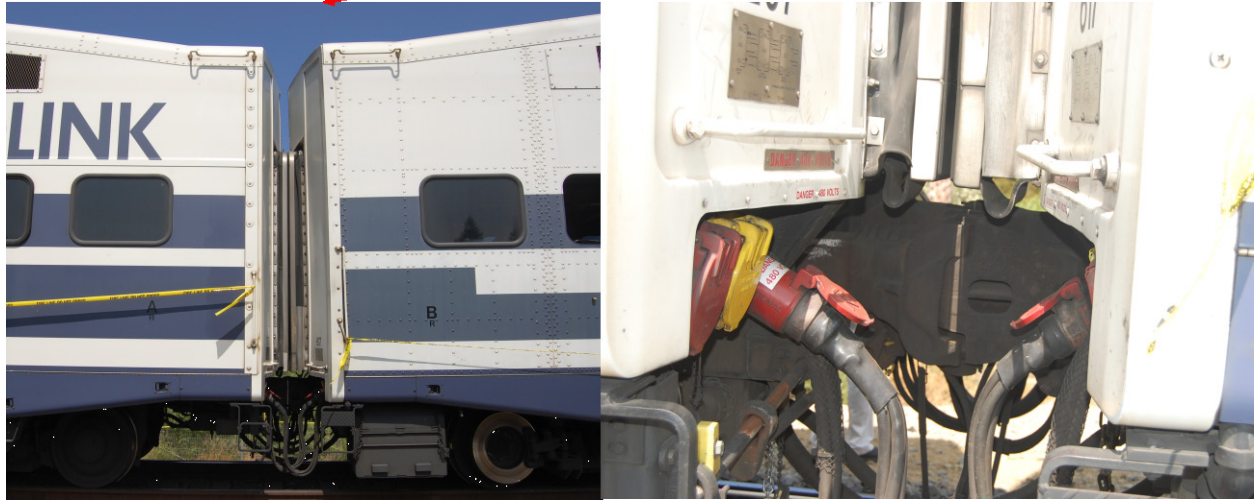
**Figure A.1-8. Interaction of Second Passenger Car and Trailing Cab Car**

Figure A.1-8 shows the coupled connection between the second passenger car and the trailing cab car. There is little damage at this interface. Both cars remained on the track, and rolled backward after the impact, for a distance of what is estimated to be between 80 and 100 feet.

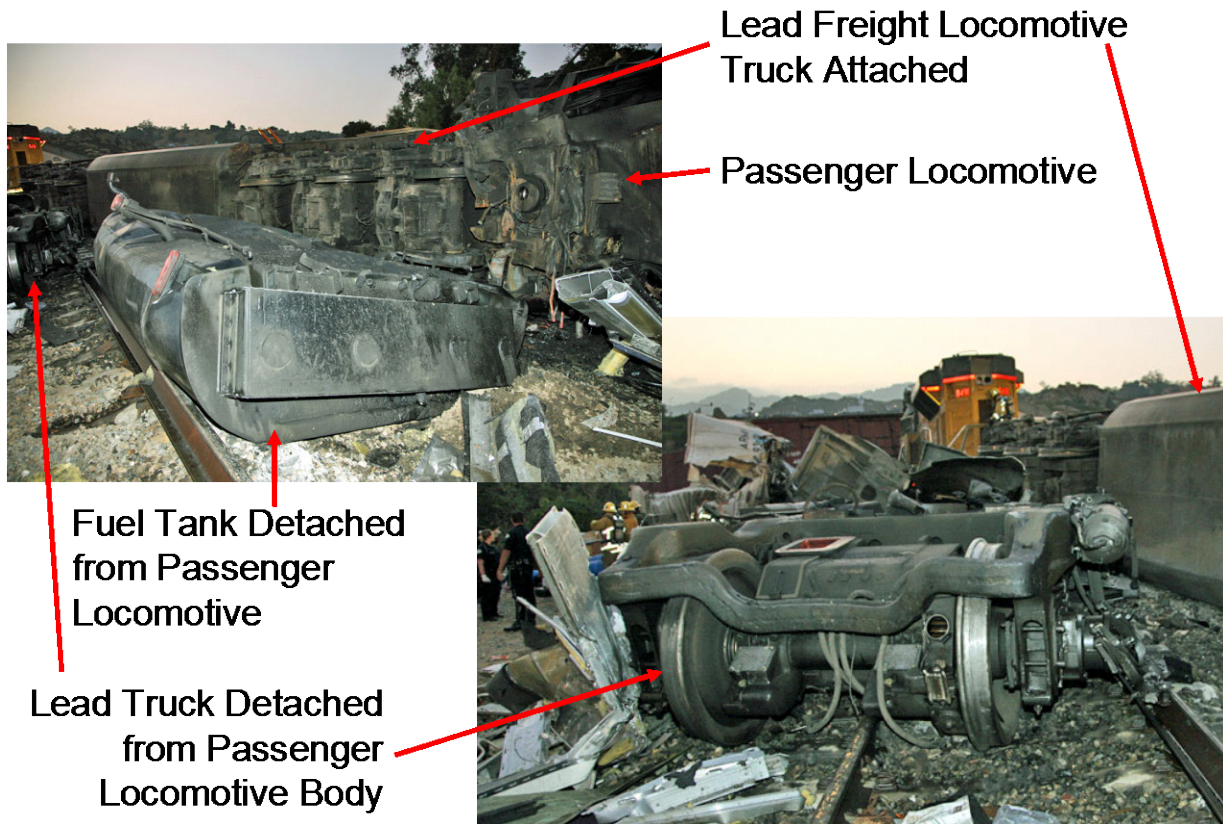
**Figure A.2.1-3. Passenger Locomotive Fuel Tank and Lead Truck Separated from Locomotive**

Figure A.2.1-3 shows the passenger locomotive fuel tank and lead truck. Both the fuel tank and truck were separated from the locomotive, and found proximate to the lead freight locomotive. It appears that the truck separated owing to crush of the attachments on the locomotive body bolster, and that the fuel tank separated due to impact with the lead truck. There were significant breaches of the fuel tank, and a fire fed by the spilled fuel. More detail on the fuel tank damage is provided in Appendix A.3.

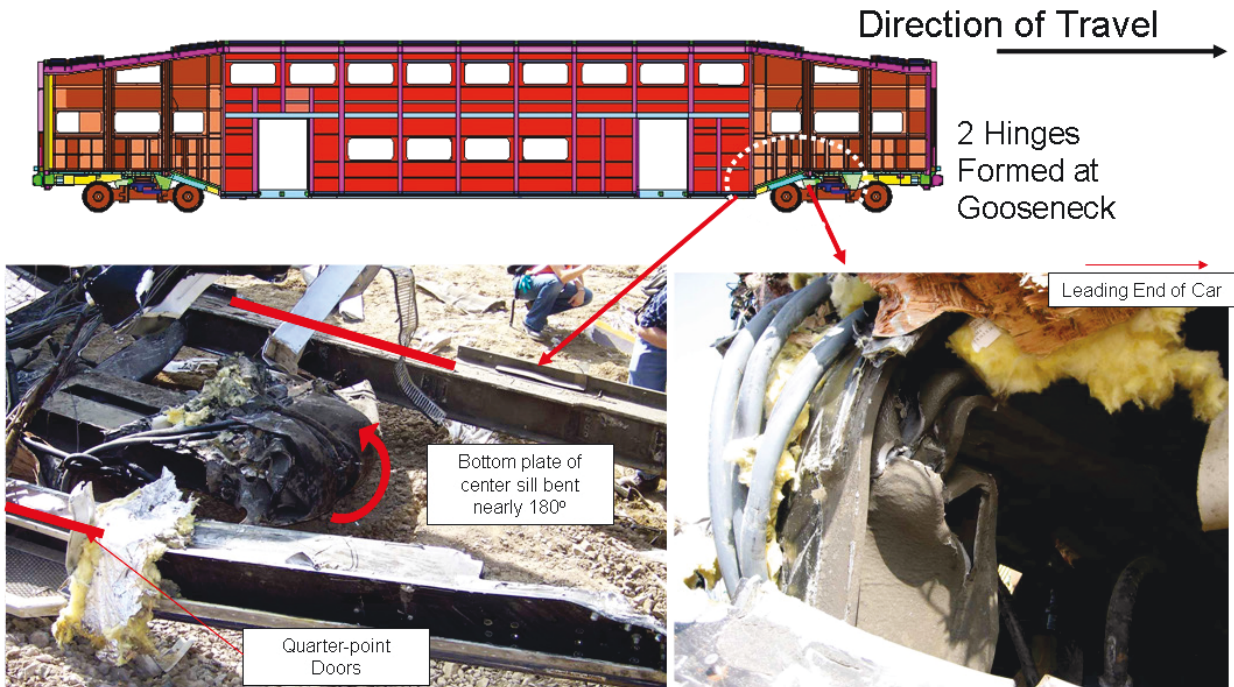
**Figure A.2.1-4. Gooseneck Damage**

Figure A.2.1-4 includes a schematic of the first passenger car, with the primary area of structural collapse circled. The primary area of structural collapse is termed the gooseneck. In this part of the structure, the underframe transitions from being above the truck, approximately 34 inches above top-of-rail (TOR), down to 18.5 inches above TOR. This transition is made to accommodate the two-level center section of the car. The diagonal section of the gooseneck was apparently destroyed in the accident; as no evidence of it was found. The photograph in the lower left of the figure shows the remains of the end of the lower center sill. It can be seen that the end has been pounded and bent nearly 180° into a ‘U’ shape. The lower side sills extend to essentially their initial length. Holes for the rivet connections to the diagonal portion of the gooseneck can be seen in the right side sill. The photograph on the right shows the remains of the end of the single-level portion of the center sill. This end has been bent down about 90 degrees into a ‘L’ shape. This end of the center sill does not appear to have been pounded repeatedly, as the lower end of the side sill in the left side photograph appears to have been.

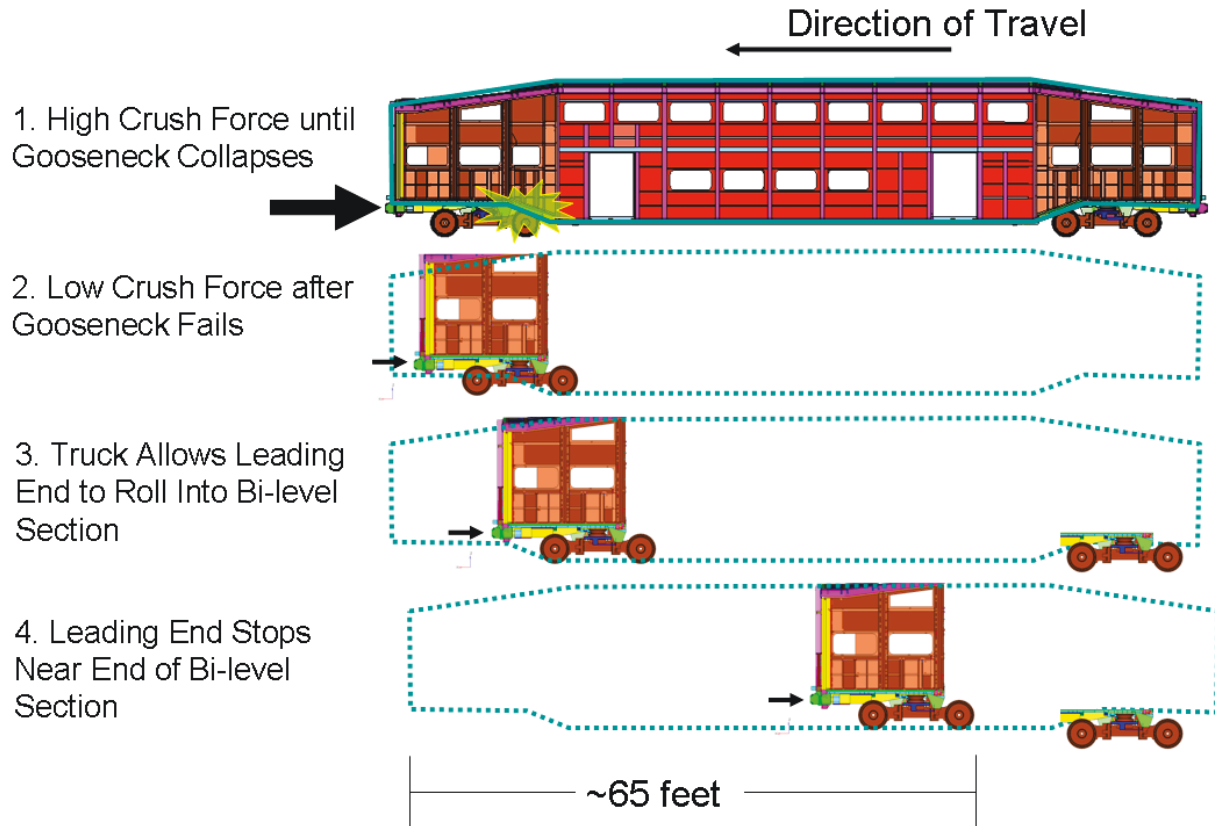
**Figure A.2.1-5. Progression of Gooseneck Collapse and Failure**

Figure A.2.1-5 shows schematics illustrating how the structural damage shown in Figure A.2.1-4 occurred. Shortly after the initial contact between the lead freight and passenger locomotives, a high force was generated between the leading passenger locomotive and leading passenger car. This force was sufficient to cripple and fail the gooseneck area of the passenger car underframe. Simultaneously, due to the geometry of the gooseneck and its mode of collapse, the end underframe and truck were vaulted upward. This upward movement raised the wheels of the lead truck to the height of the lower floor of the bi-level section of the car, and the center sill was no longer carrying a longitudinal force. A relatively low longitudinal load was provided by the remaining sidewall and roof structures. The end section of the car, including the truck that had lifted up, penetrated and moved backward through the bi-level section of the car with relatively little force.

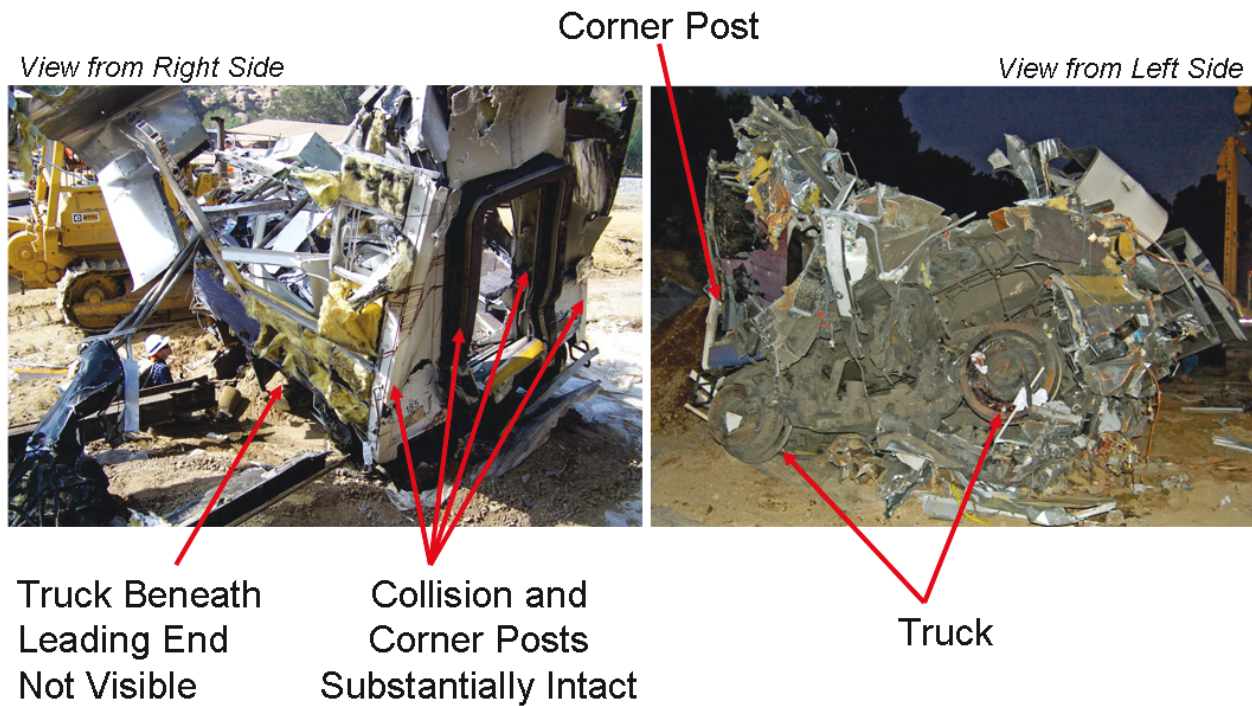
**Figure A.2.1-6. Remains of First Passenger Car Lead End Mezzanine Level**

Figure A.2.1-6 shows the remains of the lead end structure of the first passenger car, including the lead truck. The end frame, including both corner posts and both collision posts, is essentially intact. There is a significant amount of debris compacted onto the remains. The center and side sills of this single-level portion appear to be largely intact. The relatively light roof and sidewall structures have been stripped off, and likely contributed to the compacted debris.

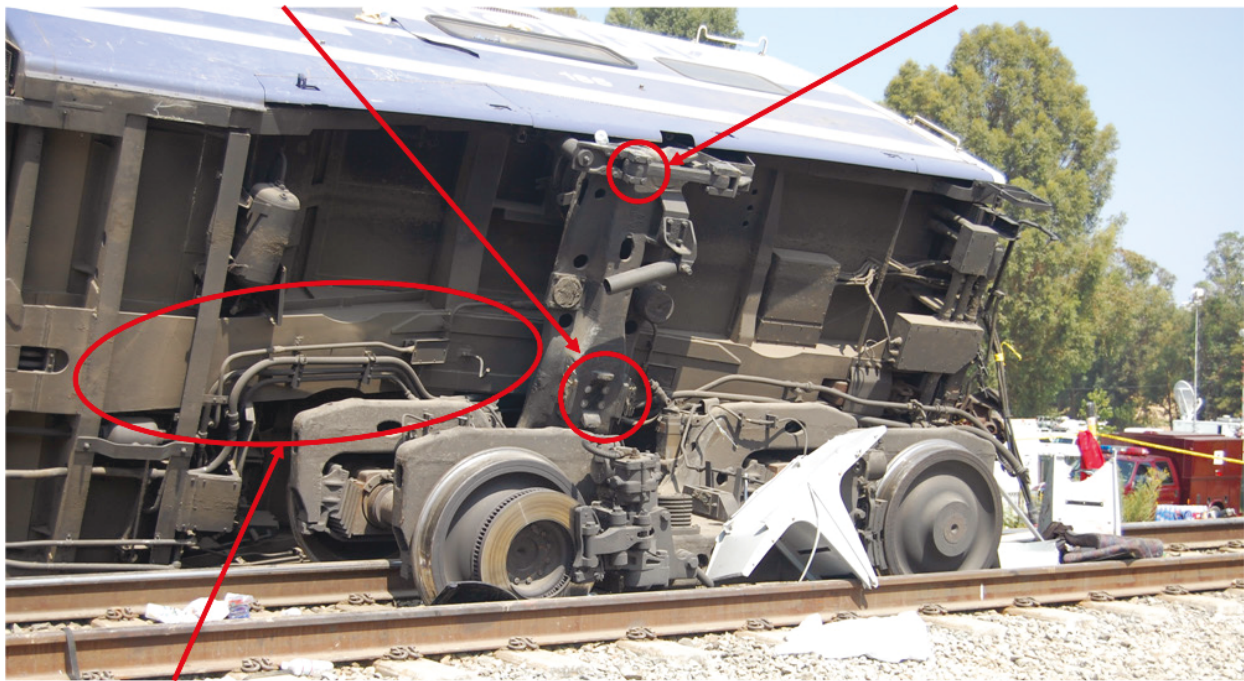
Failed Truck Retention Mechanism

Failed Linkage Connection

Gooseneck  
Substantially Intact

*Truck Attachment Failures Similar to  
Failures Observed in Single-Car Test*

Figure A.2.1-7 shows trailing end of the lead car. In the left side of the photograph, the transition structure of the underframe, including the gooseneck, can be seen to be nearly undamaged. The trailing truck, resting on the ground, is separated from the overturned carbody. The damaged truck-to-carbody connection elements are annotated. The damage to these elements is similar to damage observed in a single-car impact test of similar equipment [1].

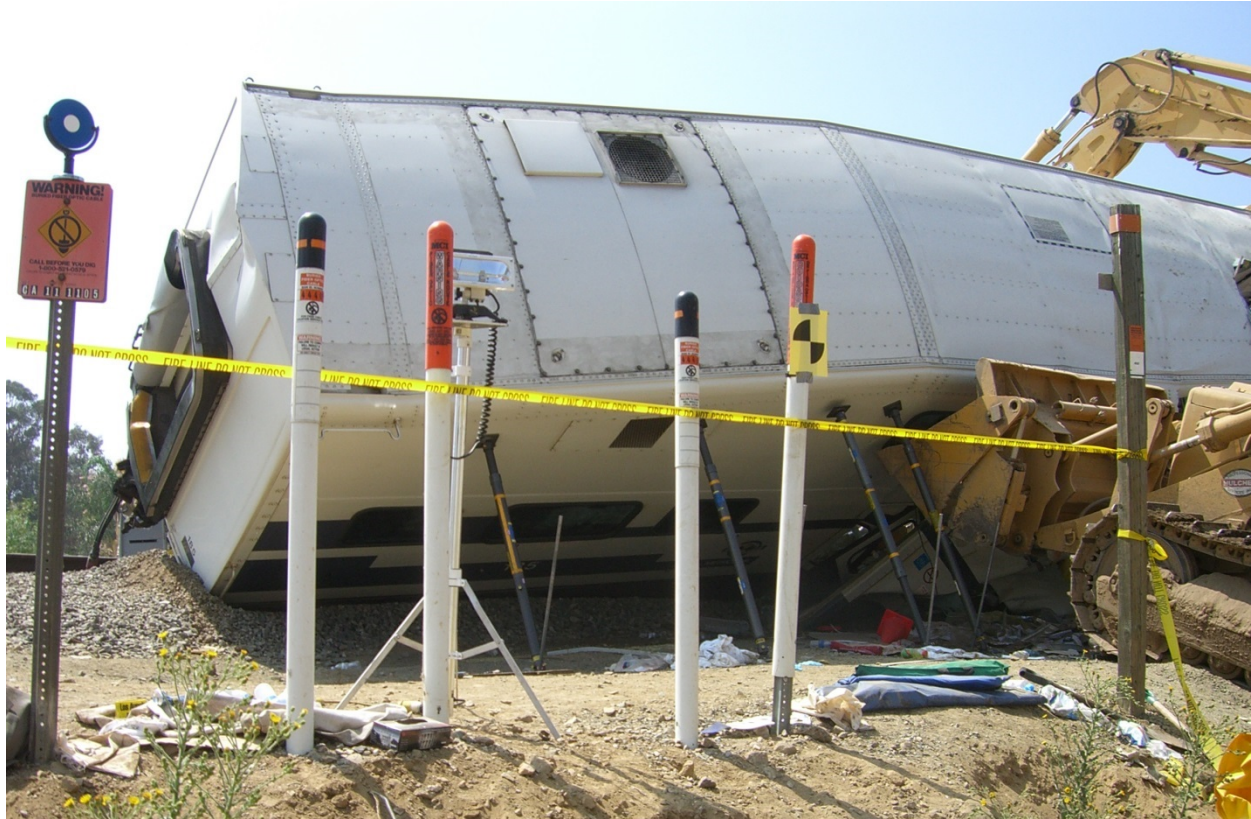
**Figure A.2.1-8. Right Side of Lead Passenger Car**

Figure A.2.1-8 shows the right exterior wall of the lead passenger car, which is being supported by a piece of earth-moving equipment. There is little visible damage to the sidewall, indicating that the car side did not slide along the ground. On the left side of the photograph, damage to the end wall can be seen, and may have been caused by contact with the roof of the trailing car.

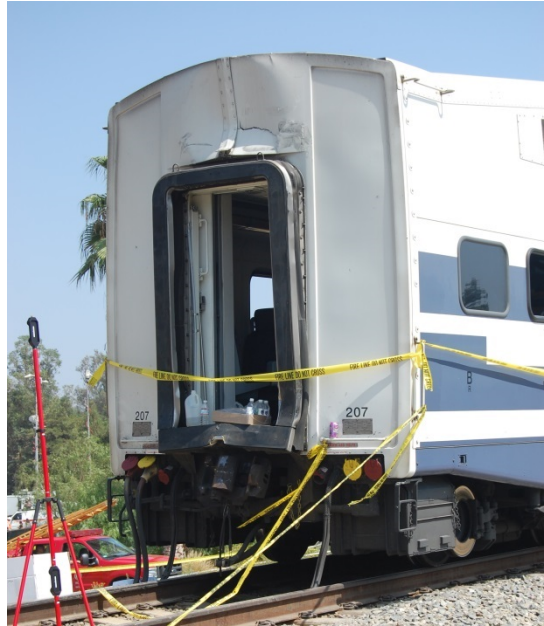
**Figure A.2.1-9. Leading End of Second Passenger Car**

Figure A.2.1-9 shows the leading end of the second passenger car. The bellows shows damage from contact with the car ahead. There are dents on the bellows frame, just above the spring loaded buffer beam. There is also damage to the fiberglass end cap above, just above the bellows. This damage is consistent with the leading car attempting to override this car.

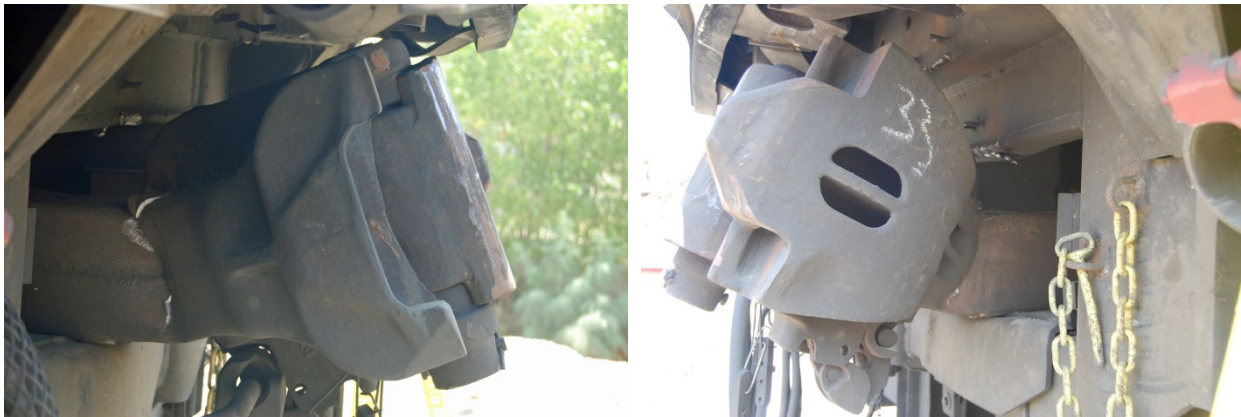
**Figure A.2.1-10. Leading (B) End Coupler of Second Passenger Car**

Figure A.2.1-10 shows left-side and right-side view of the leading end coupler of Car #207. The coupler is bent at the connection area between the head and the shank. The head is bent upward at an angle of roughly 30 degrees. There are indications of material failure near the corners of the shank where it meets the head. The material of the sidewalls of the shank remained together. The damage suggests that separation of the head and the shank is imminent. This damage is also consistent with the lead car attempting to override Car #207.

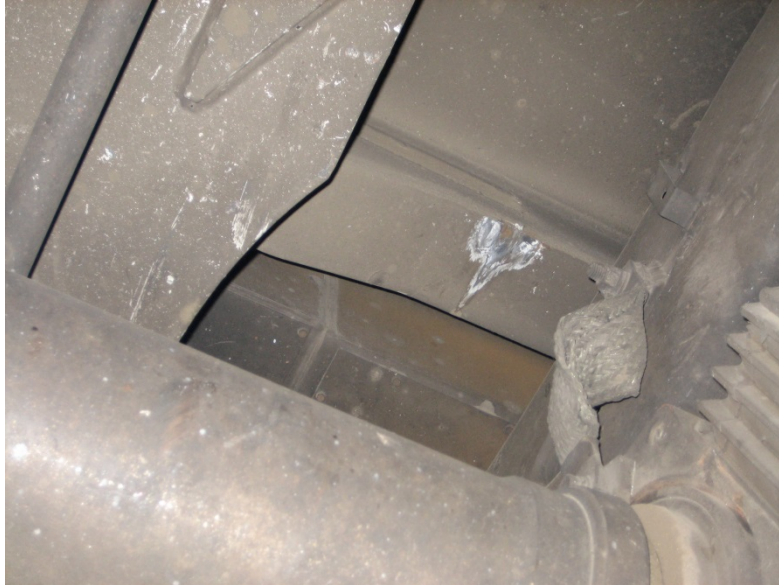
**Figure A.2.1-11. Scar on Carbody Above B End Outboard Axle Bearing Housing**

Figure A.2.1-11 shows a scar on the underframe. This scar appears to be due to the bearing housing of the truck axle contacting the underframe. Such contact could occur if the truck pitched significantly during the impact.

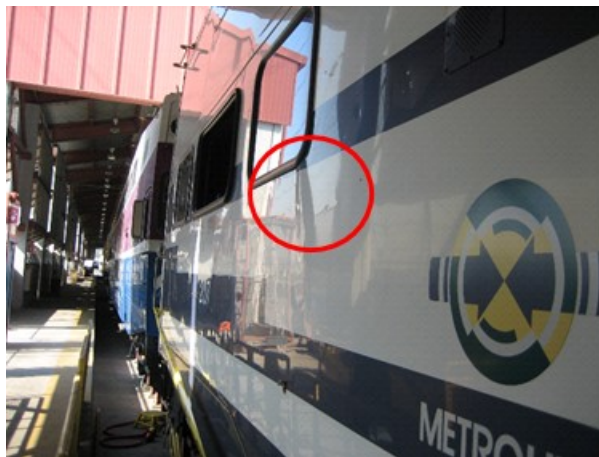
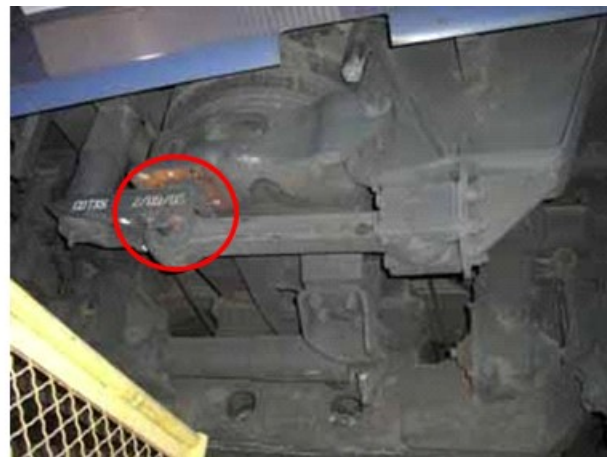
**Figure A.2.1-12. Second Passenger Car Sidewall and Truck Attachment Damage**

Figure A.2.1-12 shows sidewall deformation near the gooseneck region of the underframe. Both ends of the car showed similar damage, on opposite sides. On the leading end, the sidewall damage appeared to be associated with a bubble-shaped deformation in the bottom plate of the draft sill, however, the bubble appeared to be shallow. It was not possible to measure the flatness of this plate with the truck in place to confirm the presence of a bubble. On the left side of the leading end, the bolts to the drag link attachment to the carbody were also broken. The failure of these bolts was similar to the failure seen on the trailing truck of the first car. Similar failures have also been observed in an impact test of similar equipment [1].

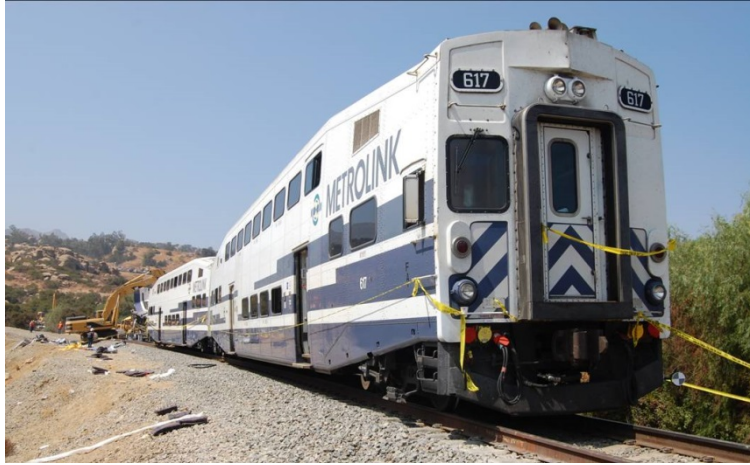
**Figure A.2.1-13. Trailing Cab Car and Failed Truck Retention Mechanism**

Figure A.2.1-13 shows the third passenger car, Metrolink Passenger Car #617. There was virtually no structural damage to this car, however the truck retention mechanism did fail (not visible in the photo). Despite this equipment failure, the running gear remained intact and the truck remained in place beneath the car.

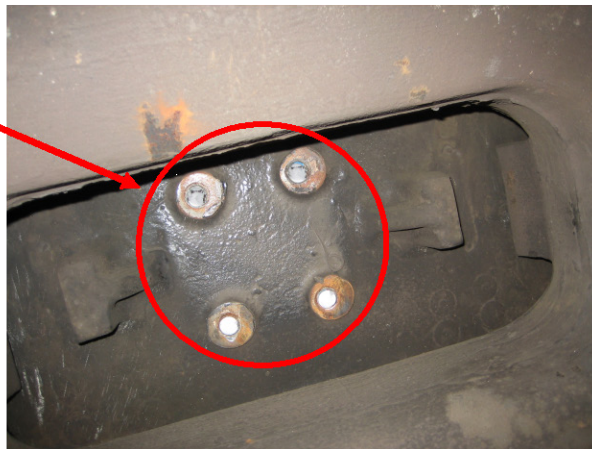
**Figure A.2.1-14. Failed Truck Retention Mechanism on Trailing (F) End of Trailing Passenger Car**

Figure A.2.1-14 shows the mounting boss for the truck retention mechanism, with the broken bolts visible. The truck retention mechanism is a tulip-shaped casting that protrudes through the rectangular hole in the truck frame. The base of the tulip normally mounts to the casting boss with four bolts. There is normally clearance between the rectangular hole and the tulip-shaped casting, which allows the truck to rotate, so the car can negotiate a curve. The failure of these bolts in the trailing cab car was similar to the failure of these bolts seen on the trailing truck of the first car. Similar failures have also been observed in an impact test of similar equipment [1].

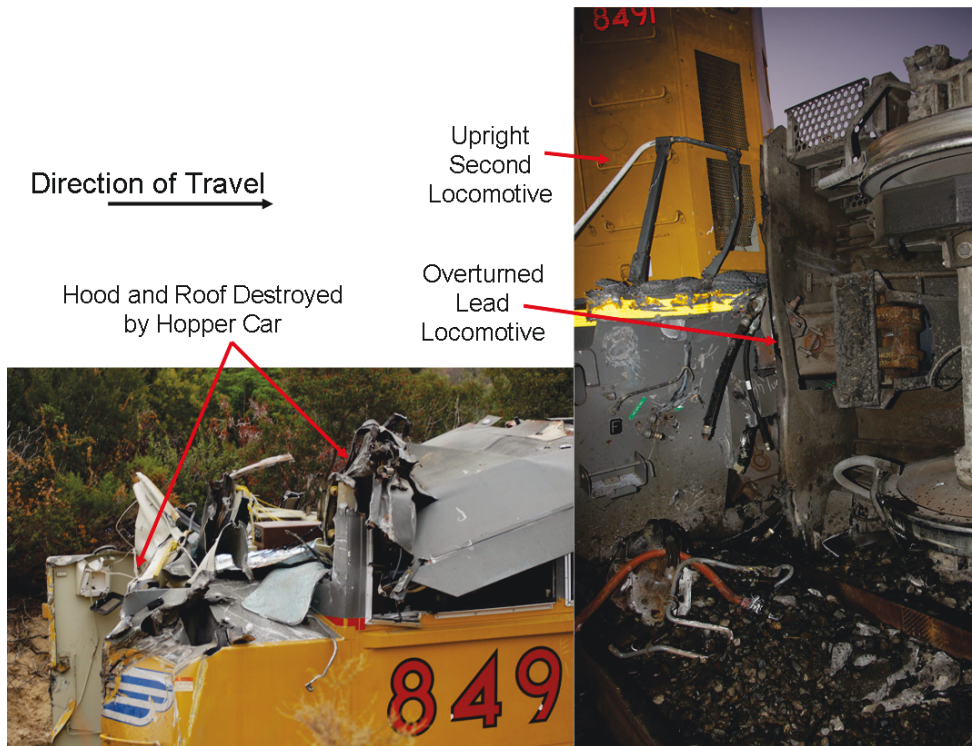
**Figure A.2.2-5. Second Freight Locomotive Structural Damage**

The photos in Figure A.2.2-5 depict the damage to the second freight locomotive inflicted by the hopper car and the damage caused by the interaction between the first and second freight locomotives.

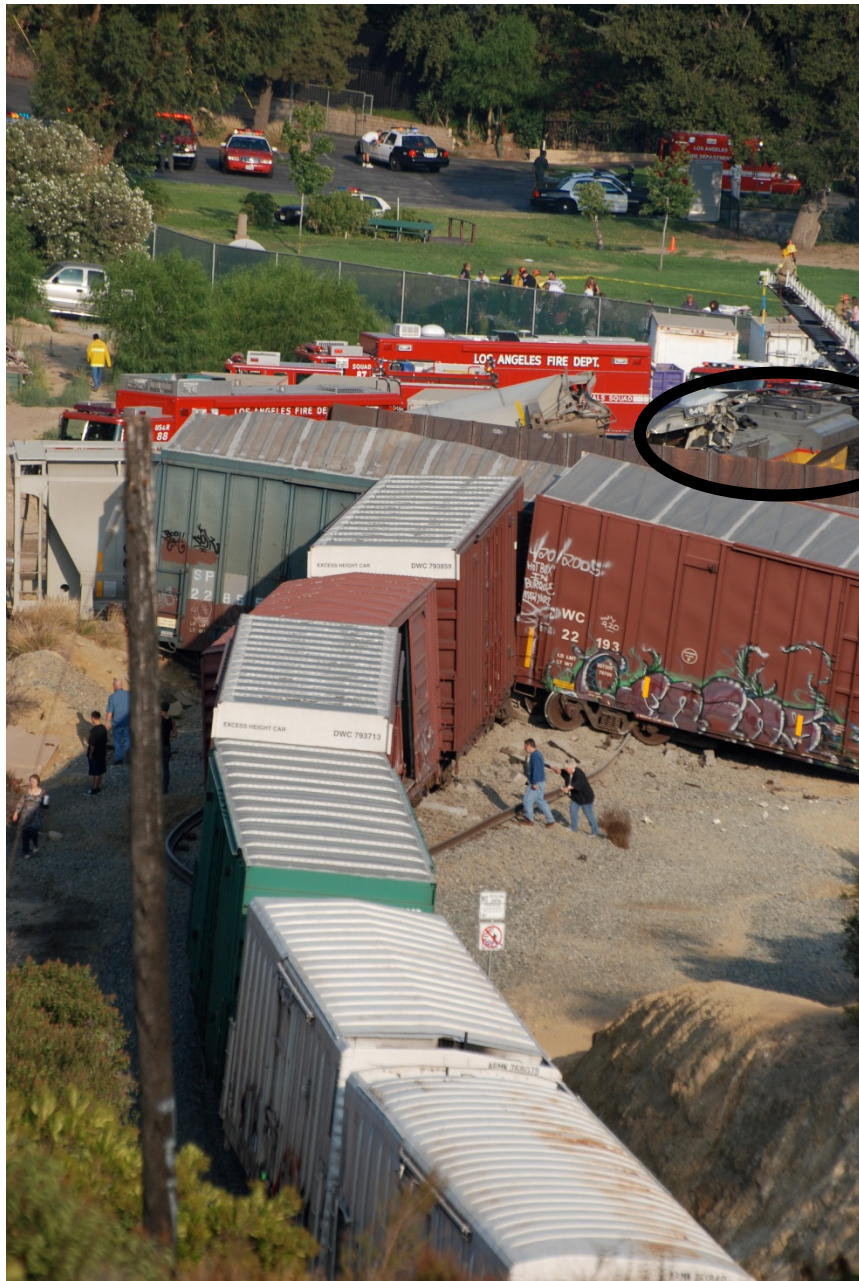
**Figure A.2.2-6. Trailing Freight Equipment**

Figures A.2.2-6 through A.2.2-8 show the trailing freight equipment. The second freight locomotive and its damaged roof can be seen in the upper-right portion of the photograph above. The end of the covered hopper car resting on the short hood can also be seen. The end of a second covered hopper car can be seen on the left side of the photograph. Three box cars are then stacked up perpendicular to the track. The next three box cars are upright and derailed. A rail can be seen near the two-people walking up to the middle upright and derailed freight car. The three freight cars near the bottom of the photograph are upright and on the track, as well as the remaining four trailing freight cars, which are not visible in the photograph.

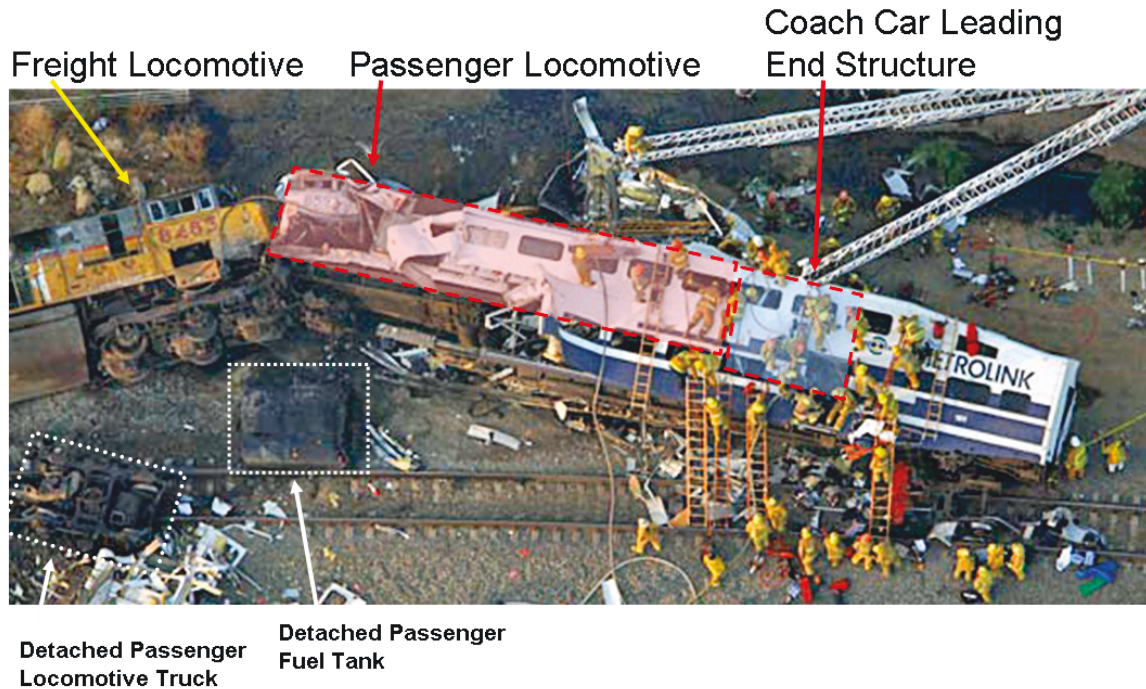
**Figure A.3-3. Post-accident View of Locomotives and First Passenger Car  
(Photo from the *LA Times* Web site)**

Post-accident, the fuel tank was found detached from the passenger locomotive, positioned on the ballast adjacent to the overturned freight locomotive. The lead truck of the passenger locomotive was also detached, and was found resting on the ballast adjacent to the running rails. An overhead view of the impacting locomotives and first passenger car are shown above in Figure A.3-3, with annotations showing the locations of the fuel tank and lead truck that detached from the passenger locomotive.

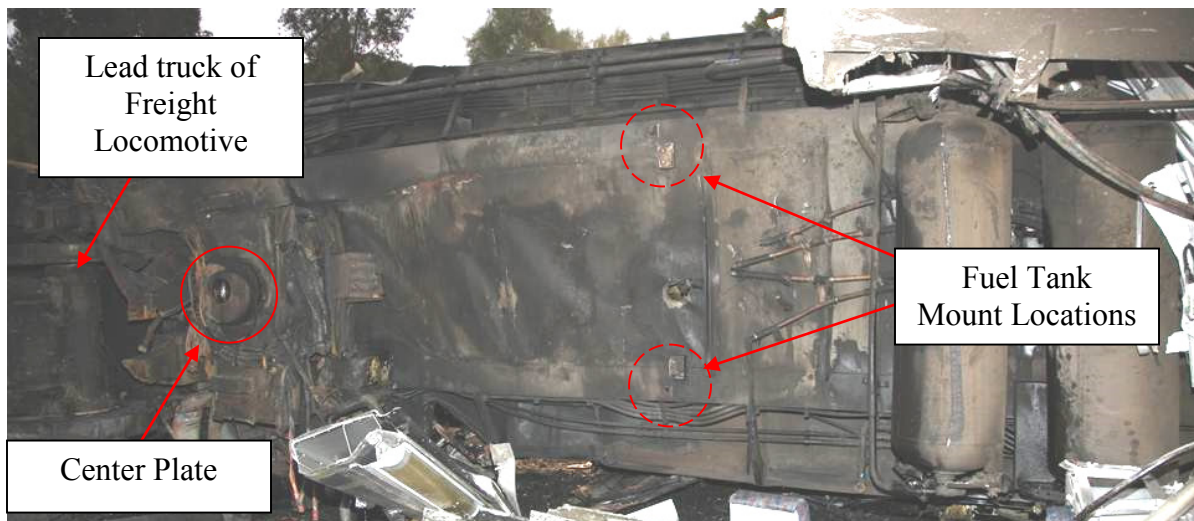
**Figure A.3-5. Passenger Locomotive Underframe, Before Locomotive Moved by Rescue and Recovery Crew**

This photograph shows the passenger locomotive's center plate, the area where the lead truck is normally attached. The underframe of the locomotive has been deformed backward, resulting in the center plate moving toward the trailing end of the locomotive. Visible toward the center of the photograph are the locations of the trailing-end fuel tank mounts. The top location (left hand side of the upright locomotive) still contains a mounting bolt that has been fractured.

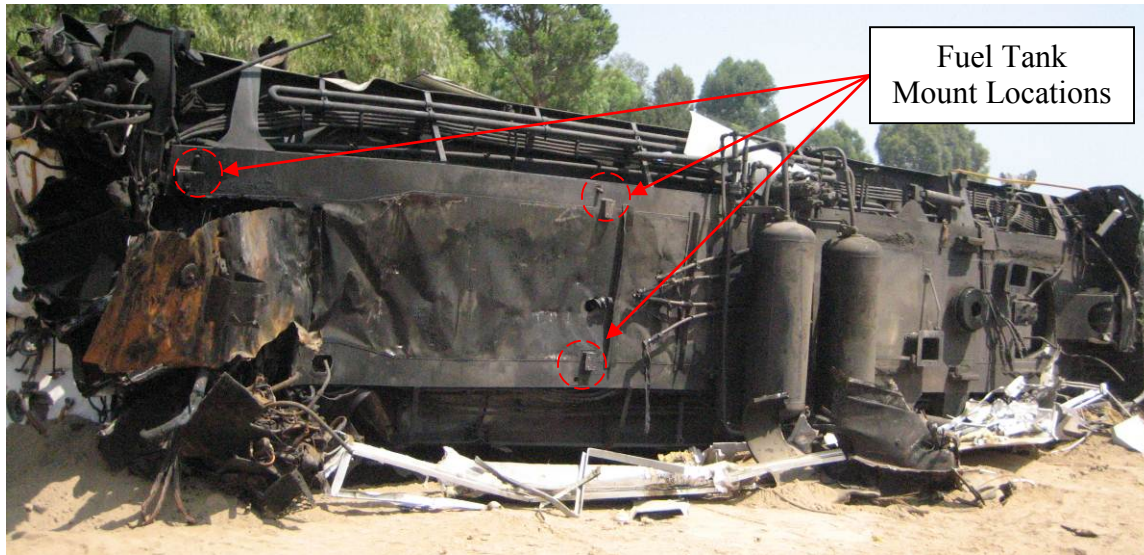
**Figure A.3-6. Passenger Locomotive Underframe, After Locomotive Moved by Rescue and Recovery Crew**

Prior to the crashworthiness team's arrival on scene, the freight locomotive and the passenger locomotive were moved as part of the rescue and recovery operations. As a result of this move, portions of the damaged passenger locomotive underframe were disturbed, including the center plate from the lead truck. Figure A.3-6 is a photograph of the underframe of the locomotive after it was moved from its post-accident location. Three fuel tank attachment locations are highlighted in this photograph. Two of these three locations include fractured mounting bolts still in their holes.

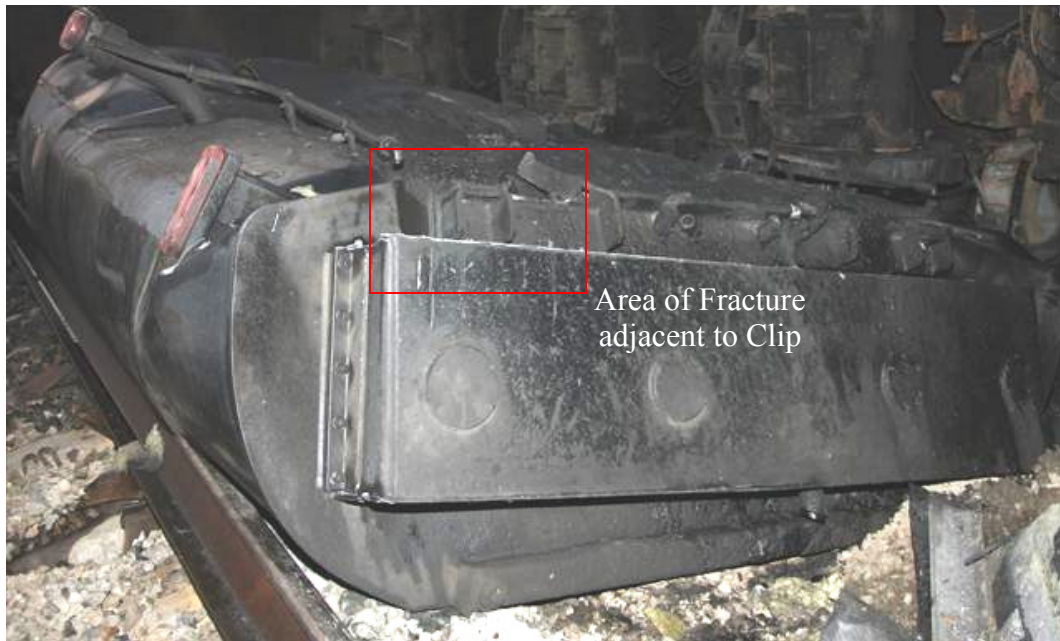
**Figure A.3-8. Trailing End of Fuel Tank**

Figure A.3-8 shows the accident fuel tank in its post-accident position. The end shown was toward the trailing end of the passenger locomotive. At the top of the fuel tank there is fracture in the area where the clip would have contacted the fuel tank, indicated above by the box. There does not appear to be a breach of the fuel tank at this end. This area of fractured fuel tank would have been mounted at the location depicted in Figure A.3-7.

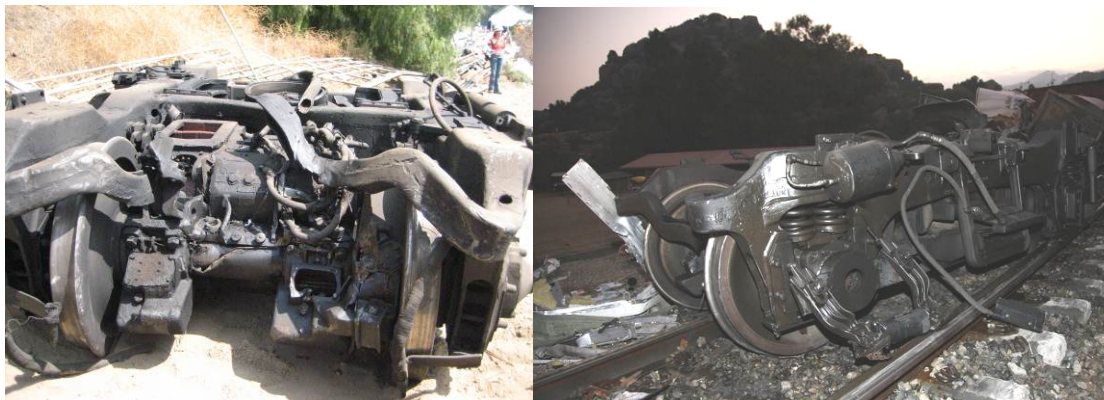
**Figure A.3-9. Passenger Locomotive Lead Truck: Leading End (left) and Trailing End (right)**

Figure A.3-9 shows the lead truck of the passenger locomotive. Note that these photographs were taken at two different times. The left side photograph was taken after the truck had been moved, and the right side photograph was taken when the truck was still in its post-accident position, prior to the arrival of the crashworthiness team. The leading end of the truck, shown on the left, featured extensive structural damage to its frame. The lateral member has been bent backward and has fractured. The trailing end of the truck, shown on the right, also shows some structural damage. The trailing lateral member has been bent toward the lead end of the locomotive. It is

probable that the trailing end of the lead truck was able to contact the leading end of the fuel tank during the collision, contributing to the breach of the tank and its eventual attachment failure.
