Federal Railroad  
Administration

# Passenger/Freight Train Collision

## September 12, 2008, Chatsworth, CA:

### Main Report

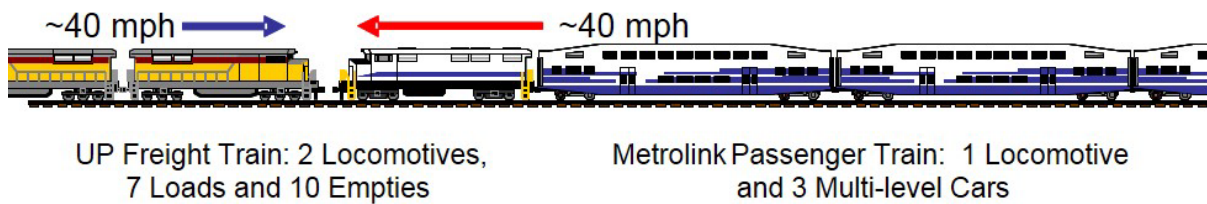
**Figure 1. Schematic of Initial Impact Conditions**

Figure 1 shows the relative positions of the trains just prior to impact, as the Union Pacific Railroad (UP) freight train and the Metrolink passenger train were each travelling at just over 40 mph. The passenger train consisted of an Electro-Motive Diesel (EMD) F-59 four-axle locomotive, two Bombardier multi-level trailer cars, and a Bombardier cab car. The freight train consisted of 2 EMD SD-70 6-axle locomotives, with the second locomotive travelling long-hood forward, followed by 7 loaded freight cars and 10 empty freight cars.

The accident occurred on a 6-degree curve, with the freight train just exiting the transition spiral<sup>1</sup> and about to enter the body of the curve, and the passenger train conversely just exiting the body of the curve and about to enter the spiral leading to the tangent track.

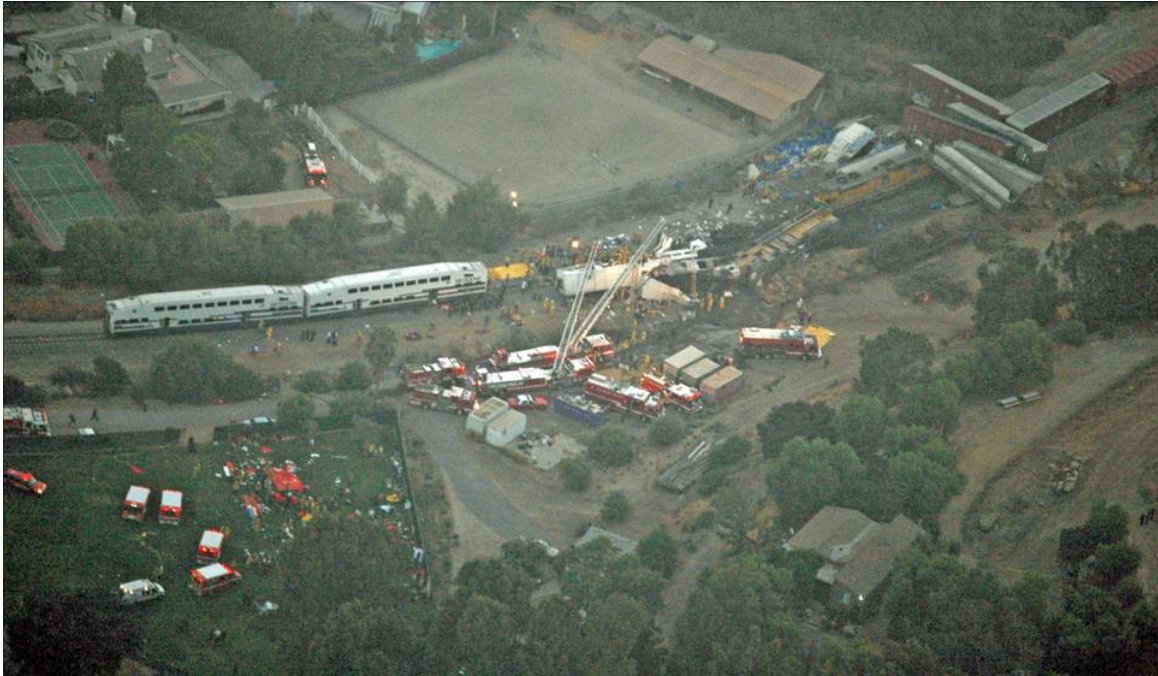
**Figure 2a. Aerial Photograph of Accident (From SCRR)**

Figure 2a is an aerial photograph provided by the Southern California Regional Rail Authority (SCRRA), the authority that governs Metrolink. The photo was taken shortly after the accident occurred. On the left side, the photograph shows the trailing two passenger cars, with little visible damage. In the center, the lead passenger car is shown, with substantial damage. The car is nearly on its side and much of the roof is peeled back. The fans and other roof-mounted equipment on the lead passenger locomotive can be seen adjacent to the sidewall of the lead passenger car. The lead freight locomotive is on its side, while the second freight locomotive is upright toward the upper right-hand side of the photograph. Seven trailing freight cars are stacked up sideways against the trailing end of the trailing freight locomotive. Behind the sideways freight equipment, three freight cars (two of which are visible in Figure 2a) are upright and derailed. The trailing seven freight cars, which are not visible in Figure 2a, remained upright and on the track.

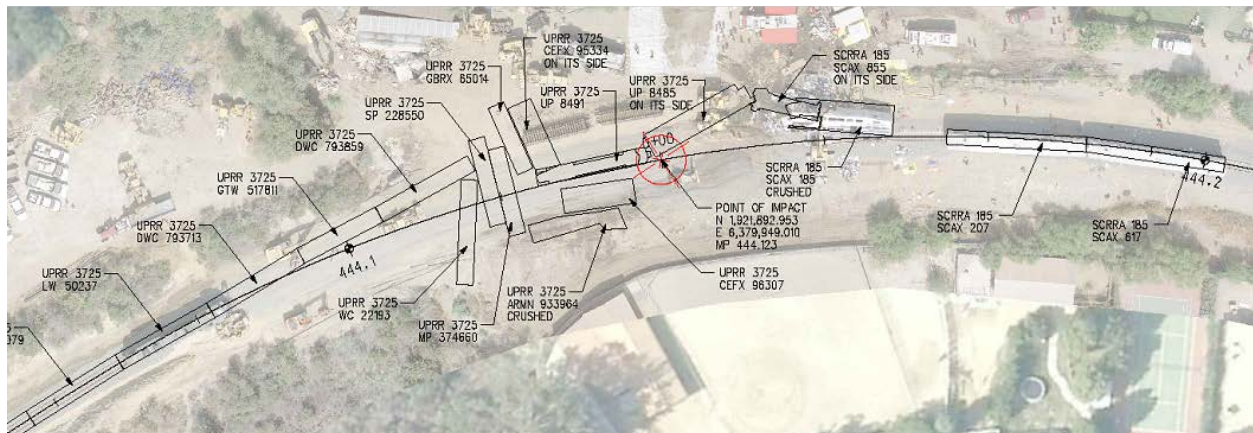
**Figure 2b. Aerial Photograph of Accident, with Equipment Locations (From SCRR)**

Figure 2b shows another aerial photograph, this time from a view looking nearly straight down at the accident. The photograph is annotated with survey locations and the equipment markings. The photograph shows a more complete sketch of the trailing freight equipment, the freight locomotive and at least 10 derailed freight cars.

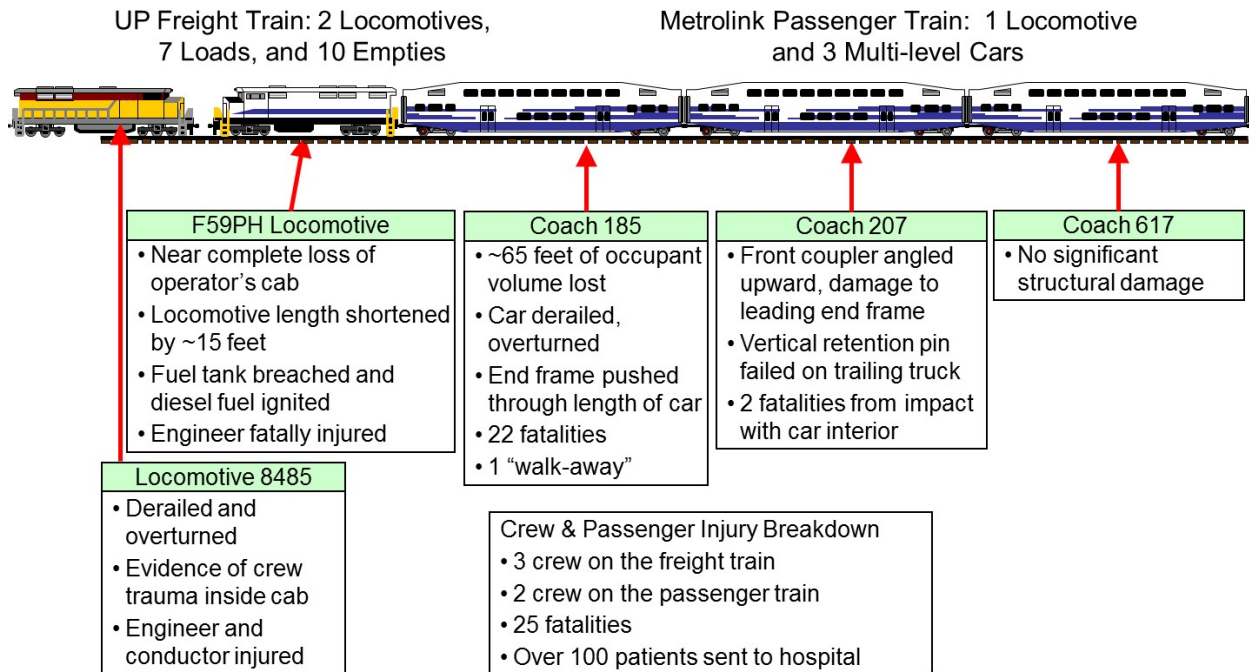
**Figure 3. Summary of Equipment Damage and Injury/Fatality Distribution**

Figure 3 shows a schematic and a summary of the equipment damage. In the passenger train, the locomotive cab was crushed, eliminating the survival space. The first passenger car, originally 85 feet in length, was crushed approximately 65 feet, back to the trailing boarding doors. The survival spaces in the forward mezzanine level and bi-level section were lost. Survival space was maintained in the trailing mezzanine level. In the two trailing passenger cars, survival space was maintained. Survival space was maintained in the freight locomotives, although a significant portion of the roof of the second freight locomotive was torn off.

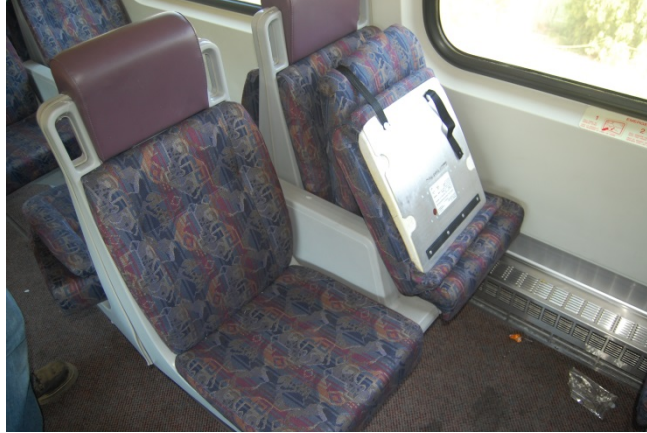
**Figure 6. Rear-Facing Seat**

Based on interior evidence and passenger interviews, the passengers seated in rear-facing seats suffered the least severe injuries as a result of secondary impacts. There was minimal structural damage to seats in consecutive rows of rear-facing seats. In cases where rear-facing seats were damaged in an open bay configuration, the cause was likely due to impacts from occupants seated in the opposite facing seat. As an example of injuries to a rear-facing occupant, Passenger #9, who was seated in a rear-facing seat, spoke of having a headache and aches and pains consistent with a game of football following the accident, but no moderate or severe injuries. This outcome is consistent with dynamic seat analyses and tests that have been conducted previously [3, 4]. The right-hand seat shown in the photograph in Figure 6 is believed to be the initial location of Passenger #9.

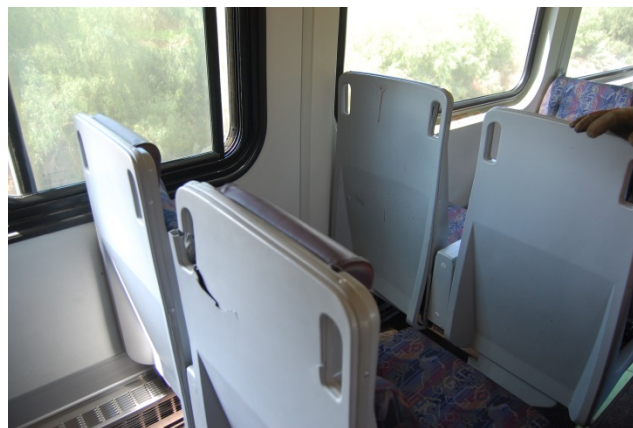
**Figure 7. Example Forward-Facing Row-to-Row Seats**

Passenger #12, who was seated in a forward-facing row-to-row seat on the upper level of Car # 617, experienced only facial injuries due to contact with the forward seatback. Passenger #12 is believed to have been initially located in the seat closest to the window, on the left side of the photograph shown in Figure 7. This passenger is believed to have impacted the back of the window-side seat on the right in the photograph.

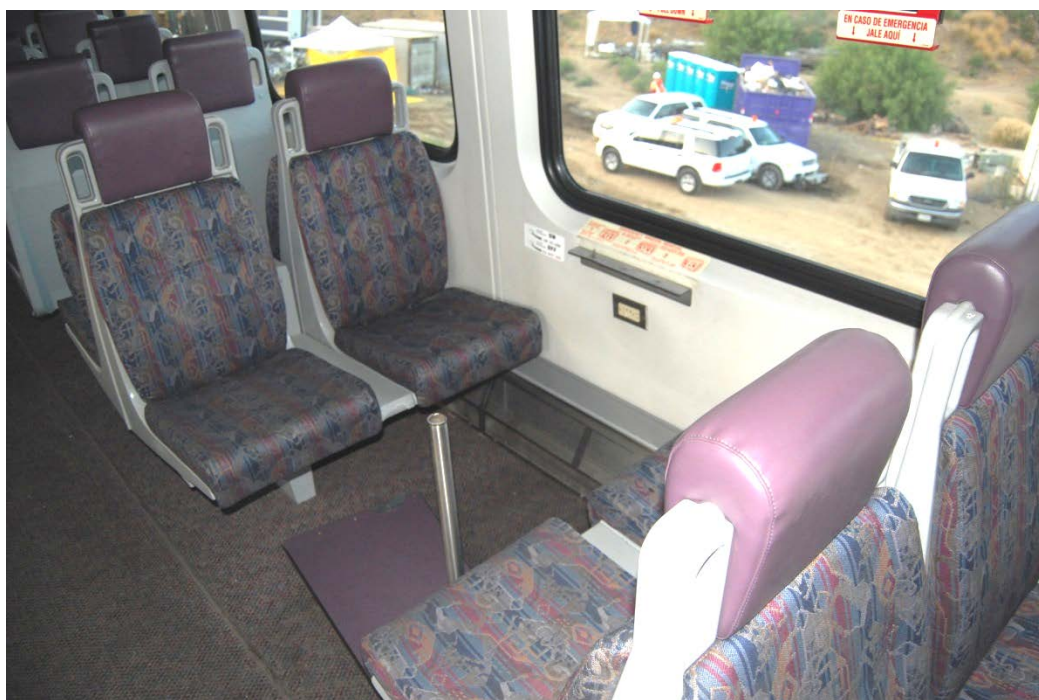
Figure 8. Example of Forward-Facing Bay Seats with Table

Figure 8 shows a table that has broken off its mounts, on the upper deck of Car #207. A number of people seated forward-facing at a table suffered serious abdominal injuries due to impact with the table. Injuries included fractured ribs, lacerated liver, mesenteric tear, and damage to the spleen.

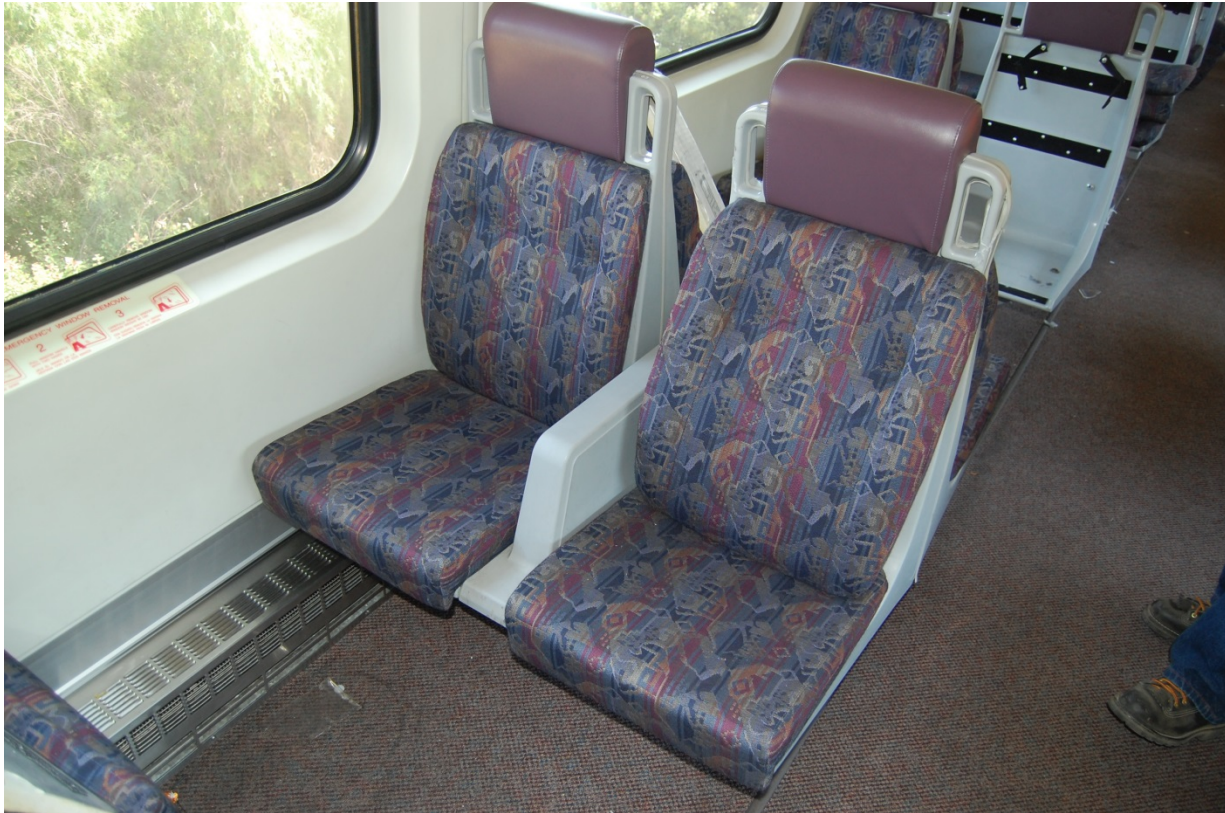
**Figure 9. Example of Forward-Facing Open Bay Seats**

The likely initial location of Passenger #8 is in the aisle-side seat shown in Figure 9. Injuries incurred by Passenger #8 include a fractured tibia, fibula, humerus, and rib, dislocated shoulder, head laceration and concussion. Interviewed forward-facing passengers that remained compartmentalized, or contained in the space between open bay seats, experienced fractures of the femur and patella, concussion, and facial lacerations.

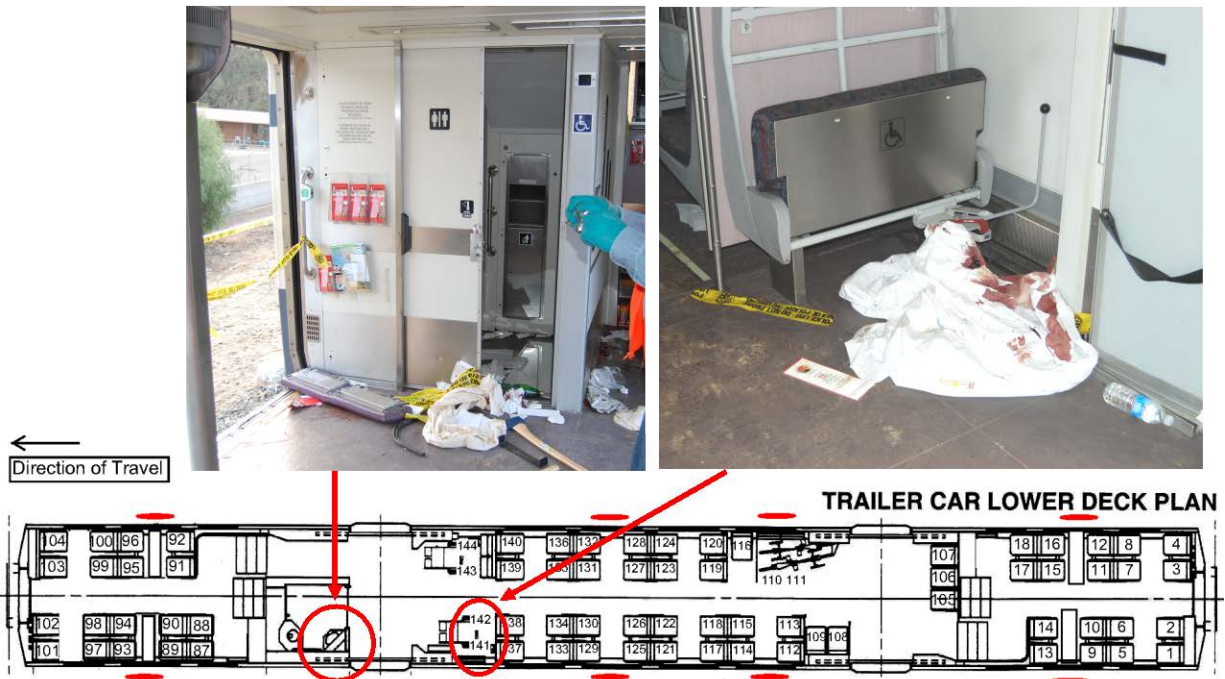
**Figure 10. Forward Stepwell, Lower Level to Mezzanine Level, and Lower Level Fold-down Seat, Car #207**

Interviewed Passenger #7 was seated on the flip-down seat on the left side of Car #207 and impacted the bulkhead about 10 feet away (see Figure 10). This passenger suffered serious injuries, including four fractured ribs, four fractured vertebrae, fractured tibia, fractured forearm, and a fractured finger. This increased severity of the injuries to these passengers was likely caused by an extremely high SIV and very rigid impact surfaces, i.e., the stairs and the bulkhead wall.

Figure 10 shows the bulkhead wall, which is next to the bathroom door, and the fold-down seat where Passenger #7 was likely initially located.

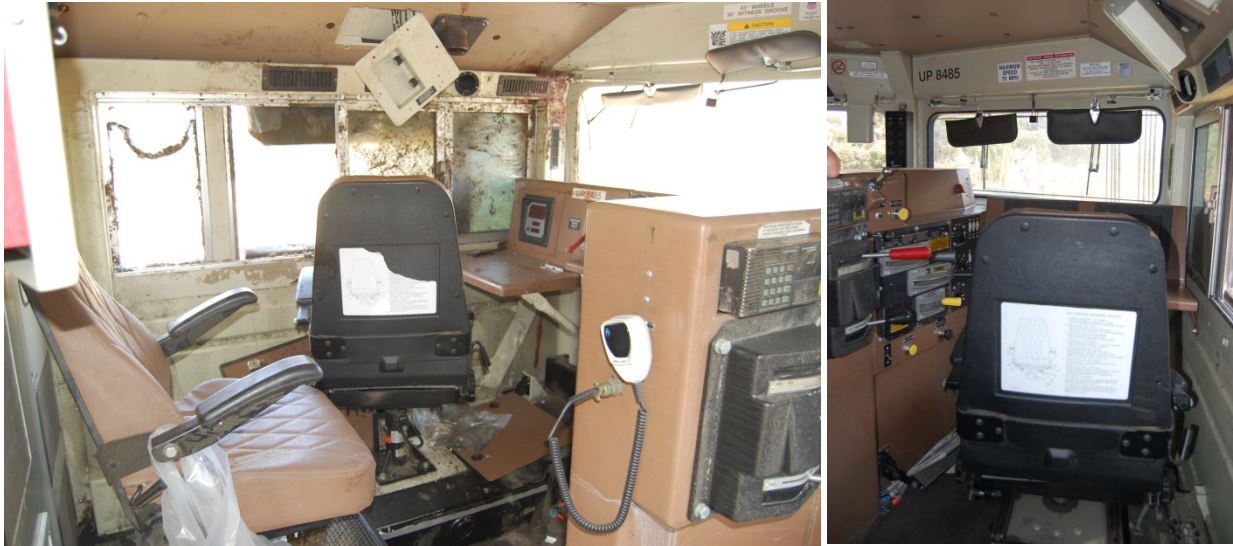
**Figure 11. Cab in Union Pacific Locomotive #8485**

The vertical console-stand in the UP freight train was operated by an engineer, with two additional crewmen on board. The engineer and conductor were seated in the cab of the leading locomotive #8485, which is shown in Figure 11. The brakeman was located in the second freight locomotive #8491, which was positioned rear-facing at the time of the accident. The first locomotive derailed and rolled onto its left side. The second locomotive derailed but remained upright.

Initially, all possible modes of egress were blocked for the crew of the first freight locomotive. As the car had tipped onto its side, the main door and right side window were out of reach above and the left side window offered no exit because it was against the ground. Another door in the nose of the locomotive was inaccessible because of the collision. The front windshield was blocked by an external fire that burned for 22 minutes. Rescuing firefighters extinguished the blaze, saw the crew trapped inside, and pried open the front windshield to allow the crew to escape the cab.

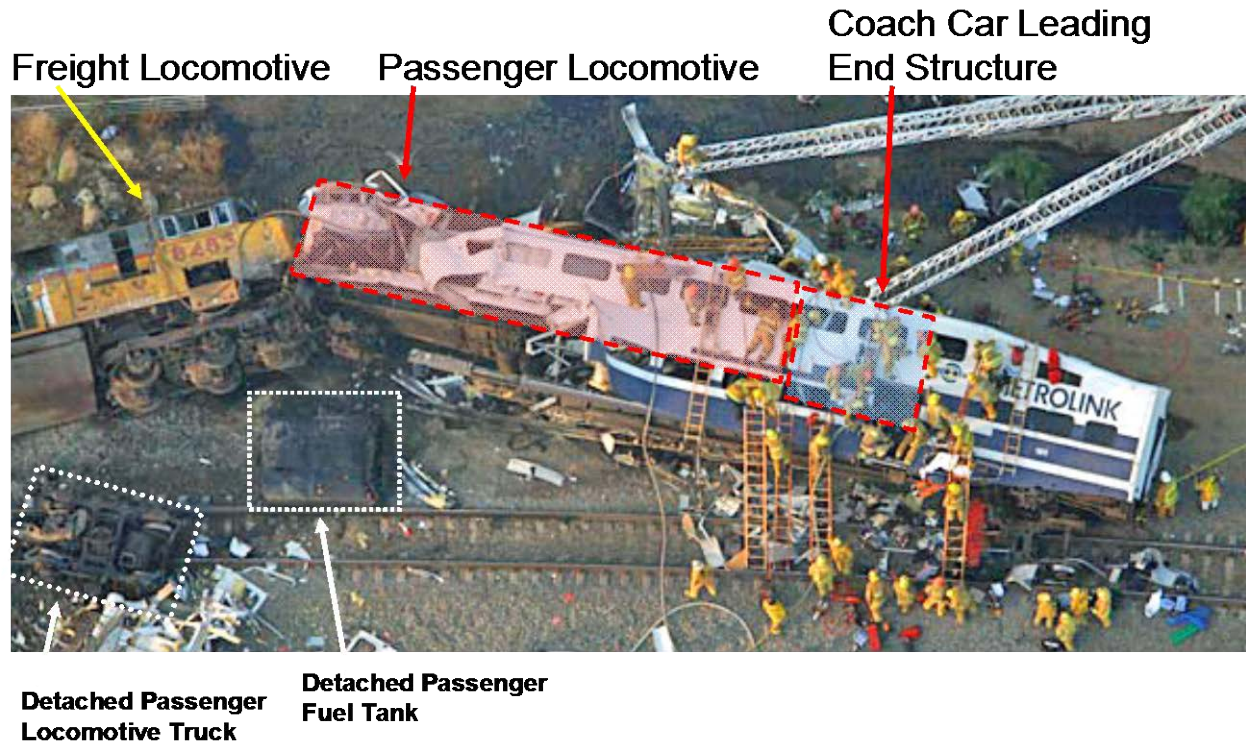
**Figure 12. Annotated Photograph of Lead Freight Locomotive, Lead Passenger Locomotive, and First Passenger Car (Photograph from *LA Times* Web site)**

The photograph in Figure 12 shows the lead freight locomotive, lead passenger locomotive, and first passenger car. The photograph is annotated to highlight the damage. Little of the passenger locomotive is visible, since it is telescoped into the passenger car. The illustration shows that the leading end structure (mezzanine level) has penetrated the bi-level section to the stairs of the trailing mezzanine level. The location of the detached passenger locomotive lead truck and fuel tank, both of which have been separated from the locomotive, are illustrated.

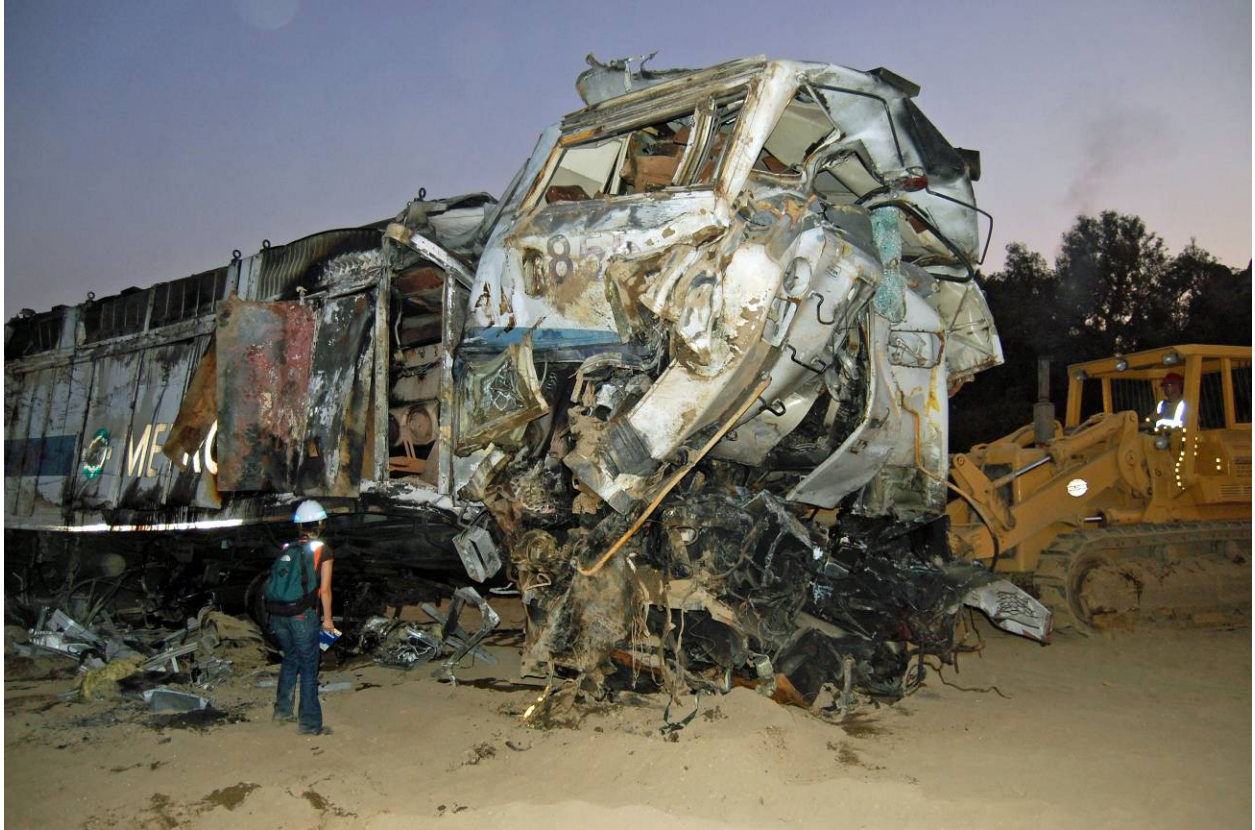
**Figure 13. Lead Passenger Locomotive**

Figure 13 shows a perspective view of the front and right side of the lead passenger locomotive, after the rear truck had been removed and the locomotive restored to an upright position. The operator's cab can be seen to be pushed back and upward, over the compartment for the rotating equipment. There is no survival space remaining inside the operator's cab. The locomotive has been crushed approximately 15 feet, from the coupler back to the lead body bolster. The front truck normally mounts to the frame at the lead body bolster, however the attachments were destroyed in the collision. Both the fuel tank and front truck were separated from the locomotive, and found proximate to the lead freight locomotive after the accident. It appears that the front truck separated owing to crush of the attachments on the locomotive body bolster, and that the fuel tank separated due to impact with the lead truck. There were significant breaches of the fuel tank, and a fire was fed by the spilled fuel. More detail on the fuel tank damage is provided in Appendix A.3. The trailing truck of the locomotive was found still attached after the accident, and was separated from the locomotive during clean-up of the accident site.

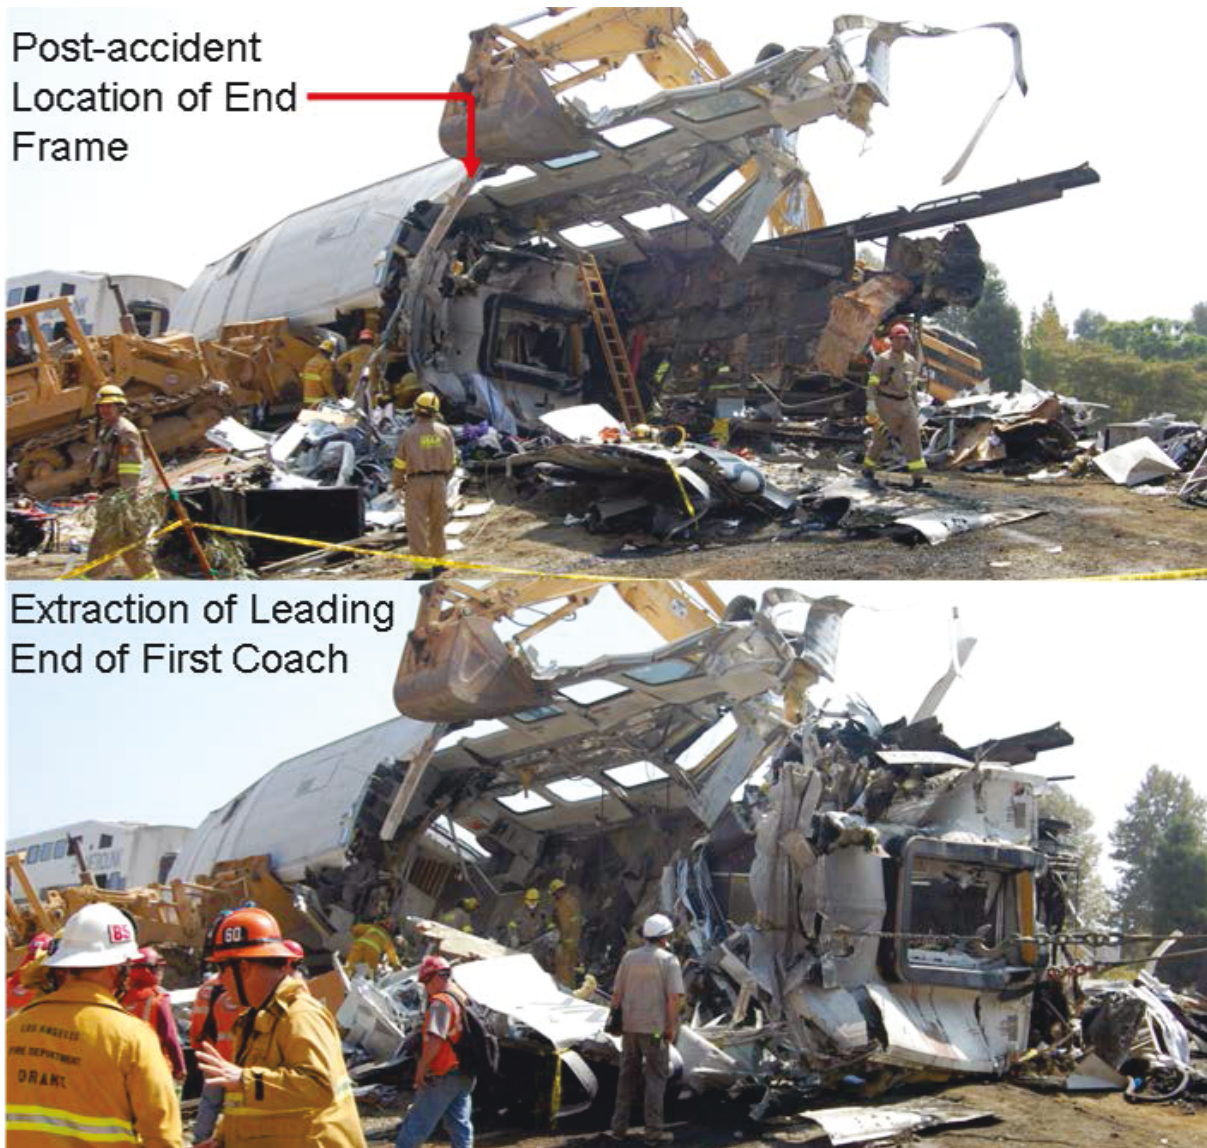
**Figure 14. First Passenger Car Structural Damage**

The top photograph in Figure 14 shows the lead passenger car after the passenger locomotive was cleared away. The bellows and end frame from the front of the car are visible, pushed into rear portion of the car, with the left side wall ahead of it held up by the backhoe. The side sill can be seen, pointing to the right. Close inspection shows the threshold for the left side door on the side sill. The lower photograph shows the end frame being pulled from the interior of the car. Though not visible in this figure, the underframe of the separated leading end of the car is essentially intact, with the lead truck still attached.

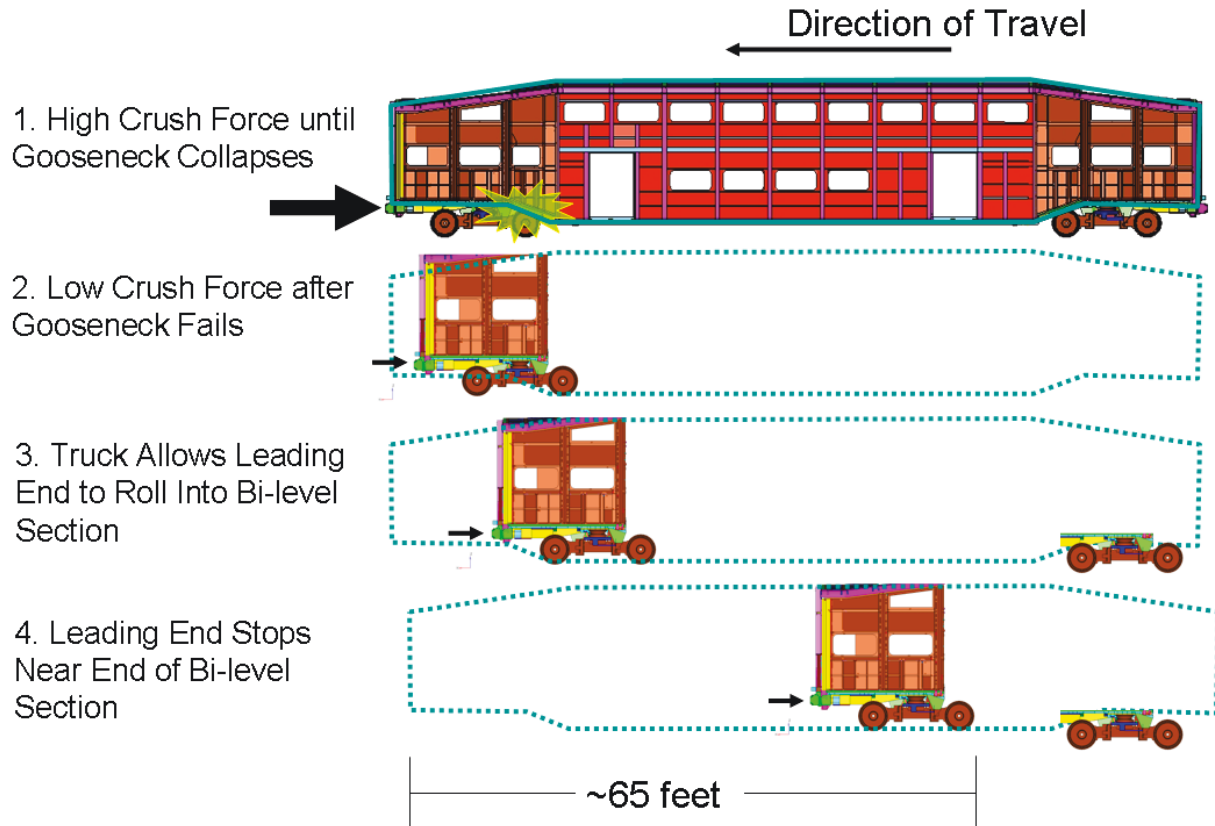
**Figure 15. Likely Progression of Gooseneck Collapse and Failure**

Figure 15 shows schematics illustrating how the structural damage shown in Figure 12 likely occurred. Shortly after the initial contact between the lead freight and passenger locomotives, a high force was generated between the rear of the lead passenger locomotive and front of the lead passenger car. This force was sufficient to cripple and fail the gooseneck area of the underframe. Simultaneously, due to the geometry of the gooseneck and its mode of collapse, the end underframe and truck were vaulted upward. This upward movement was sufficient to raise the wheels of the lead truck to the height of the lower floor of the bi-level section of the car. When the gooseneck failed, the primary longitudinal structure of the railcar was no longer loaded longitudinally. A relatively low longitudinal force was provided by the remaining sidewall and roof structures to resist intrusion into the car. The end section of the car, including the truck, penetrated the bi-level section of the car with relatively little force.

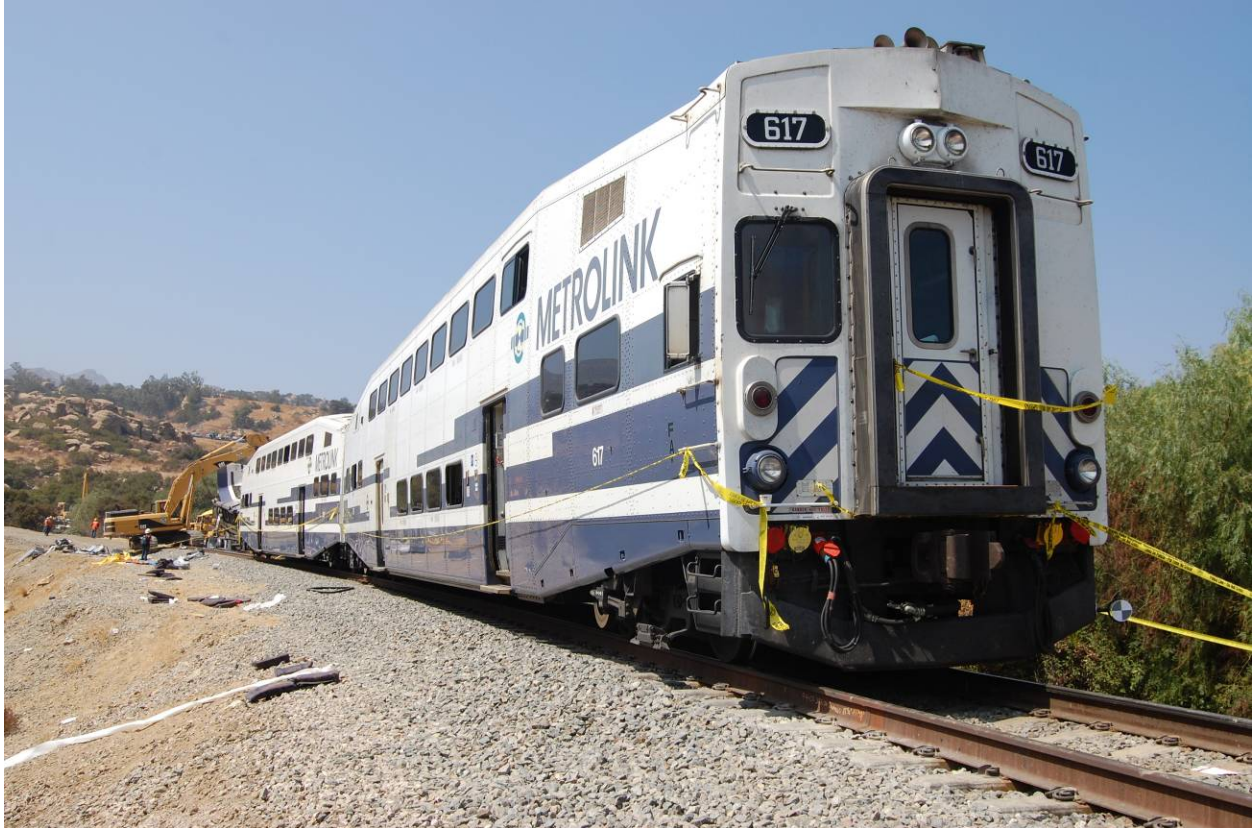
**Figure 16. Second and Trailing Passenger Cars, (#207 and #617)**

Figure 16 shows the second passenger car, Metrolink Trailing Passenger Car #207. Damage to this car was relatively minor. There was some damage to the leading end, which was coupled to the first passenger car. There was also some wrinkling of sidewall panels and damage to the lead truck attachment. There appeared to potentially be some distortion to the leading end draft sill, however, it was difficult to tell conclusively with only a visual inspection. Measurements were not possible with the truck in place. The leading bellows showed damage from contact with the car ahead. There were dents on the bellows frame, just above the spring loaded buffer beam. There was also damage to the fiberglass end cap above, just above the bellows. This damage was consistent with the leading car attempting to override this car.

Figure 16 also shows the third passenger car, Metrolink Trailing Passenger Car #617. There was very little structural damage to this car. The truck retention mechanism did fail, but the running gear remained intact and the truck remained in place beneath the car. Similar failures have been observed in an impact test of like equipment [1].

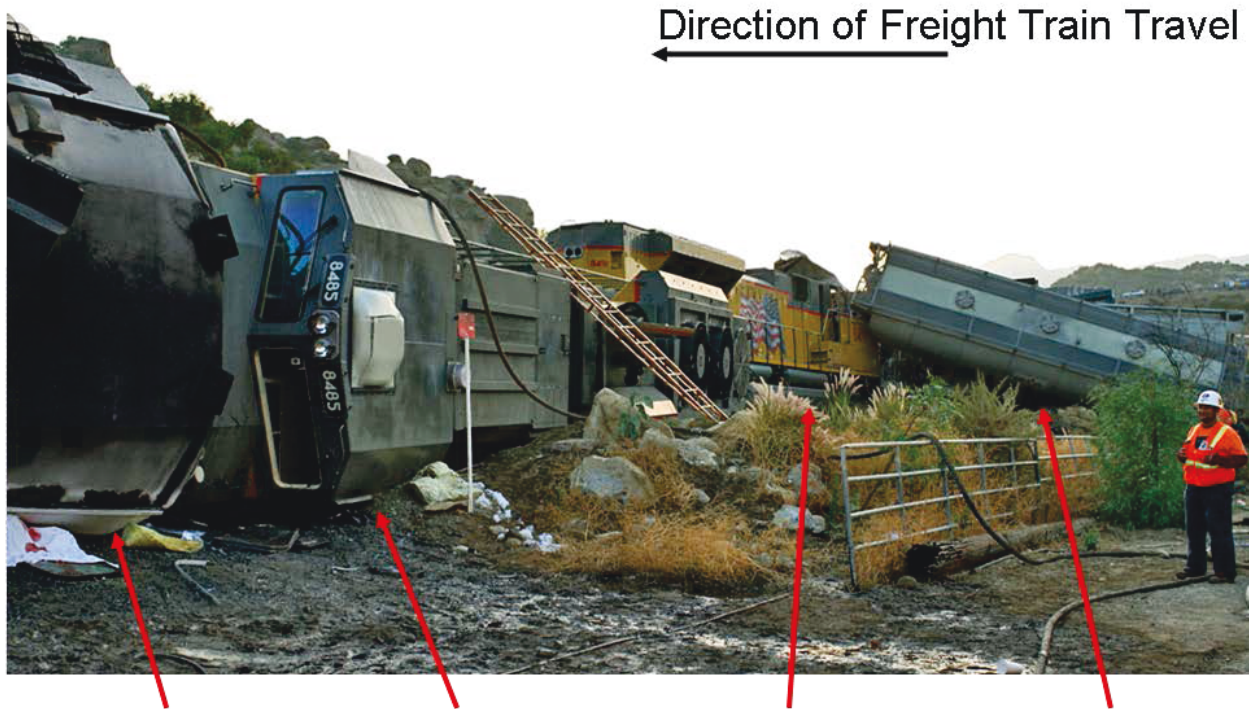
**Figure 17. Annotated Photograph: Lead Passenger Locomotive, Lead and Second Freight Locomotives, and Trailing Freight Equipment**

Figure 17 shows the damage to the freight train, which consisted of 1 forward-facing locomotive, 1 rear-facing locomotive, and 17 trailing freight cars. The leading end of the lead passenger locomotive is shown on the left side of the photograph. This locomotive is on its side. The leading freight locomotive is also on its side. As they collided, the lead passenger and freight locomotives apparently rolled outward, away from the center of the curve. The second, rear-facing freight locomotive is shown upright, with a freight car resting on its roof. Damage to the roof is evident. On the right side of the photograph, two of the stacked-up freight cars can be seen.

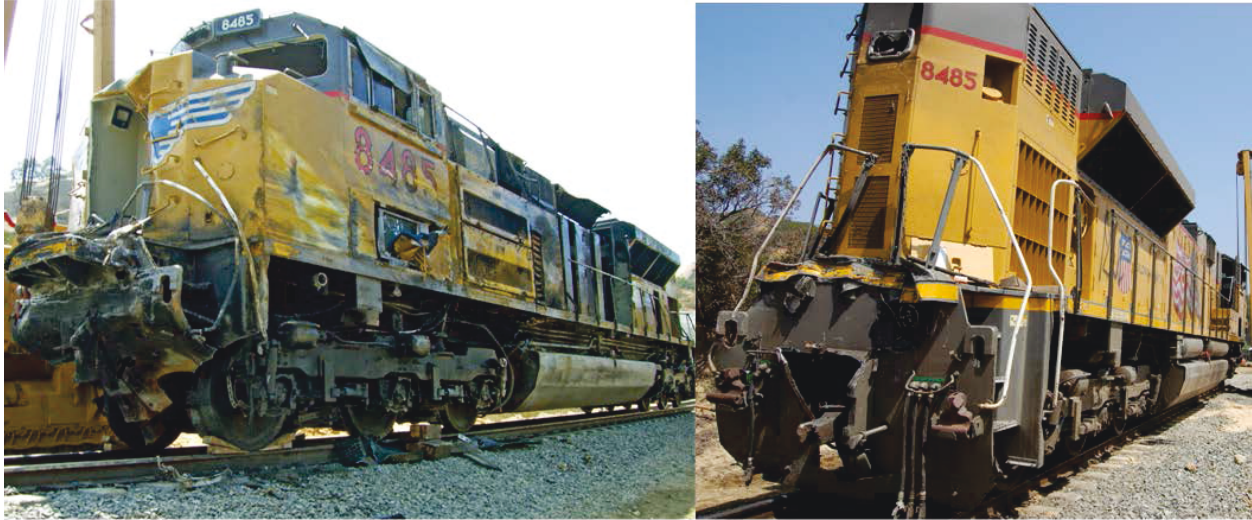
**Figure 18. Lead Freight Locomotive Structural Damage**

Figure 18 includes photographs of the front and the rear of the lead freight locomotive after the locomotive was made upright. Damage to the front of the locomotive, shown in the left-side photograph, includes substantial damage to the draft gear housing, which hangs beneath the underframe and supports the draft gear and coupler. The lower part of the normally vertical breast plate, which surrounds the draft gear housing, is bent back at about a 45° angle. This plate normally supports the plow; however, the plow apparently was ripped off during the accident. The paint on the left side of the fuel tank has been scraped off. The side of the locomotive also shows some scraping damage. This suggests that there was continued motion once the car overturned.

The right-hand photograph shows the rear of the locomotive. The coupler shank is broken, and the bellmouth surrounding the shank has some damage. The left side of the rear breast plate can also be seen to have some damage. The right side of the locomotive has little damage. The underframe is essentially intact, and both trucks and the fuel tank remained attached.

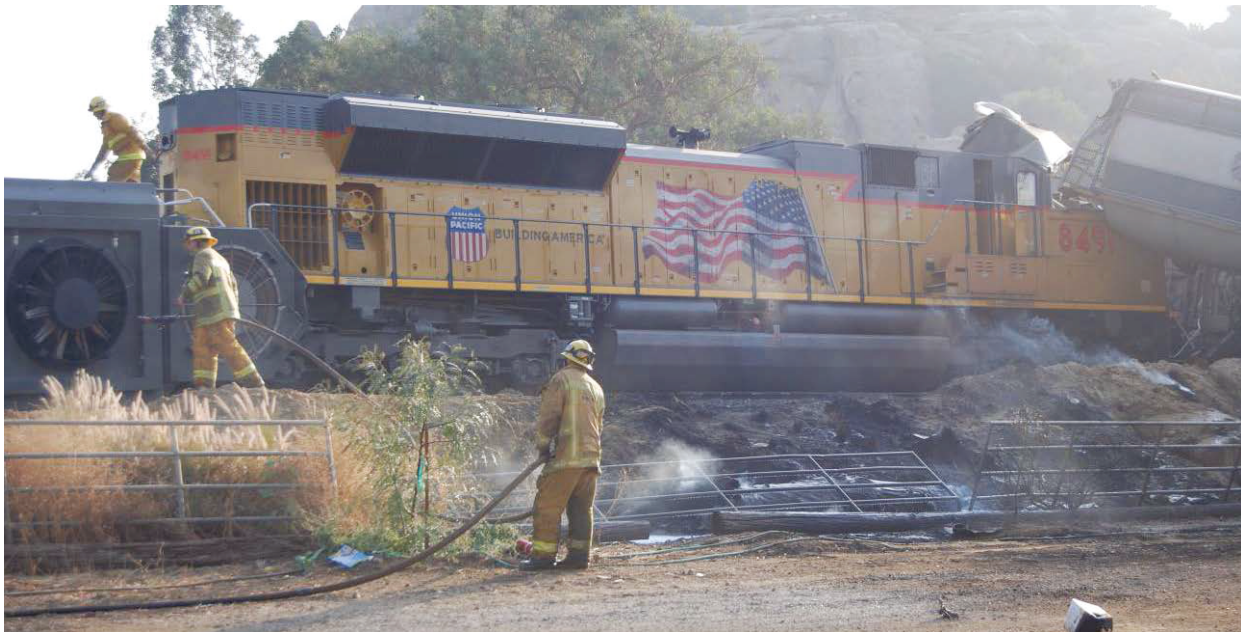
**Figure 19a. Second Freight Locomotive Structural Damage**

The photographs in Figures 19a and 19b show the second freight locomotive and a hopper car that collided with it. This locomotive was travelling long-hood forward. On the left side of Figure 19a, the lead locomotive can be seen to be on its side. On the right side of this photograph, the roof of an empty covered hopper car can be seen. The end of the covered hopper car is resting on the short hood of the locomotive. The roof of the locomotive was apparently significantly damaged owing to the impact from the covered hopper car.

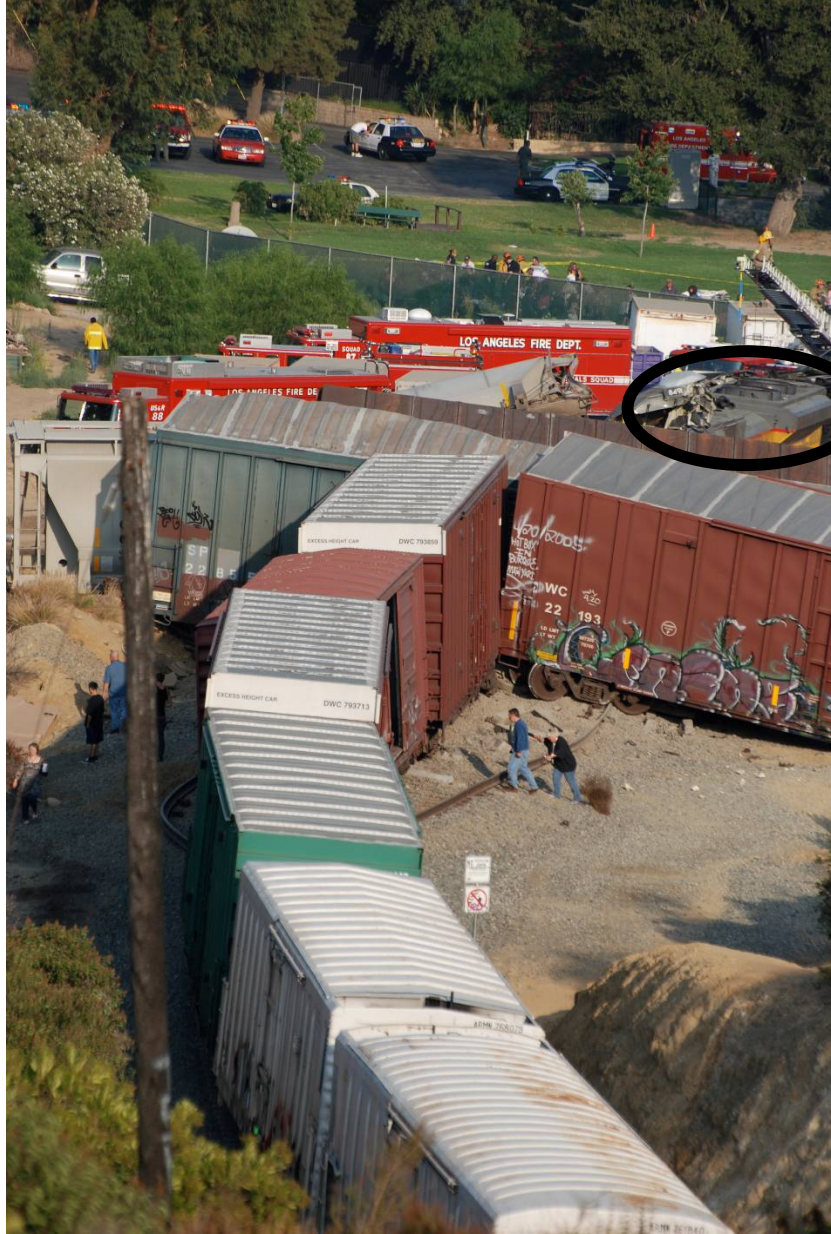
**Figure 20. Freight Equipment Structural Damage**

Figure 20 shows the trailing freight equipment. The second freight locomotive and its damaged roof can be seen in the upper-right portion of the photograph. The end of the covered hopper car resting on the short hood can also be seen. The end of a second covered hopper car can be seen on the left side of the photograph. Three box cars are then stacked up sideways to the track. The next three box cars are upright and derailed. A rail can be seen near the two-people walking up to the middle upright and derailed freight car. The three freight cars near the bottom of the photograph are upright and on the track, as well as remaining four trailing freight cars, which are not visible in the photograph.

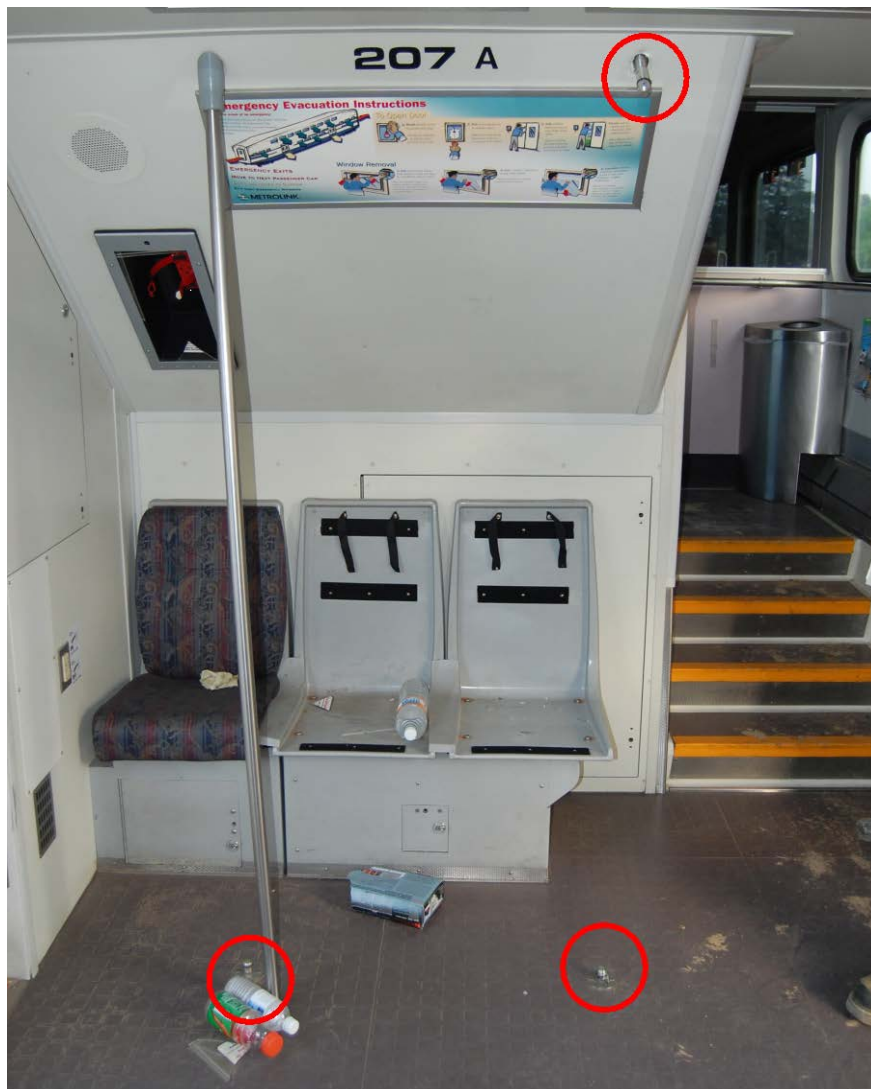
**Figure 21. Detached Stanchion Near Aft Doors, Lower Level, Car #207**

was observed on two seats. Numerous seat cushions were missing or displaced. A stanchion was completely separated from the floor and wall on the lower level, near the aft doors (see Figure 21).

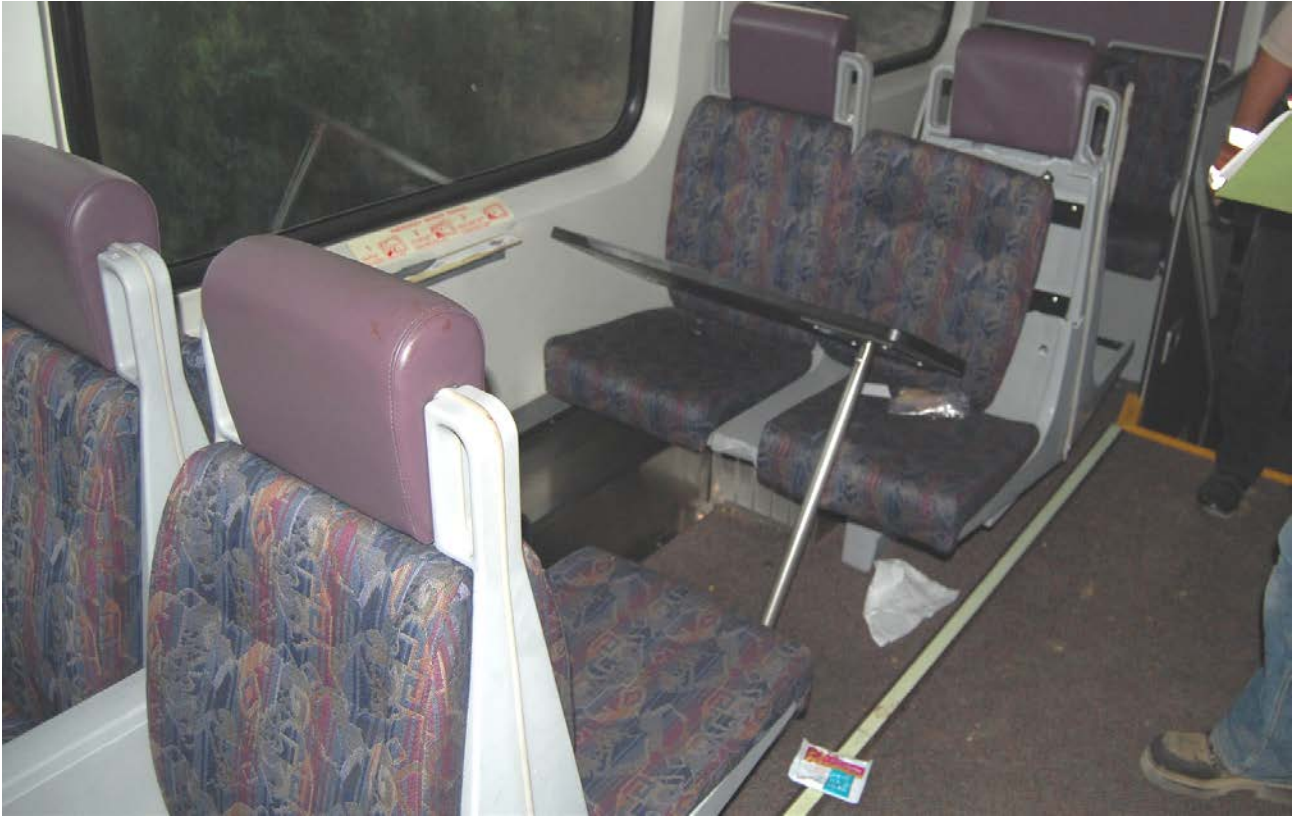
**Figure 22. Detached Table, Upper Level, Car #617**

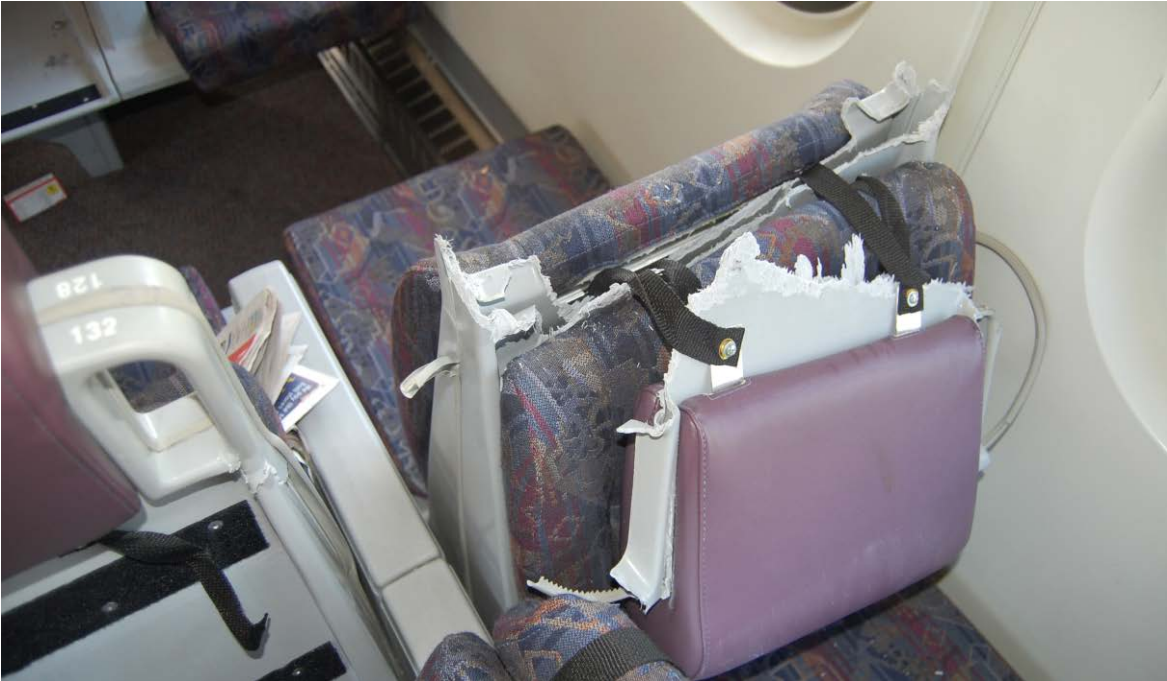
**Figure 23. Broken Head Rests in Lower Level, Car #617**
