Federal Railroad  
Administration

# Passenger/Freight Train Collision

## September 12, 2008, Chatsworth, CA:

### Main Report

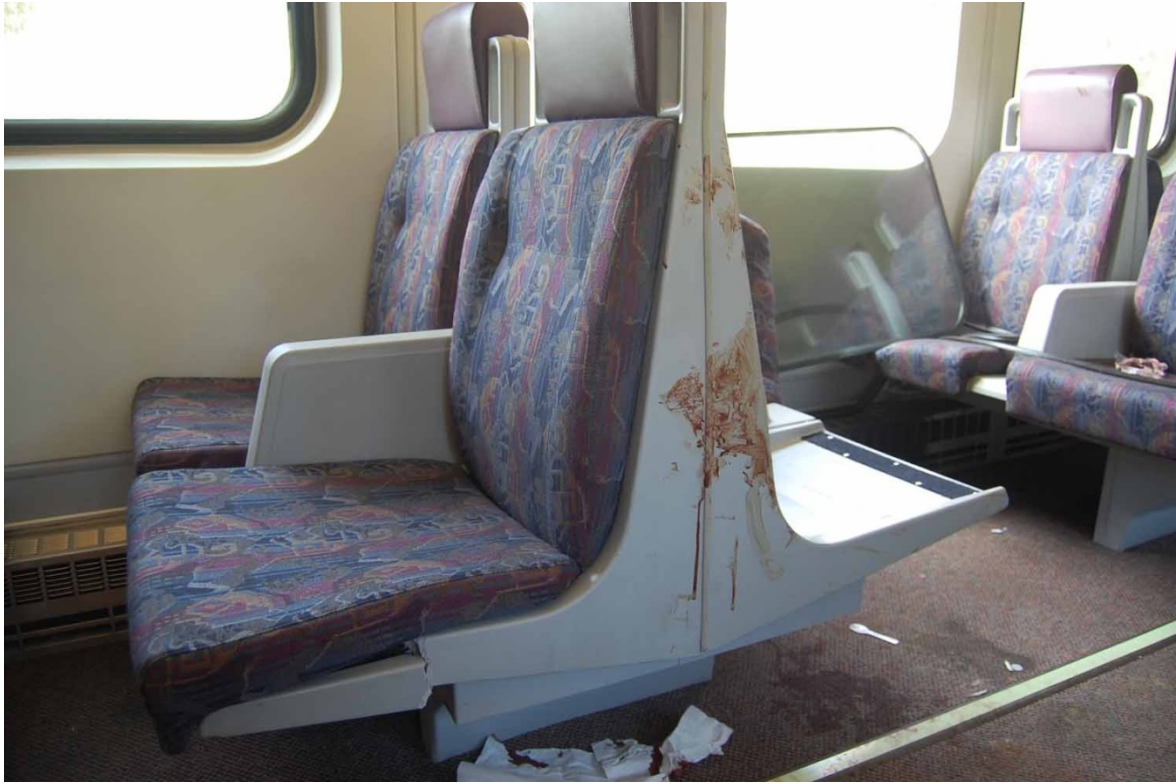
**Figure 24. Fractured Seat Pan, Front Mezzanine, Car #617**
