**Federal Railroad
Administration**

In-Track Demonstration of Laser-Treated Rail to Reduce Friction and Wear

1. AGENCY USE ONLY (Leave blank)		2. REPORT DATE May 2007	3. REPORT TYPE AND DATES COVERED	
4. TITLE AND SUBTITLE In-Track Demonstration of Laser-Treated Rail to Reduce Friction and Wear			5. FUNDING NUMBERS DTFR 53-00-C-00012 Task Order 226

9. SPONSORING/MONITORING AGENCY NAME(S) AND ADDRESS(ES) U.S. Department of Transportation Federal Railroad Administration Office of Research and Development, MS 20 1120 Vermont Avenue, NW Washington, DC 20590			10. SPONSORING/MONITORING AGENCY REPORT NUMBER DOT/FRA/ORD-07/17

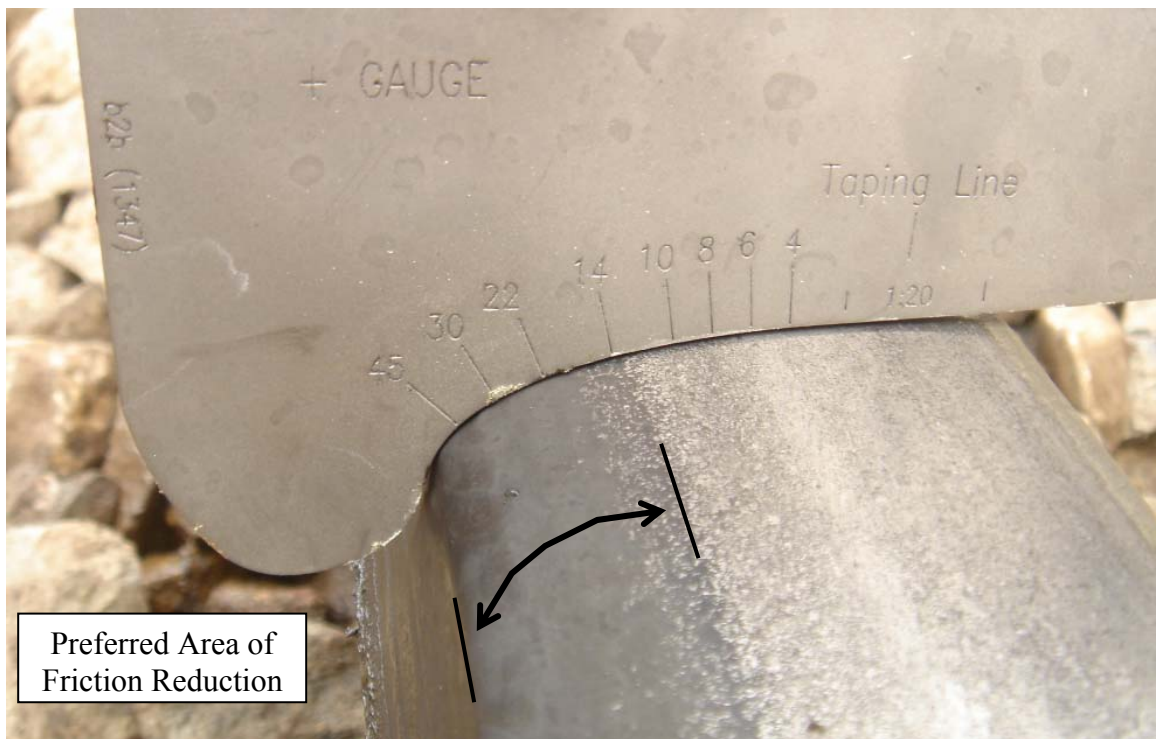
Figure 2. A Typical Rail Showing Dark Grease in Area that Should Have Reduced Friction

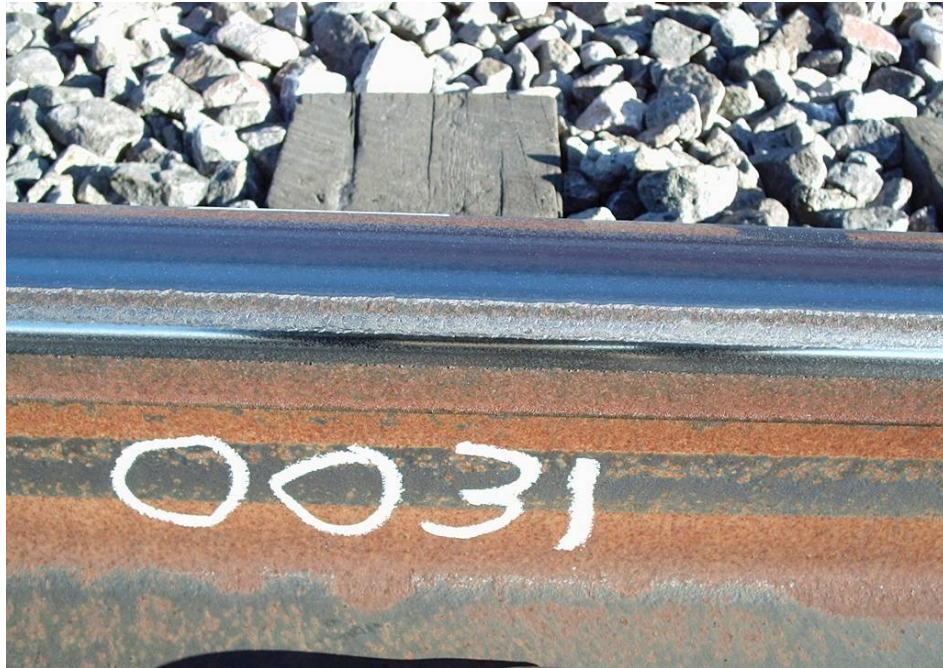
Figure 6. Control Rail After 1.2 MGT. Compare with Figures 14 and 15, Same Location After 5.6 MGT

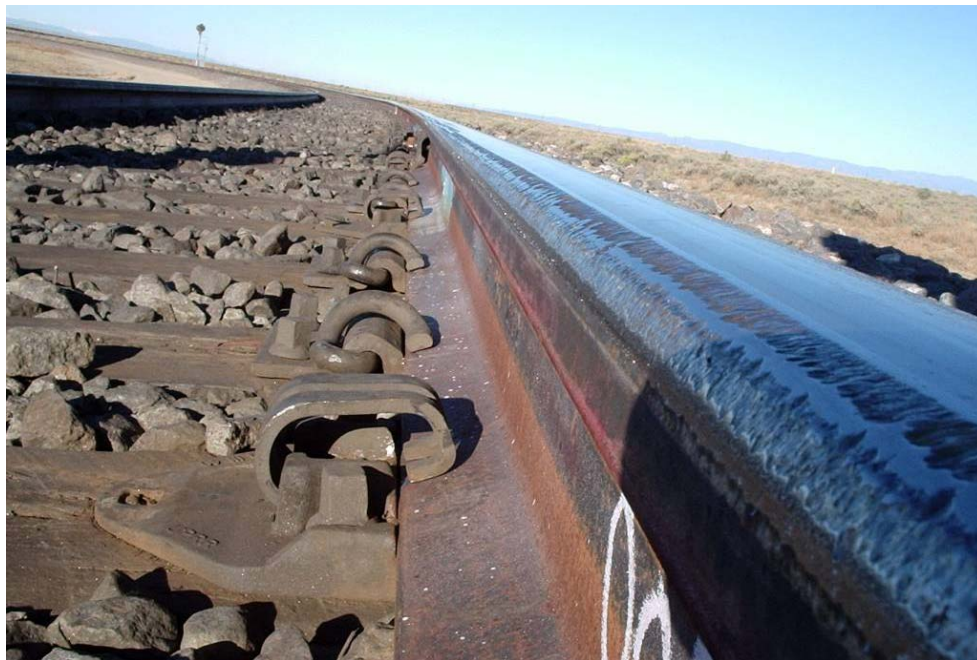
Figures 7 through 12 show the laser-treated rail surface conditions after 1.2 MGT of traffic. In Figure 7, note the smoothed gage corner, where most of the wheel contact appears to have occurred as compared to Figures 3 and 4, which show the gage corner before operating any trains and show no wear on the rail.

Figure 7. View Along Gage Corner, Looking in the Clockwise Direction After 1.2 MGT

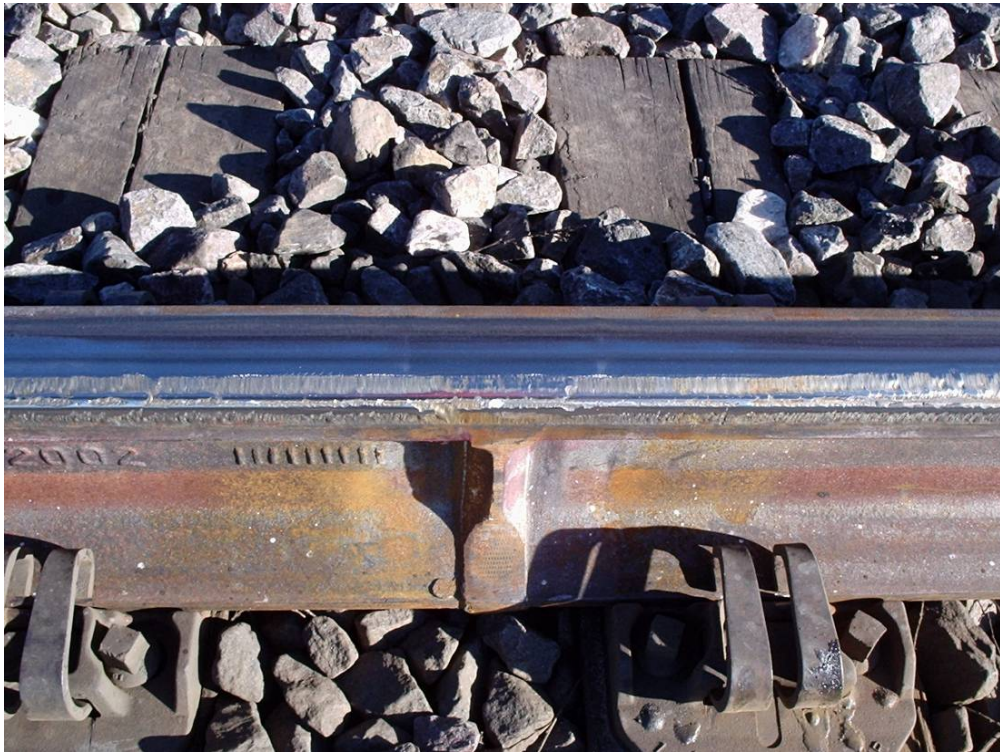
Figure 11. Overall View of Thermite Weld in Laser-Treated Section After 1.2 MGT. Compare with Figure 19 at the Same Location After 5.6 MGT

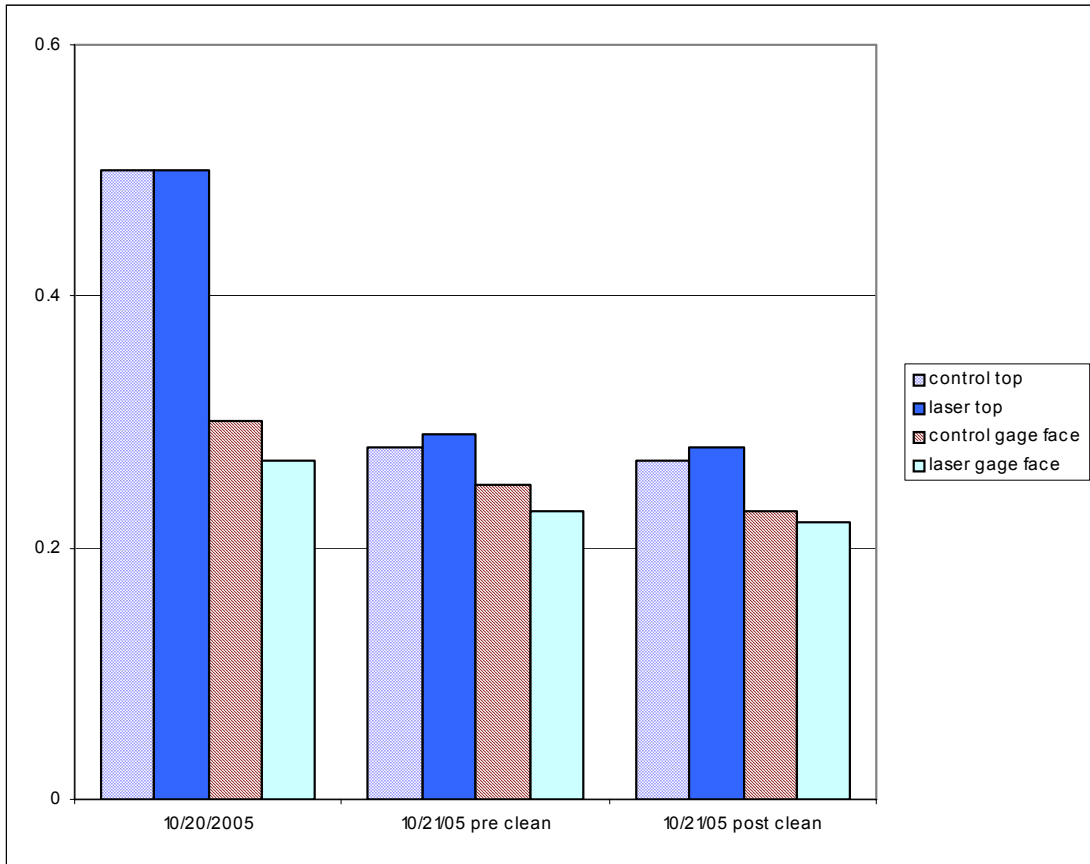
During the initial 5.6 MGT, tribometer data indicated almost no significant difference between the laser-treated and untreated surfaces, as summarized in Figure 13.

Figure 13. Summary of Tribometer/Friction Data Showing Only a Slight Reduction or No Change Between the Laser-Treated and Untreated Surfaces

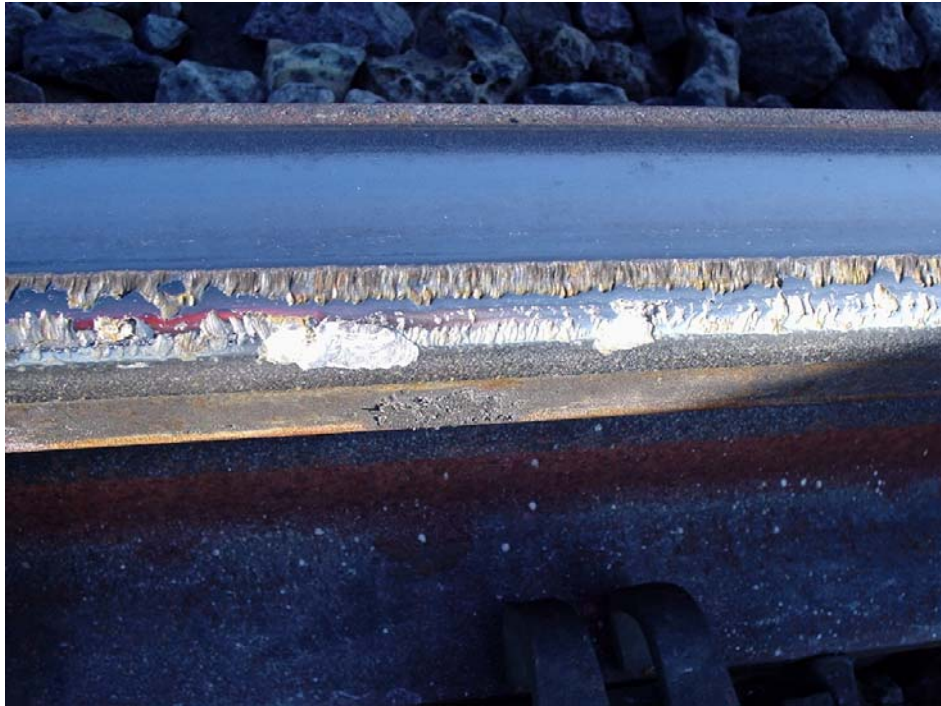
Figure 17. Laser-Treated Rail After 5.6 MGT Showing Two Spalls. Compare with Same Location as Shown in Figures 9 and 10 After 1.2 MGT

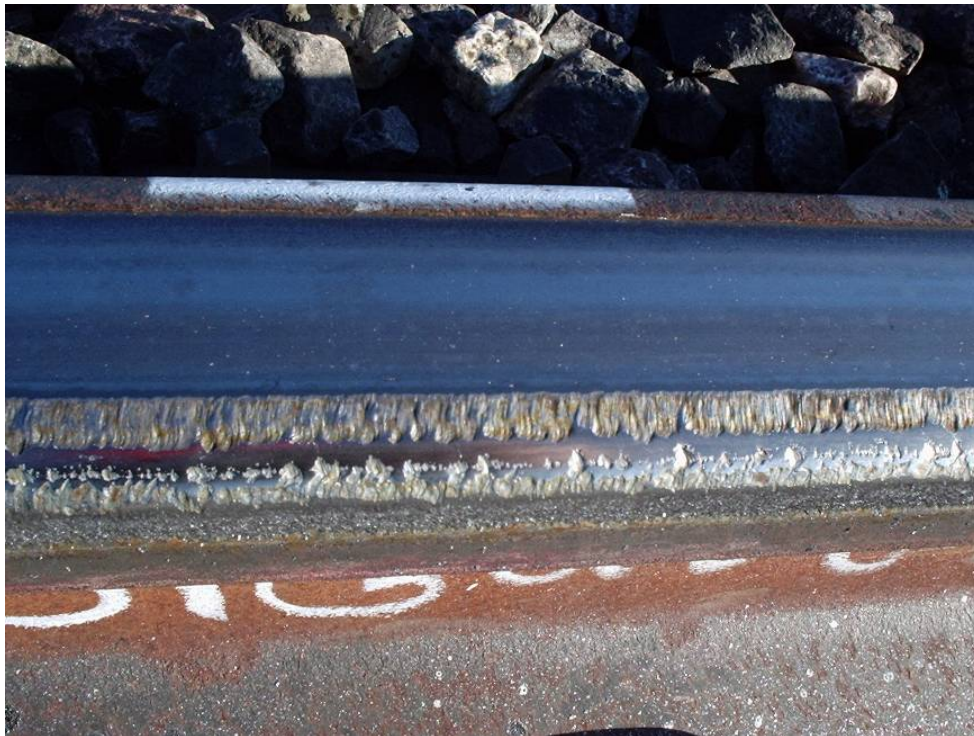
Figures 17 through 20 show various locations along the laser-treated rail after 5.6 MGT. Figure 18 shows the smooth gage corner from contact with wheels but with large valleys and rougher surface of laser-treated area. Figure 19 shows spalling at the center and each side of the thermite weld; compare with the same location shown in Figure 11 after 1.2 MGT.

Figure 18. Typical View of Gage Corner on Laser-Treated Rail, No Spalls. Compare to Figures 3 and 4, Which Show the Gage Corner Before Train Operation

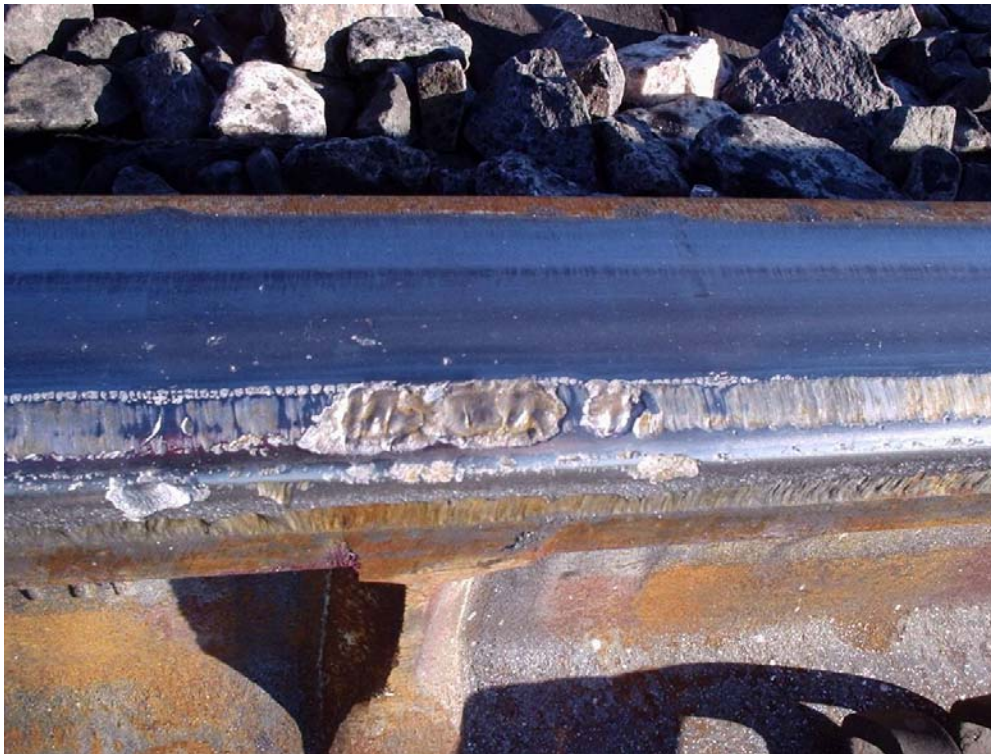
Figure 20. Close View of Spalls At and Near Thermite Weld After 5.6 MGT. Compare with Same Location as Shown in Figure 12 After 1.2 MGT

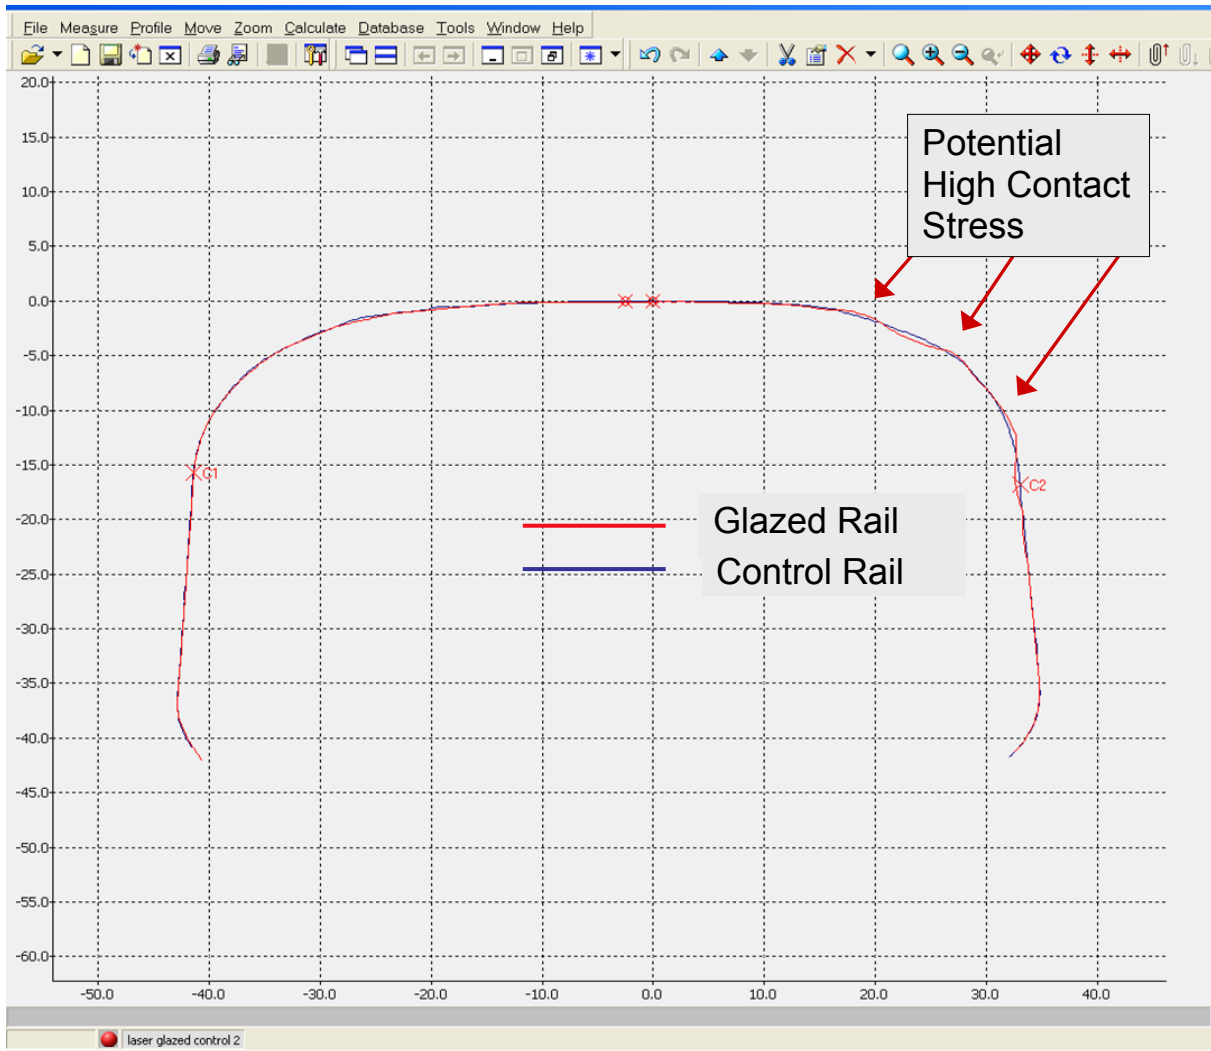
One issue that may have accelerated the development of spalls and chipping is that the laser treatment appears to have very slightly altered the rail's profile. Examination of Figure 21 shows an overlay between a new 141 AB rail and the laser-treated 141 AB rail sections. The profile of the glazed/treated rail has minor bumps that are higher than the original profile. These locations likely make more frequent contact with passing wheels and would create much higher contact stresses until they are worn down or away. During the brief 5.6 MGT of exposure to traffic, it appears that many of these bumps resulted in chips and spalls.

Figure 21. Overlay of Control (untreated) and Laser-Treated Rail

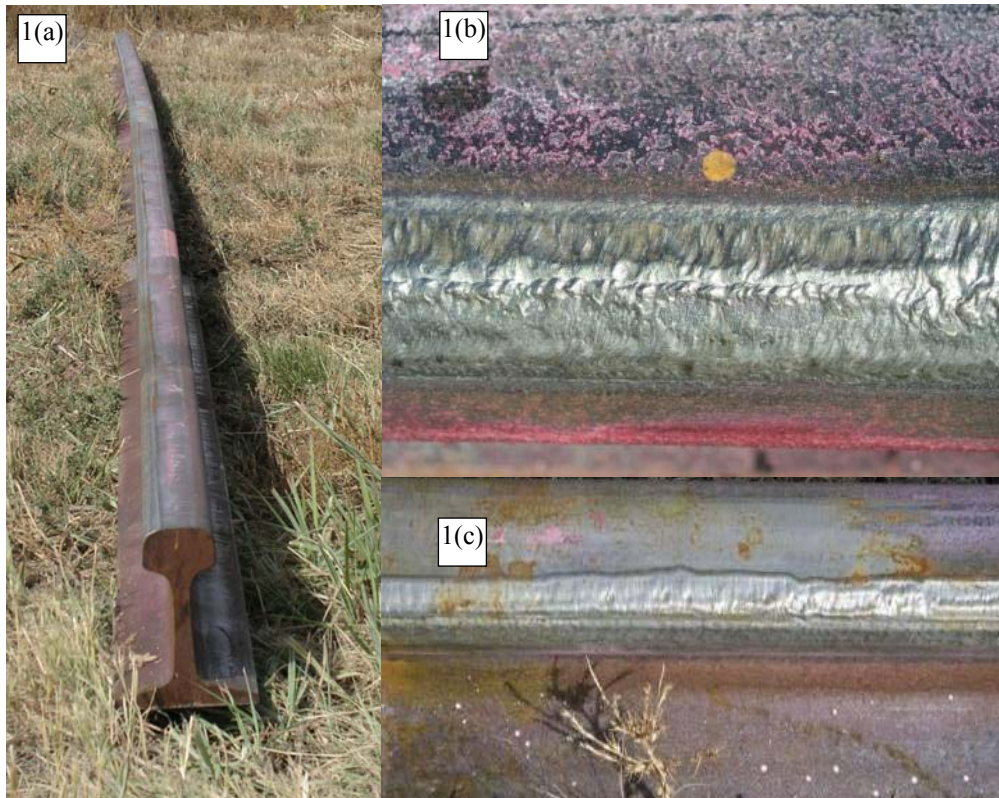
Figure A-1. Figure 1(a). Laser-Glazed Treated Rail, Figure A-1(b). Rough, and Figure A-1(c). Uneven Glazed-Treated Gages for the Untested Rail

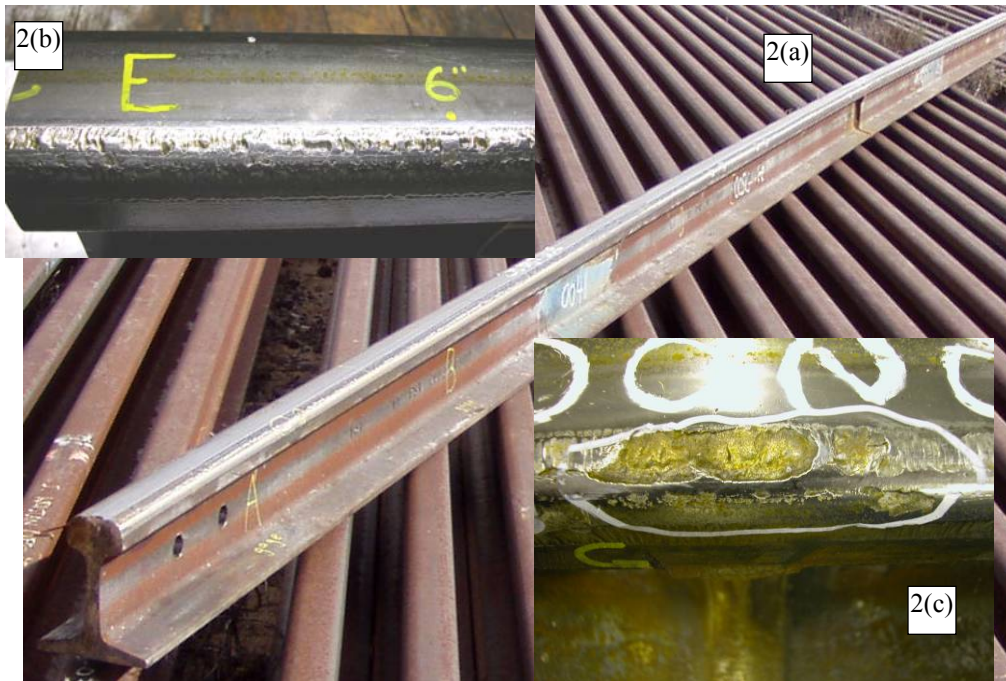
Figure A-2. Figure A-2(a) Rail Removed from FAST Facilities After Approximately 5.6 MGT of HAL Traffic, Figure A-2(b). Macro-Picture Showing Severe Wear, and Figure A-2(c). Macro-Picture Showing Shelling Regions of the Laser-Glazed Rail

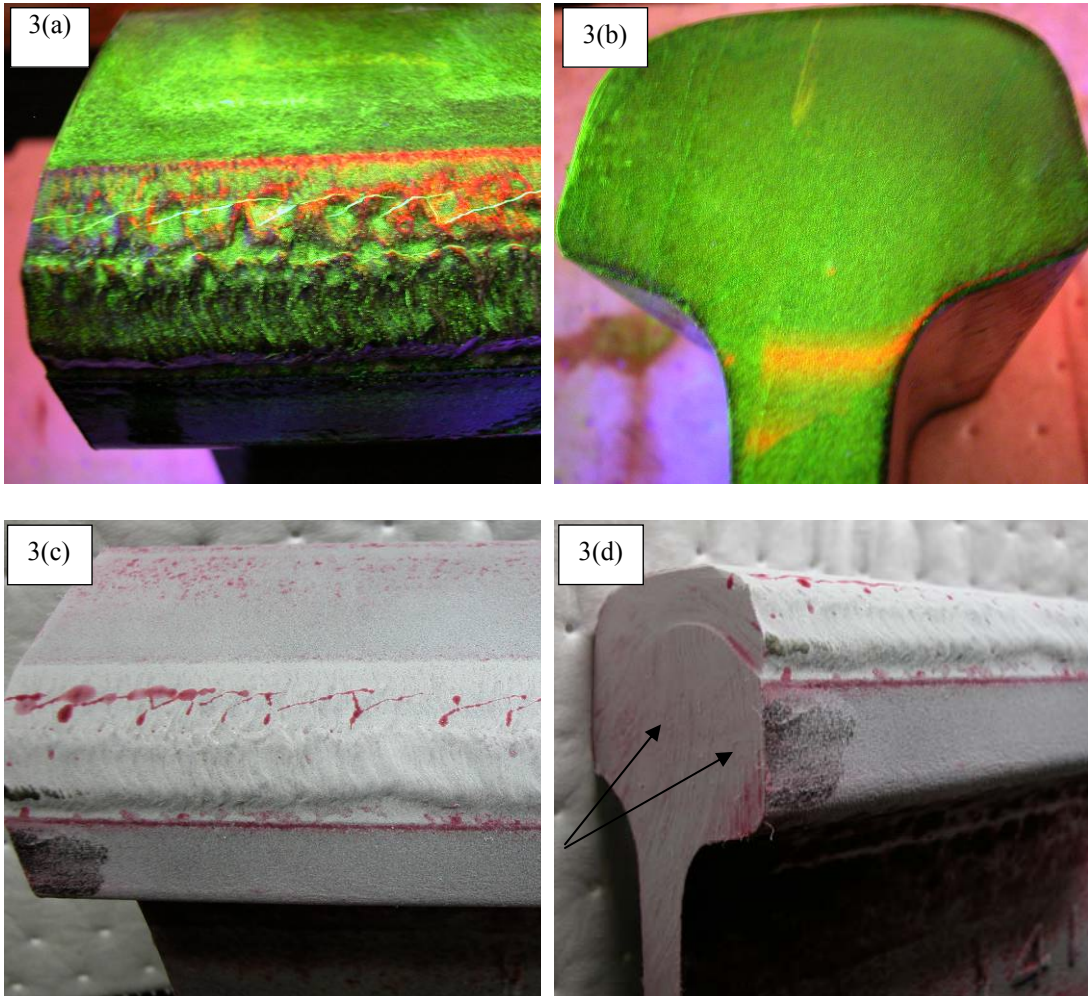
A 6-foot piece of the rail was cut from the original rail sample. This section was used for the present metallurgical analysis in order to compare the effect of HAL traffic on the integrity of the glazed rail. The visual examination showed no cracks on the glazed regions; however, using magnetic particle and liquid penetrant inspections, several cracks were identified particularly along the regions where the two laser-glazed treatments overlap, as shown in Figures A-3(a) and 3(c). No cracks were revealed in the cross section (Figures A-3(b) and 3(d)) of the rail by NDT techniques.

Figure A-3. Figures A-3(a) and 3(b). Macro-Pictures of the Laser-Glazed Rail Analyzed with Magnetic Particles. Figures A-3(c) and 3(d). Liquid Penetrant (Arrows in 3(d) Show Damage Caused with the Cutting Tool)

The damage revealed by the NDT of the laser-glazed treated rail removed from FAST shows more severe damage at the gage corners when compared to the non-service tested rail. This damage is the result of increased susceptibility of the laser-glazed treated regions to cracking and shelling. Figure A-5 shows pictures of the magnetic particle analysis of the gage regions and the cross section of the rail. In the cross section of the rail, no cracks were revealed by the NDT methods used.

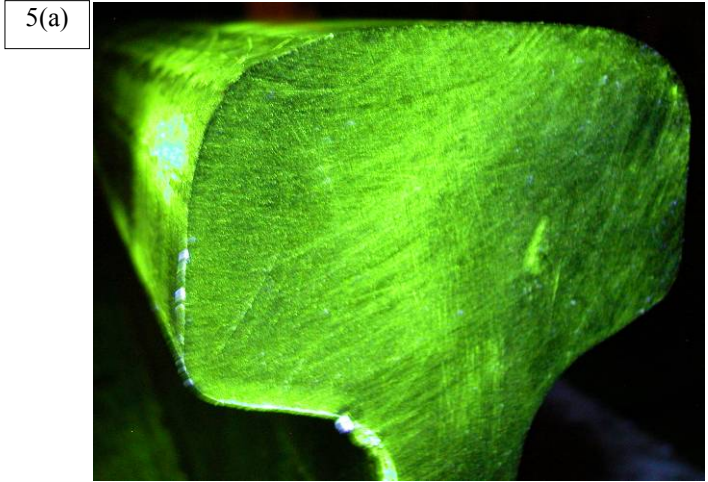
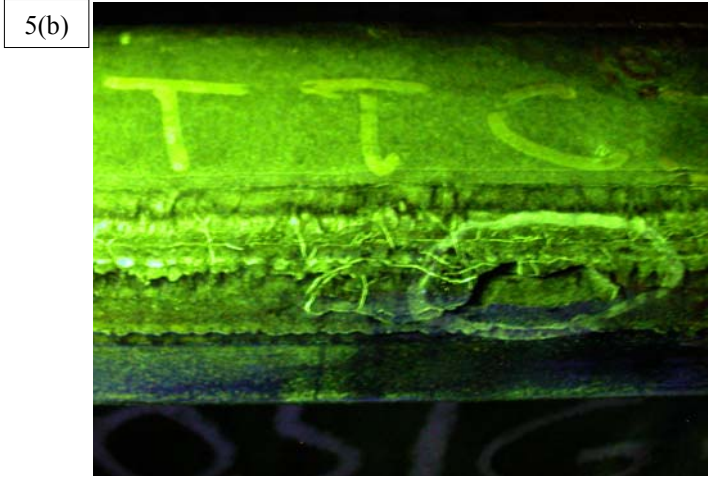
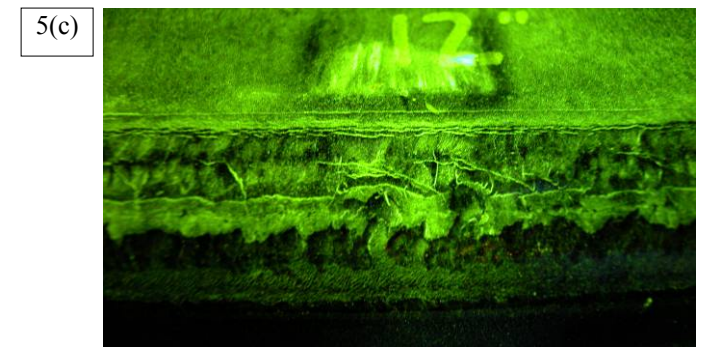
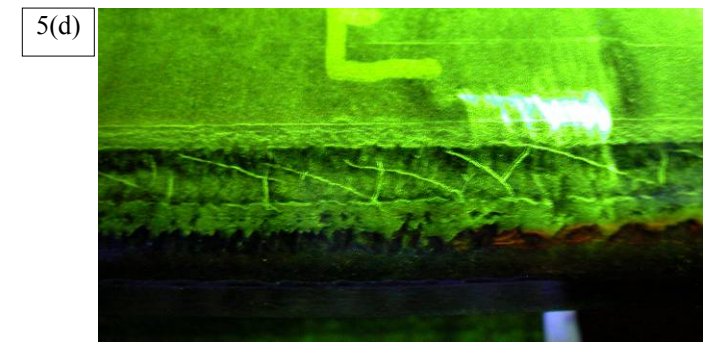
Figure A-5. Photographs of Magnetic Particles Analysis of Various Sections of Laser-Glazed Rail After Removal from FAST at Approximately 5.6 MGT of HAL Traffic Showing No Cracks in Cross Section of Rail.
Figure A-5(a). Section Showing Shelling at the Gage Corner of the Rail.
Figure A-5(b). Extended Cracks Along the Gage Corner of the Rail.
Figures A-5(c) and A-5(d). Compare with Laser-Glazed Non-Service Tested Rail that Presents a Less Severe Damage

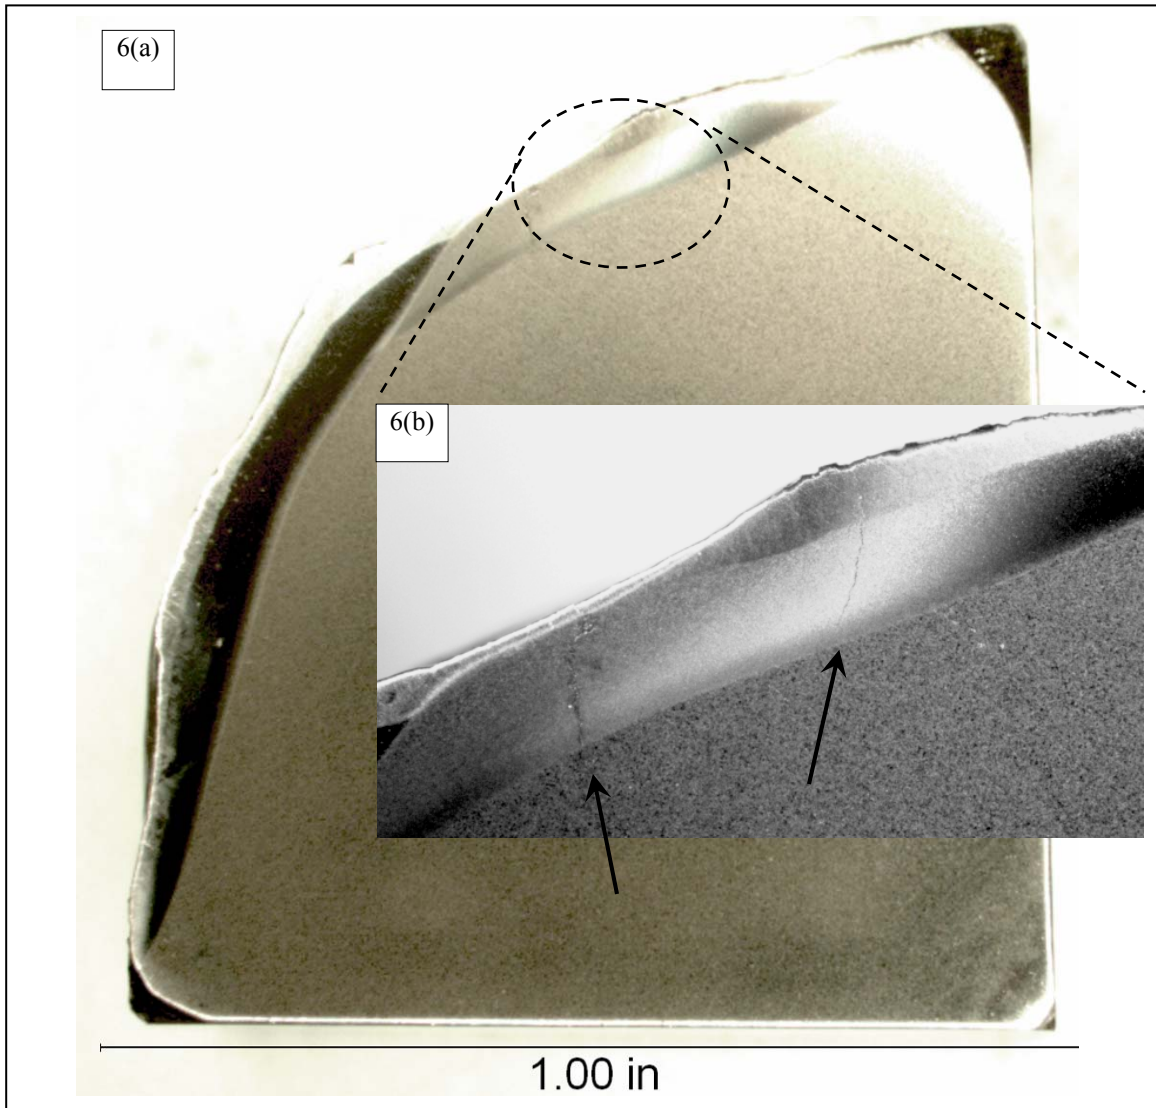
Figures A-6(c) and 6(b) show that for the non-service tested rail, the macrographs of the laser-glazed (gage, Figure A-6(b)) and (field, Figure A-6(c)) sections of the rail. The macrographs were taken at magnifications of 3.5x for Figure A-6(a), 45x for Figure A-6(b), and 3.5x for Figure A-6(c). In the gage side of the rail, cracks were found along the glazed regions. In all cases, the cracks did not propagate past the interface between the glazed region and the parent rail material. In contrast, the field side of the rail did not have cracks present.

Figure A-6. Macrographs of Laser-Glazed Treated Rail at Gage Corner Showing Cracks Across Glazed Areas. Arrows Point to Cracks.
Figure A-6(a). Macrograph with 3.5x Magnification
Figure A-6(b). Macrograph with 45x Magnification

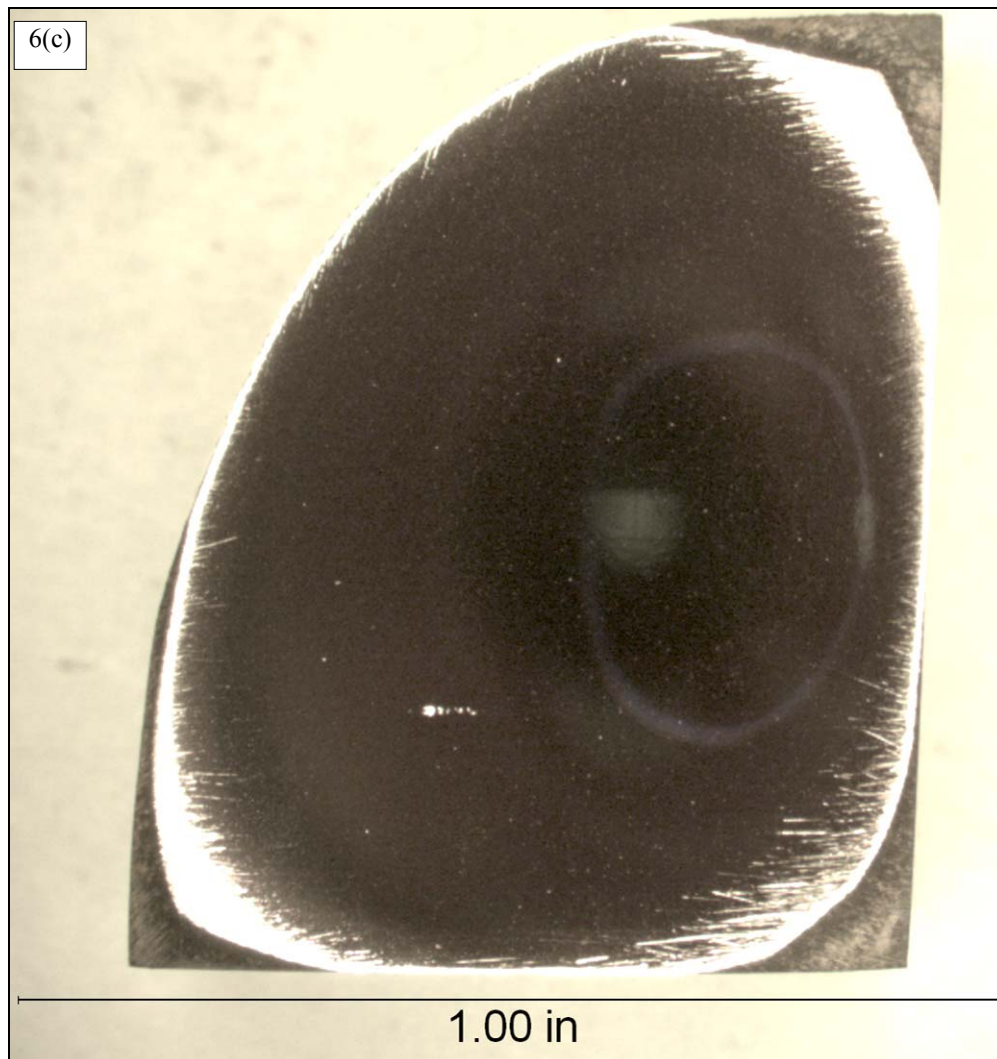
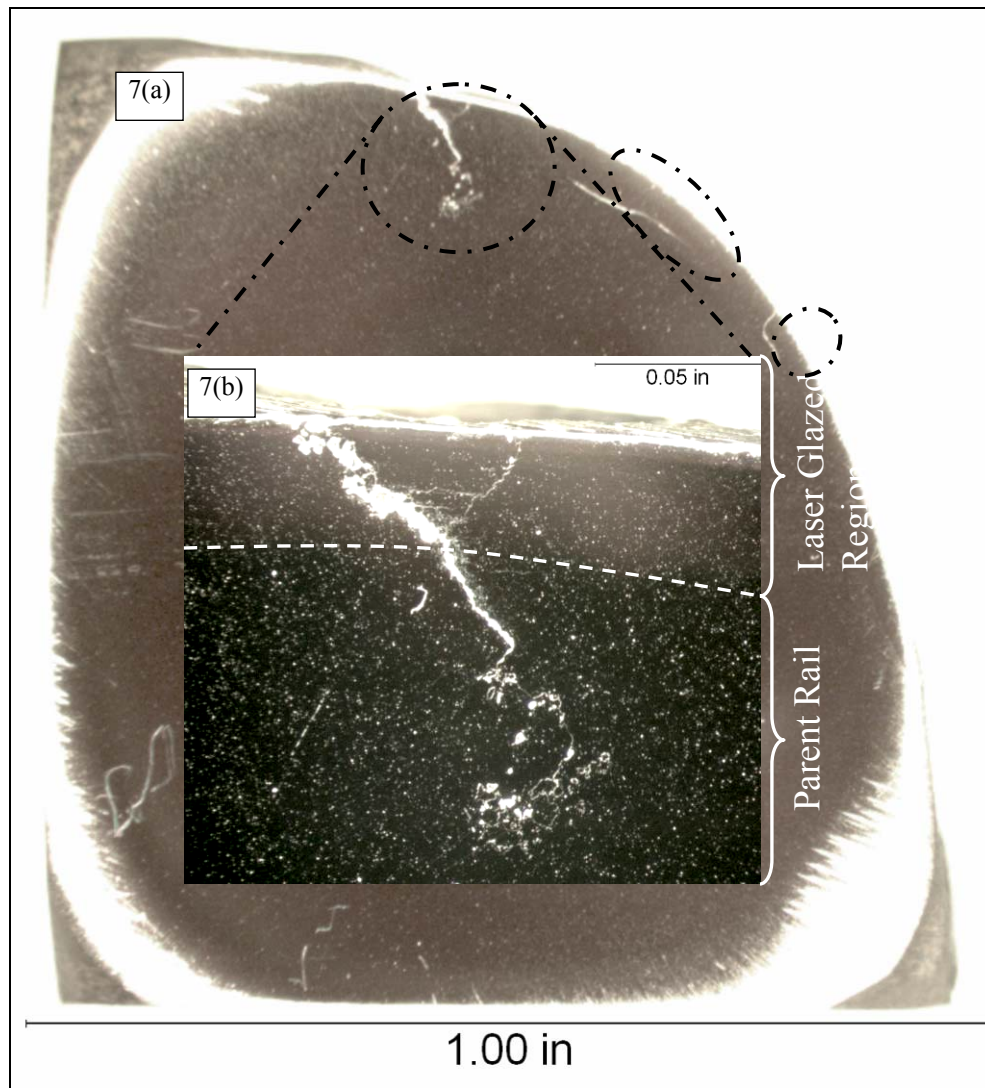
Figure A-7 shows macrographs with magnifications at 3.5x (Figure A-7(a)) and 45x (Figure A-7(b)) of the gage side of the laser-glazed rail removed from FAST after approximately 5.6 MGT of HAL traffic. Cracks were observed at the gage region within the glazed areas. The circled areas show the cracks on the glazed region and parent rail material. Comparing Figures A-7(a) and 7(b) with Figures A-5(b) through 5(d), it is clear that an increase in the severity of the damage observed in the gage corner of the rail increased under HAL traffic. The stereoscopic analysis further confirms the previously mentioned damage on the microstructure of the laser-glazed rail. In addition, not only were perpendicular cracks to the glazing region identified, but also the cracks going into the parent rail branched, resulting in a web of cracks. The branched cracks can act as stress concentrators that promote premature failure of the rail particularly under cyclic fatigue conditions. Figure A-6(b) shows that the samples extracted from the field side from the non-service and service-tested samples did not contain areas with cracks or other damage associated with the laser-glazing process.

Figure A-7. Macrographs of the Laser-Glazed Treated Rail Removed from FAST After Approximately 5.6 MGT of HAL Traffic

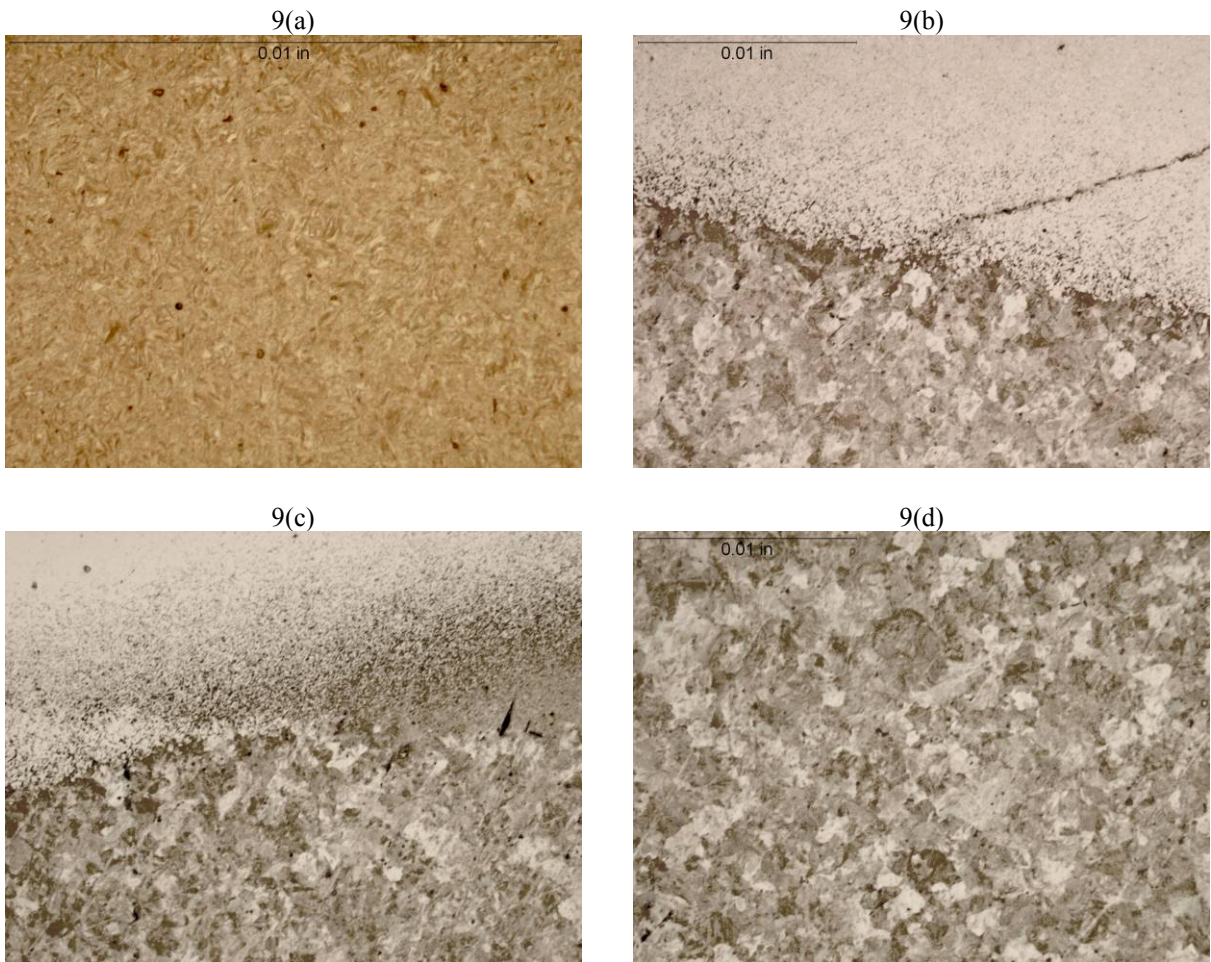
Figure A-9 shows the etched microstructure of the glazed regions and parent rail material for the non-service tested rail. It shows the various microstructures presented by different zones of the rail in the glazed region (selected areas from Figure A-8). Figure A-9a shows the presence of martensite that is evident at magnifications of 200x and 500x. At 200x it can also be observed that the cracks end at the interface between the glazed region (martensite) and the unaffected parent material (pearlite; Figure A-9(b)). Figure A-9(c) shows overlapping of the two glazing treatments. Some porosity along the interface of both regions can be observed at 200x in (Figures A-9(b) and 9(c)). The porosity was presumably created during the glazing treatment and is detrimental to the integrity of the rail. Figure A-9(d) at 200x shows a fully pearlitic region found in the parent rail material.

Figure A-9. Etched Microstructure of the Glazed Regions and Parent Rail Material for the Non-Service Tested Glazed Rail. Figure A-9(a). Martensite (500x). Figure A-9(b). Crack Stopped at Interface Between Glazed Region and Unaffected Parent Rail (200x). A-9(c). Overlapping of Two Glazing Treatments (200x). Figure A-9(d). Peralitic Region in Parent Rail Material (200x)

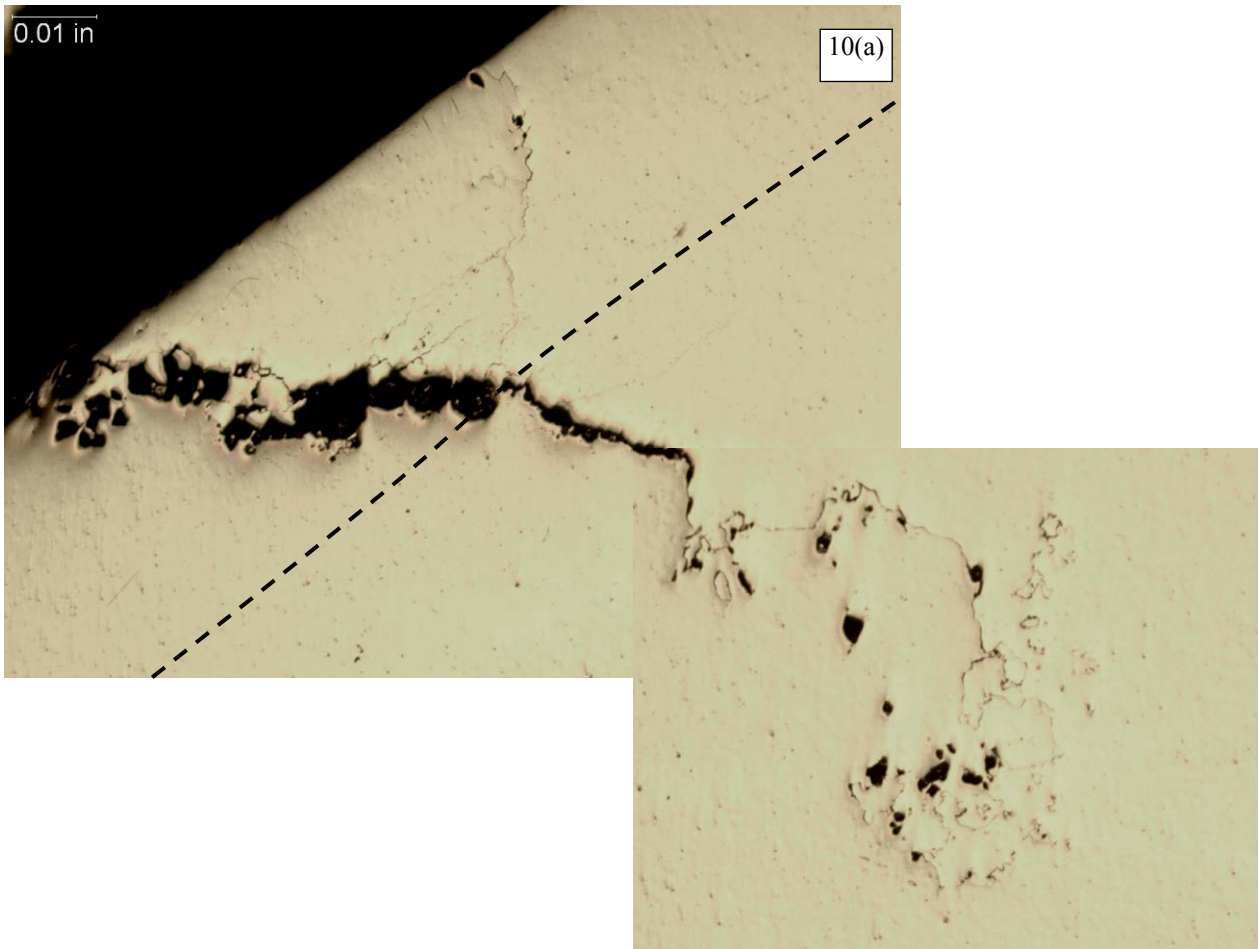
Figure A-10 shows the polished microstructures of the glazed region of the service-tested rail. The number, location, and severity of the cracks observed on the gage sides for the service-tested rail (5.6 MGT of HAL traffic at FAST) has increased considerably. For instance, Figure A-10(a) shows a crack that ended at the interface between the glazed region and the parent rail material and a crack that ramified into the parent rail material. Figure A-10(b) shows a crack along the glazed region of tested rail removed from FAST after approximately 5.6 MGT of HAL traffic. This crack was likely created from the shelling of the glazed treated surface under HAL traffic. Figure A-10(c) shows a crack across the laser-glazed region where both laser-glazed treatments overlap. In both ends the crack ramified (arrows indicate the interface). It is a good example of the possible residual stresses created due to the glazing treatment that created regions highly susceptible to cracks. This is further assisted by the martensite formation. The above-mentioned residual stresses promote susceptibility to crack formation, in particular to cracks in the gage surface and the interface between the glazed regions and the parent rail material. This accelerates the progress of shelling.

Figure A-10(a). A Crack Ending at the Interface Between the Glazed Region and Parent Material and a Crack that Ramified Into the Parent Rail Material

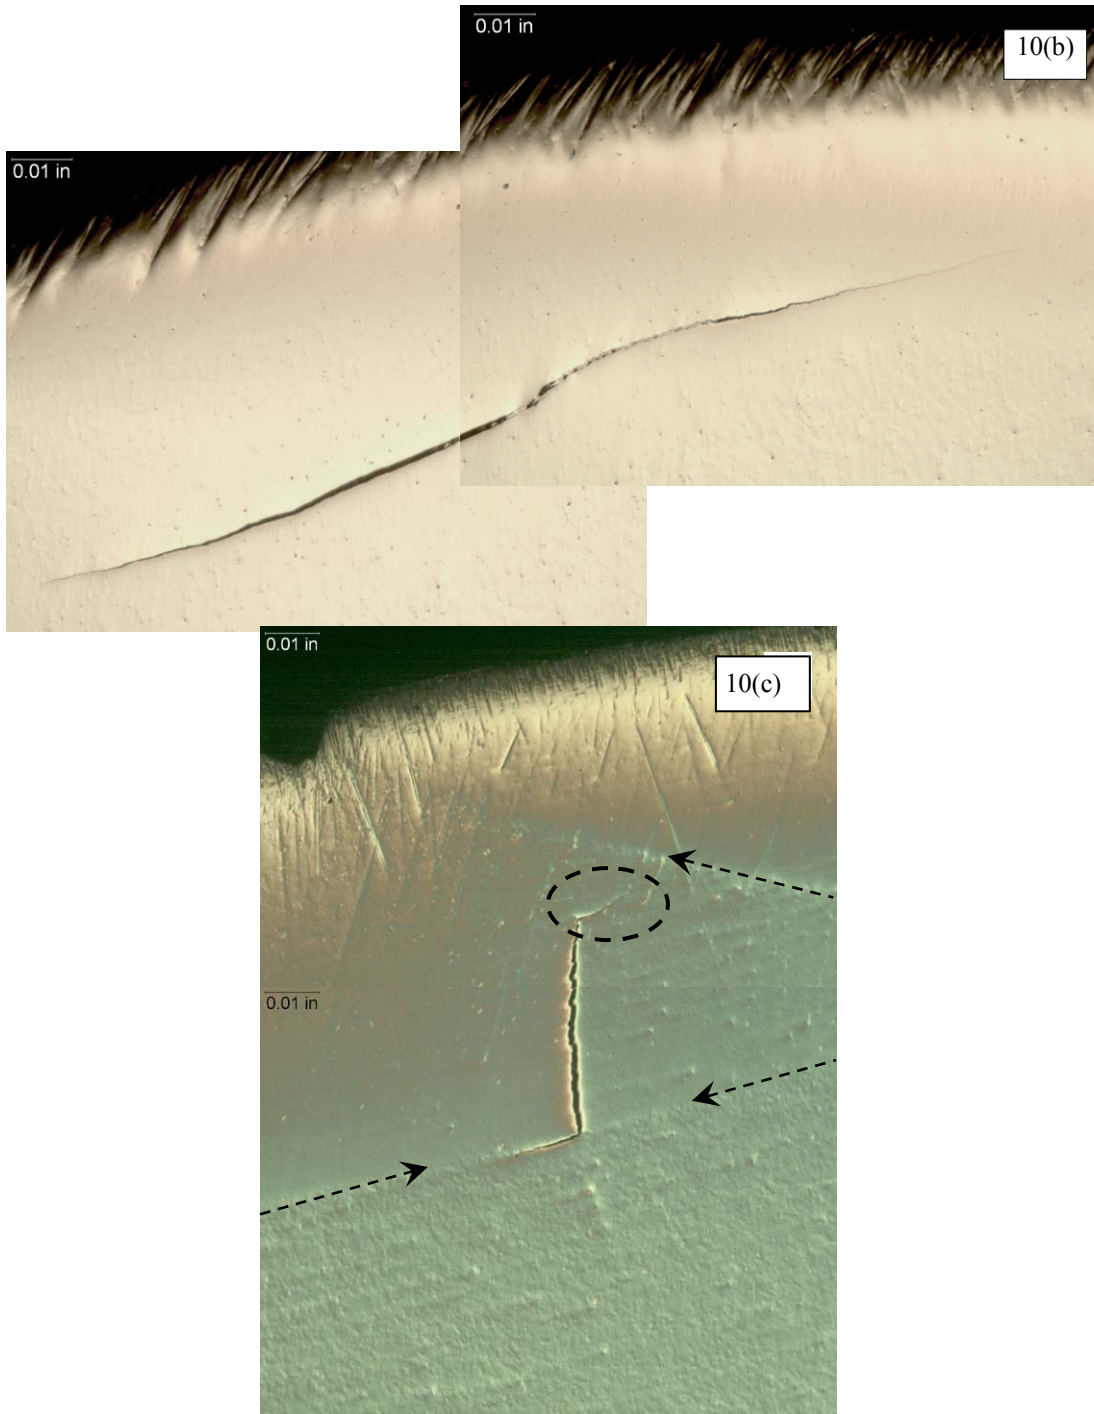
**Figure A-10(b). A Crack Along the Glazed Region.
Figure A-10(c). A Crack Across the Laser-Glazed Region
Where Both Laser-Glazed Treatments Overlap**

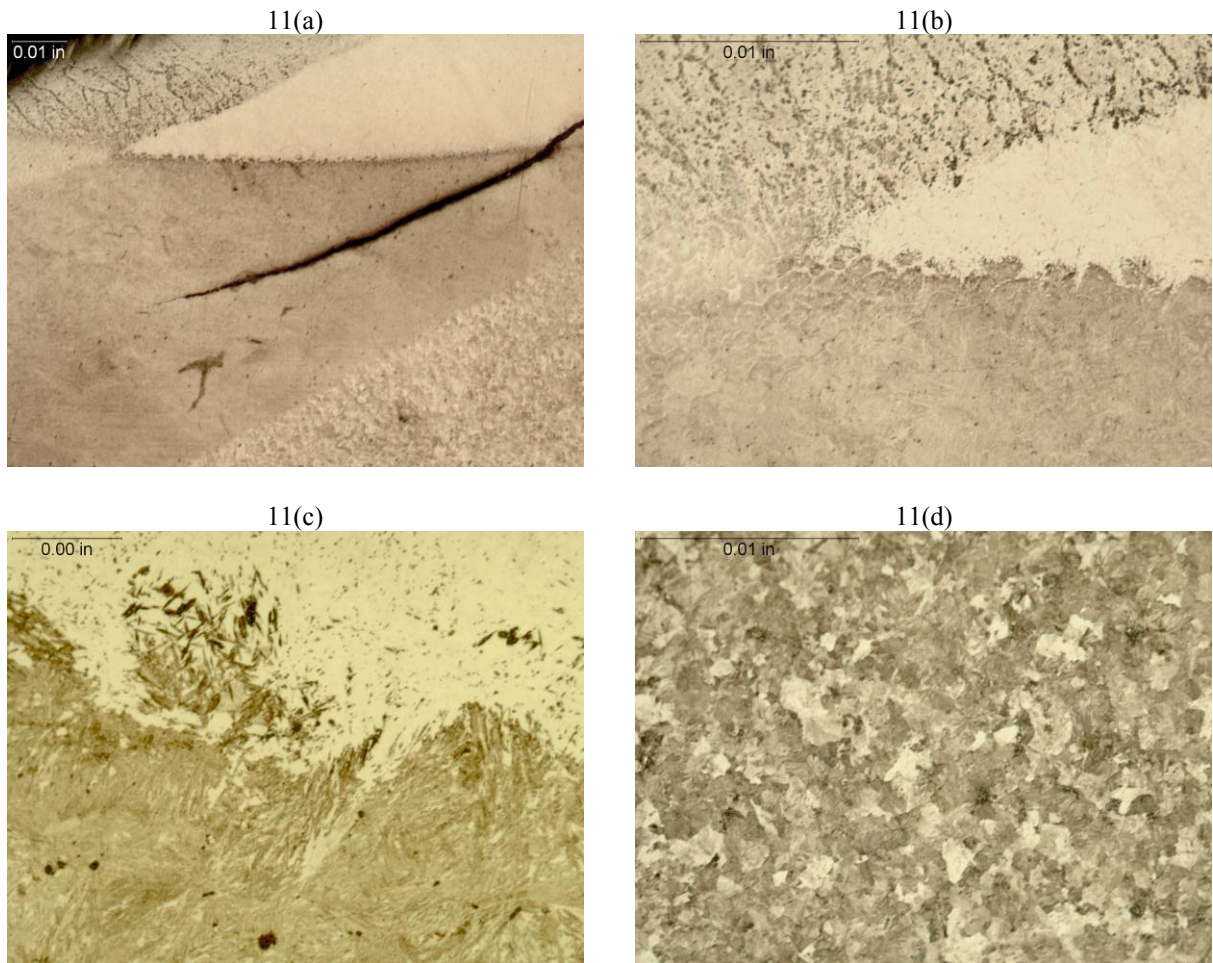
Figure A-11 shows the etched microstructure of the glazed regions and parent rail materials for the rail removed from service after approximately 5.6 MGT of HAL traffic. Micrographs in Figure A-11 are magnified areas of the micrographs shown in Figure A-9(b) after etching. Figure A-11(a) shows micrographs on the etched microstructure of the various phases that form in the microstructure. The regions where sequential glazing treatments overlap present sections with sharp edges acting as stress concentrators. These build up stresses that can be detrimental and can compromise the integrity and service characteristics of the rail, resulting in crack formation (Figure A-11(b)). Figure A-11(c) shows sharp needles of lath martensite that formed at the interface between the glazed region and the parent rail material. The microstructure of the parent rail material is comparable to the non-glazed rail (field section) that is fully pearlitic.

Figure A-11. Micrographs of the Etched Microstructure of the Service-Tested Glazed Rail.
Figure A-11(a). Affected Regions of the Rail by the Glazed Treatment (50x).
Figure A-11(b). Overlapping of Both Glazed Treatments (200x).
Figure A-11(c). Zones Showing Sharp Laths of Martensite (1,000x).
Figure A-11(d). Pearlitic Regions of the Parent Rail Material (200x)
