**Federal Railroad
Administration**

In-Track Demonstration of Laser-Treated Rail to Reduce Friction and Wear

1. AGENCY USE ONLY (Leave blank)		2. REPORT DATE May 2007	3. REPORT TYPE AND DATES COVERED	
4. TITLE AND SUBTITLE In-Track Demonstration of Laser-Treated Rail to Reduce Friction and Wear			5. FUNDING NUMBERS DTFR 53-00-C-00012 Task Order 226

9. SPONSORING/MONITORING AGENCY NAME(S) AND ADDRESS(ES) U.S. Department of Transportation Federal Railroad Administration Office of Research and Development, MS 20 1120 Vermont Avenue, NW Washington, DC 20590			10. SPONSORING/MONITORING AGENCY REPORT NUMBER DOT/FRA/ORD-07/17

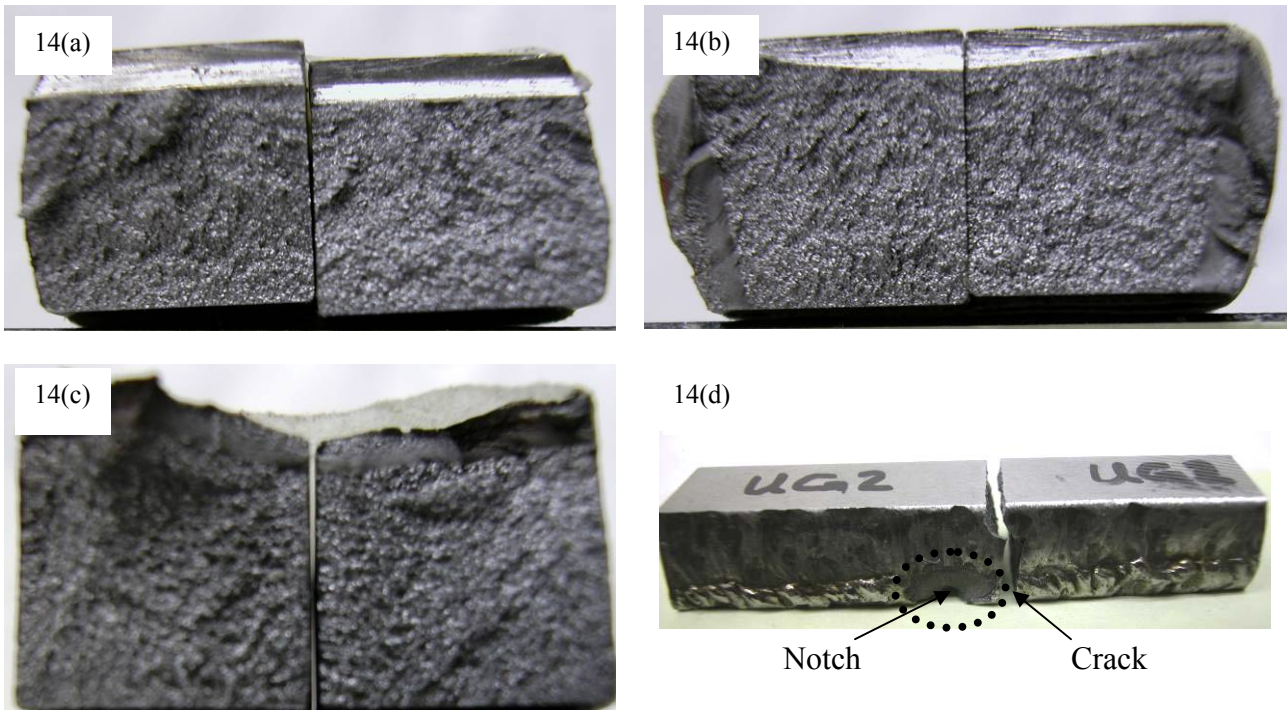
Figure A-14. Pictures of Selected Charpy Tested Samples Showing Fresh Fractures
