## **Office of Railroad Safety Summary Report**

**Derailed and Subsequent Hazmat Release on CSX Transportation  
Freight Train # S541-01**

**Maryville, Tennessee**

**July 1, 2015**

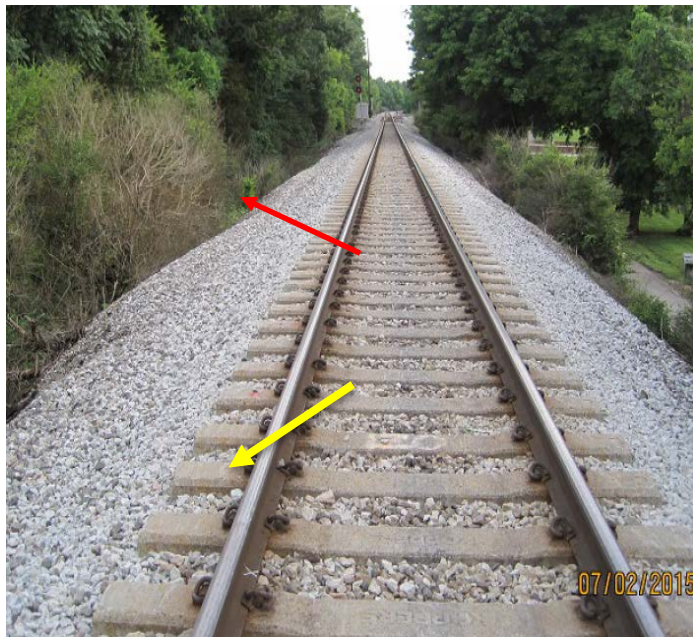
A burned-off roller bearing from UTLX 901717 was recovered near the initial point of derailment (POD) (*Figure 1*).

**Figure 1: POD (yellow arrow) and location of failed roller bearing (red arrow).**

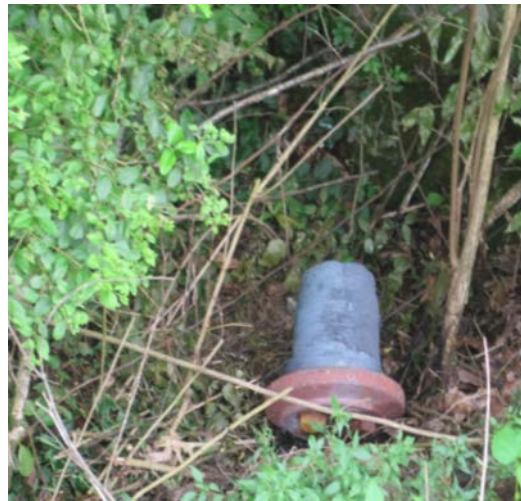
FRA's Investigators found a burned-off roller bearing near MP 282.6 on the east side of the tracks, 114 feet in the direction of travel (south) from the POD. (*Figure 2*).

***Figure 2: Burned-off roller bearing.***

The burned-off roller bearing was from the second (trailing) axle on the lead truck (A-end) of UTLX 901717. Parts of the truck were found scattered across the 8.5 miles the tank car traveled after it derailed. The second axle of the lead truck was found at the South End Singleton switch at MP 283.8, more than one-mile south of the POD (*Figure 3*).

A burned-off roller bearing was located near the POD. The roller bearing was from the second axle of the lead truck, which happened to be the A-End of the car. Therefore, in railroad nomenclature, the failed roller bearing was on the L-3 axle of UTLX 901717.

The probable cause of the derailment was the sudden overheating and failure of a roller bearing on the second axle of the lead truck of UTLX 901717.

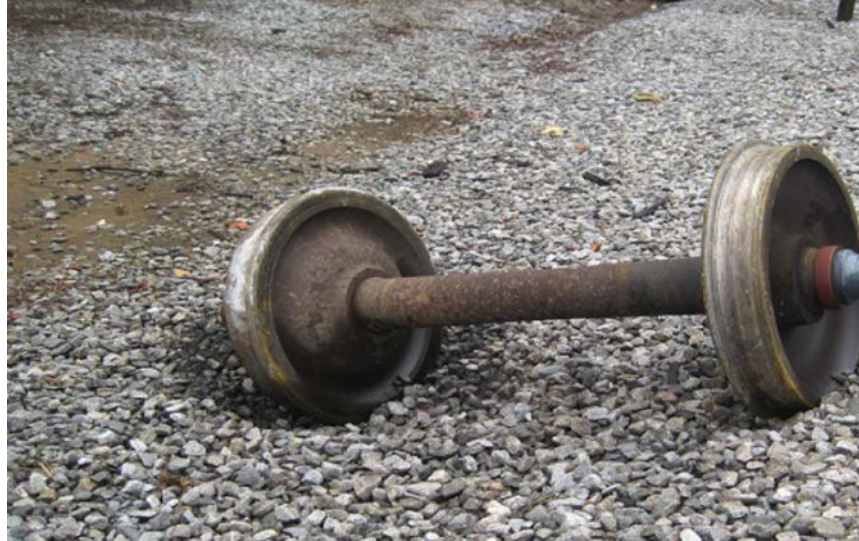
***Figure 3: Second axle of lead truck***

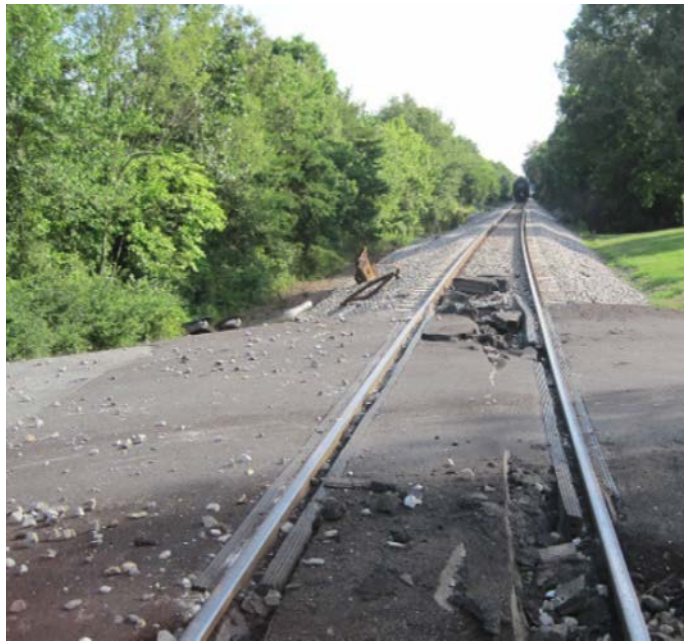
Visible damage to the railroad ties and highway-railroad grade crossings indicates that the lead truck traveled 8.5 miles before it disengaged completely from the underframe of UTLX 901717. Damage to the roadway surface was apparent at the Mt. Tabor Road highway-railroad grade crossing in Maryville, TN, at MP 290.62 (*Figure 4*).

***Figure 4: Mount Tabor Road grade crossing.***

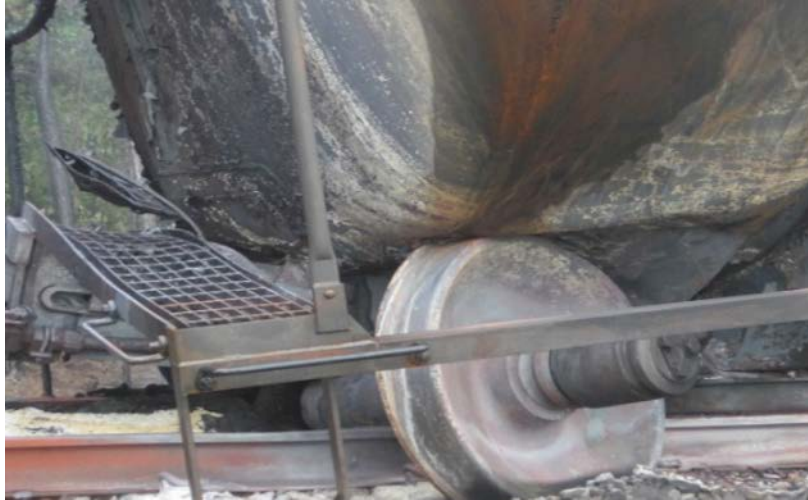
The lead axle of the lead truck on UTLX 901717 was broken in half (*Figure 5*). Investigators determined that the axle broke as a result of derailment, and was not the cause of the derailment.

**Figure 5: Lead axle of lead truck on UTLX 901717**

Once UTLX 901717 derailed, the forces from the derailed truck likely caused the lead axle to break. When the axle broke, the friction from wheel contact burned through the tank shell. These openings allowed the flammable lading to leak, and sparks from the excessive friction heating or steel on steel contact ignited the substance and created the fire.

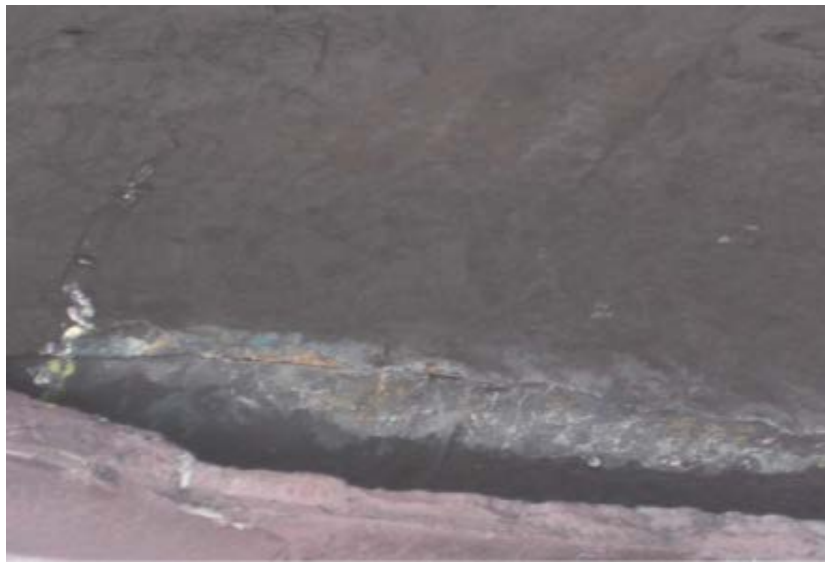
Because the axle broke in half, the wheels came in contact with the tank shell, and friction caused the wheels to burn through the underside of the tank car's shell (*Figure 6* and *Figure 7*).

**Figure 6: Burn through of tank shell located at the outboard A-end right side of draft sill.**

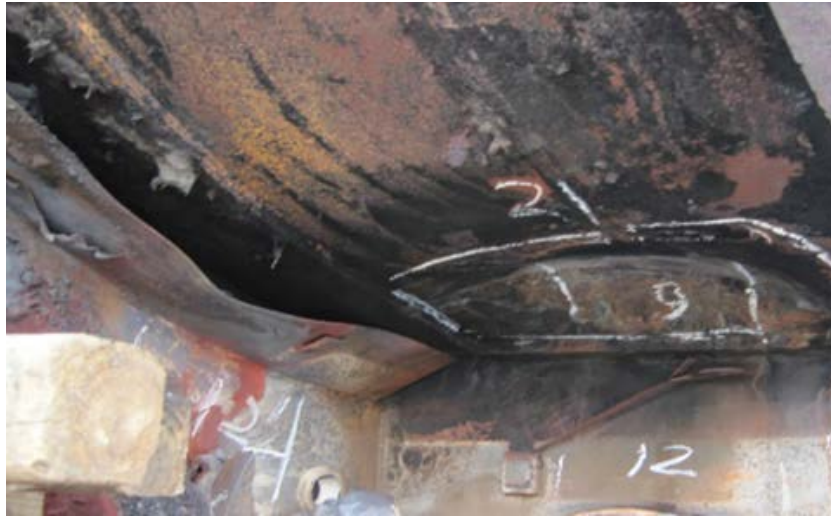
**Figure 7: Burn through of tank shell on the outboard A-end, left side of draft sill.**

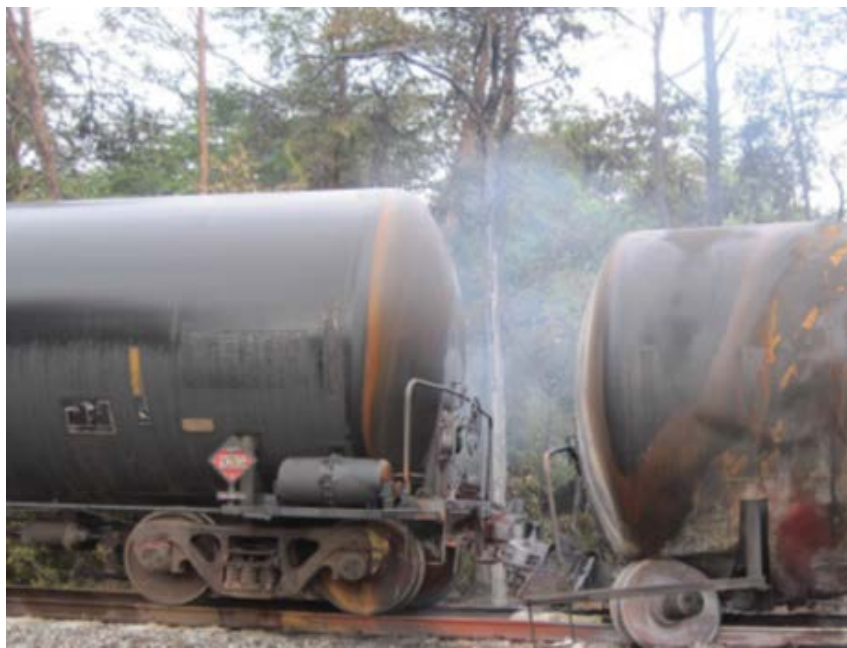
These breaches allowed the acrylonitrile to leak. Sparks or excessive heat buildup from the steel on steel contact likely ignited the substance resulting in the fire (*Figure 8*).

Over the course of approximately 20 hours, approximately 24,710 gallons of acrylonitrile ignited as it leaked onto the ground where UTLX 901717 came to rest. Due to environmental concerns, Emergency Responders made the decision to let the fire burn and consume the liquid, acrylonitrile, to prevent it from soaking into the ground rather than extinguishing the fire. The trailing truck of UTLX 901717 did not derail (*Figure 9*). UTLX 901717 and the adjacent leading tank car were both impinged upon by the fire resulting from the ignition of the acrylonitrile.

**Figure 8: The A-end of UTLX 901717 and B-end of the adjacent car UTLX901708.**

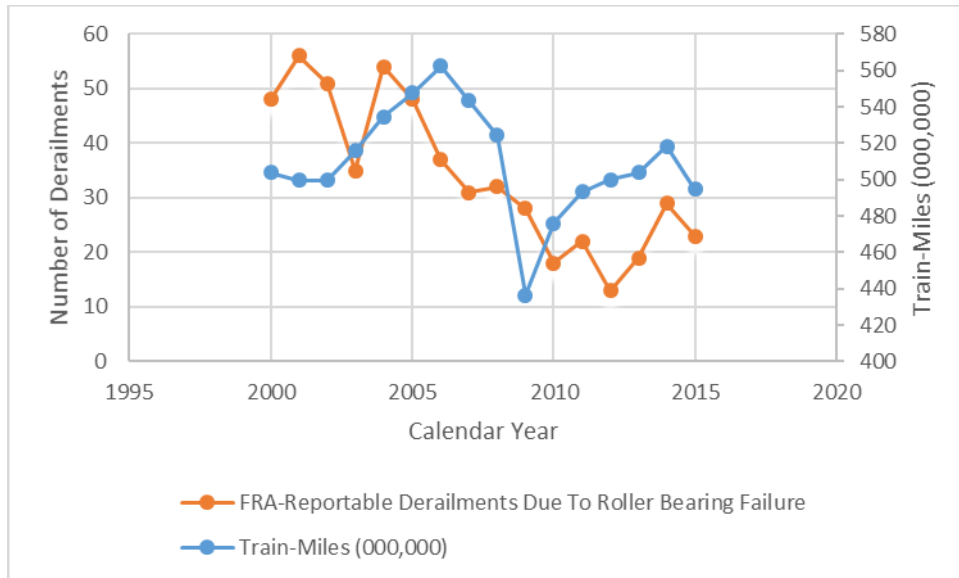
In support of the field investigation, FRA reviewed 15 years of data for reportable derailments, focusing on derailments caused by roller bearing failures. An analysis of the data indicates that industry as a whole and CSX individually experienced a decline in derailments caused by roller bearing failure (*Figure 10* and *Figure 11*). This decline coincides with the installation of Hot Box detectors.

**Figure 10: Reportable derailments due to roller bearing failures for all railroads.**

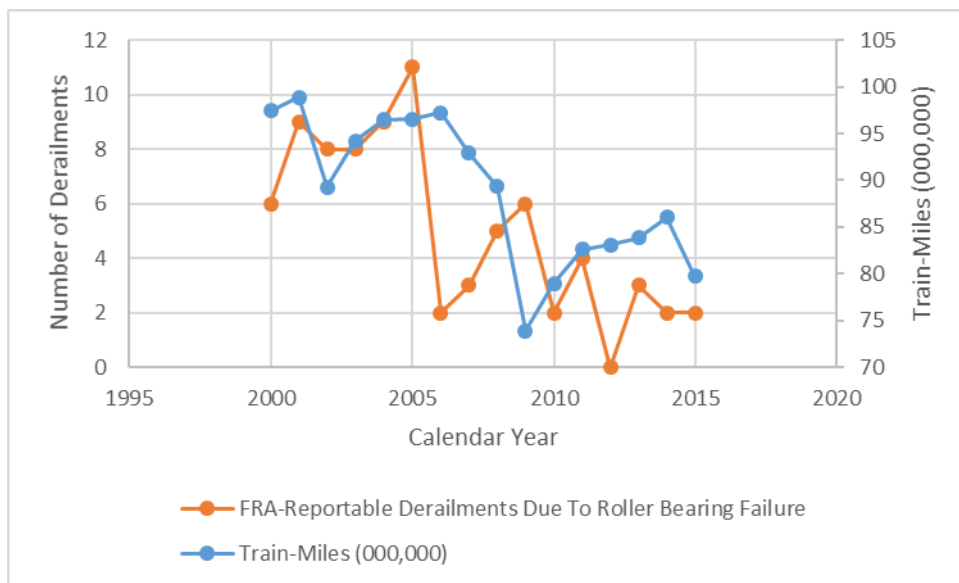
**Figure 11: Reportable derailments due to roller bearing failure for CSX.**
