***Federal Railroad Administration
Office of Railroad Safety
Accident Analysis Branch***

***Accident Investigation Report
HQ-2015-1061
Technical Report***

***CSX Transportation
Maryville, TN
July 1, 2015***

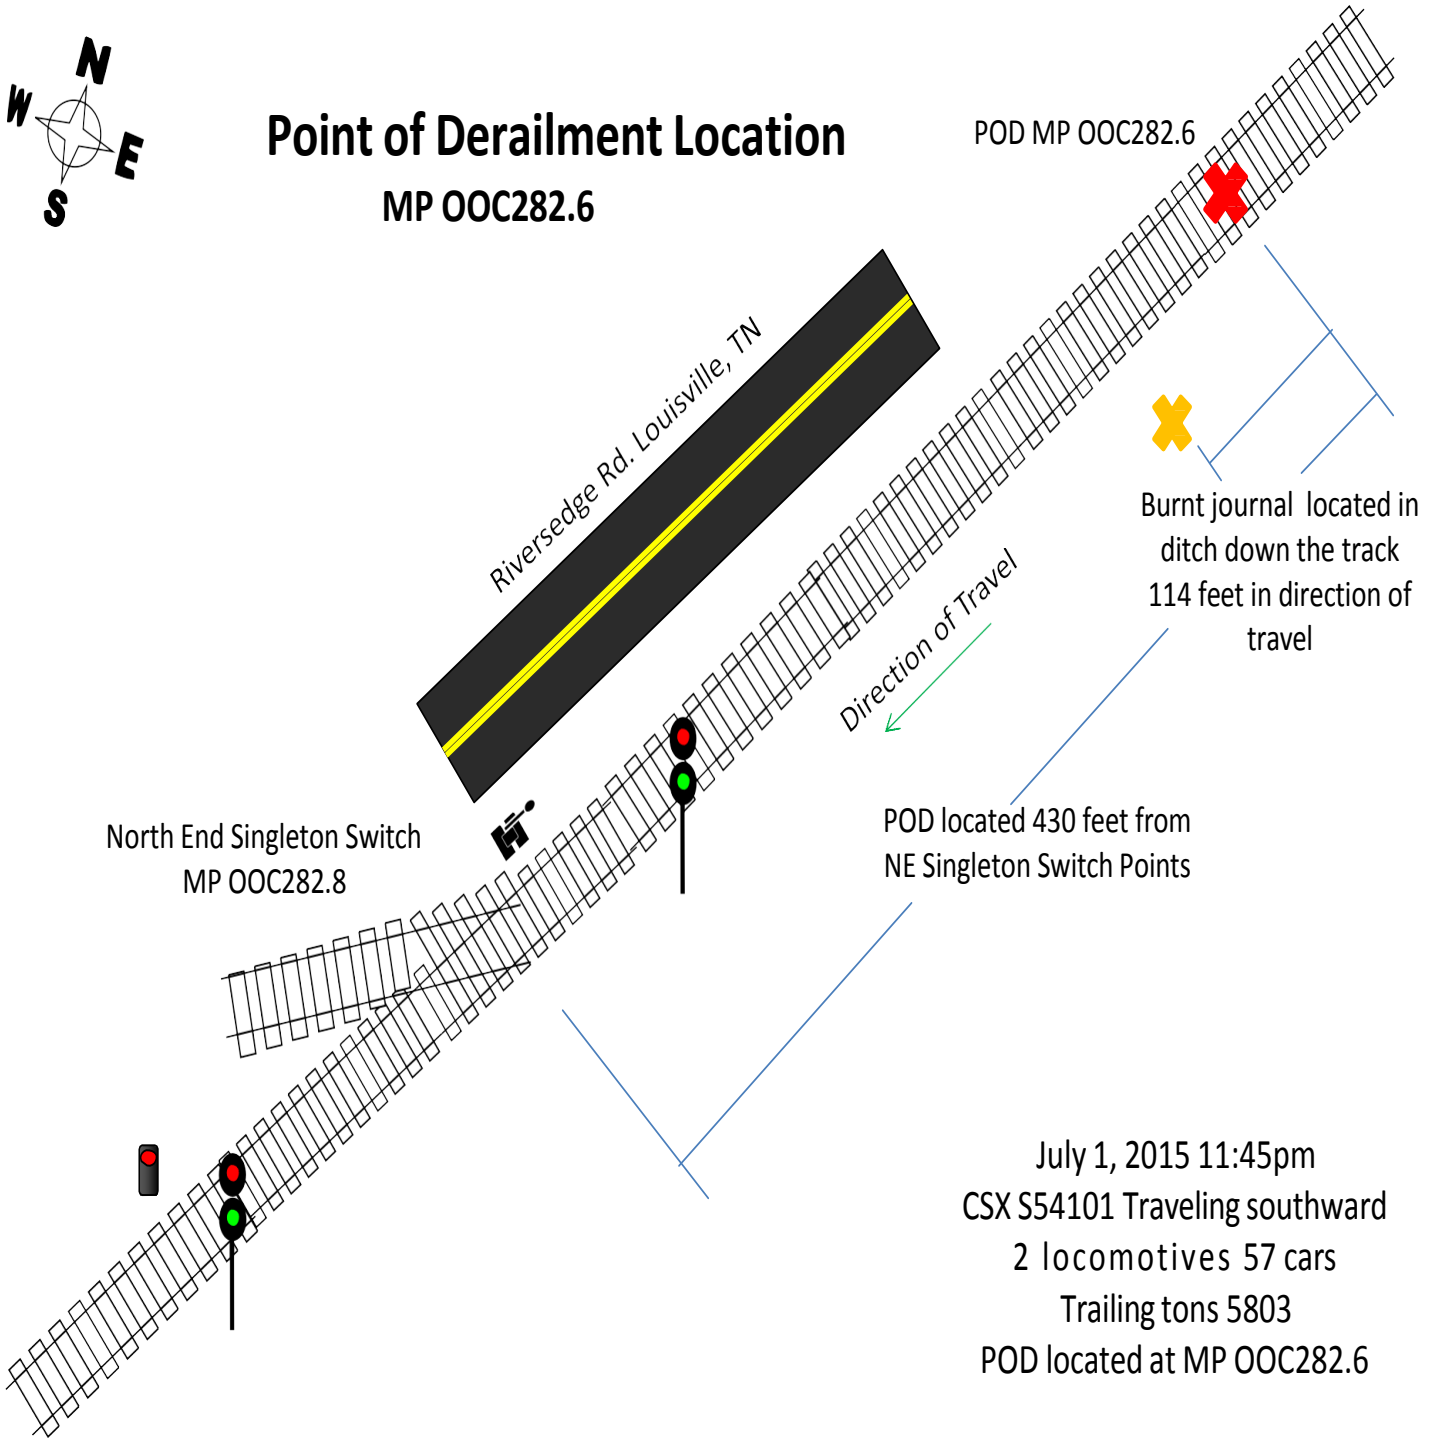
HQ-2015-1061 Maryville Sketch Revision

Burnt journal located in ditch down the track 114 feet in direction of travel

POD located 430 feet from NE Singleton Switch Points

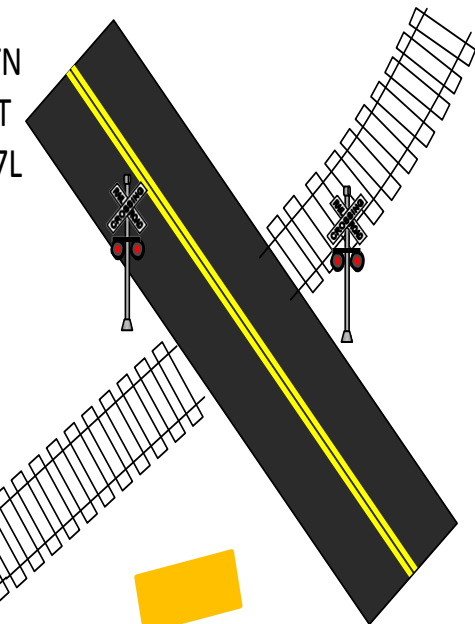
Entire truck frame assembly from leading truck of derailed car located southeast quadrant off road crossing.

UTLX 901717 Loaded tank car
39th car in train

Derailed leading truck set 'A' end of car
