**Federal Railroad
Administration**

Measurement of Wheel Load Environment of a Standard 3-piece Truck

9. SPONSORING/MONITORING AGENCY NAME(S) AND ADDRESS(ES) U.S. Department of Transportation Federal Railroad Administration Office of Research, Development and Technology 1200 New Jersey Avenue, SE Washington, DC 20590			10. SPONSORING/MONITORING AGENCY REPORT NUMBER DOT/FRA/ORD-17/25

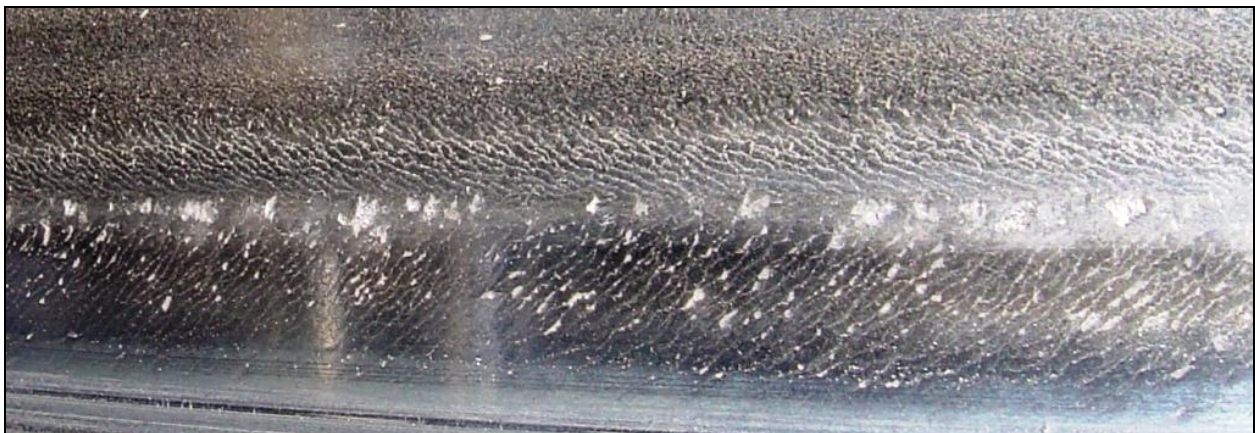
Shelling is a fatigue based process and one mechanism by which large voids can be left in the running surface of a wheel. Many cycles of high stress create surface cracks in the wheel tread through the process of RCF. Frequently, bands of these cracks will form on the wheel tread surface. Figure 1 shows a wheel with a band of RCF cracks. As the cracks propagate and grow, they can connect and dislodge a patch of wheel tread, leaving a void in the process.

Figure 1. Wheel Tread Surface with RCF Cracks

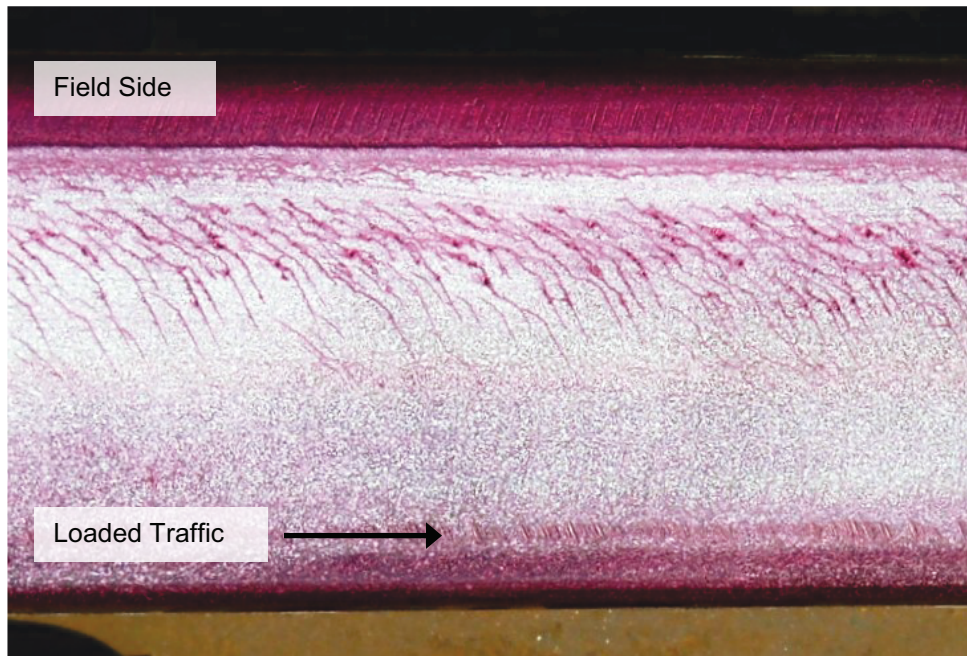
Curves A and C provide a good opportunity for a direct comparison, because the rail at both sites was installed in early 2009. The IWS data exceeded the shakedown limit at curve C, but not at curve A. Visual inspection of the rail condition showed more RCF damage at curve C compared to curve A, indicating a good correlation between the IWS data and the rail condition. The improved performance and reduced RCF at curve A could be attributable to the higher level of lubricant present. No curves had fresh lubricant present during the inspection. However, a minimal amount of lubricant was present at curve A, and it was an improvement over curve C, which was extremely dry with metal flakes on the ballast and tie plates. The residual lubricant found at curve A was on the gage face of the high rail and no lubricant was found on the low rail. While lubrication on the gage face of the high rail can reduce rail gage face wear and wheel flange wear, it is the friction on the top of the low rail that is a potential means to reduce the tangential forces that lead to RCF. With currently available wayside application systems and lubricants, lubricant applied to the rail gage face tends to migrate to the top of the rail. In areas with multiple alternating curves, the lubricant can be carried down the track from one curve to another of the opposite sense and reduce the coefficient of friction on the top of the low rail.

Curve A is a 4.2-degree curve with 4.3 inches of superelevation. Figure 15 shows the condition of the low rail with relatively mild RCF cracks. Figure 16 shows the transverse profiles of the high and low rails, both installed in 2009. Minimal residual lubricant was found at this site. Figure 17 shows that the shakedown limit was not exceeded in this curve during the first trip. Figure 18 shows that minimal distance was traveled above the shakedown limit during the second trip.

Figure 15. Photograph of Low Rail in Curve A

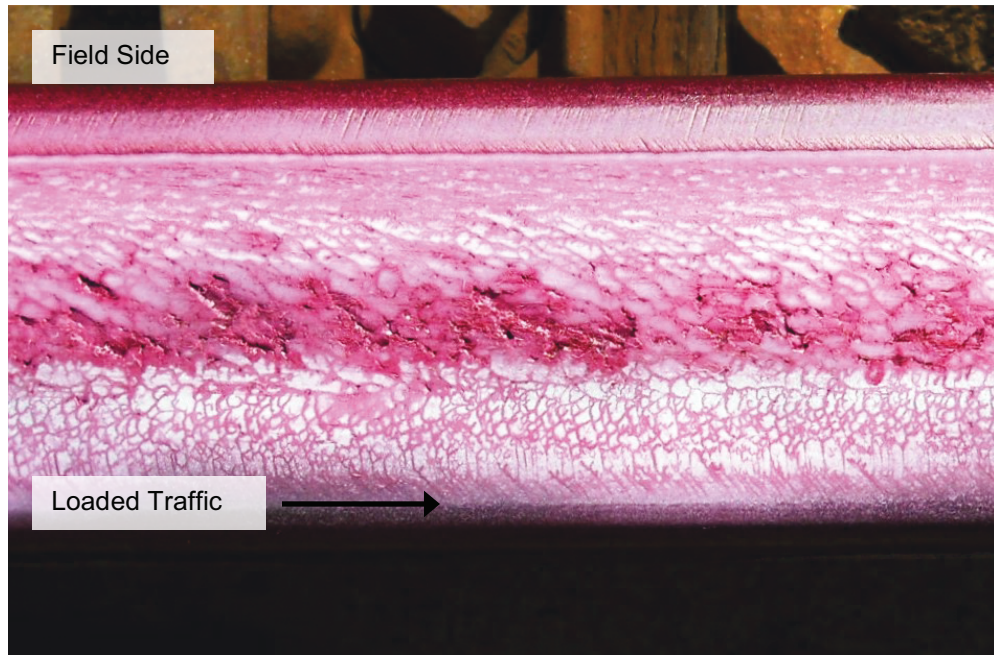
Curve B is a 6.46-degree curve with 3.9 inches of superelevation. Curve B is also rank ordered site 14, as Figures 8 and 9 show. Figure 19 shows the condition of the low rail with relatively severe RCF cracks and spalls. Figure 20 shows the transverse profiles of the high and low rails, both installed in 2009. Rail at this site was extremely dry with metal wear flakes visible in the ballast. Figures 21 and 22 show that the shakedown limit was exceeded in this curve during the first and second trips, respectively.

Figure 19. Photograph of Low Rail in Curve B

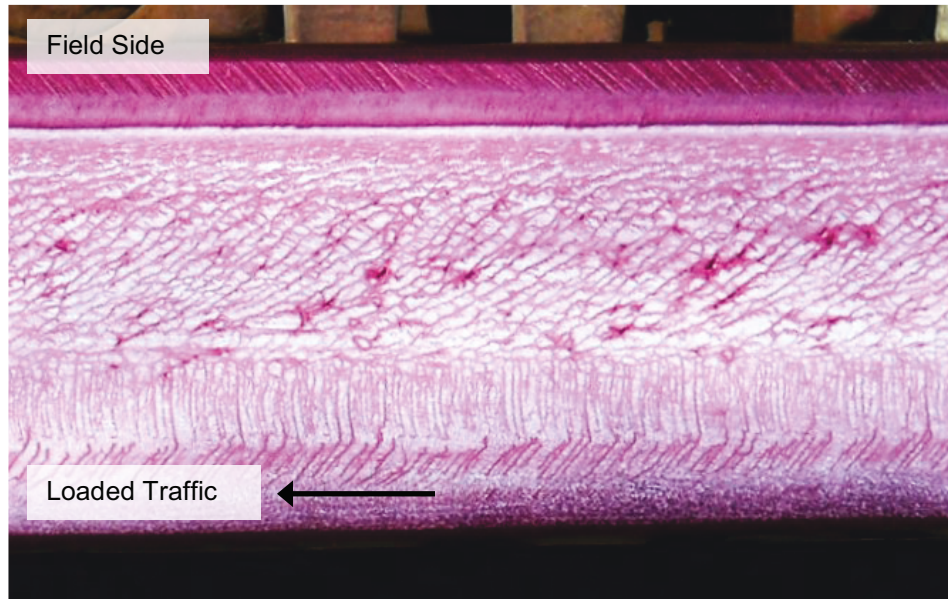
Curve C is a 4.12-degree curve with 4.3 inches of superelevation. Figure 23 shows the condition of the low rail with moderate RCF cracks and tiny spalls. Figure 24 shows the transverse profiles of the high and low rails, both installed in 2009. Rail at this site was extremely dry with metal wear flakes visible in the ballast. Figures 25 and 26 show that the shakedown limit was exceeded in this curve during the first and second trips, respectively.

Figure 23. Photograph of Low Rail in Curve C

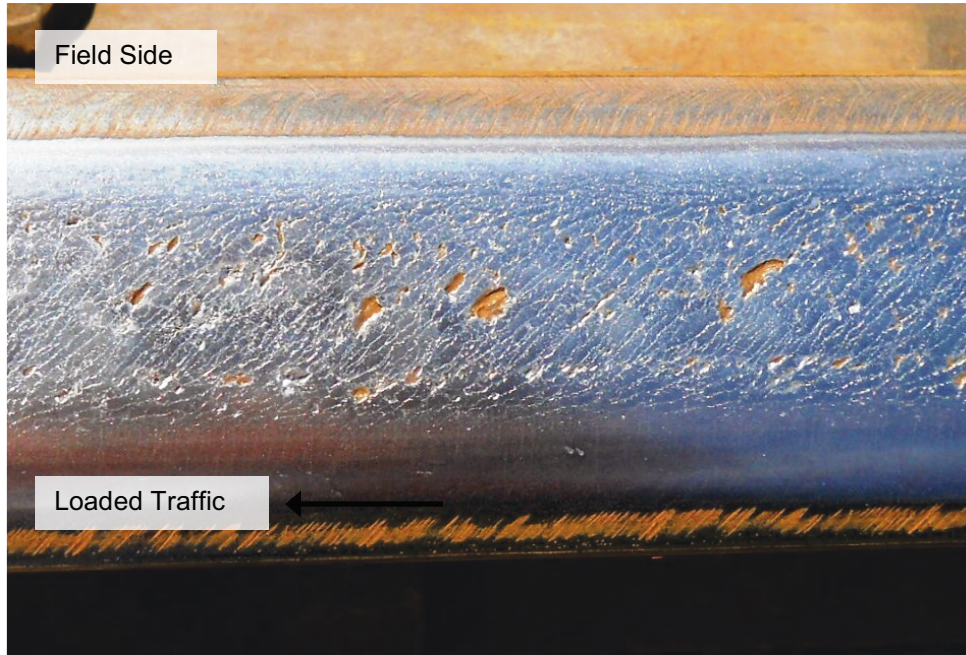
Curve D is a 4.04-degree curve with 3.5 inches of superelevation. Curve D is also rank ordered site 1, as Figures 8 and 9 show. Figure 27 shows the condition of the low rail with relatively severe RCF cracks and spalls. Figure 28 shows the transverse profiles of the high and low rails, both installed in 2004. Rail at this site was extremely dry with metal wear flakes visible in the ballast. Figures 29 and 30 show that the shakedown limit was exceeded in this curve during the first and second trips, respectively.

Figure 27. Photograph of Low Rail in Curve D

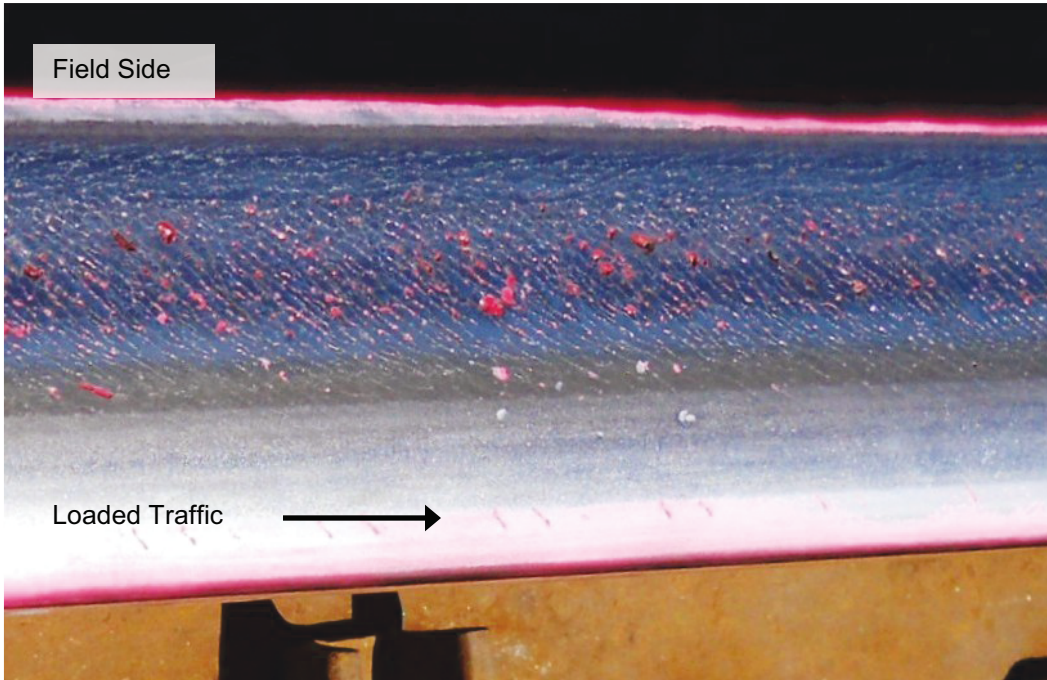
Curve E is a 4.12-degree curve with 3.5 inches of superelevation. Figure 31 shows the condition of the low rail with moderate RCF cracks and small spalls. Figure 32 shows the transverse profiles of the high rail (installed in 2004) and low rail (installed in 1994). Rail at this site was extremely dry with metal wear flakes visible in the ballast. Figure 33 shows that the shakedown limit was exceeded only briefly in this curve during the first trip. Figure 34 shows that the shakedown limit was not exceeded during the second trip.

Figure 31. Photograph of Low Rail in Curve E

- Moderate RCF was found at another site where shakedown was not exceeded (E) although the low rail was at least 10 years older than any other site inspected. The additional fatigue cycles accumulated at this site may be responsible for the RCF damage. The train speed was near the curve balance speed at this curve on both trips, which may help explain why the shakedown limit was not exceeded.

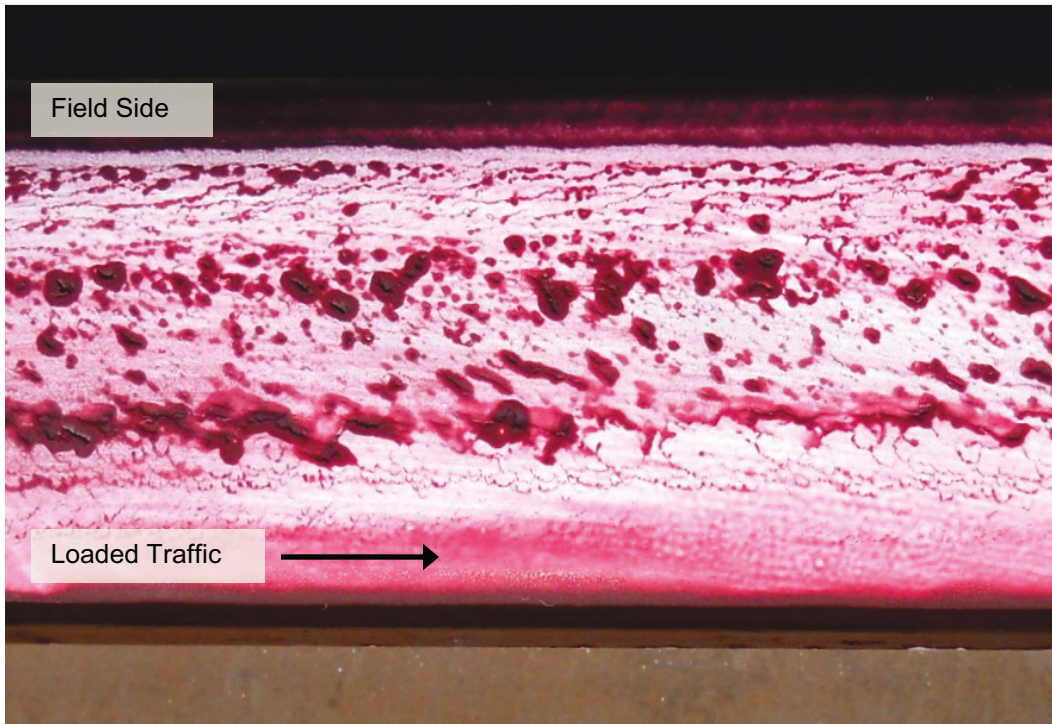
Curve F is a 4.25-degree curve with 5 inches of superelevation. Figure 35 shows the condition of the low rail with relatively severe RCF cracks and small spalls. Unmatched dye penetrant and developer caused dye bleed-out, as Figure 35 shows. Figure 36 shows the transverse profiles of the high rail (installed in 2001) and low rail (installed in 2007). Rail at this site was extremely dry with metal wear flakes visible in the ballast. Figure 37 shows that the shakedown limit was not exceeded in this curve during the first trip. No data was available from this curve during the second trip.

Figure 35. Photograph of Low Rail in Curve F

- Relatively severe RCF was found at the third site where shakedown was not exceeded (F). This curve had the most superelevation of all the inspected sites. Although the train was operated at a speed to produce only a small superelevation excess while the IWS data was recorded, slower train speeds could easily produce much higher

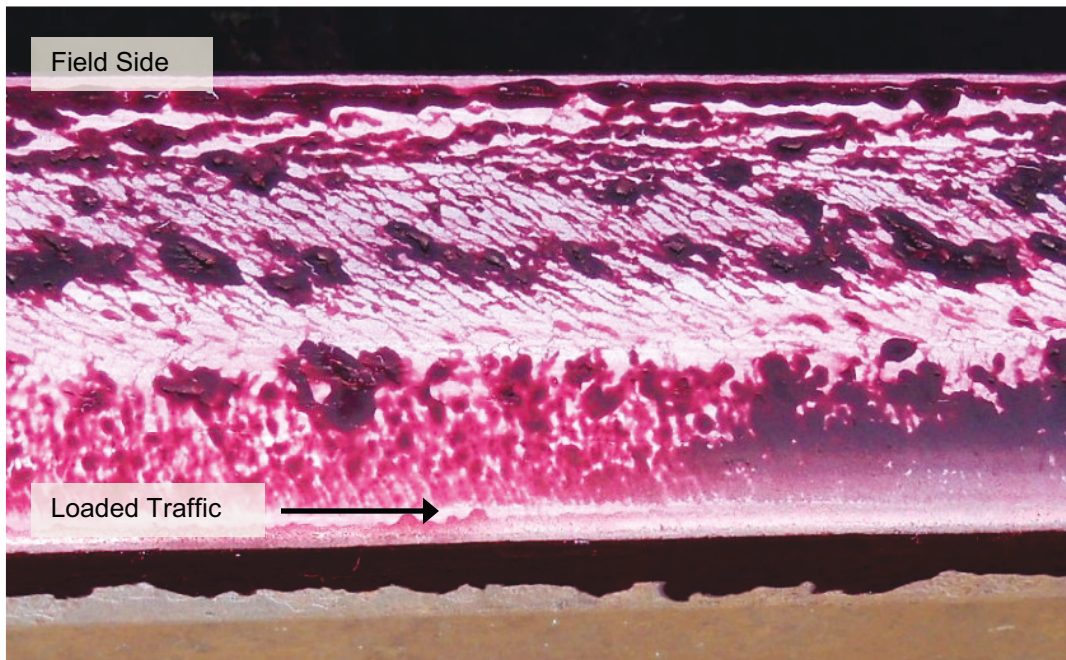
Curve G is a 4.02-degree curve with 5 inches of superelevation. Curve G is also rank ordered site 20, as Figures 8 and 9 show. Figure 38 shows the condition of the low rail with relatively severe RCF cracks and small spalls. Unmatched dye penetrant and developer caused dye bleed-out, as Figure 38 shows. Figure 39 shows the transverse profiles of the high rail (installed in 2008) and low rail (installed in 2006). Rail at this site was extremely dry with metal wear flakes visible in the ballast. Figures 40 and 41 show that the shakedown limit was exceeded in this curve during the first trip and second trips, respectively.

Figure 38. Photograph of Low Rail in Curve G
