***Federal Railroad Administration
Office of Railroad Safety
Accident and Analysis Branch***

***Accident Investigation Report
HQ-2016-1127***

***Norfolk Southern Railway Company (NS)
Birmingham, AL
May 3, 2016***

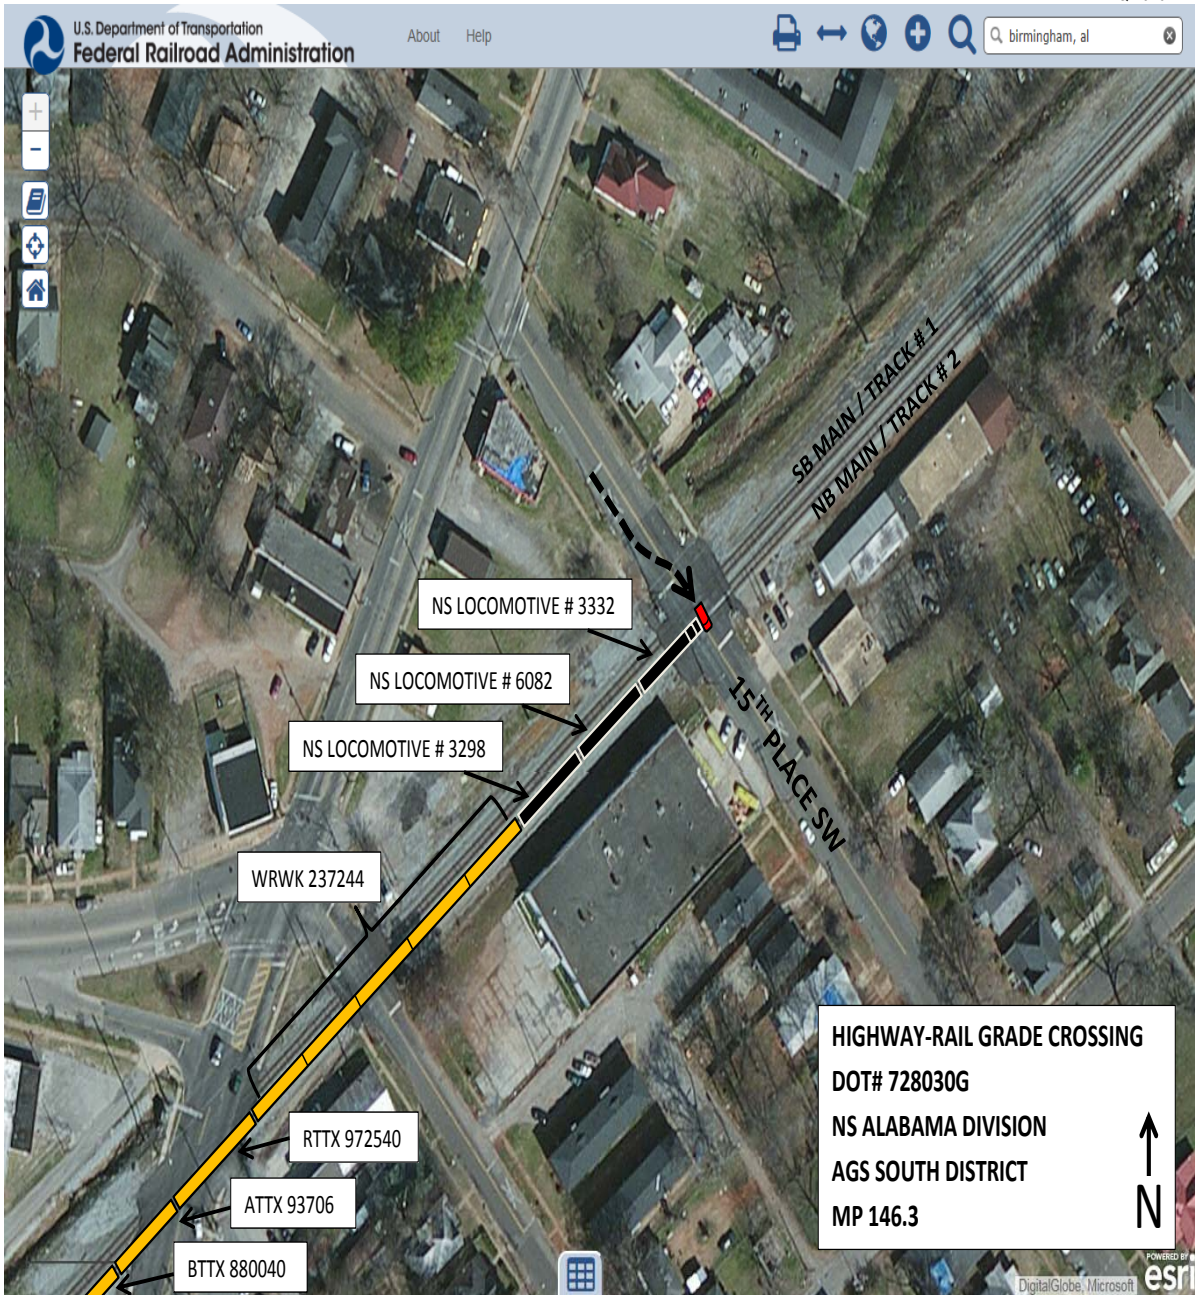
Sketch

At approximately 10:15 p.m., Train A38A7-03 collided with the highway vehicle. The train was traveling at a recorded speed of 42 mph upon impact. The train impacted the passenger side of the pickup truck between its cab and truck bed. The vehicle was projected in a geographically eastward direction causing damage to the crossing signal bungalow and the crossing gate on the east side of the crossing. The vehicle came to a stop at the crossing signal bungalow. The train proceeded about 1,265 feet before coming to a stop.
