***Federal Railroad Administration  
Office of Railroad Safety  
Accident and Analysis Branch***

***Accident Investigation Report  
HQ-2016-1146***

***Union Pacific Railroad Company (UP)  
Dermott, AR  
July 15, 2016***

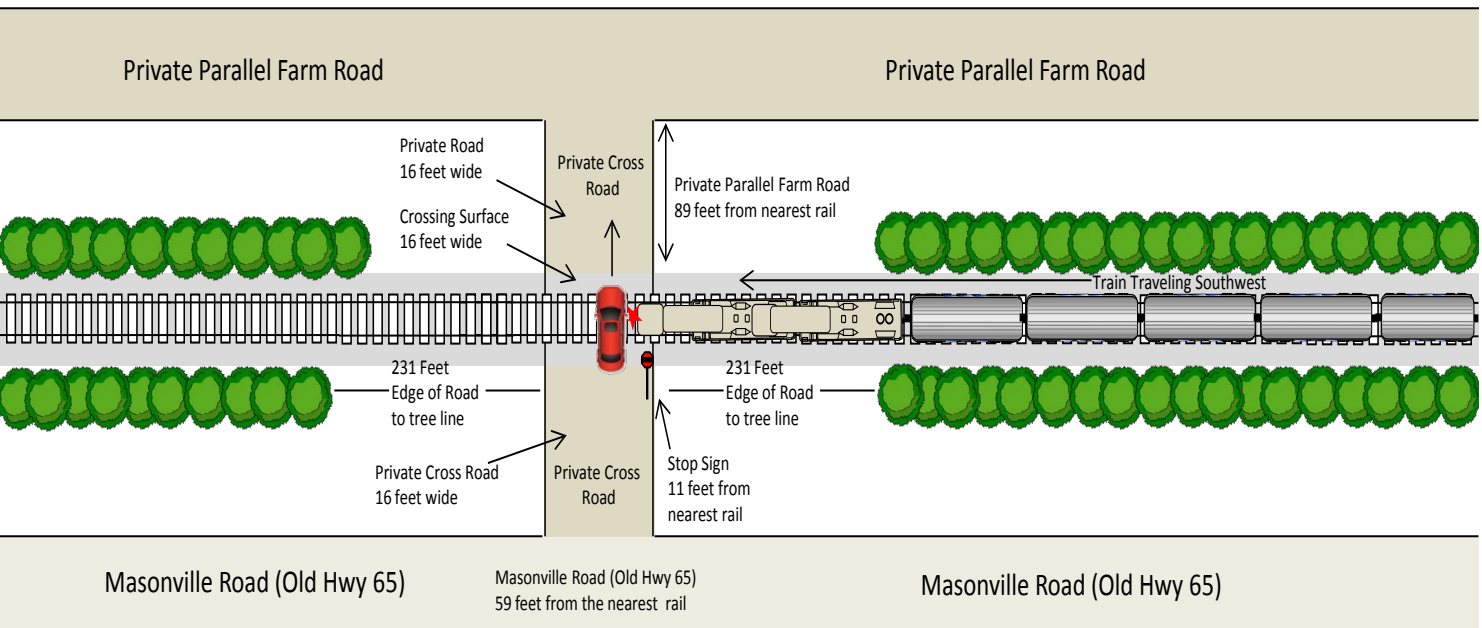
Sketch, Dermott, Arkansas Collision, HQ 2016-1146 (Quadruple Fatality)

The train impacted the front right side of the automobile behind the front passenger door while the automobile was still on the tracks. The impact caused the automobile to become airborne and spin in a counterclockwise rotation. The front of the automobile made contact with the ground facing a northeast direction. The automobile then rolled onto its roof with the vehicle facing north. After impact, the train continued southwest on the tracks and the engine came to rest approximately 1/3-mile south of the area of impact.
