***Federal Railroad Administration
Office of Railroad Safety
Accident and Analysis Branch***

***Accident Investigation Report
HQ-2016-1142***

***Union Pacific (UP)
Green River, WY
June 27, 2016***

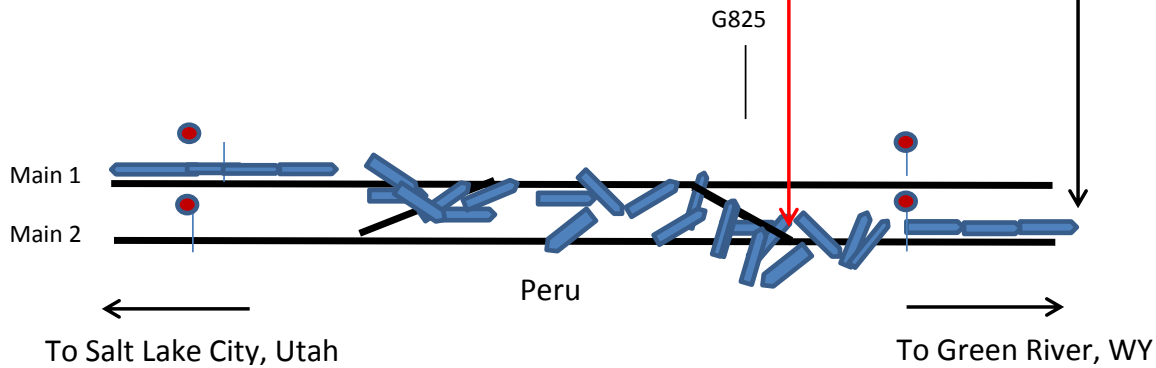
Sketch

UP Train KG1LAC 26 was proceeding west on Main Track #2 and crossed over to Main Track #1 at the east crossover at Peru, Wyoming (Control Point CP825). The train crossed over at 39 MPH (in 40 MPH crossover), the three leading locomotives and 101 railcars made it through the crossover with the 102nd railcar derailing (DTTC 727746) causing a total of 19 railcars; cars 102 through 121 in consist to derailed.
