***Federal Railroad Administration  
Office of Railroad Safety  
Accident and Analysis Branch***

***Accident Investigation Report  
HQ-2016-1139***

***CSX Transportation (CSX)  
Baltimore, MD  
June 13, 2016***

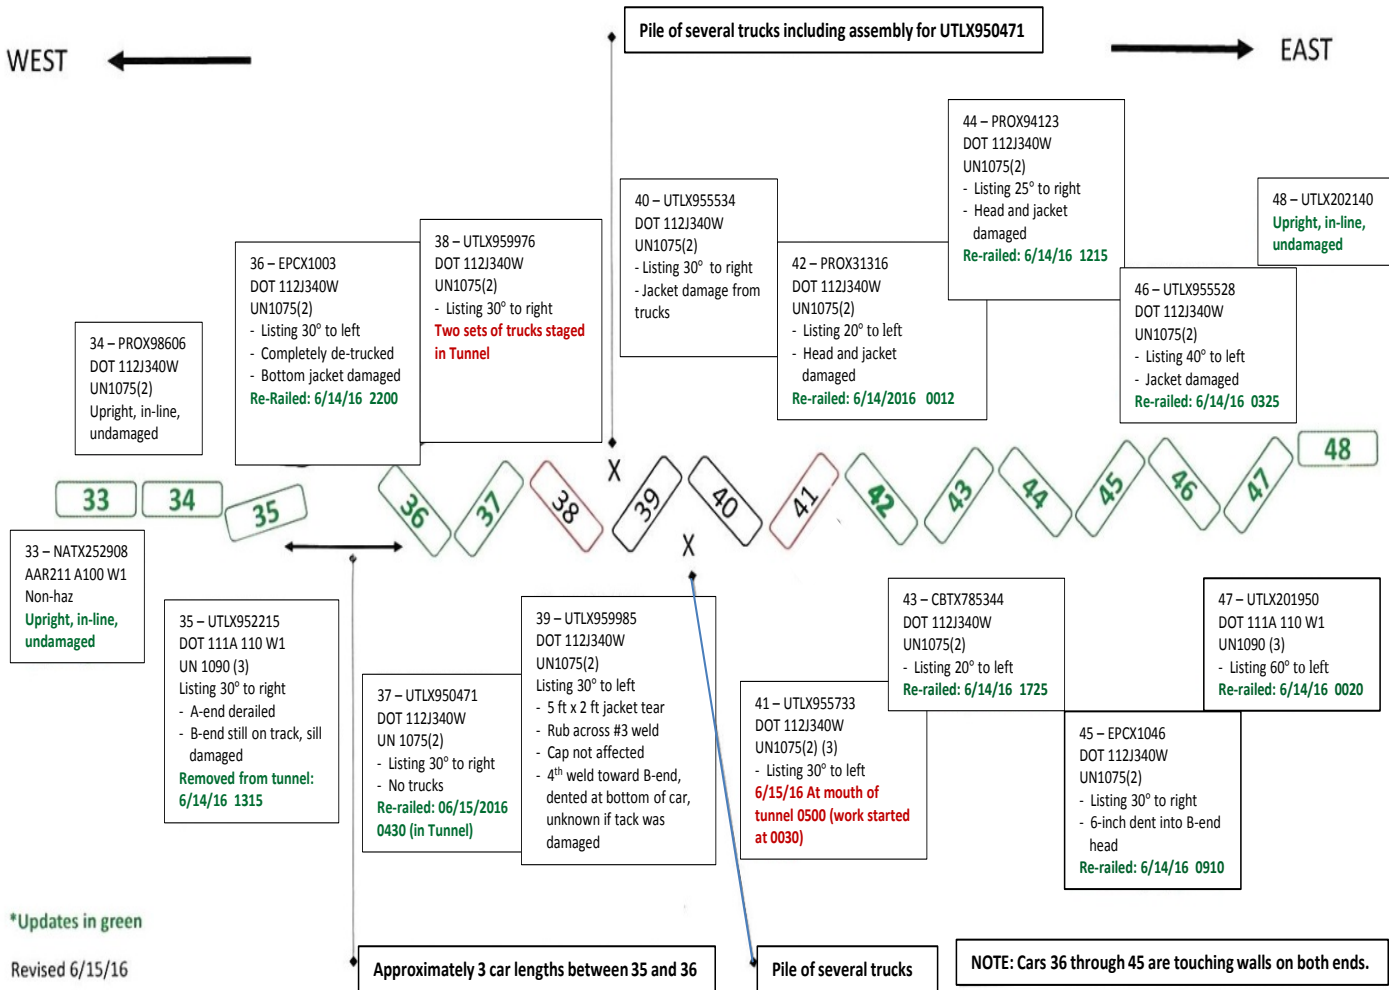
**Diagram CSX Howard Street Tunnel Derailment Reconstructed**

**Westbound CSX Train Q37312 - June 13, 2016**  
**Howard Street Tunnel Derailment**  
(Directions noted per CSX Timetable)

In the effort to provide a better quality image this diagram has been partially reconstructed from the field marked-up document provided by CSX.
