**Federal Railroad  
Administration**

## **Slab Track at Facility for Accelerated Service Testing: Performance and Serviceability**

Office of Research,  
Development  
and Technology  
Washington, DC 20590

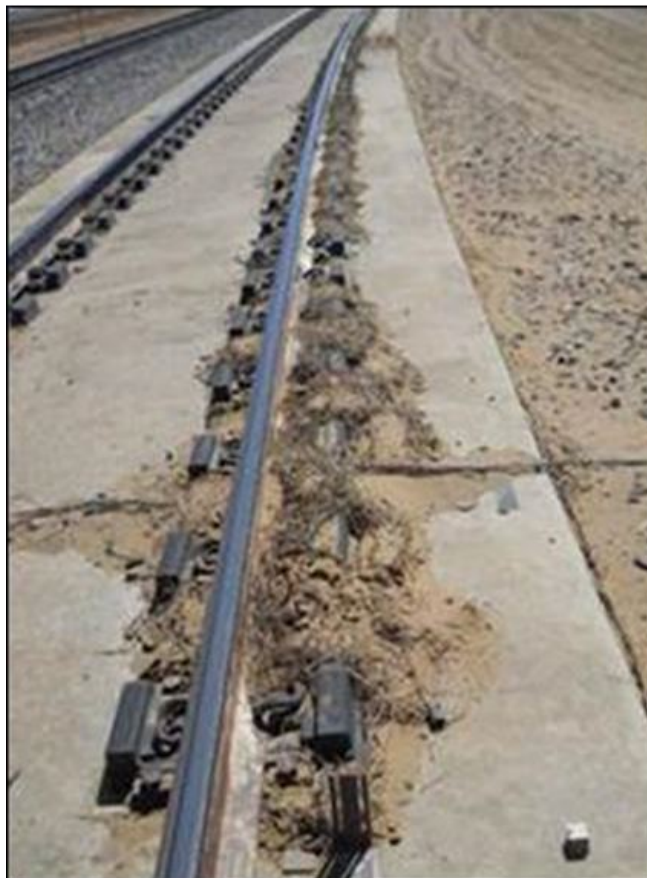
Sand buildup and cleaning of the slab also affects the standard track as well as the slab track. In the southwest United States, blowing sand and accumulation of fouling materials in track is a continual issue that must be resolved. Standard tie and ballast track allows for more time between cleaning (for better or for worse) as sand can infiltrate into the ballast before it accumulates around the rail base and ties. Concerning the slab track, no infiltration is available so the accumulation of sand and other debris begins quickly. Figure 1 shows typical accumulation of sand and other debris around the fastenings and rail at the slab track section.

**Figure 1. Sand and Debris Accumulation on the Slab Track**

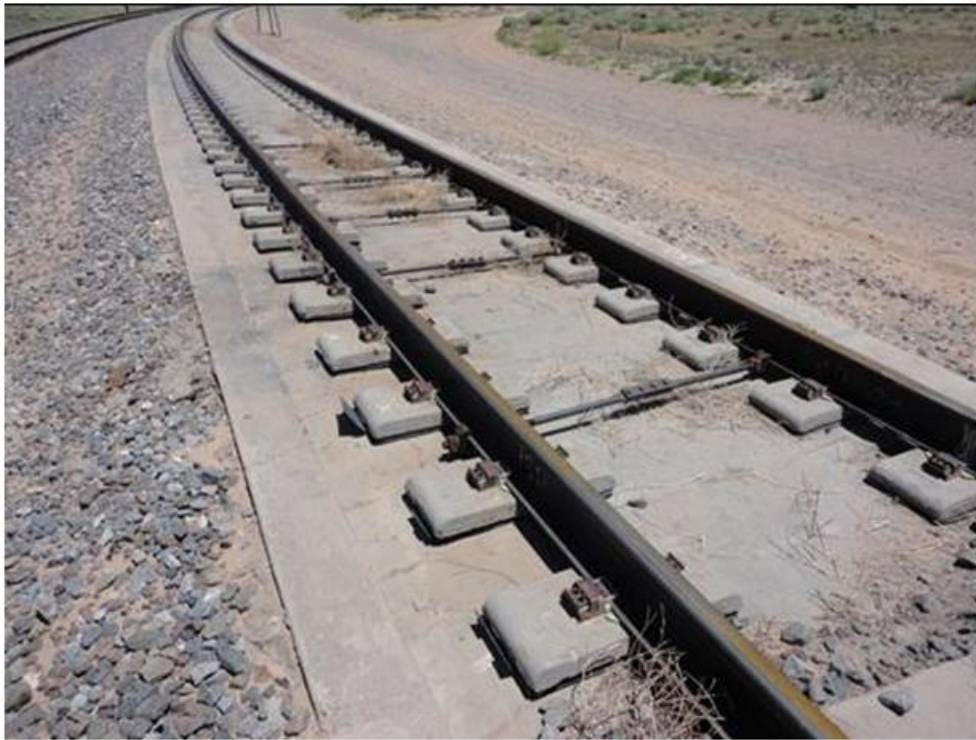
Testing records were available for Track Loading Vehicle (TLV) data ranging from 2008 to 2013. Gage widening was beginning to appear in the spiral of the IDBT section. Spiral portions of curves can have increased lateral/vertical (L/V) ratios due to the change in curvature over the length of the spiral. Gage rods were installed on the slab in 2011, and the maintenance records show that broken gage rods were repaired in 2014. Figure 2 shows the condition of the IDBT spiral section near the end of the service life. The 5 gage rods were placed at approximate 5-foot intervals from the end of the slab for a total of 25 feet. The fasteners at the end of the slab needed to have additional elastomer pads installed at the end of the concrete block to shift the blocks toward the center of the track. In regards to the need to install additional material to

maintain gage in association with gage rods, one can assume that the integrity of the rubber boot holding the concrete block had been compromised and is no longer functioning properly.

**Figure 2. Installation of Gage Rods in IDBT Section at Curve Spiral**

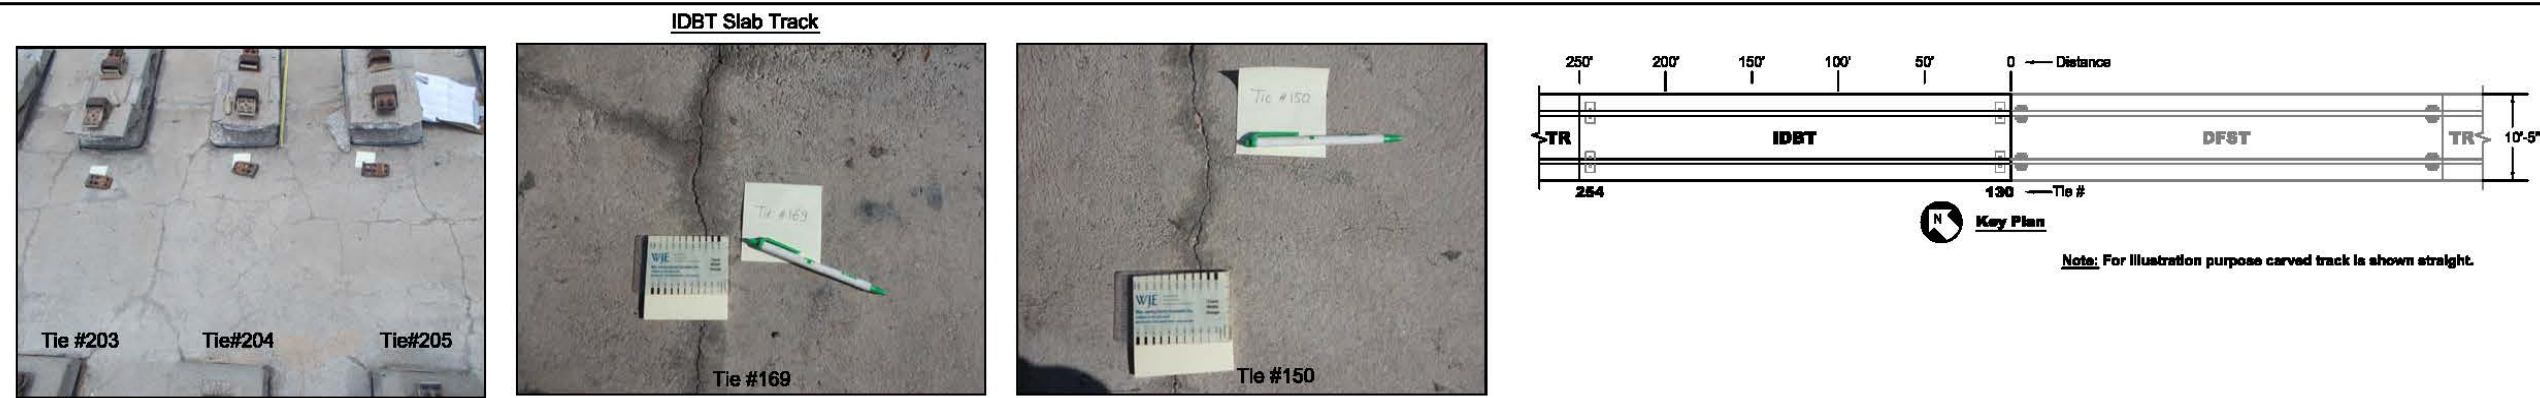
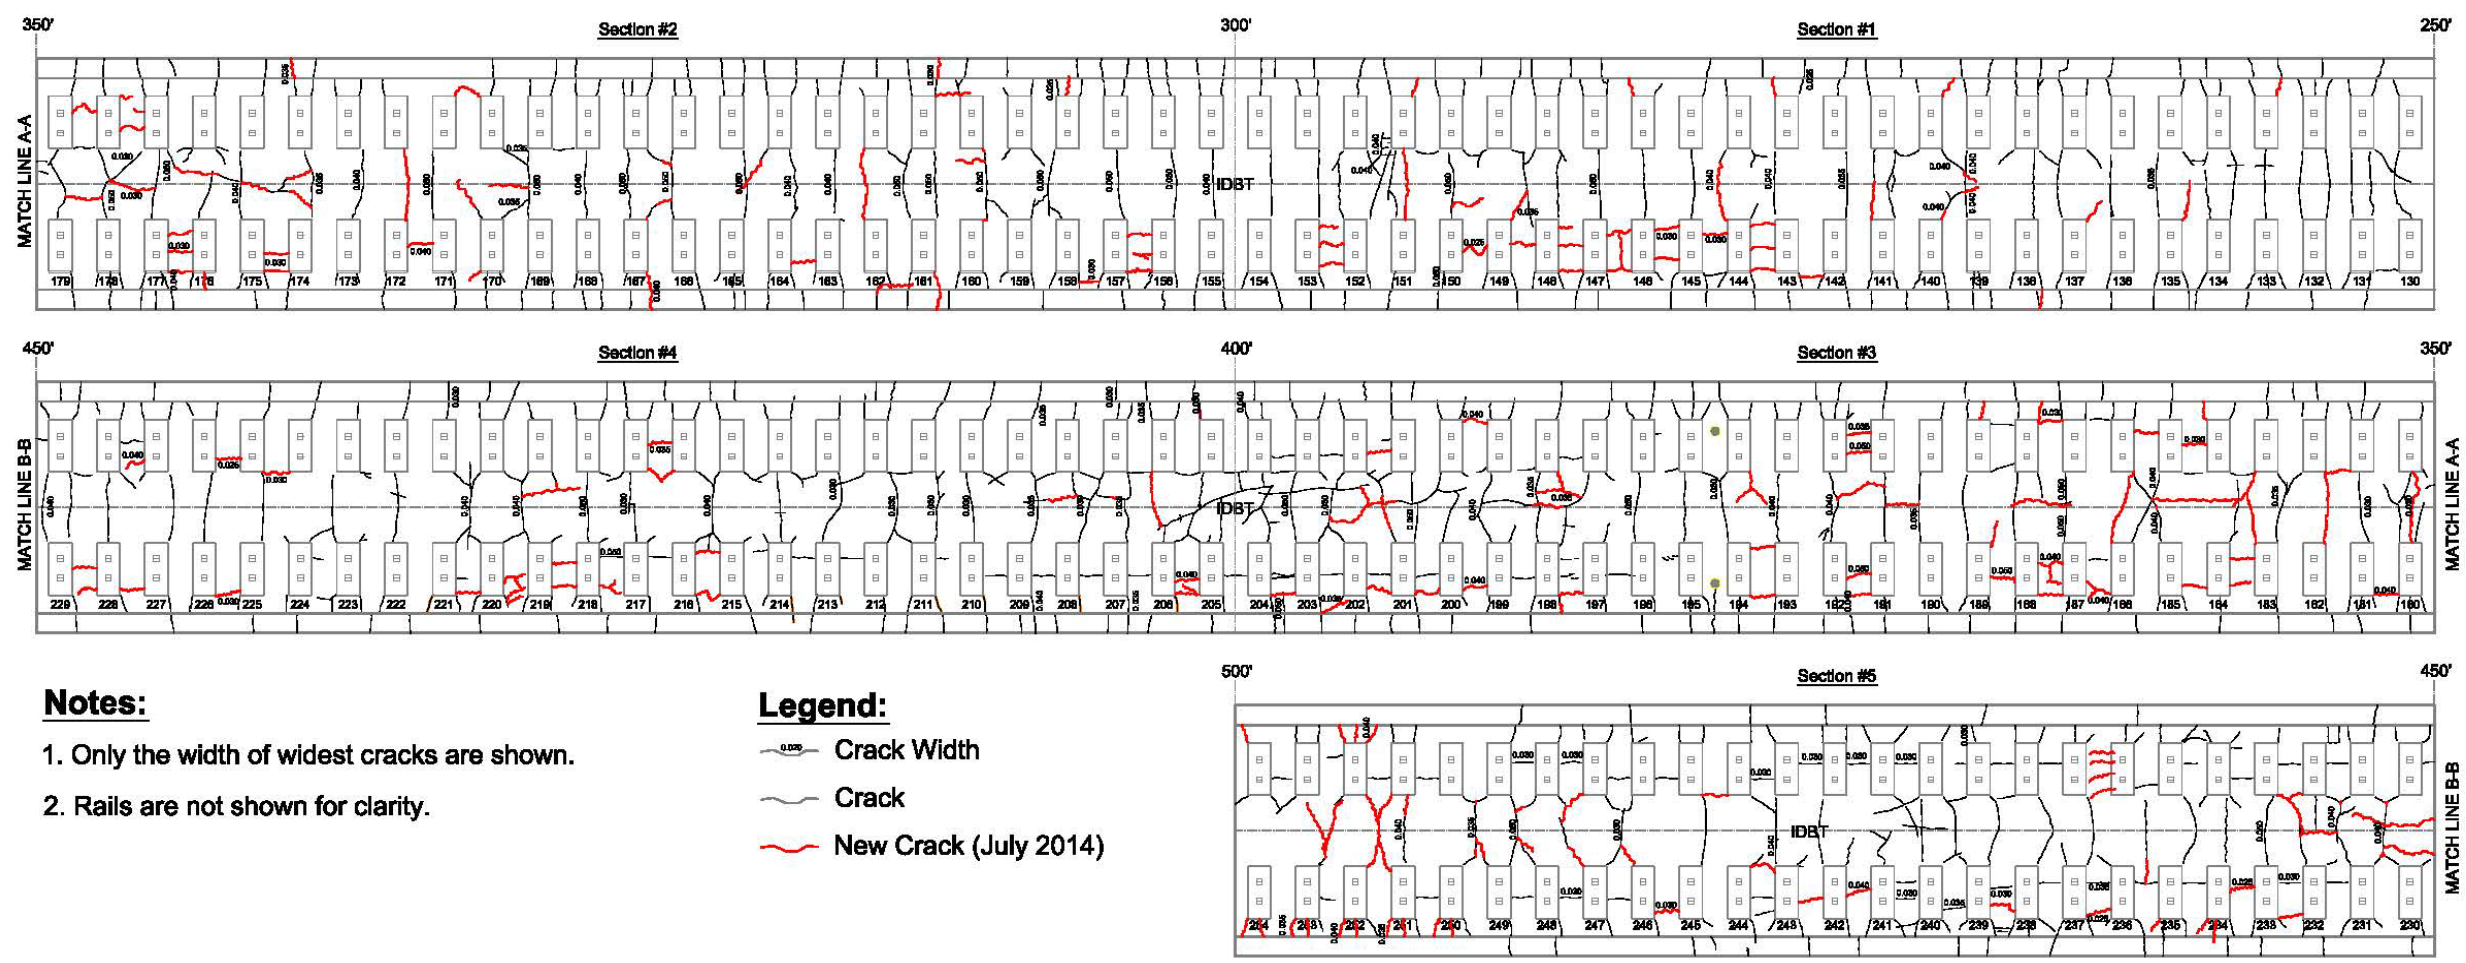
Figure 3. August 2014 Crack Map for IDBT Slab Track Section

The concrete slab remained in very good condition during the entire test period. By the end of the life of the slab track, only minor crack widths were experienced. No repairs to the slab were made at any time during its life nor were any required. Many cracks existed, but they were typical of shrinkage cracks in slabs. The surface of the slab, while more than adequate for the service, was not typically smooth, so cracking was more frequent. Also, the open box sections for the IDBT fasteners were prone to crack from the corners. Once demolition of the slab was completed, a cursory examination of the rubble pile did not find any extensive rust on exposed rebar or signs of corrosion. The slab itself was maintenance-free for the installation.

The cracks in the slab were originally mapped in 2006. Prior to removing the rail, the slab was re-examined to find and measure additional cracks that were developed. Figure 3 shows the map for the IDBT section and Figure 4 shows the map for the DFST section. Both sections had additional cracks that were developed, but the majority of cracks in the slab were the early cracks documented in 2006.

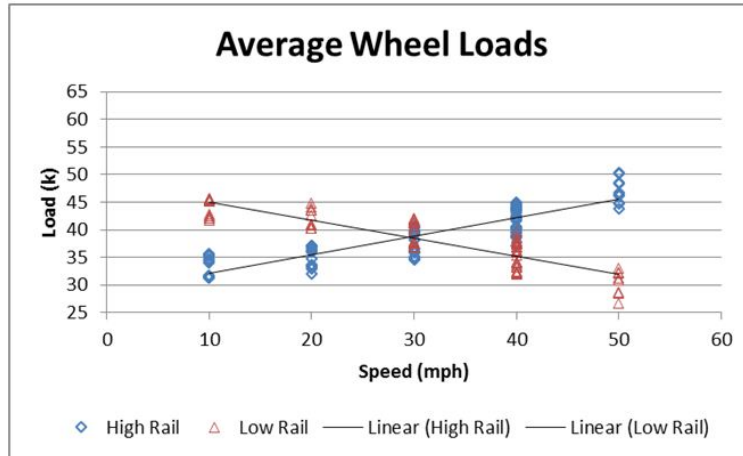
**Figure 5. Average Wheel Loads (High Rail and Low Rail) for All Test Runs**

Figure 5 displays the data for average vertical wheel loads of the IWS test runs for all test speeds recorded from five test runs that the concrete slab test section was in service. The complete service life of the slab track section was 10 testing seasons from July 2003 to August 2014. Average wheel loads show the effects of superelevation and train speed. Nominal superelevation on the slab track section was 4 inches. Balanced speed for this curve was approximately 34 mph.

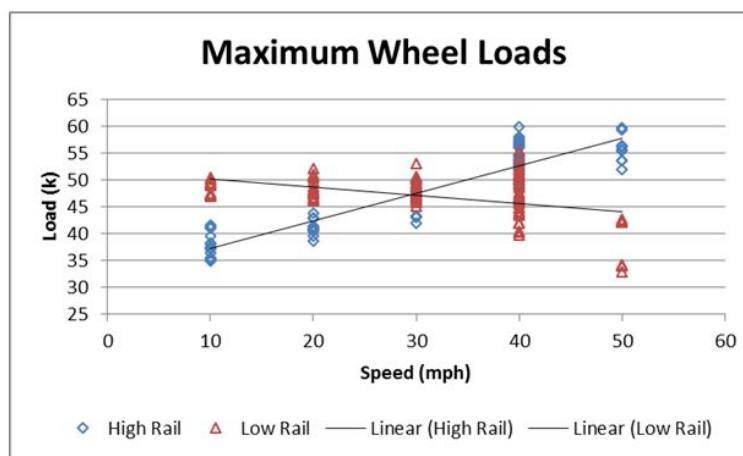
**Figure 6. Maximum Wheel Loads for All Test Runs**

Figure 6 shows maximum vertical wheel loads based on the speeds of the test train. The maximum wheel loads display a slightly different behavior than the average wheel loads. Maximum wheel loads show the effects of increased speed, which is in line with the design recommendations. A maximum load of 60 kips at 50 mph indicate a normal dynamic vehicle-track interaction for the slab track test section. In fact, an increase of speed from 40 mph to 50 mph did not cause a significant increase in maximum wheel load.

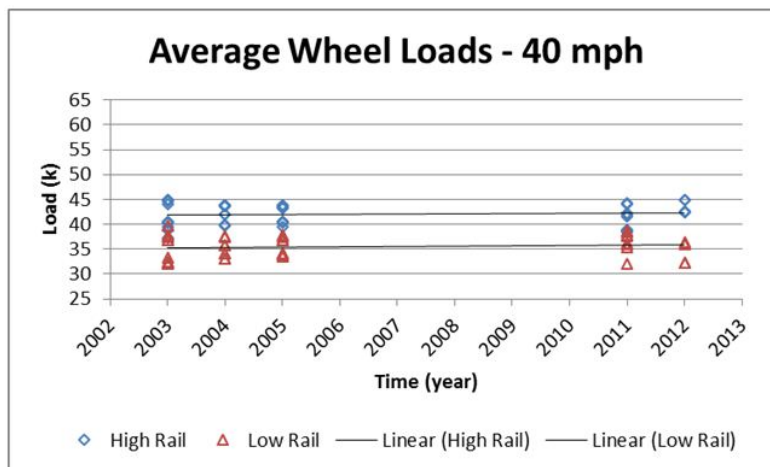
Figure 7. Average Wheel Loads by Year for 40 mph

Figure 7 shows that with the slab track in place, the average load at 40 mph remained consistent over time. Figure 8 shows that the maximum wheel loads increased over time. Over the service life, the approaches to the slab track required periodic surfacing maintenance, because of the track transition issues in differential deformation and change of track stiffness from standard tie and ballast track to the slab track. The maximum wheel loads increased due to track irregularities that developed. The ratios of the maximum wheel load to the average wheel load were calculated from the IWS data for each run. The ratio for the years of testing increased from 1.26 in 2003 to 1.38 in 2012.

Figures 7 and 8 provide a clear indication that over time the condition on the slab remained quite stable in terms of the response to the axle loadings. Average loads remained constant while maximum loads increased over time. As with any type of track, subtle changes create minor effects that can increase dynamic augment of the wheel load increasing impact. The wheel load values are all reasonable and within the range of assumed design values.

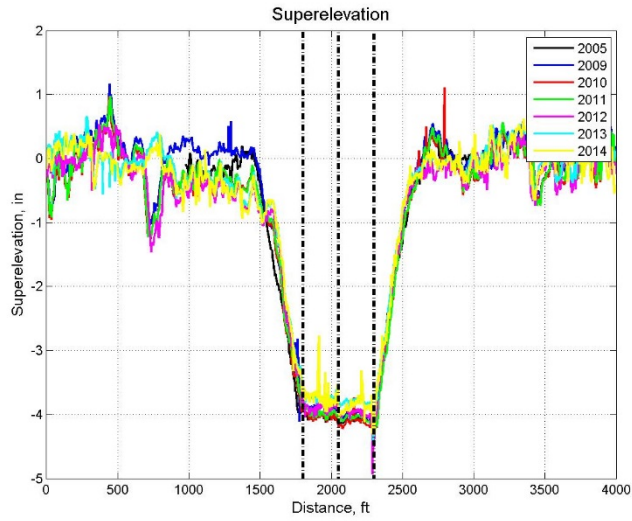
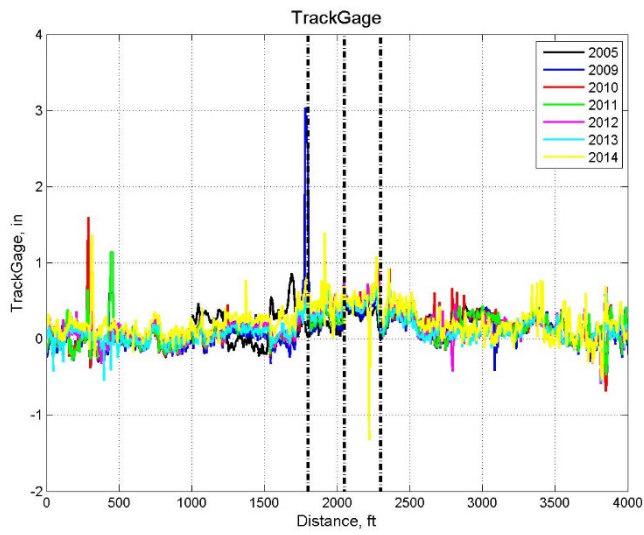
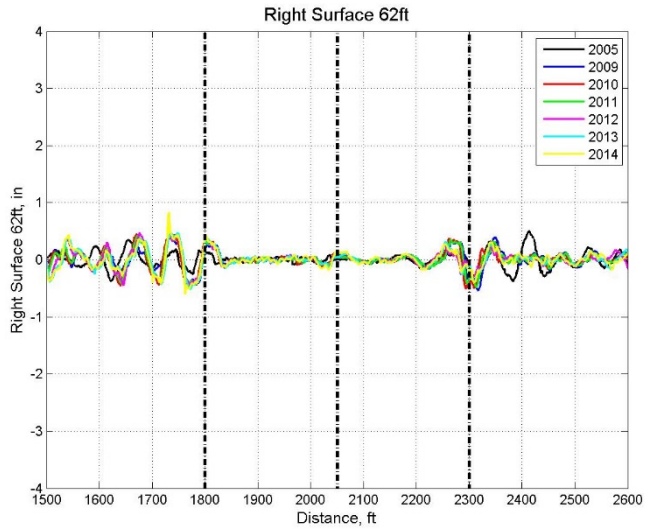
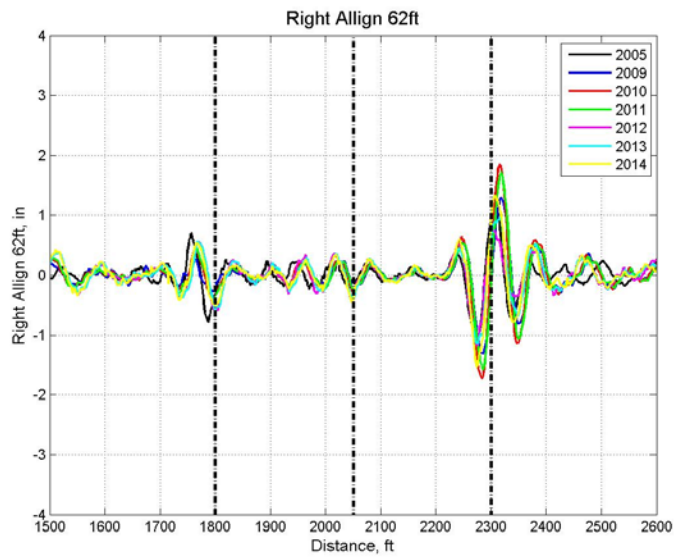
Changes in stiffness from ballasted track to slab track are evident in the surface and alignment measurements where the immediate transition zone shows roughness behavior. Figures 9–12 display the characteristics.

In general, the slab track performed better than the adjacent standard ballasted track, and the surface on the slab track was especially stable. The evidence of the spiral gage issue displays itself in the figures. Boot deterioration in the spiral was the primary reason for the loss of the gage restraint.

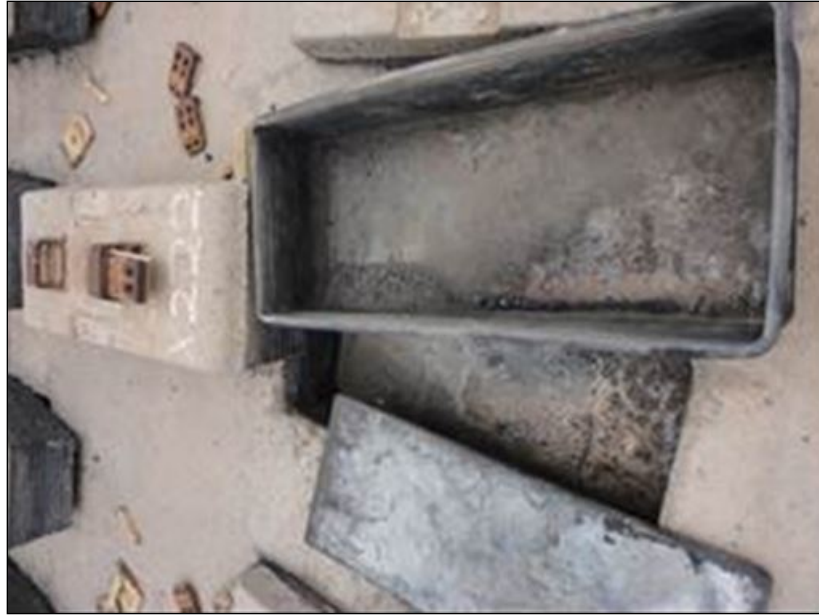
The cause of the deterioration was due to the accumulation and infiltration of sand and dirt into the boot (between the concrete block and the boot). The block and boot assembly did not fit snugly enough into the voids, which allowed movement or dislocation. This allowed sand and dirt to infiltrate the boot creating an abrasive condition which slowly degraded the boots. Figure 15 shows a typical amount of sand and dirt in the bottom of an extracted boot.

**Figure 15. Sand and Dirt Infiltration into the Rubber Boot**

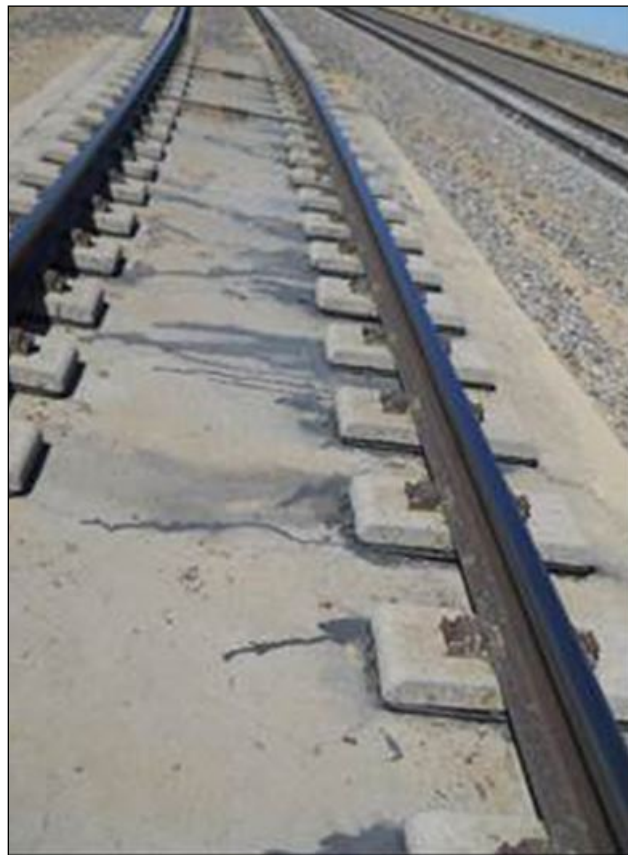
The movement of the block and boot assembly in the void also created other issues with the rubber boot. The abrasion caused wear holes, and split seams and corners; many of the boots had already come apart as they were removed. Water was also able to infiltrate the boots during rainy weather and the abraded boot material would float out of the block and boot assembly. The evidence of the water issue is shown in Figure 16. The staining on the slab was consistent through the length of the IDBT portion. A more detailed look at typical boot deterioration buildup is shown in Figures 17 and 18.

**Figure 16. Staining of the Concrete Slab from Rubber Boot Abrasion**

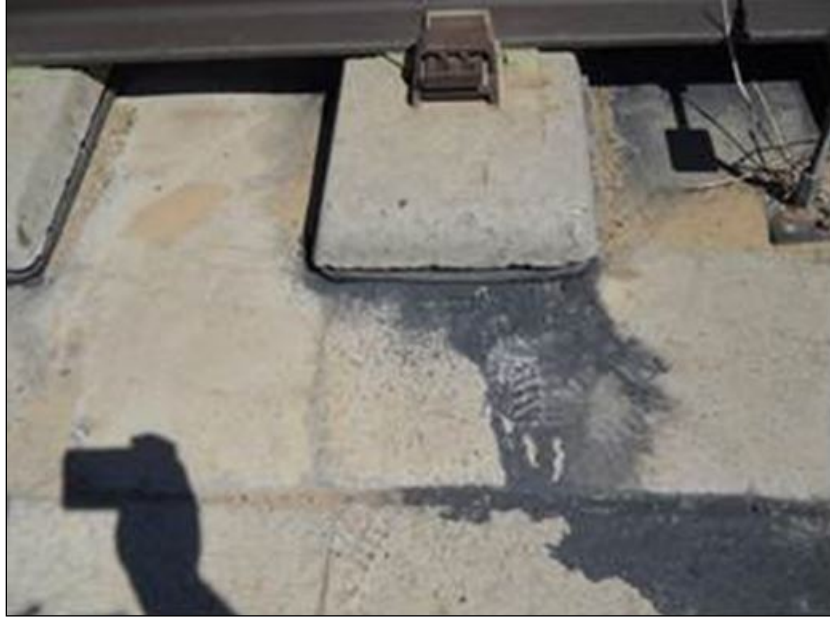
**Figure 17. Close-up of Rubber Boot Deterioration and Staining**

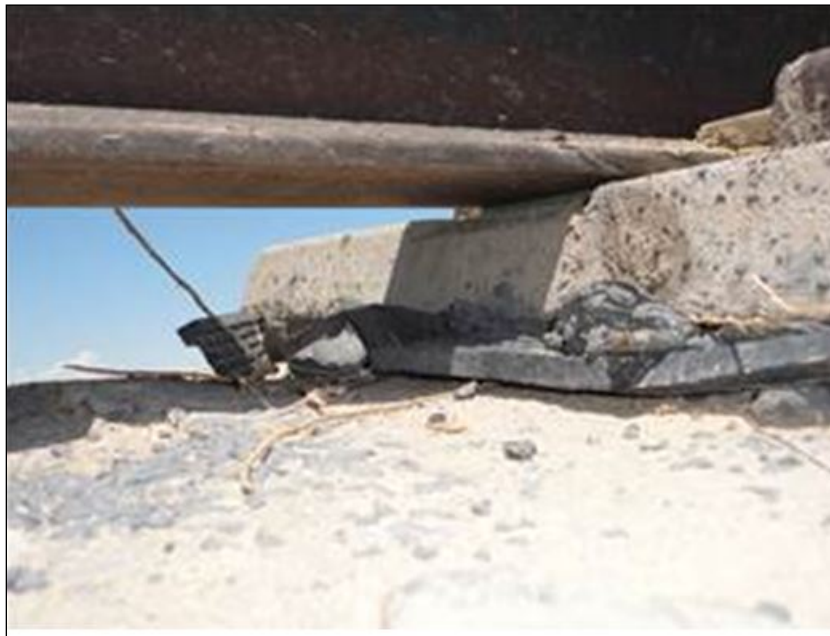
**Figure 18. Close-up of Rubber Boot Abrasion and Deterioration**

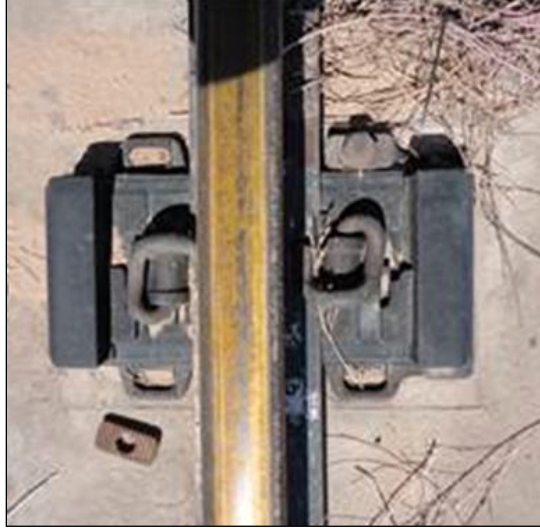
The bolt was considered loose if a slight tap of a hammer would jar or move a serrated washer under a bolt. A very loose bolt allowed the serrated washer to be dislocated by fingers. Skewed washers are not seated properly, but are snug and cannot be moved. Some bolts were missing and this included both missing bolts and broken bolts where the bolt is broken off in the anchor insert.

**Figure 20. DFST Fastener with Three Missing Bolts**

The DFST fastener system performed well during its life in the concrete slab in the HTL. Over time, bolt tension became an issue where the bolts were allowing dislocation of the serrated washers, which developed resistance to movement. Bolt tension was examined in 2010 and again in 2014. The inventory of the plates showed that a significant number of anchor bolts were not providing adequate hold-down force to the serrated washers to maintain adequate lateral resistance. As with the IDBT fasteners, program maintenance would have likely been required to address all the anchor bolt issues at the same time.

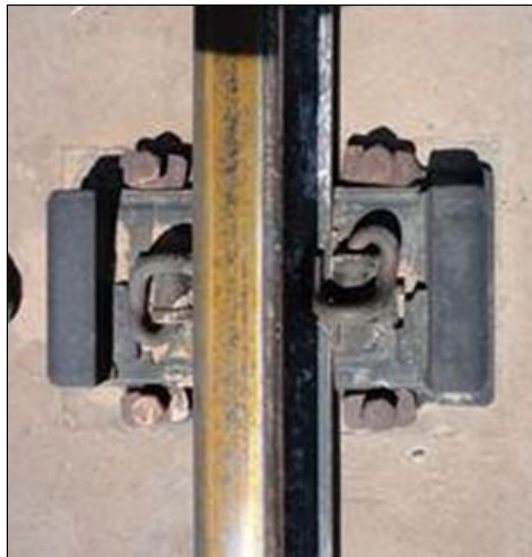
**Figure 21. DFST Fastener with Four Loose Bolts**
