***Federal Railroad Administration
Office of Railroad Safety
Accident and Analysis Branch***

***Accident Investigation Report
HQ-2016-1140***

***Amtrak (ATK)
Trinidad, CO
June 26, 2016***

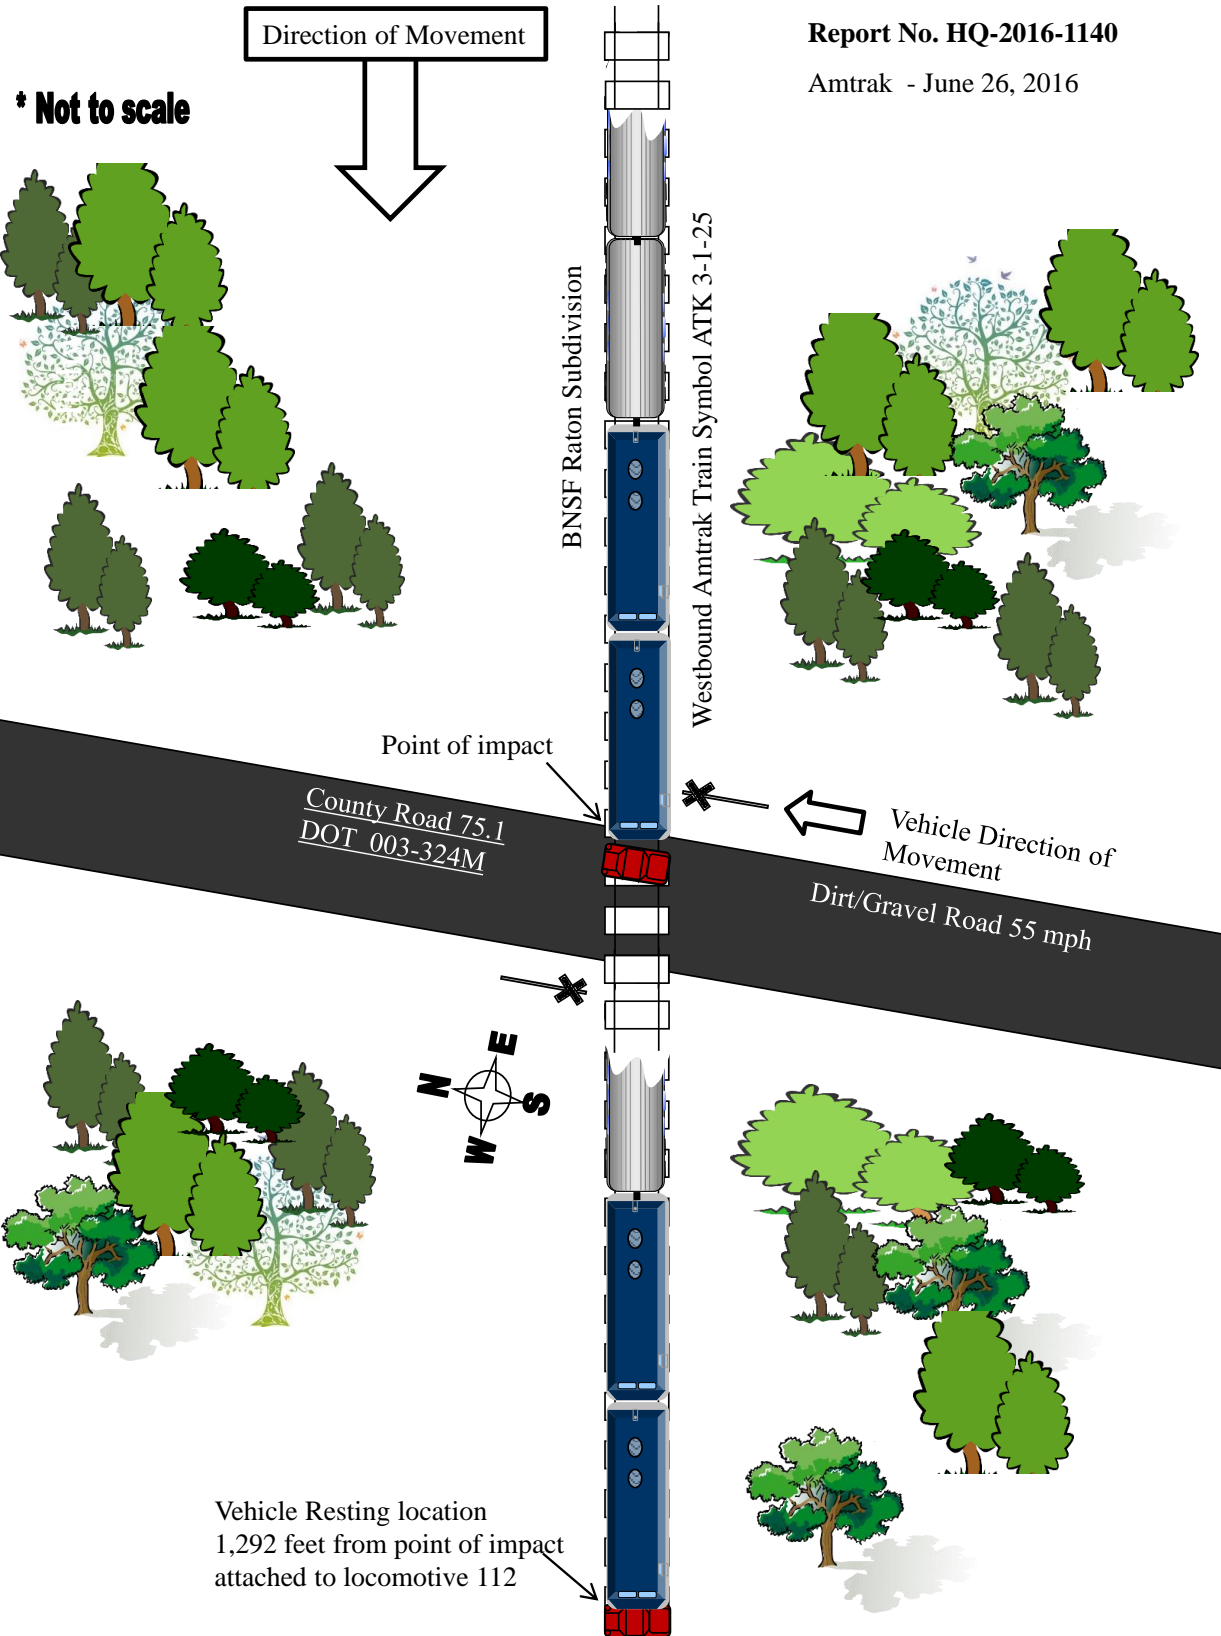
HQ-2016-1140 Sketch

At 9:45 a.m., MDT, Train ATK 3-1-25 struck the right side of the passenger van at approximately the midpoint of the vehicle in the HGC. The passenger van was carried west along the track for approximately 1,292 feet before coming to a stop on the front of the train.

Except for a very narrow view of the crossing directly ahead, a vehicle driver traveling north on County Road 75.1 approaching this HGC would not be able to observe a train approaching the HGC from the east while in the “Approach Zone” (between “Cone A” and “Cone B” - 1,030 feet to 535 feet from the HGC) due to trees, brush, and other vegetation east of the roadway and south of the railroad tracks. As a vehicle continues north into the “Non-recovery Zone” (between “Cone B” and “Cone C” - 535 feet to the crossing stop line), visibility for the driver continues to be obstructed until the vehicle is 94 feet from the crossing stop line. This is the “Actual Sight Distance,” and the point at which a driver would now be able to see an approaching train approximately 895 feet away. The “Actual Sight Distance” along with “Cone C” and “Cone D” represents the “Approach Sight Triangle” where a driver’s view would remain relatively unobstructed to the HGC.

Conclusion: By the time the vehicle operator would have had an unobstructed line of sight with the train (94 feet from the safe zone), the vehicle would be well past the point of non-recovery.
