***Federal Railroad Administration
Office of Railroad Safety
Accident and Analysis Branch***

***Accident Investigation Report
HQ-2016-1152***

***Union Pacific (UP)
Lewisville, AR
August 14, 2016***

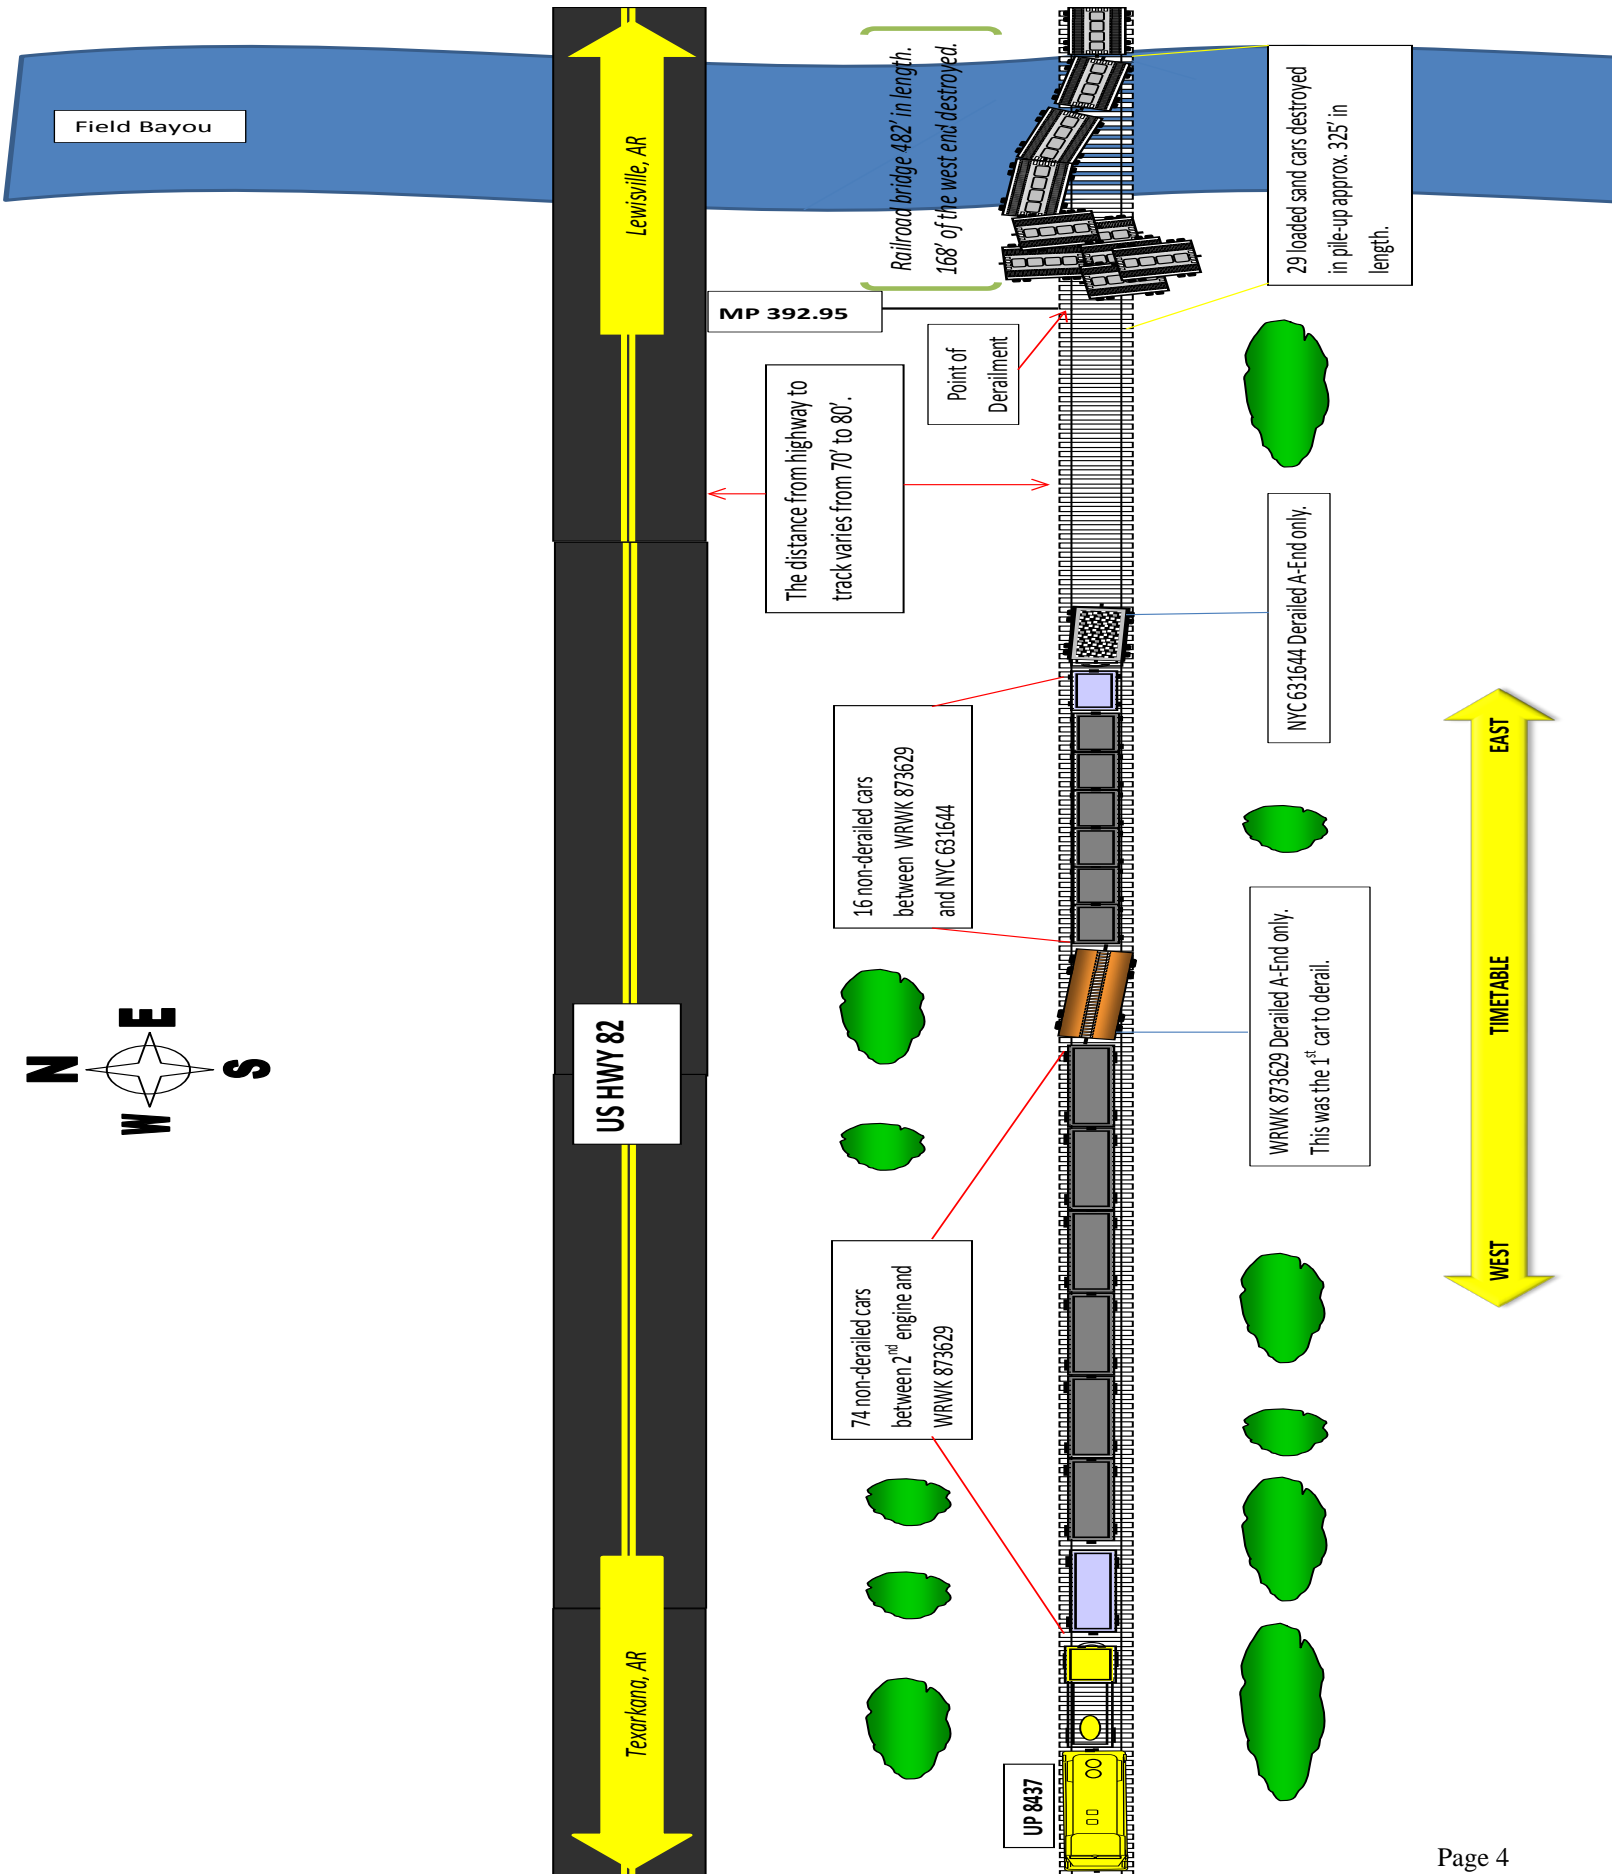
Sketch 392.95

The derailment occurred approximately 3.25 miles west of Lewisville, Arkansas, on UP's Pine Bluff Subdivision at Milepost 392.95 on a single main track owned and maintained by UP. Movements on this part of the railroad are governed by centralized traffic control, with a maximum authorized speed of 70 mph.

This derailment occurred in tangent track approximately 8/10-mile from the last curve traversed and 1.75 miles to the next curve. Timetable directions are used throughout this report.
