***Federal Railroad Administration
Office of Railroad Safety
Accident and Analysis Branch***

***Accident Investigation Report
HQ-2016-1158***

***Union Pacific Railroad Company (UP)
Dexter, MO
September 2, 2016***

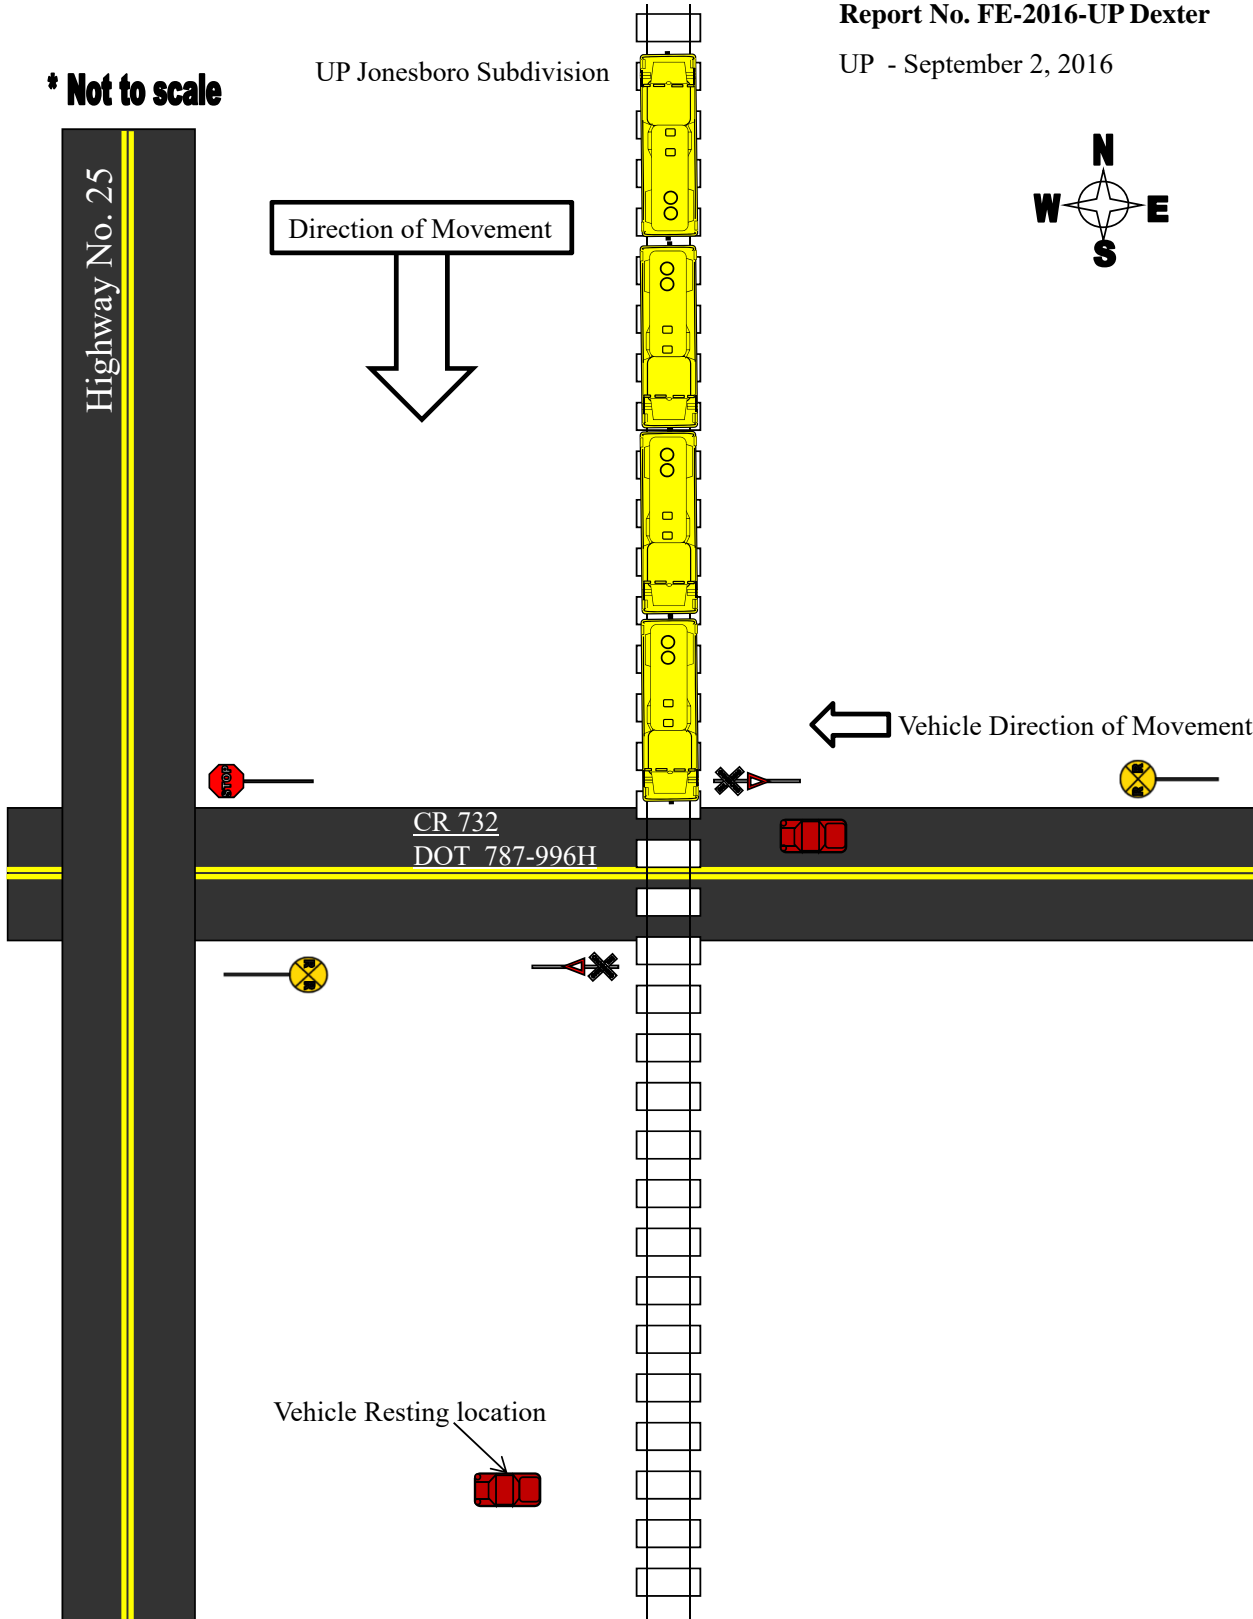
HQ-2016-1158 Sketch

Direction of Movement

Vehicle Direction of Movement

Vehicle Resting location
