**RESEARCH RESULTS**  
FRA OFFICE OF RAILROAD POLICY & DEVELOPMENT

RR 18-03 | February 2018

## FULL-SCALE SHELL IMPACT TEST OF A DOT-117 TANK CAR

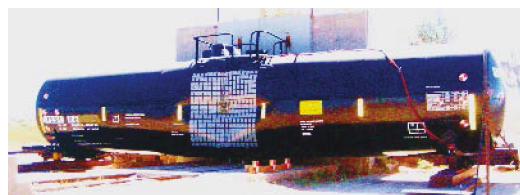
Figure 2. Post-test Photo of DOT-117

The DOT-117 tank car's jacket experienced two vertical tears during the test, but the tank was not punctured. The impact created an approximately 52-inch indentation and a peak force of nearly 900 kips. After the test, the impact vehicle and the tank car itself rebounded from the impact wall, which created a 10 inch to 14 inch gap between the wall and the back of the tank. Figure 2 shows the tank car in its post-test condition.

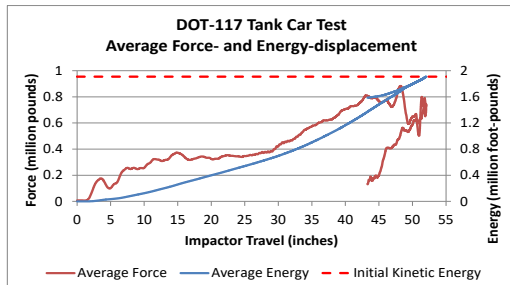
Figure 4. Force- and Energy-displacement Test Results

The impact occurred at 13.9 mph and tore the jacket, but did not puncture the tank. The impactor had a maximum displacement of approximately 52 inches after making contact with the jacket of the tank. The peak force during the impact was nearly 900 kips. The force-displacement and energy-displacement results from the test are shown in Figure 4, as well as the initial kinetic energy of the ram. These results are the average of the five longitudinal accelerometers mounted on the impact cart, with data filtered according to SAE J211/1. [3]

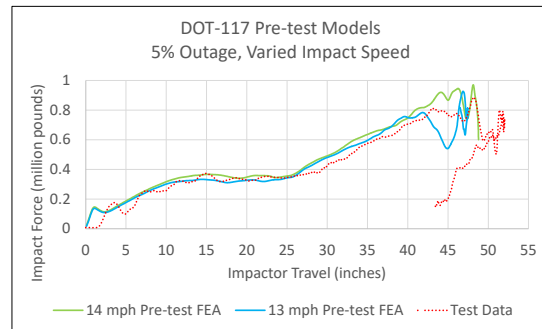
Figure 5. Pre-test FEA and Force-displacement Test Results

The force-displacement results from the test and from the pre-test FEA model were run at 13 mph and 14 mph. They are compared to one another in Figure 5. The pre-test model used a material response based on strength and ductility measurements of the plates used to build this car. Generally, there was good agreement between the test and the model over the full range of the test measurements.

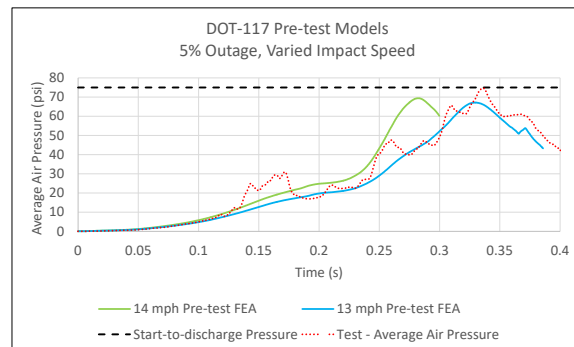
Figure 6. Pre-test FEA and Test Air Pressure Results

The average air pressure in the pre-test FEA models were compared to the air pressure measured during the test in Figure 6. Overall, there was good agreement between the air pressure in the FEA model and the test.
