***Federal Railroad Administration
Office of Railroad Safety
Accident and Analysis Branch***

***Accident Investigation Report
HQ-2016-1136***

***Union Pacific (UP)
Mosier, OR
June 3, 2016***

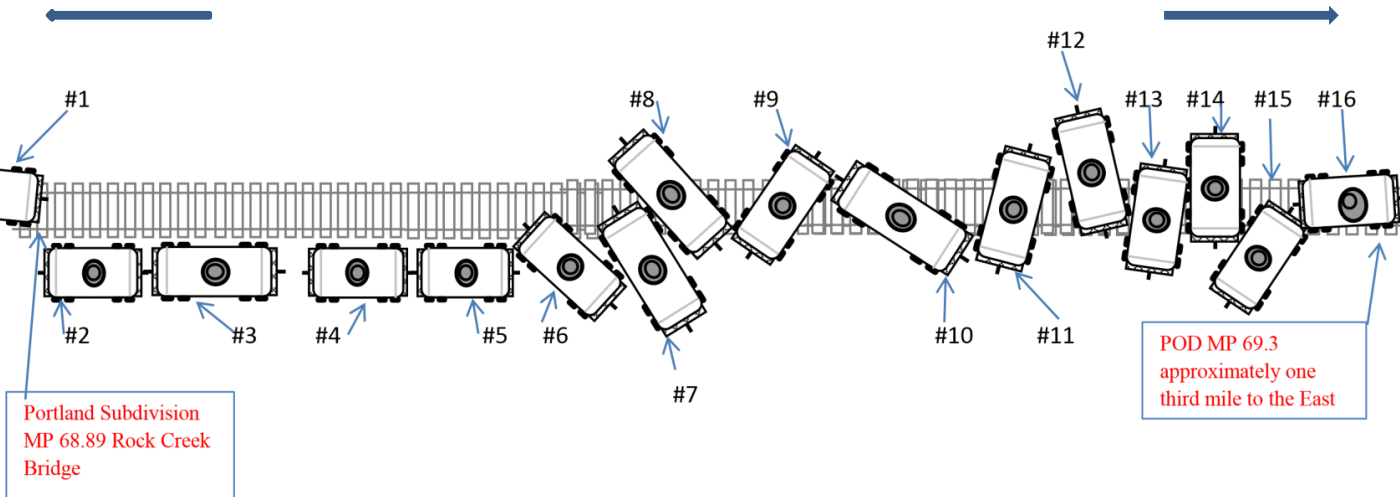
HQ-2016-1136 Site Sketch

1. #19 GATX 213306 East end of car derailed, came to rest 432 feet west of car #20
2. #20 GATX 213166 First car to derail at POD, B end of car was down first, lying on right side
3. #21 GATX 213175 Approximately 25 feet from car #20, lying on left side
4. #22 GATX 213247 Derailed, lying on left side.
5. #23 GATX 213214 Derailed, lying on right side.
6. #24 GATX 213161 Derailed, lying on right side. Fire damaged.
7. #25 GATX 213190 Derailed, lying on right side, **on fire.**
8. #26 GATX 213345 Derailed, lying on right side. Fire damaged.
9. #27 GATX 213338 Derailed, lying on right side, **on fire.**
10. #28 GATX 213332 Derailed upright, **on fire.**
11. #29 GATX 213236 Derailed upright
12. #30 GATX 213341 Derailed upright
13. #31 GATX 213343 Derailed, laying on right side.
14. #32 GATX 213178 Derailed upright.
15. #33 GATX 213280 Derailed upright
16. #34 GATX 213222 Derailed upright
